SUBJECT: Soils Report and Recommendation for Project SS-1-003(034)059

LINEAR SOIL REPORT AND RECOMMENDATION

Project: SS-1-003(034)059

Project Description: Jct 34 N to I-94 Dawson

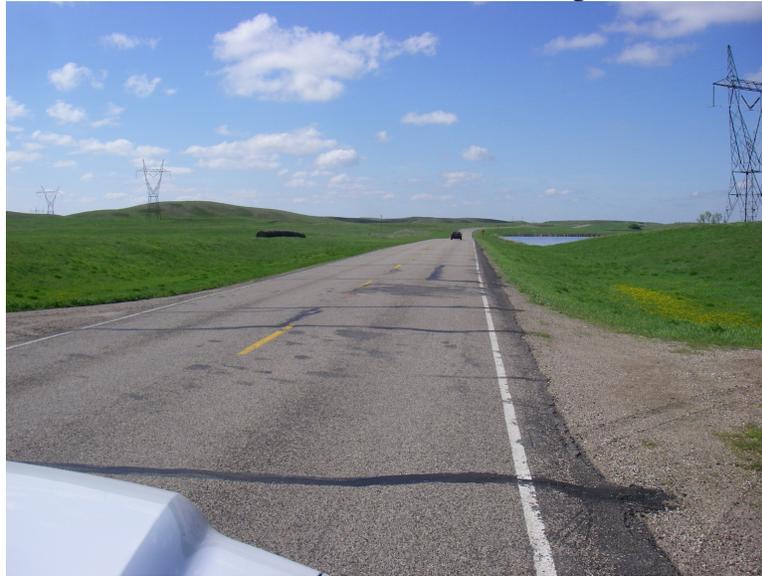
RP 67+5040 (Distress Area 1) Looking South

This area is indicated as a medium severity frost heave that is primarily in the SB lane. This area is seasonally signed. The group indices in this area are low, and swell potential for the soils in this area are low. The average moisture content of the soil samples in this area were 5.3% over their optimum moisture values. The differing soil types (shown below) are the most likely cause of the frost heave. The clay soil types heave in the winter, and the aggregate soil types do not heave. In a phone conversation with Marvin Lang on 6/22/2010, he mentioned that this bump gets so severe in the winter that local SB traffic moves into the other lane to avoid it. Plows have to raise the blade or else they will hit the road. Due to the severity of the distress in this section of the roadway, the Geotechnical Section recommends a subcut in this area.

The analysis of the soils shows that most of the samples have a low group index and low swell potential. However, one area had high in-place moisture contents. This area has large differentials in moisture contents and material within the area. In Distress Area 1, there is a three foot differential in base thickness within this area. This area was listed by maintenance personnel as a frost heave and is seasonally signed. The Geotechnical Section recommends subcutting this area.

<u>RP + Feet</u>	to	<u>RP + Feet</u>	<u>Remarks</u>
67+5005		67+5125	Subcut to a depth of 48" below the top of the existing pavement elevation at full width of the roadway embankment. Place reinforcement fabric (R1) at the bottom of the subcut excavation and backfill with Class 3 or Class 5 aggregate. Place 6 inches of aggregate on the fabric prior to compacting. Do not scarify the bottom of the subcut. Compaction of aggregate shall comply with 90% of the maximum dry density as determined by AASHTO T-180.

Total Subcut Length = **120 feet**

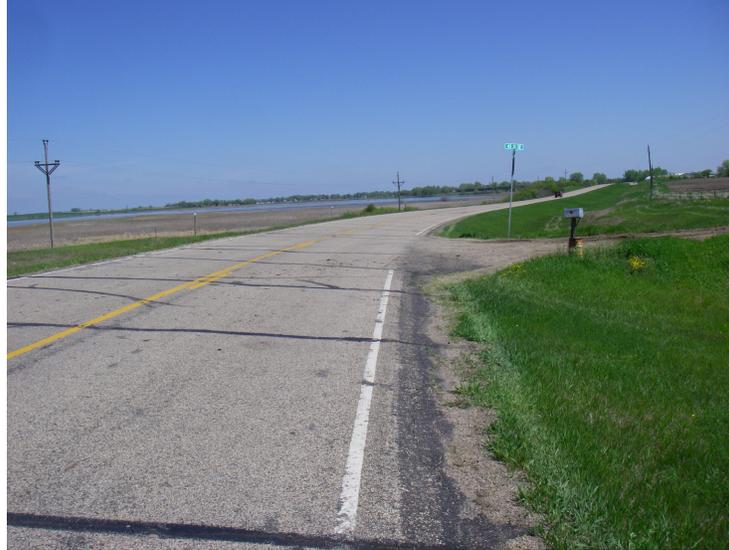
RP 78+3690 to RP 78+3800 (Distress Area 2) Looking North

This area is indicated as a low severity frost heave that is primarily in the NB lane. **This area is not seasonally signed.** The group indices in this area ranged from 0 to 30, and swell potential for the soils in this area are low to moderate. The average moisture content of the soil samples in this area were 11.4% over their optimum moisture values. The differing soil types (shown below) are the most likely cause of the frost heave. The clay soil types heave in the winter, and the aggregate soil types do not heave. On 10/6/2010 Jon Ketterling, Jeff Jirava, and Greg Wolter conducted a site visit of the project. During the site visit no apparent pavement distress was found in this area. In a phone conversation with Marvin Lang on 10/7/2010, he mentioned that this heave is not a sharp heave in the winter, and the distress is minor. Due to the lack of severity of distress in this section of the roadway, the Geotechnical Section does not recommend a subcut in this area.

Frost boil - north bound lane is very bad in the winter time. South bound lane is fair.

Currently frost boil is healed out completely. Frost boil starts south end of the approach past the north end of the approach.

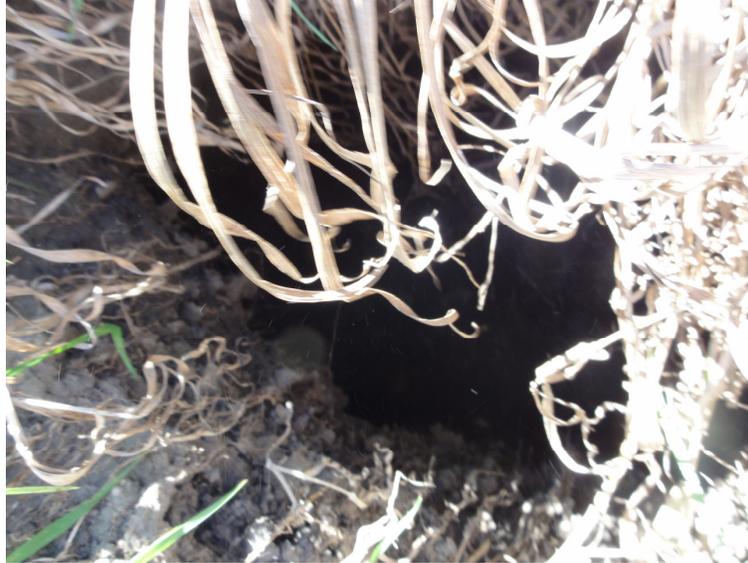
RP 79+0986 (void in inslope above cattle pass)

On 10/6/2010 Jon Ketterling, Jeff Jirava, and Greg Wolter conducted a site visit of the project. During the site visit, we investigated a cattle pass mentioned in a fax from Marvin Lang. In the embankment above the cattle pass there are voids. The Geotechnical Section recommends filling these voids.

Cattle pass fitted into square box culvert. Internal separation which needs to be addressed.

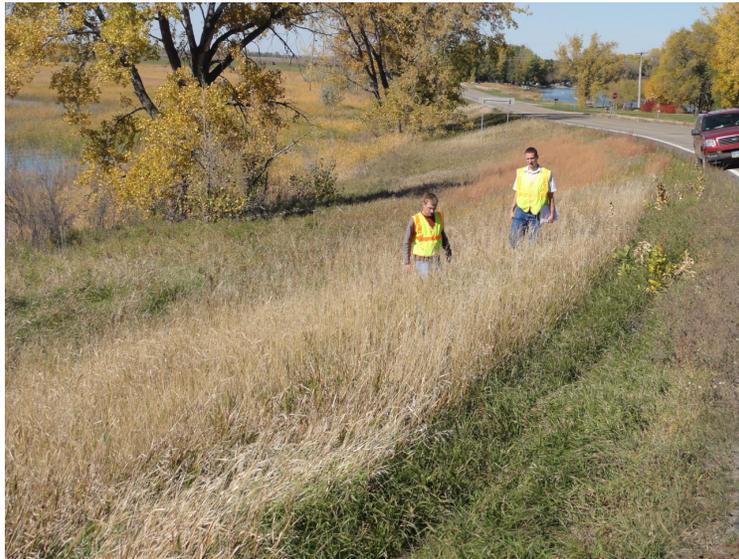
RP 79+4431

During the site visit on 10/6/2010, the Geotechnical Section investigated a landslide. The landslide is not affecting the roadway at this time, and is considered a low risk. The slide begins five feet from the edge of the roadway. Marvin Lang mentioned that this slide has been here for the last 15 years. The Geotechnical Section recommends that this area be monitored.

Mm 79 - 4431 ft. N - west side of road – large slide area. Have been fighting this area for the last 15 years. Shoulder area slides away within 3-4 ft. of asphalt. Area is sliding into the lake. This area is several hundred feet long and is in poor condition at this time.

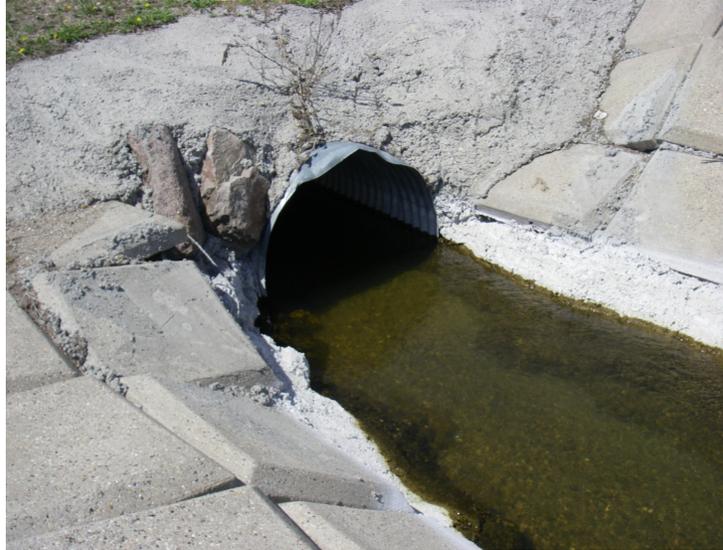
RP 80+1578 (Distress Area 3)

This area is indicated as a low severity dip at culvert. The pipe is 36" diameter corrugated steel. It is one of three that drain Lake Isabel. This area is not signed. The group indices and swell potential in this area are low. The average moisture content of the soil samples in this area were 1.2% over their optimum moisture values. Due to the lack of distress in this section of the roadway, the Geotechnical Section does not recommend a subcut in this area.

Mile .80 - regarding 3 drainage pipes on SW corner of Lake Isabelle. – outlet of all 3 pipes is eroding and needs ripwrap with concrete slurry added to hold rocks in place.

Main pipe in channel (the west pipe) was leaking water between the pipe and the road in 1997 – contractor was hired and did not dig up roadway but was able to stop seepage with betonite. (same stuff used on oil wells)

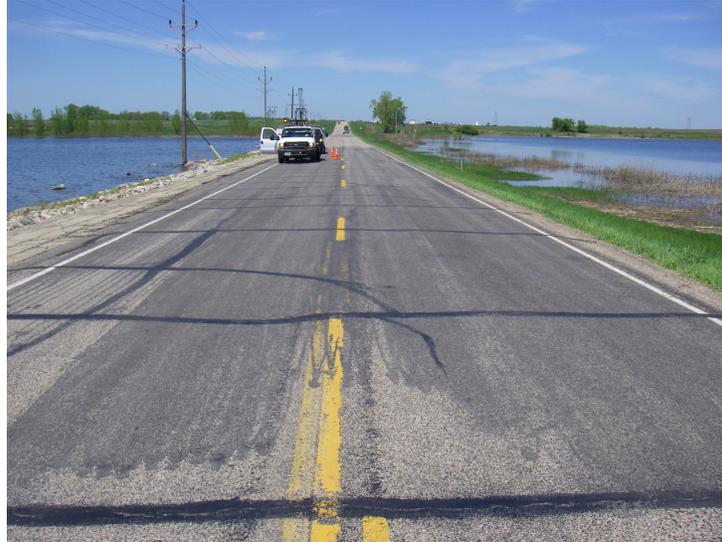
RP 82+2410 (Distress Area 4)

This area is indicated as a low severity transverse crack at culvert. The pipe is 36" diameter RCP. This area is not signed. The group indices and swell potential in this area are low. The average moisture content of the soil samples in this area were 2.5% over their optimum moisture values. According to Marvin's fax, the pipe is separating. There are no pictures of the pipe separated, because the pipe is completely full of water. Since the remedy for the distress in this section of the roadway would require replacing/relaying the pipe, the Geotechnical Section does not recommend a subcut in this area, and would defer to the Hydraulics Section for further repair recommendations.

2402 ft. N of mm .82 - pipe under highway completely plugged – water backing up – it was working last year fine. This pipe has a separation for sure in the north bound lane – in 1997 this collapsed leaving hole in lane 5 feet across. It was fixed temporarily and has never been addressed. Concrete pipes have wide separation – sheet of tin laid over separation , filled hole with asphalt. This must be addressed.

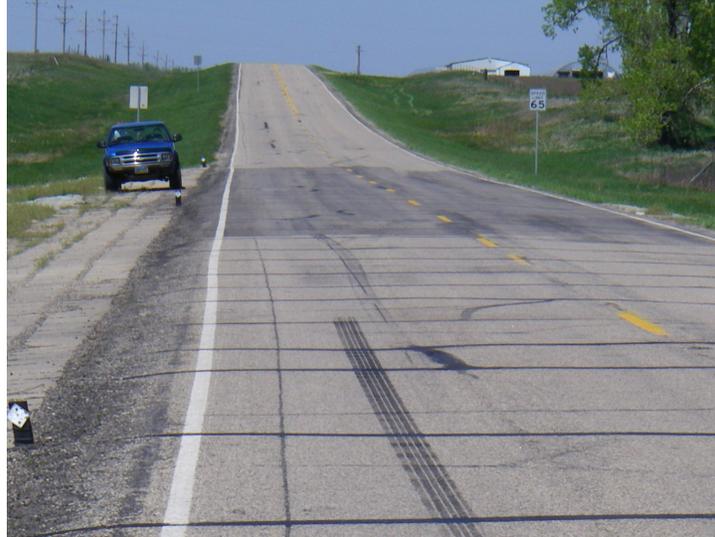
RP 82+3067 (Distress Area 5)

This area is indicated as a low severity transverse crack at culvert that appears patched. The pipe is 36" diameter RCP. This area is not signed. The group indices and swell potential in this area are low. The average moisture content of the soil samples in this area were 4.5% over their optimum moisture values. According to Marvin's fax, water flow is restricted in the culverts in this area. Marvin stated, "These two culverts as well as the 3 on the south end of Lake Isabelle need to have grates put over them and extended out several feet into the channels which would allow water to pass but keep public from trying to plug culvert with rocks, sand bags, etc." Due to the lack of subgrade distress in this section of the roadway, the Geotechnical Section does not recommend a subcut in this area.

3057 ft. N of mm 82 - culvert has numerous rocks inside and unable to get out . water flow is restricted. May have to address this issue soon . These two culverts as well as the 3 on the south end of Lake Isabelle need to have grates put over them and extended out several feet into the channels which would allow water to pass but keep public from trying to plug culvert with rocks, sand bags, etc. Grates should be hinged for clean out purposes. This has been an ongoing issue that even as of today we have been fighting for the last 30 years since this recreation area was established.
