Asbestos Survey Report

June 2015

North Washington Street Reconstruction
Bismarck, North Dakota

Prepared by:
KLJ
4585 Coleman Street
Bismarck, ND 58503

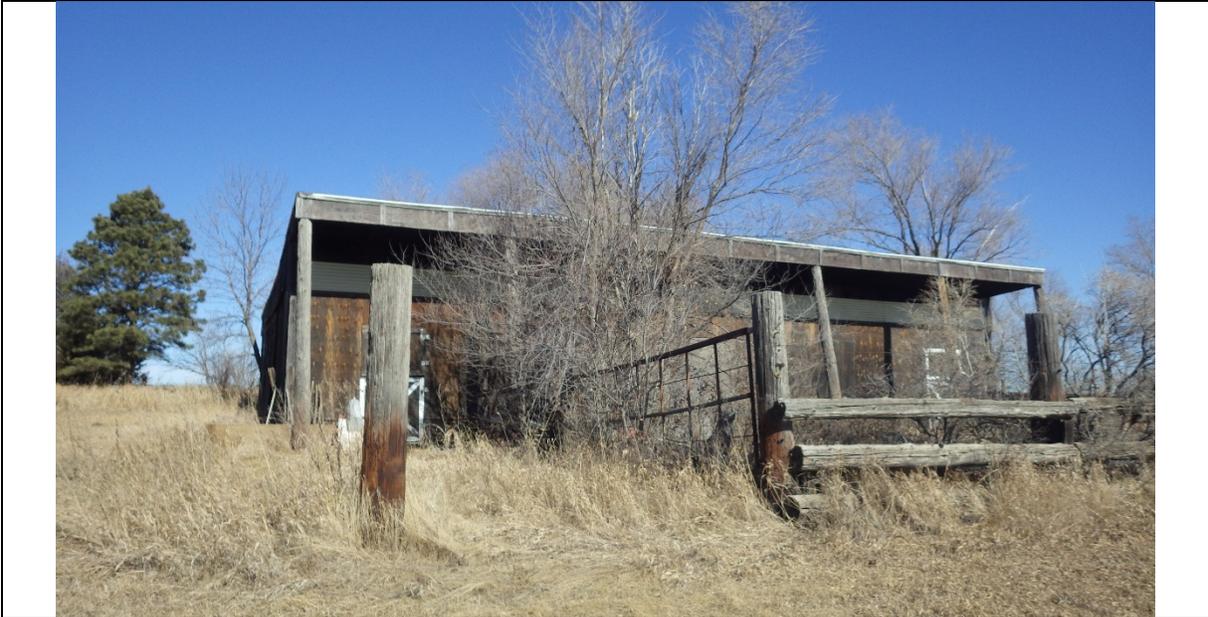
Photograph #1	Barn Structure

Date Taken:	March 9, 2015	
Direction:	North	
Description:	Barn exterior

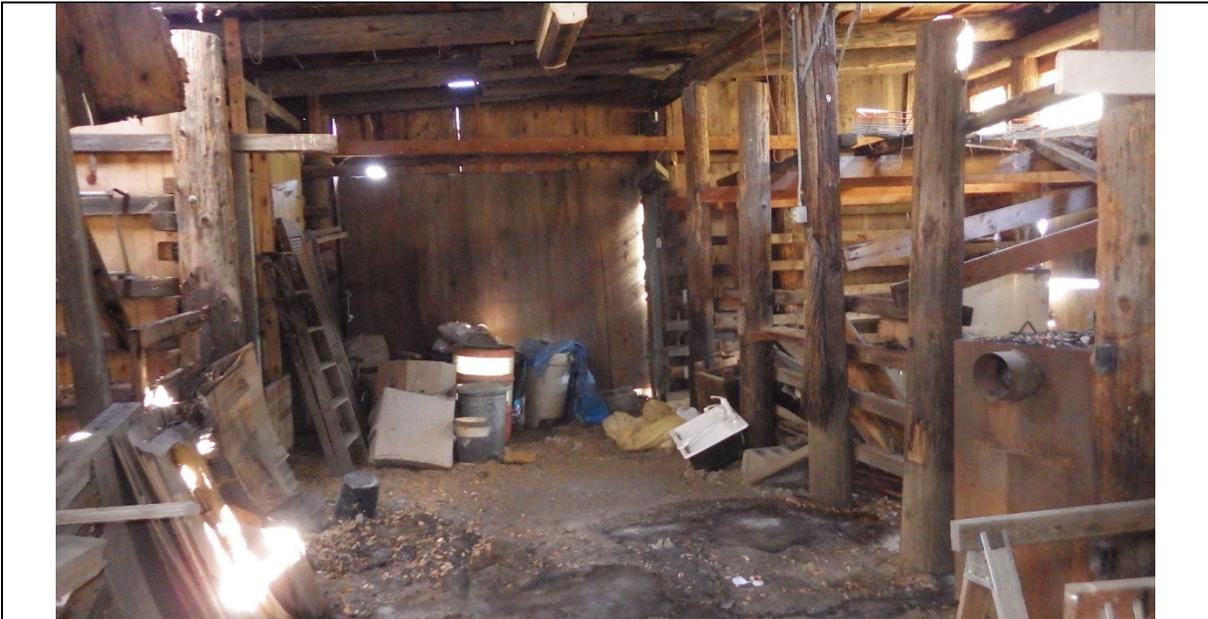
Photograph #2	Barn Structure

Date Taken:	March 9, 2015	
Direction:	East	
Description:	Barn interior

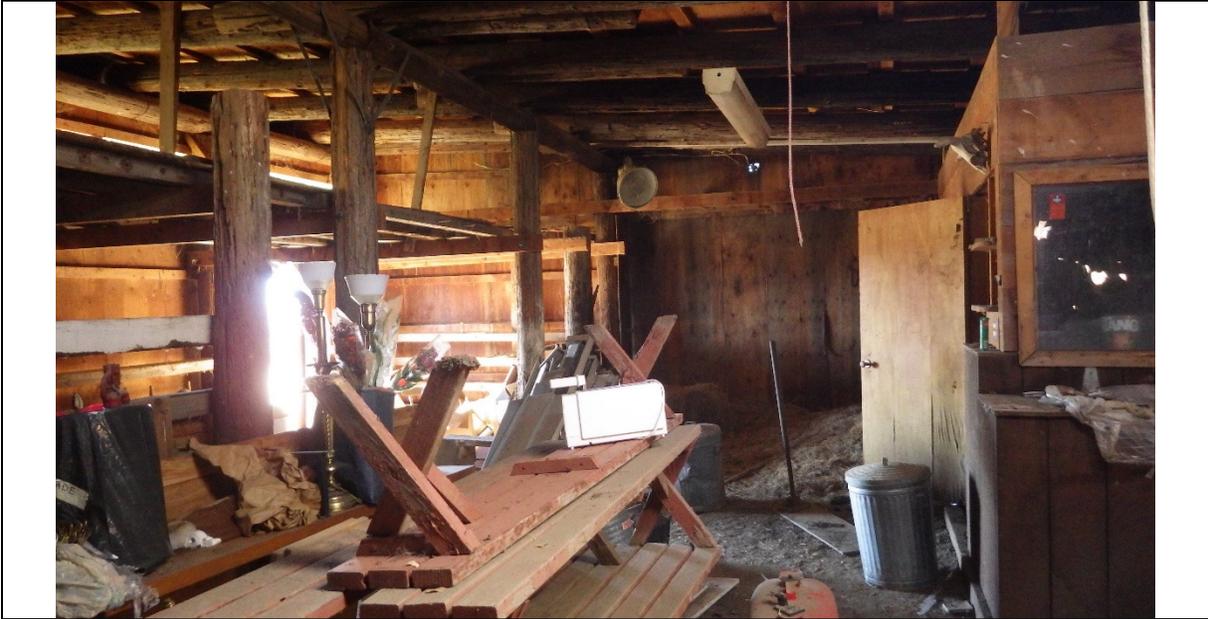
Photograph #3	Barn Structure

Date Taken:	March 9, 2015	
Direction:	West	
Description:	Barn interior

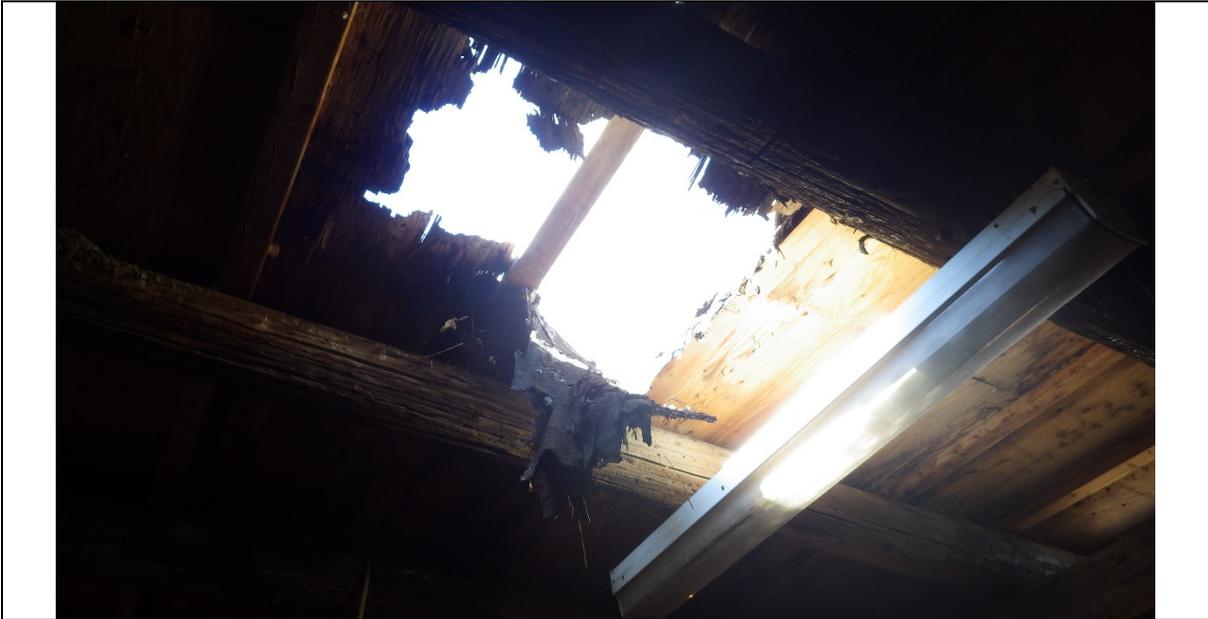
Photograph #4	Barn Structure

A total of three bulk samples (asphalt shingles) were collected and analyzed during the assessment of the barn; no ACMs were identified. The laboratory results for this sample can be found in **Appendix C: Lab Results and Chain of Custody Documentation**.

Date Taken:	March 9, 2015	
Direction:	Northwest	
Description:	Roof – Note the asphalt shingles
