# ***Asbestos Survey Report***

Edgewater Country Club  
Asbestos Inspection  
New Town, North Dakota

Prepared for:  
North Dakota Department of Transportation  
608 East Boulevard Avenue  
Bismarck, North Dakota 58505-0700

Prepared by:  
KLJ  
4585 Coleman Street  
Bismarck, North Dakota 58503

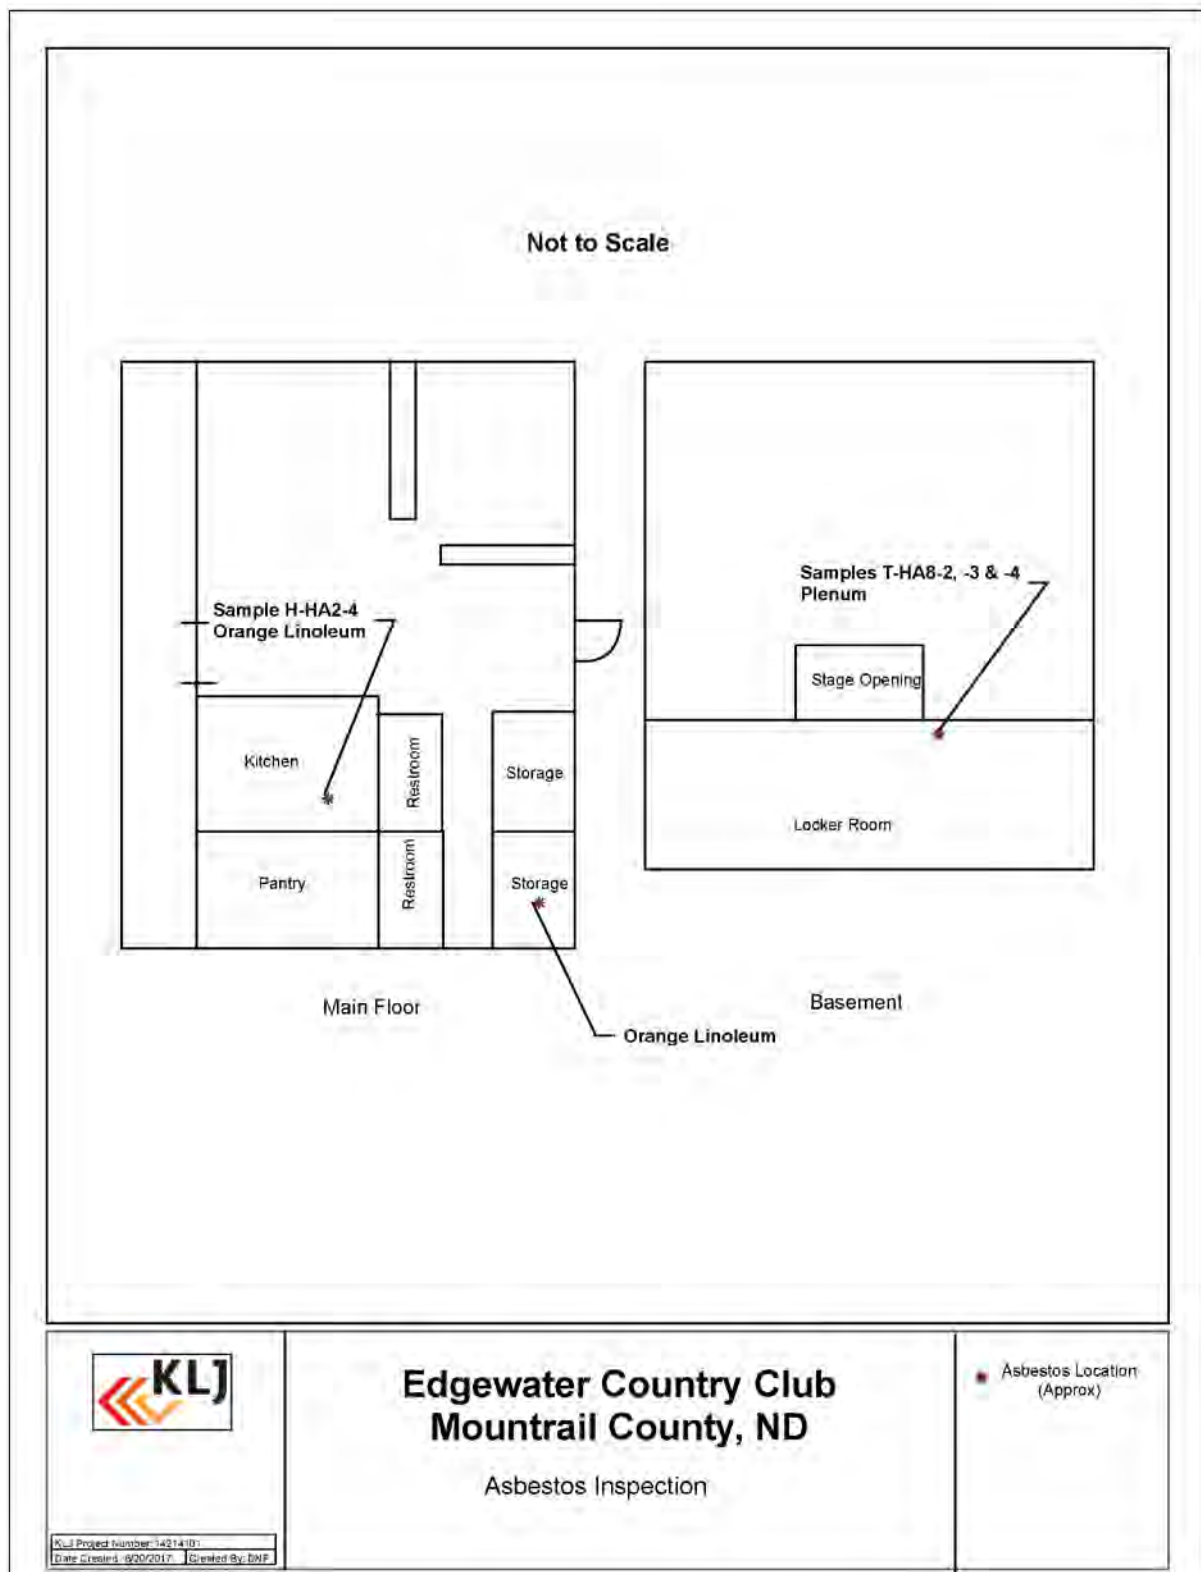
**Figure 2, ACM Locations within Clubhouse**

- M-HA2-4: This non-friable sample was collected from a layer of older clubhouse flooring that was visible under newer layers of flooring in the kitchen area. This flooring was seen in the storage room of the clubhouse as well. The layered sample contained orange linoleum with a fibrous backing along with a yellow mastic. The orange linoleum with fibrous backing was found to contain 15 percent chrysotile asbestos. It is unknown how much of the ACM exist within the building due to multiple renovations and remodeling projects, which may have removed some material or have covered up the material.

- T-HA8-2, 3,4: These samples were collected from a plenum near the old stage opening in the locker room area. The layered sample contained off-white wrapping material that was extremely friable. The wrapping was found to contain 70 percent chrysotile asbestos. This material was not seen in any other part of the structure. It is unknown how much of the ACM exists within the building due to multiple renovations and remodeling projects, which may have removed or covered up the material.

Three of the four buildings associated with the Edgewater Country Club did not contain asbestos. Four asbestos containing samples were obtained from the clubhouse. All ACMs must be handled according to Occupational Safety and Health Administration (OSHA), EPA, and applicable state and local regulations.

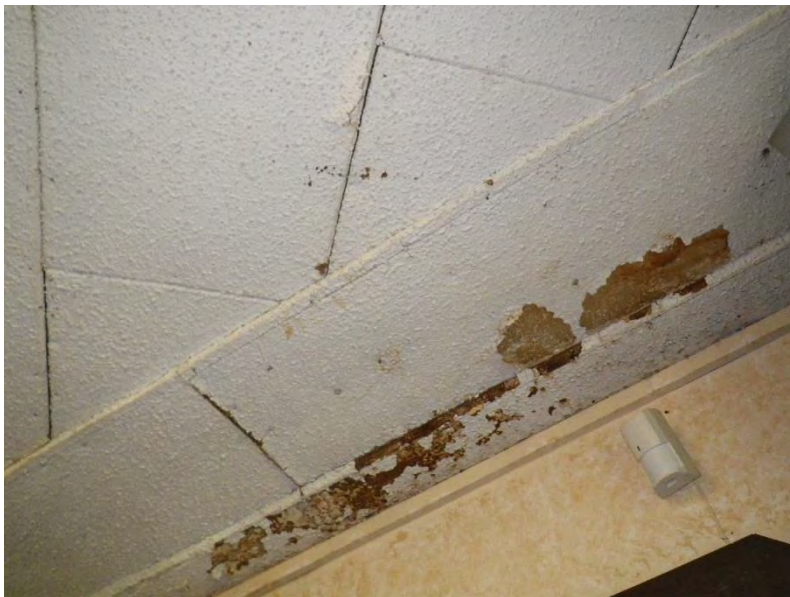
**Photograph #818**

<b>Building:</b>	Edgewater Country Club	Sample #: M-HA1-1,2
<b>Date Taken:</b>	May 18, 2017

<b>Sample Location:</b>	Main Dining	
<b>Description:</b>	White 6'x 1' ceiling tile and 2'x1' ceiling tile

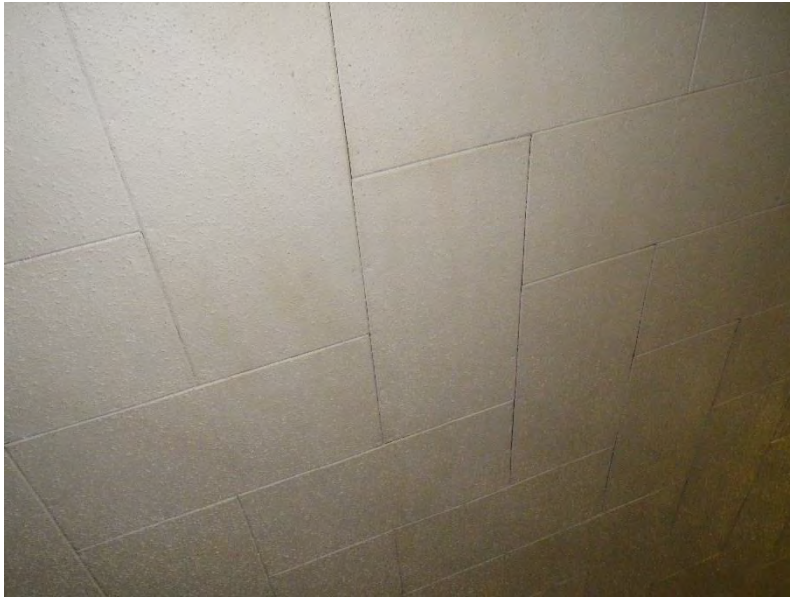
**Photograph #815**

<b>Building:</b>	Edgewater Country Club	Sample #: M-HA1-1

<b>Date Taken:</b>	May 18, 2017	
<b>Sample Location:</b>	Main Dining	
<b>Description:</b>	White 2'x1' ceiling tile

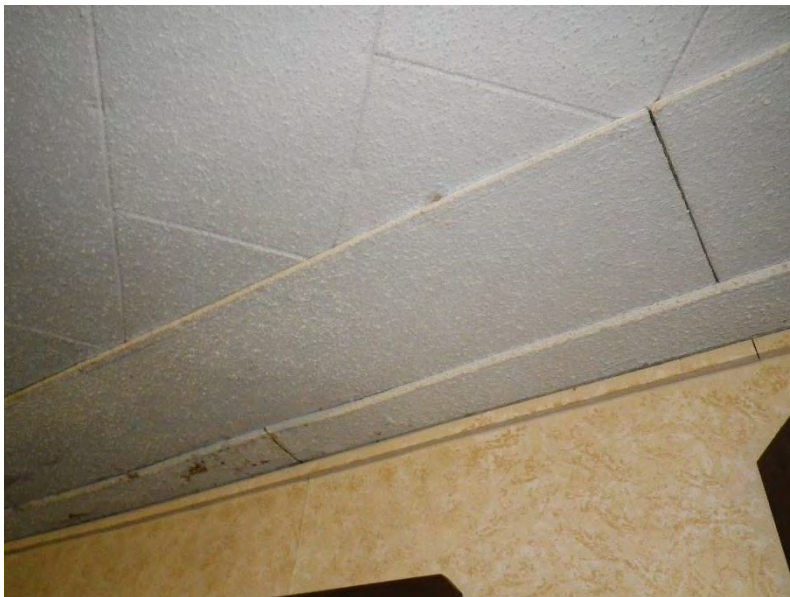
**Photograph #817**

<b>Building:</b>	Edgewater Country Club	Sample #: M-HA1-2

<b>Date Taken:</b>	May 18, 2017	
<b>Sample Location:</b>	Main Dining	
<b>Description:</b>	White 6'x 1' ceiling tile

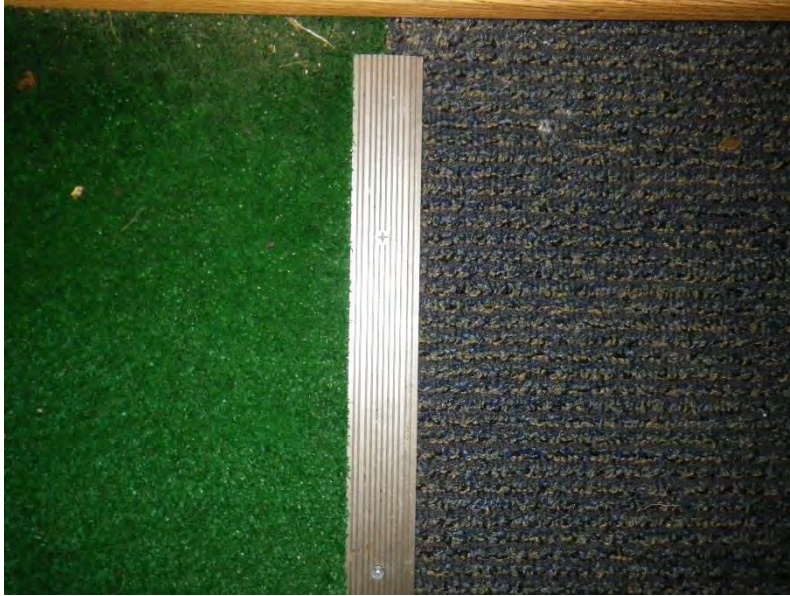
**Photograph #819**

<b>Building:</b>	Edgewater Country Club	Sample #: M-HA1-3, 4

<b>Date Taken:</b>	May 18, 2017	
<b>Sample Location:</b>	Main dining	
<b>Description:</b>	Green carpet and adhesive/ Blue carpet and adhesive

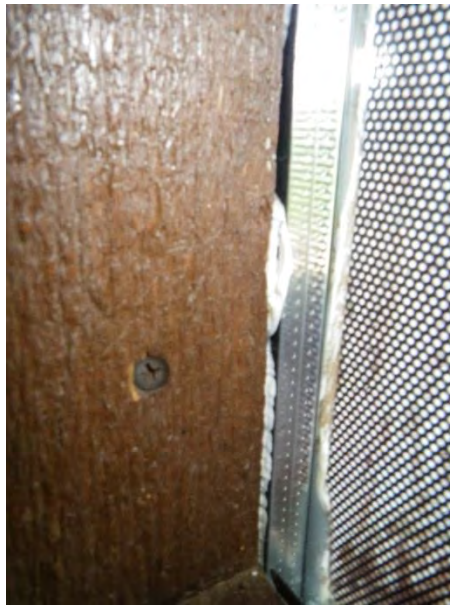
**Photograph #820**

<b>Building:</b>	Edgewater Country Club	Sample #: M-HA1-5

<b>Date Taken:</b>	May 18, 2017	
<b>Sample Location:</b>	Main Dining	
<b>Description:</b>	White window caulk

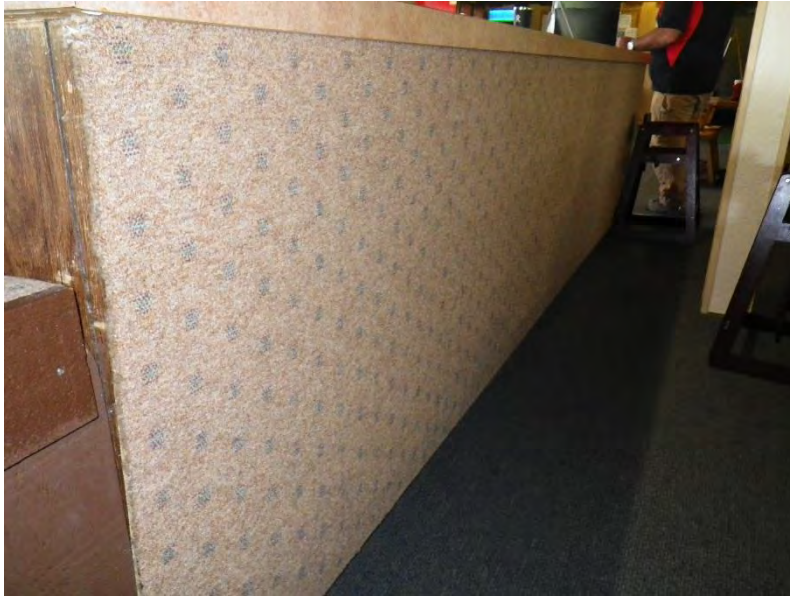
**Photograph #821**

<b>Building:</b>	Edgewater Country Club	Sample #: M-HA1-6
<b>Date Taken:</b>	May 18, 2017

<b>Sample Location:</b>	Main Dining	
<b>Description:</b>	Tan checked carpet and adhesive

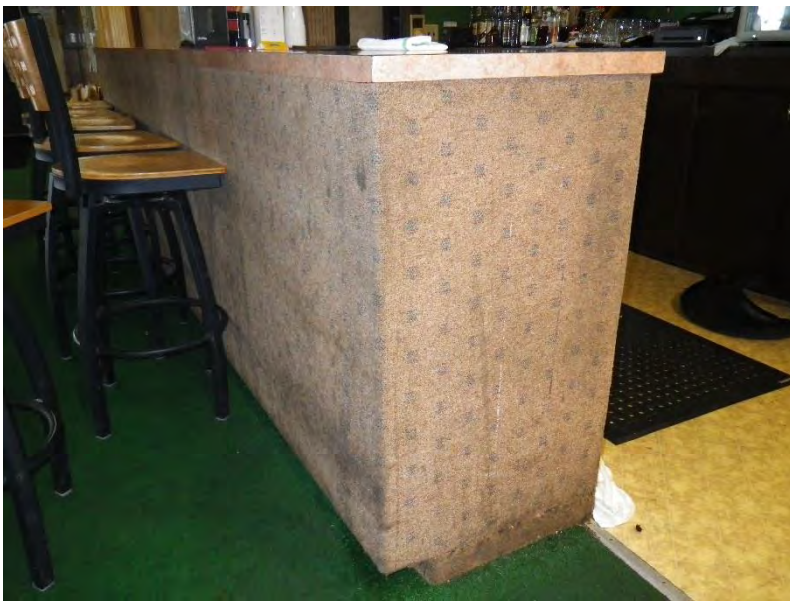
**Photograph #822**

<b>Building:</b>	Edgewater Country Club	Sample #: M-HA1-7
<b>Date Taken:</b>	May 18, 2017

<b>Sample Location:</b>	Main dining	
<b>Description:</b>	Tan checked carpet and adhesive

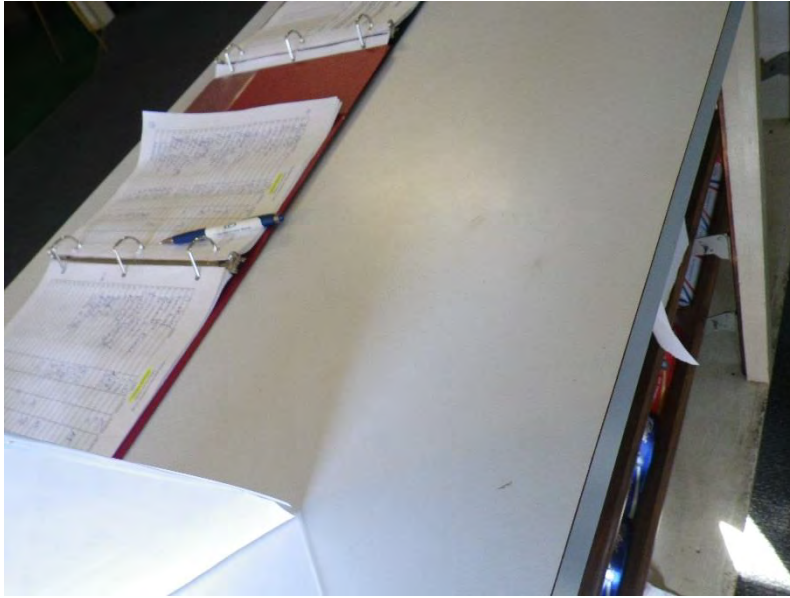
**Photograph #823**

<b>Building:</b>	Edgewater Country Club	Sample #: M-HA1-8
<b>Date Taken:</b>	May 18, 2017	 
<b>Sample Location:</b>	Main Dining	
<b>Description:</b>	White Formica counter top and adhesive

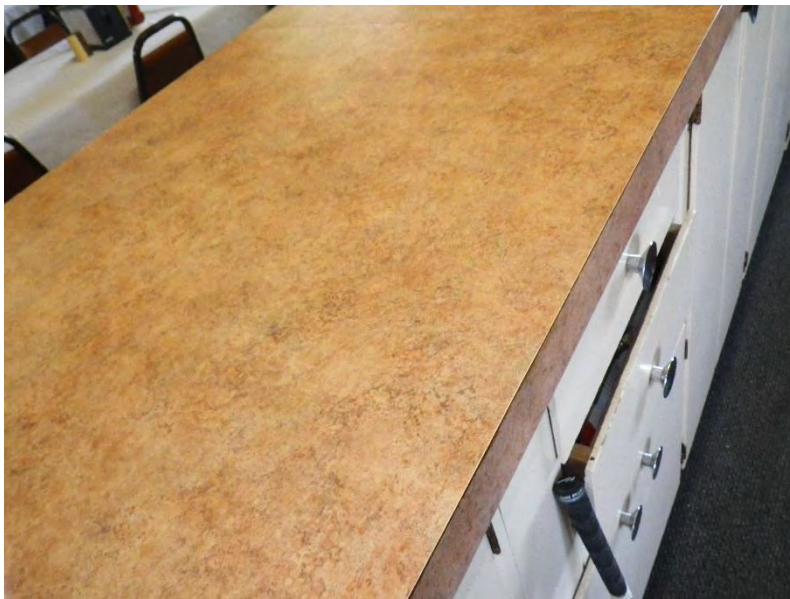
**Photograph #824**

<b>Building:</b>	Edgewater Country Club	Sample #: M-HA1-9
<b>Date Taken:</b>	May 18, 2017	 
<b>Sample Location:</b>	Main dining	
<b>Description:</b>	Pecan Formica counter top and adhesive

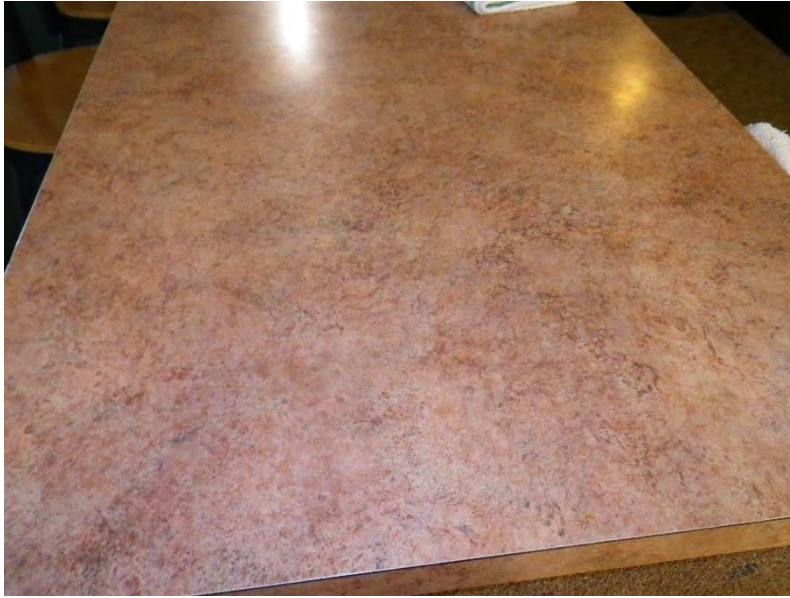
**Photograph #825**

<b>Building:</b>	Edgewater Country Club	Sample #: M-HA1-10
<b>Date Taken:</b>	May 18, 2017	 
<b>Sample Location:</b>	Main dining	
<b>Description:</b>	Peach Formica counter top and adhesive

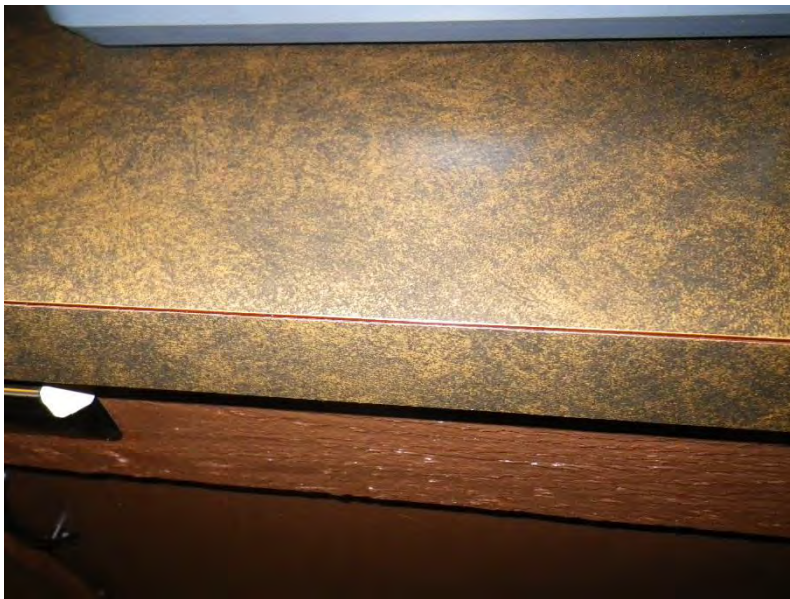
**Photograph #826**

<b>Building:</b>	Edgewater Country Club	Sample #: M-HA2-1
<b>Date Taken:</b>	May 18, 2017

<b>Sample Location:</b>	Kitchen	
<b>Description:</b>	Brown Formica counter top and adhesive

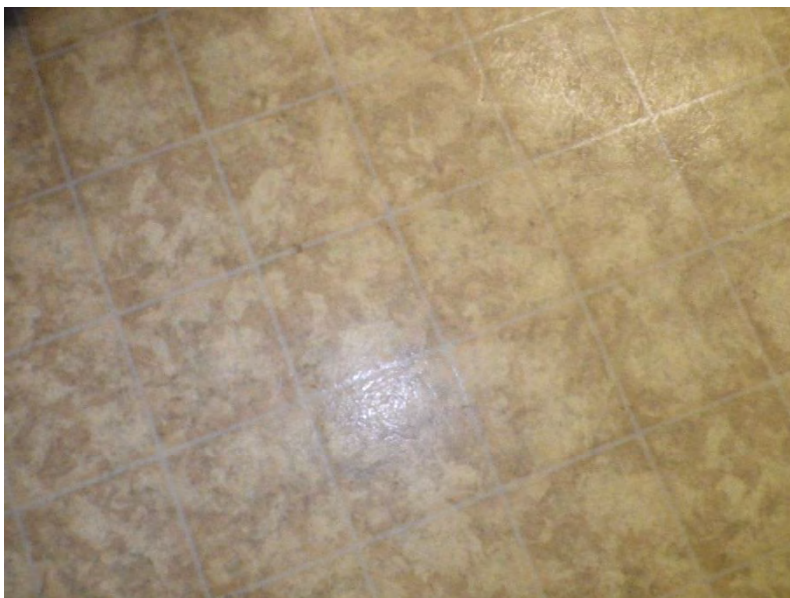
**Photograph #827**

<b>Building:</b>	Edgewater Country Club	Sample #: M-HA2-2

<b>Date Taken:</b>	May 18, 2017	
<b>Sample Location:</b>	Kitchen	
<b>Description:</b>	Tan 2"x2" linoleum and adhesive

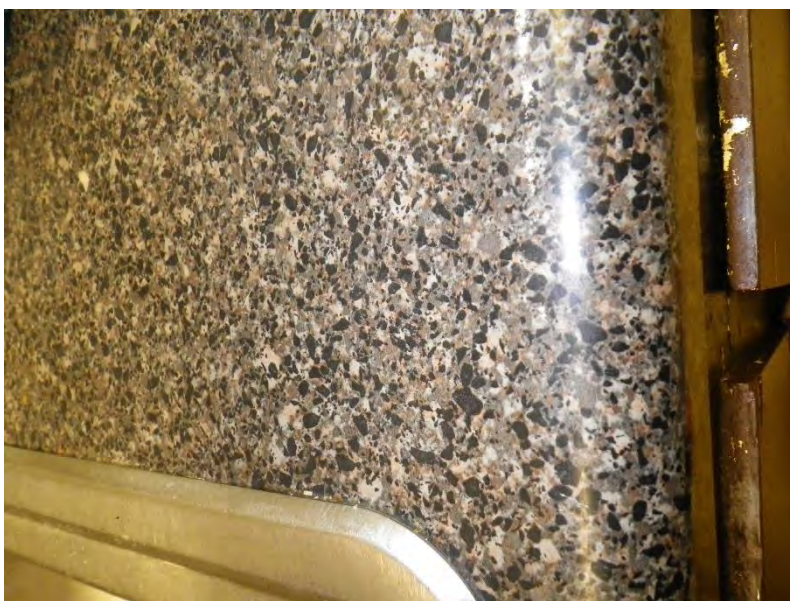
**Photograph #828**

<b>Building:</b>	Edgewater Country Club	Sample #: M-HA2-3

<b>Date Taken:</b>	May 18, 2017	
<b>Sample Location:</b>	Kitchen	
<b>Description:</b>	Granite Formica counter top and adhesive

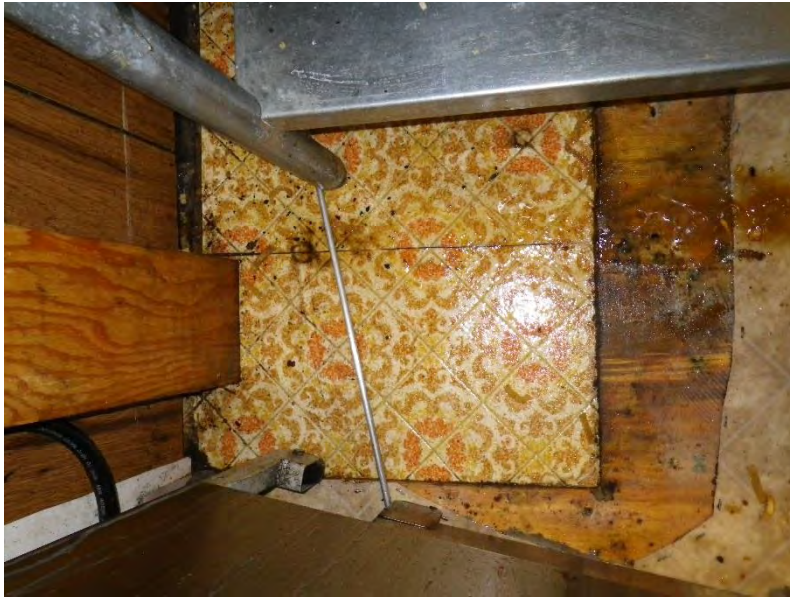
**Photograph #829**

<b>Building:</b>	Edgewater Country Club	Sample #: M-HA2-4
<b>Date Taken:</b>	May 18, 2017

<b>Sample Location:</b>	Kitchen	
<b>Description:</b>	Orange linoleum and adhesive-ACM

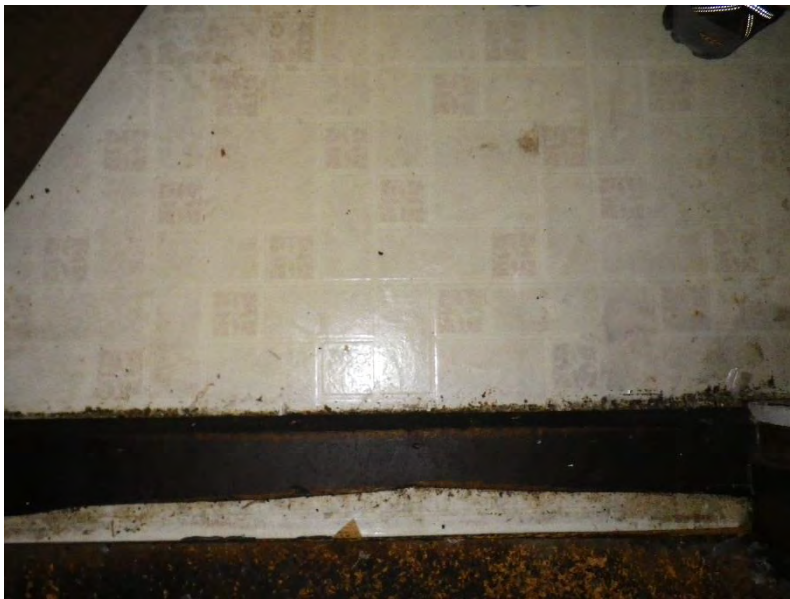
**Photograph #830**

<b>Building:</b>	Edgewater Country Club	Sample #: M-HA3-1
<b>Date Taken:</b>	May 18, 2017

<b>Sample Location:</b>	Pantry	
<b>Description:</b>	White mosaic linoleum and adhesive

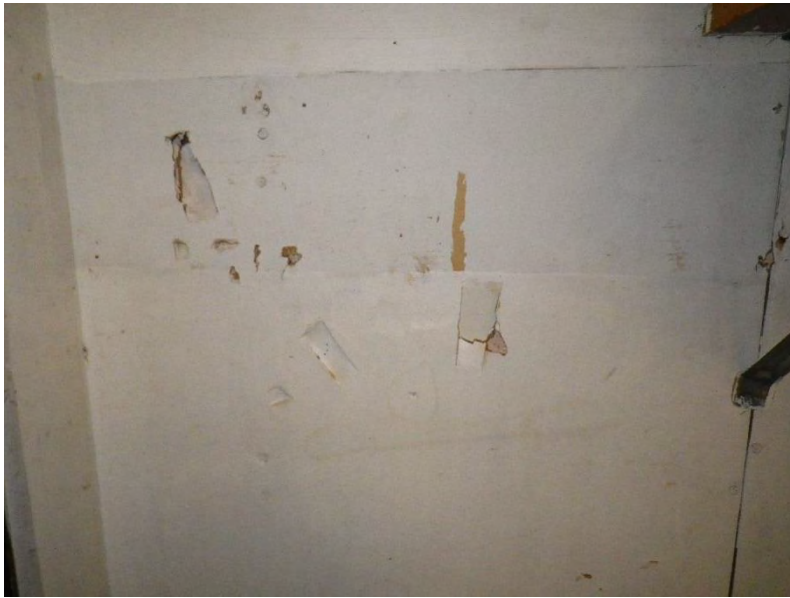
**Photograph #831**

<b>Building:</b>	Edgewater Country Club	Sample #: S-HA3-1,2,3

<b>Date Taken:</b>	May 18, 2017	
<b>Sample Location:</b>	Pantry	
<b>Description:</b>	Drywall and texture

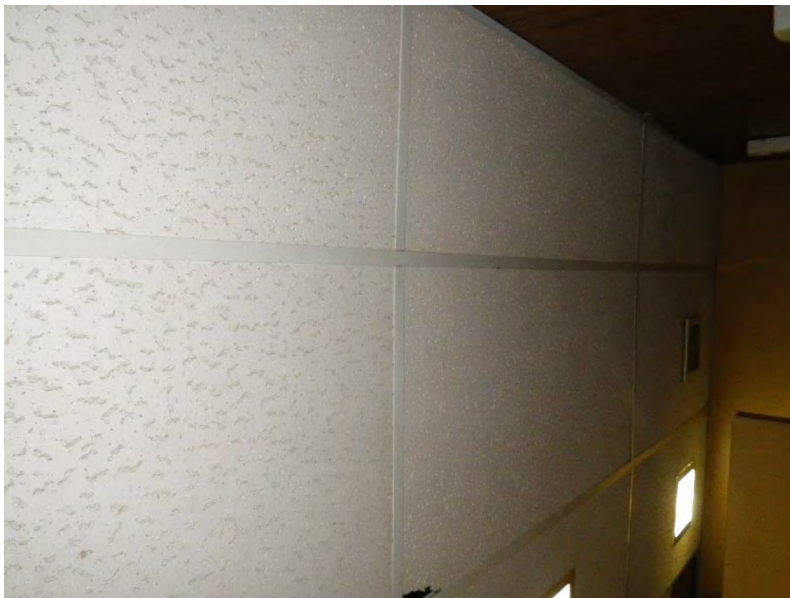
**Photograph #833**

<b>Building:</b>	Edgewater Country Club	Sample #: M-HA4-1

<b>Date Taken:</b>	May 18, 2017	
<b>Sample Location:</b>	Men's restroom	
<b>Description:</b>	Drop ceiling tile

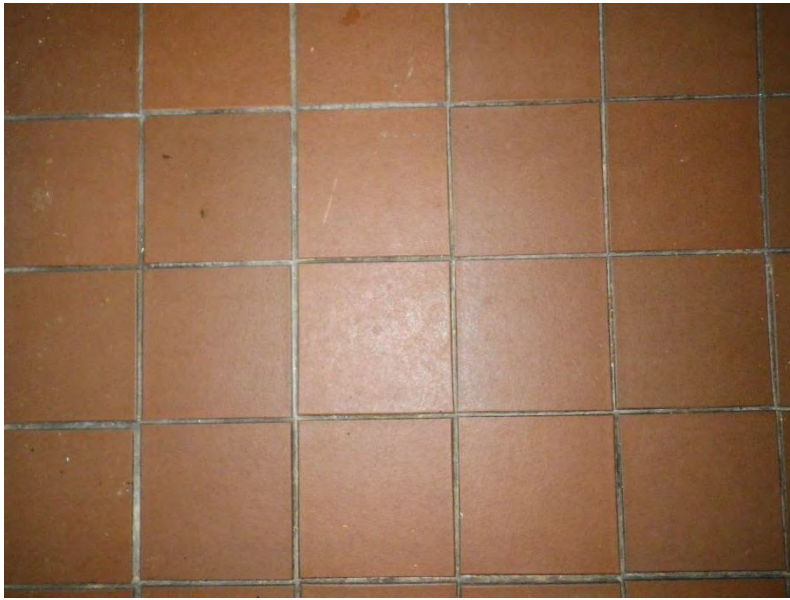
**Photograph #834**

<b>Building:</b>	Edgewater Country Club	Sample #: M-HA4-2
<b>Date Taken:</b>	May 18, 2017

<b>Sample Location:</b>	Men's restroom	
<b>Description:</b>	Tile and mastic

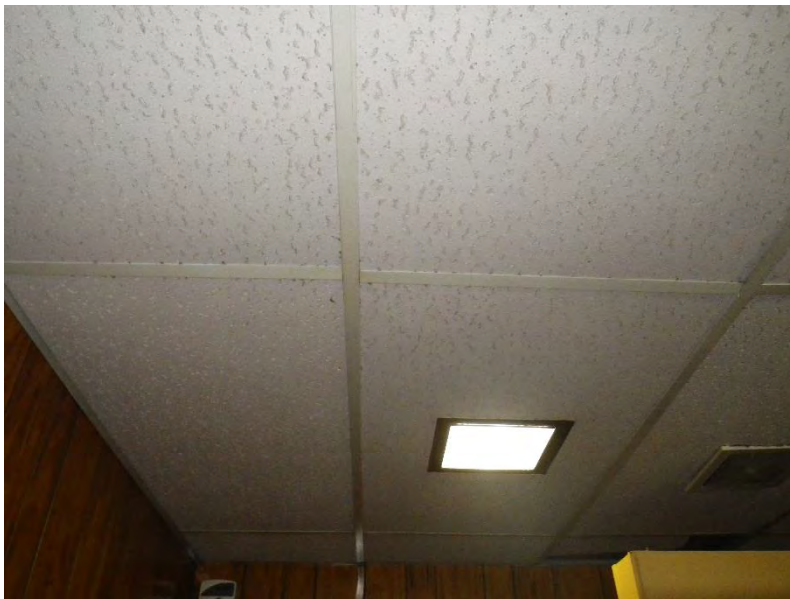
**Photograph #835**

<b>Building:</b>	Edgewater Country Club	Sample #: M-HA5-1
<b>Date Taken:</b>	May 18, 2017

<b>Sample Location:</b>	Women's restroom	
<b>Description:</b>	Drop ceiling tile

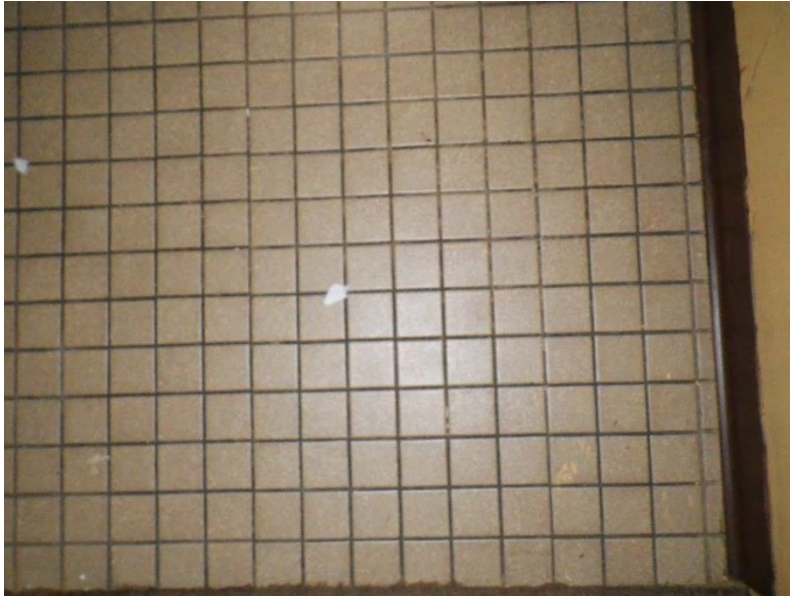
**Photograph #836**

<b>Building:</b>	Edgewater Country Club	Sample #: M-HA5-2

<b>Date Taken:</b>	May 18, 2017	
<b>Sample Location:</b>	Women's restroom	
<b>Description:</b>	Tile and mastic

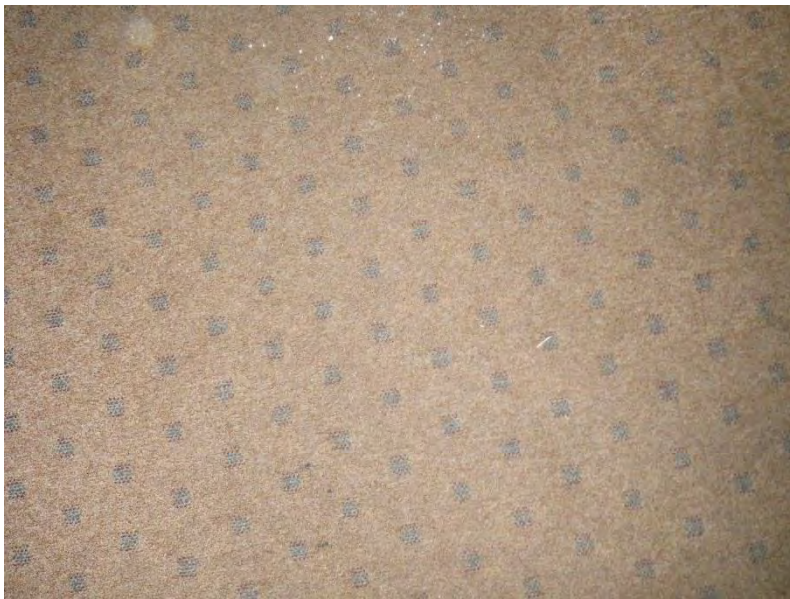
**Photograph #837**

<b>Building:</b>	Edgewater Country Club	Sample #: M-HA5-3

<b>Date Taken:</b>	May 18, 2017	
<b>Sample Location:</b>	Women's restroom	
<b>Description:</b>	Bathroom carpet and adhesive

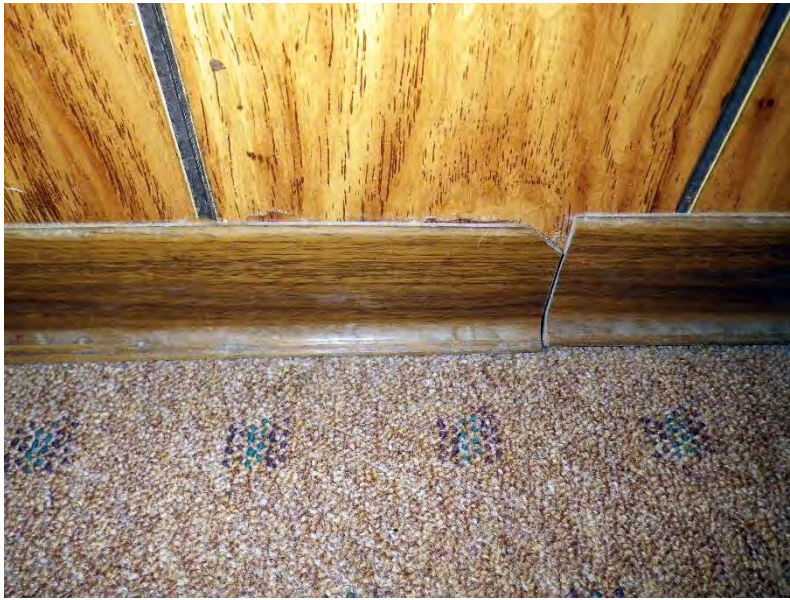
**Photograph #838**

<b>Building:</b>	Edgewater Country Club	Sample #: M-HA5-4

<b>Date Taken:</b>	May 18, 2017	
<b>Sample Location:</b>	Women's restroom	
<b>Description:</b>	Baseboard and mastic

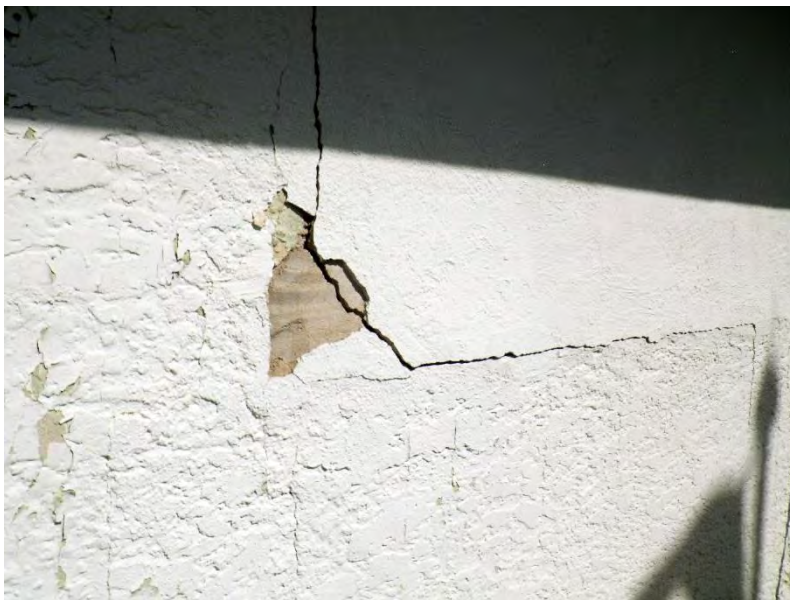
**Photograph #839**

<b>Building:</b>	Edgewater Country Club	Sample #: S-HA6- 1,2,3,4,5,6,7

<b>Date Taken:</b>	May 18, 2017	
<b>Sample Location:</b>	Exterior	
<b>Description:</b>	Stucco

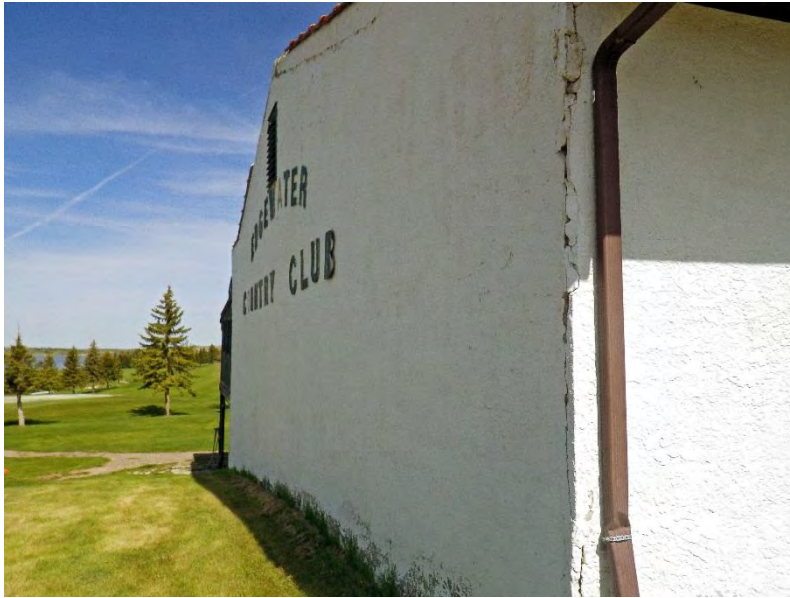
Photograph #840

Building:	Edgewater Country Club	Sample #: S-HA6-1,2,3,4,5,6,7
Date Taken:	May 18, 2017	 
Sample Location:	Exterior-facing road	
Description:	Stucco

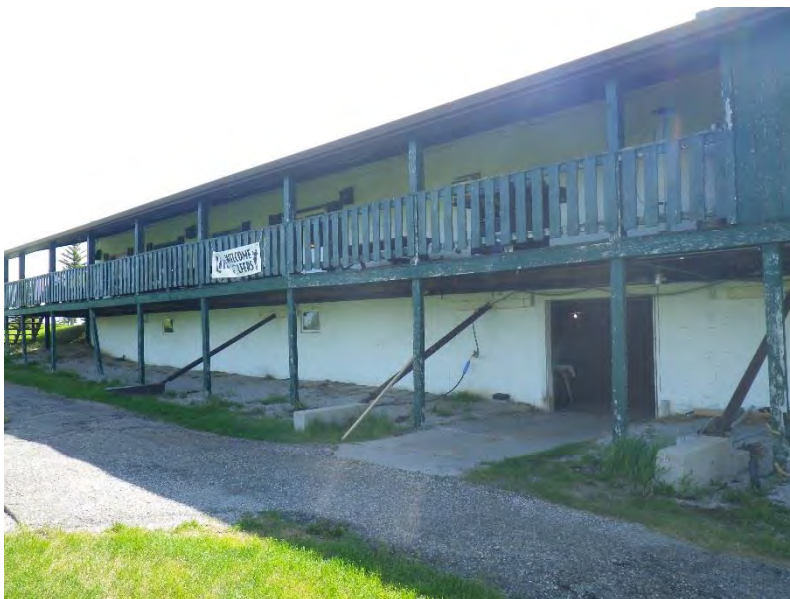
Photograph #841

Building:	Edgewater Country Club	Sample #: S-HA6-1,2,3,4,5,6,7
Date Taken:	May 18, 2017	 
Sample Location:	Exterior-rear deck	
Description:	Stucco

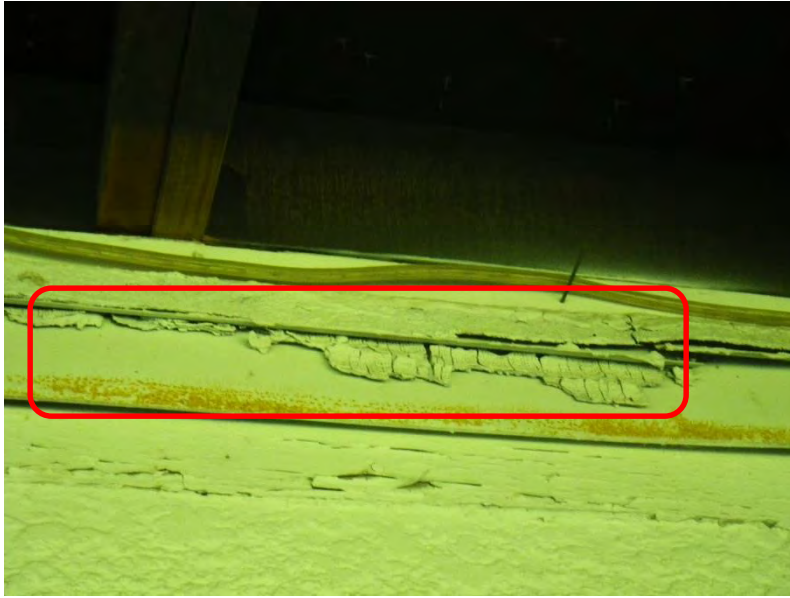
**Photograph #842**

<b>Building:</b>	Edgewater Country Club	Sample #: M-HA6-8, 9

<b>Date Taken:</b>	May 18, 2017	
<b>Sample Location:</b>	Exterior	
<b>Description:</b>	Tar-paper

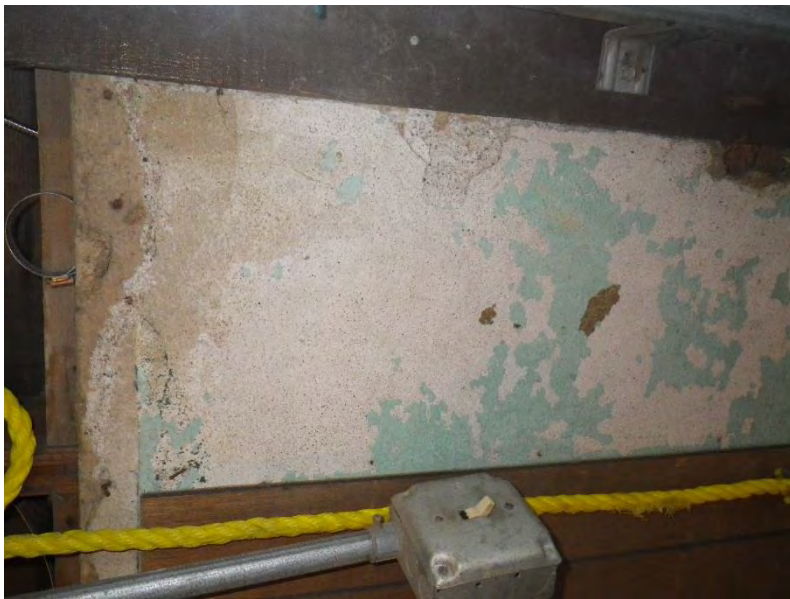
**Photograph #843**

<b>Building:</b>	Edgewater Country Club	Sample #: S-HA7- 1,2,3,4,5,6,7  
<b>Date Taken:</b>	May 18, 2017	
<b>Sample Location:</b>	Golf cart storage	
<b>Description:</b>	Wall surfacing

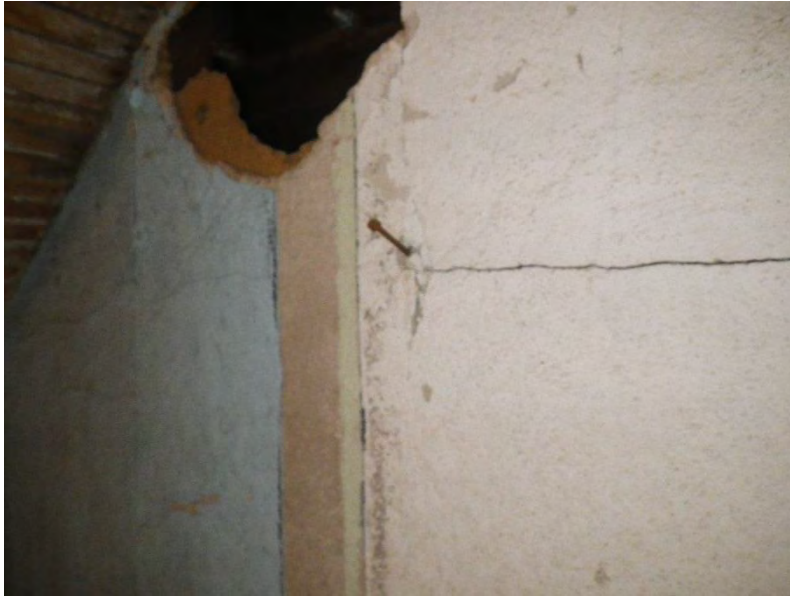
**Photograph #844**

<b>Building:</b>	Edgewater Country Club	Sample #: S-HA7-1,2,3,4,5,6,7
<b>Date Taken:</b>	May 18, 2017

<b>Sample Location:</b>	Golf cart storage	
<b>Description:</b>	Wall surfacing

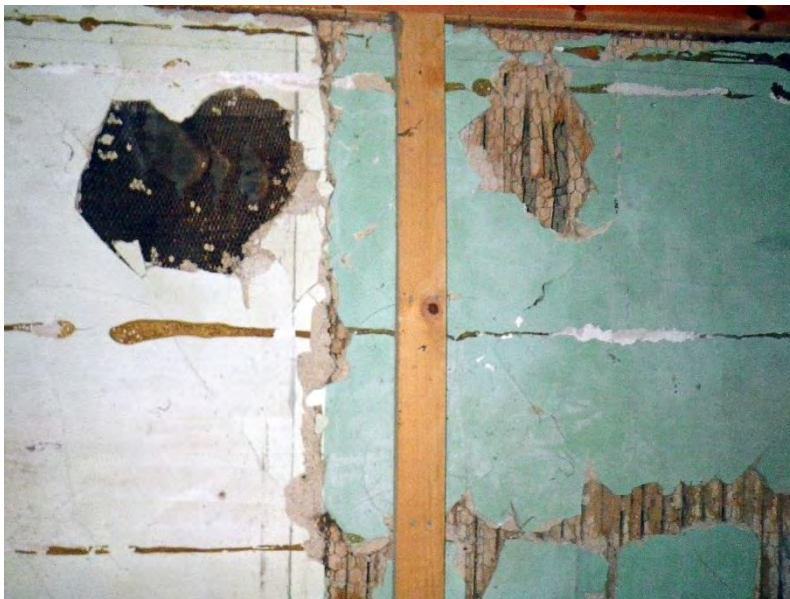
**Photograph #845**

<b>Building:</b>	Edgewater Country Club	Sample #: S-HA7-1,2,3,4,5,6,7
<b>Date Taken:</b>	May 18, 2017

<b>Sample Location:</b>	Golf cart storage	
<b>Description:</b>	Wall surfacing

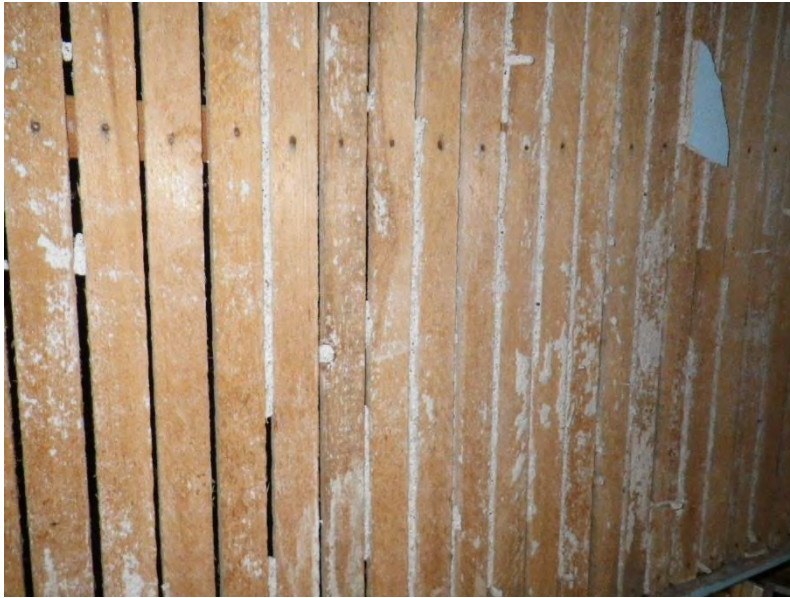
**Photograph #846**

<b>Building:</b>	Edgewater Country Club	Sample #: S-HA7-8,9,10

<b>Date Taken:</b>	May 18, 2017	
<b>Sample Location:</b>	Golf cart storage	
<b>Description:</b>	Lath and plaster

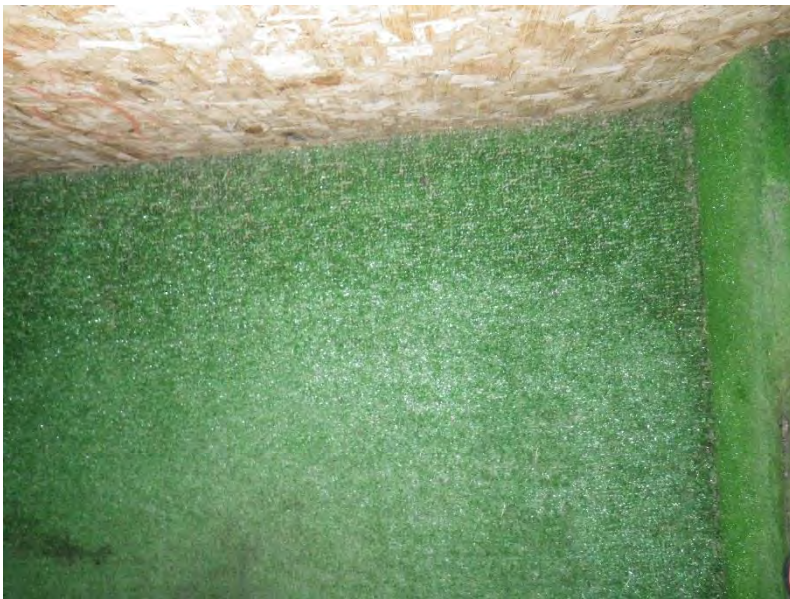
**Photograph #847**

<b>Building:</b>	Edgewater Country Club	Sample #: M-HA8-1

<b>Date Taken:</b>	May 18, 2017	
<b>Sample Location:</b>	Locker room	
<b>Description:</b>	Carpet and adhesive

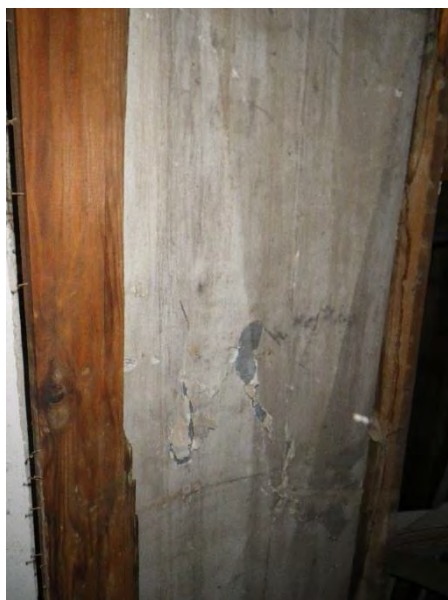
**Photograph #848**

<b>Building:</b>	Edgewater Country Club	Sample #: T-HA8-2,3,4
<b>Date Taken:</b>	May 18, 2017

<b>Sample Location:</b>	Locker room	
<b>Description:</b>	Duct covering-Asbestos Containing Material

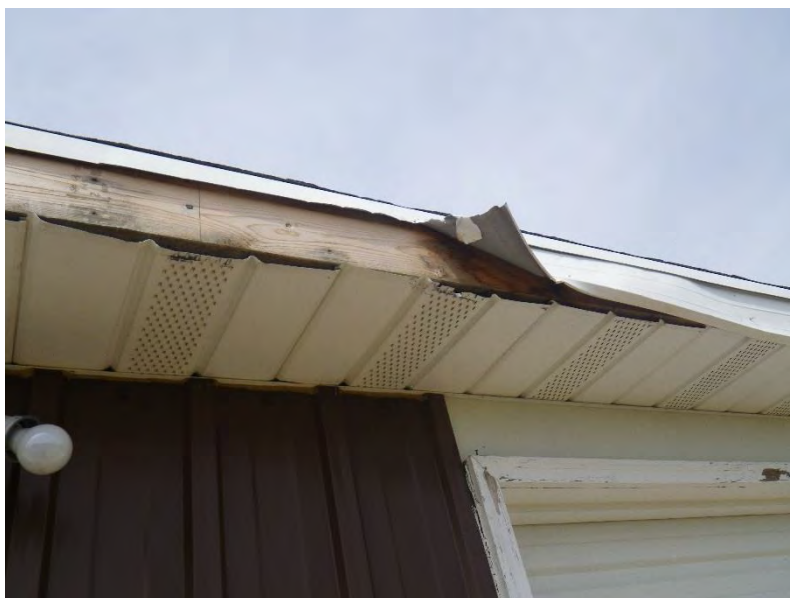
**Photograph #854**

<b>Building:</b>	Edgewater Country Club	Sample #: M-HA9-1, 2, 3
<b>Date Taken:</b>	May 18, 2017	 
<b>Description:</b>	Large garage exterior

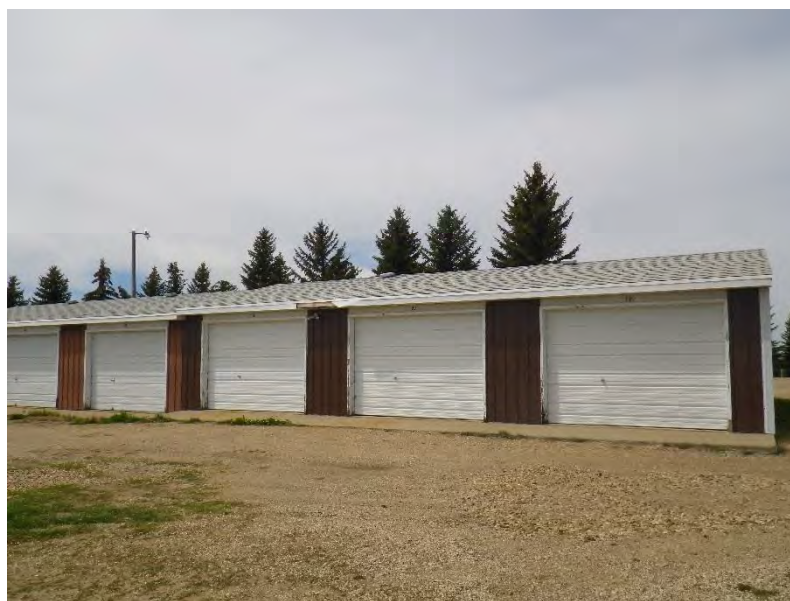
**Photograph #855**

<b>Building:</b>	Edgewater Country Club	Samples: M-HA9-1, 2, 3
<b>Date Taken:</b>	May 18, 2017

<b>Description:</b>	Large garage exterior
