Site 2: Structure No 17-042.967

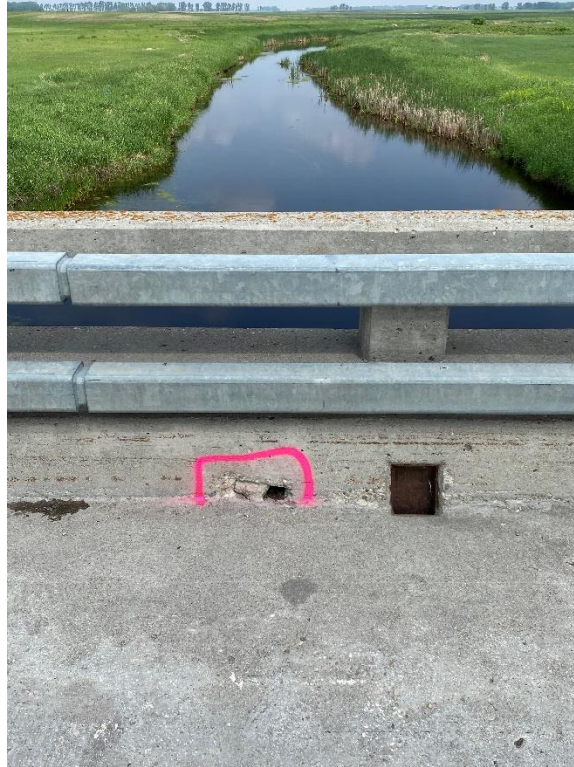
Photo 1: Spall repair in north curb (1 SF)

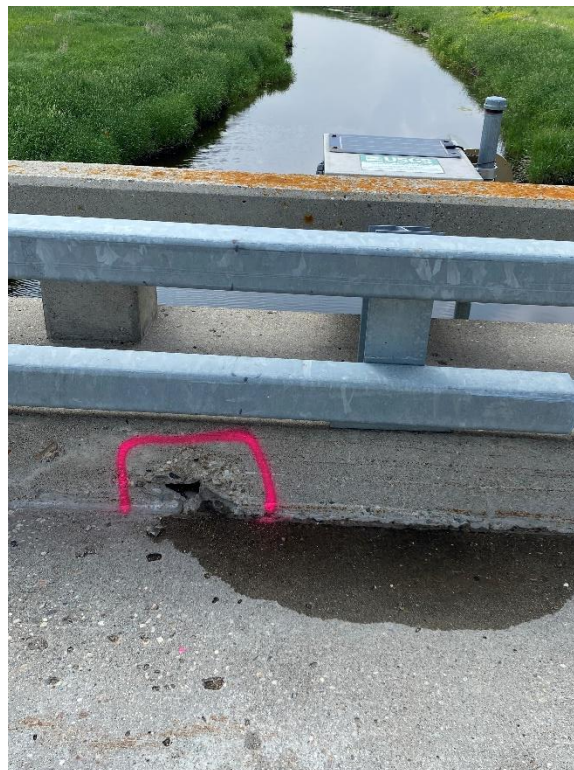
Photo 2: Spall repair in south curb (1 SF)

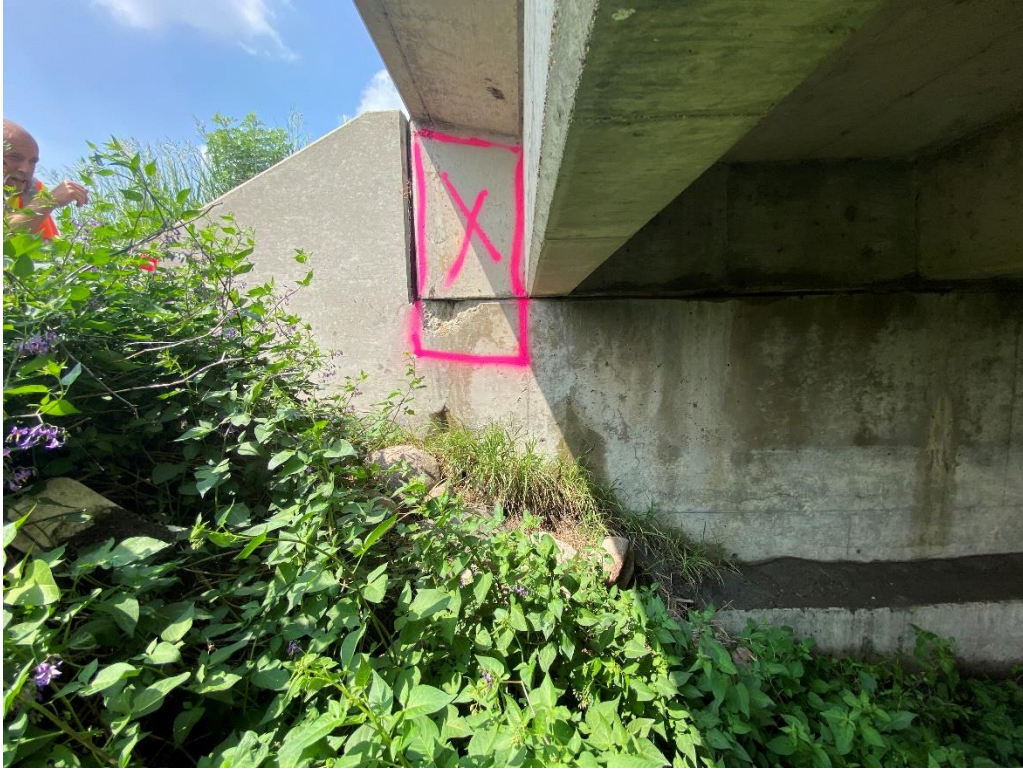
Photo 3: Spall repair at Abutment 1 (7 SF)

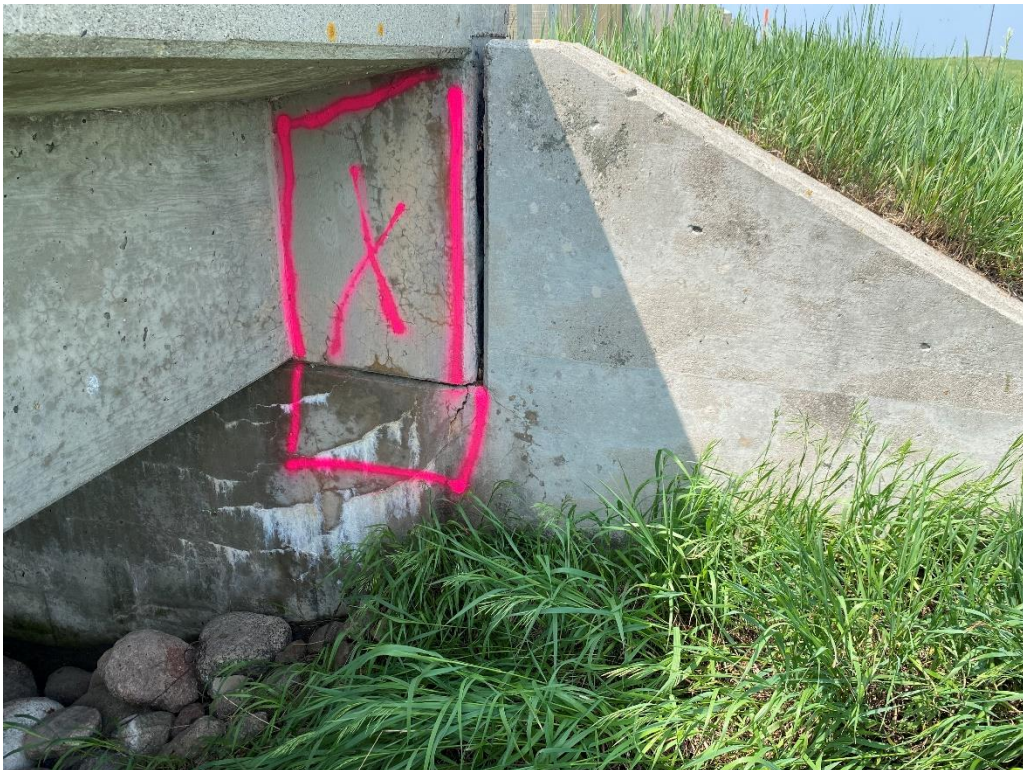
Photo 4: Spall repair at Abutment 1 (7 SF)

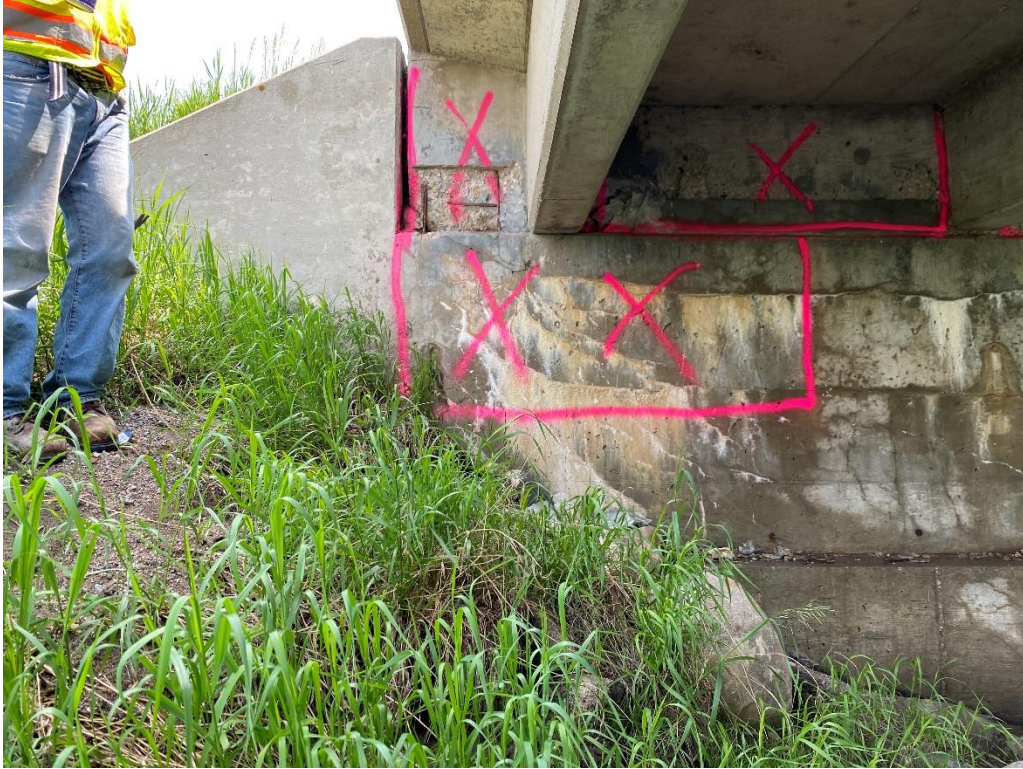
Photo 5: Spall repair at Abutment 4 (15 SF)

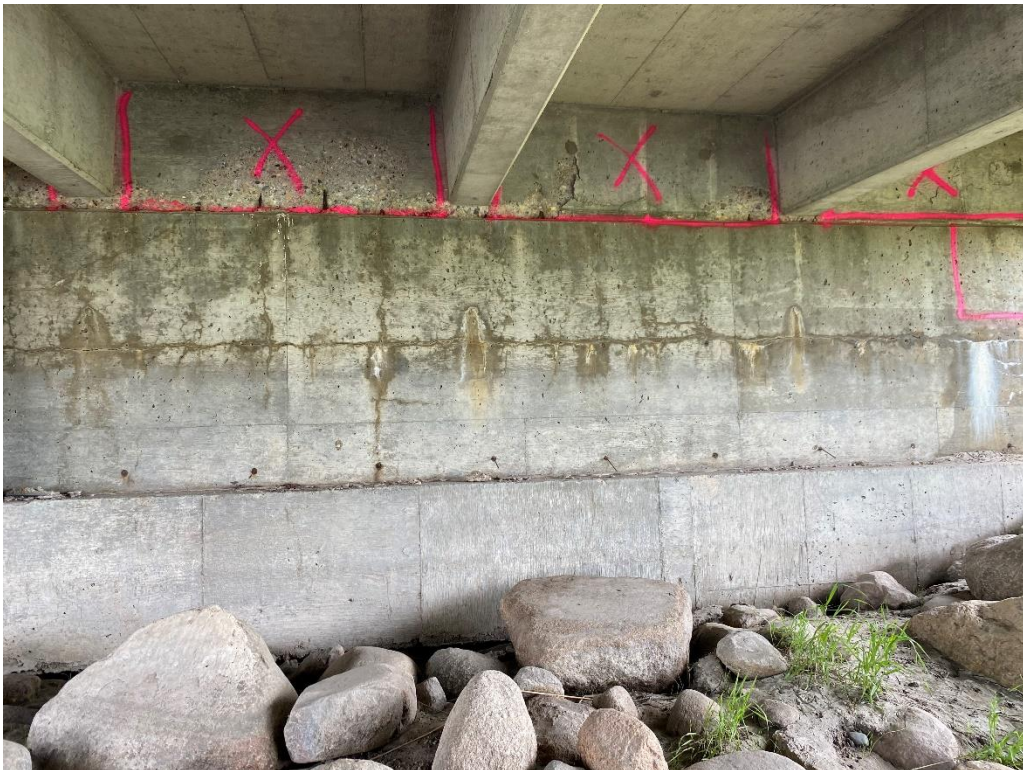
Photo 6: Spall repair at Abutment 4 (12 SF/ Girder Bay = 60 SF)

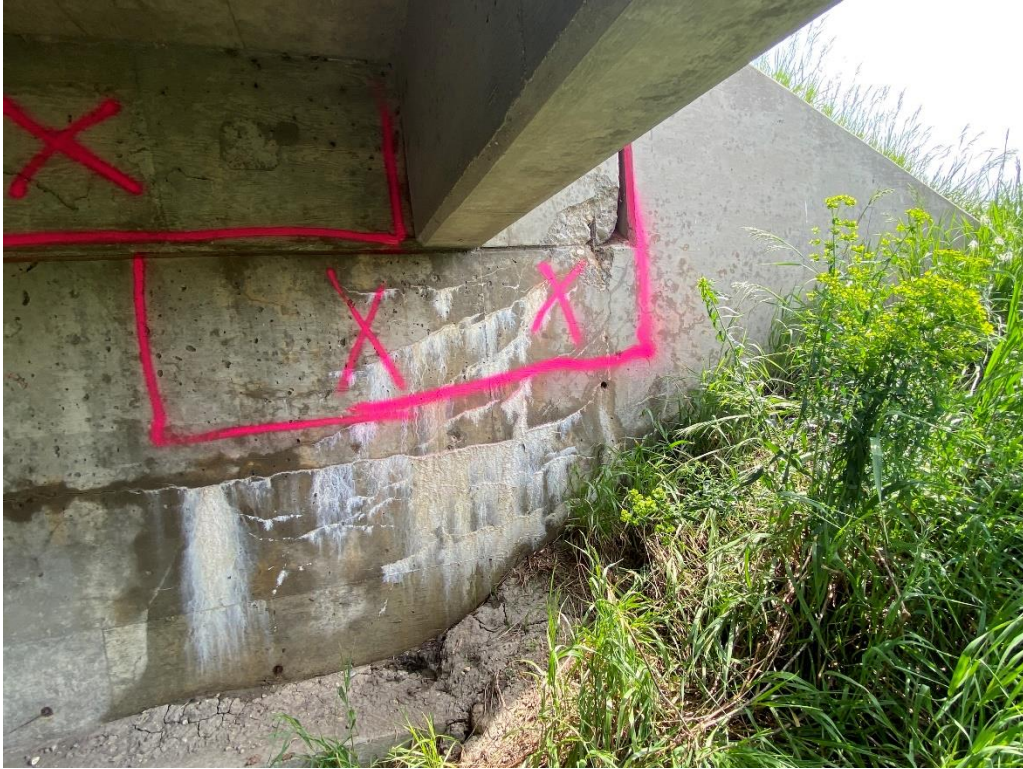
Photo 7: Spall repair at Abutment 4 (11 SF)
