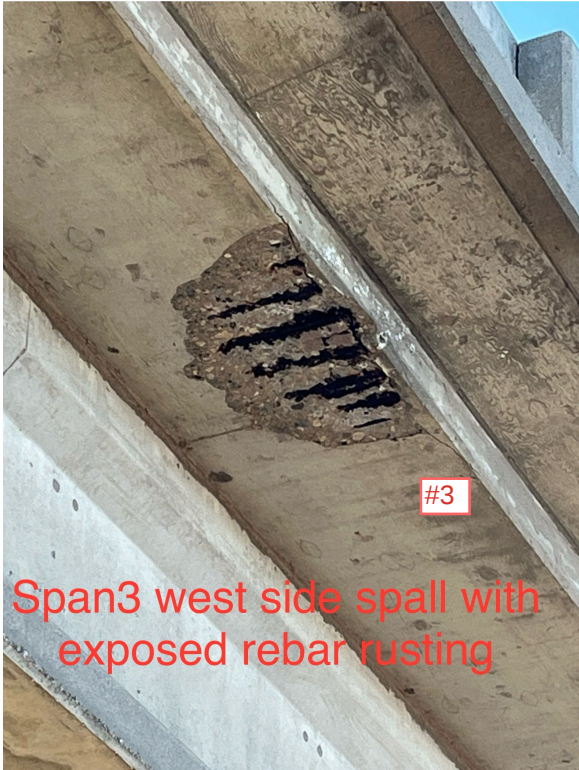
#3

Span3 west side spall with  
exposed rebar rusting

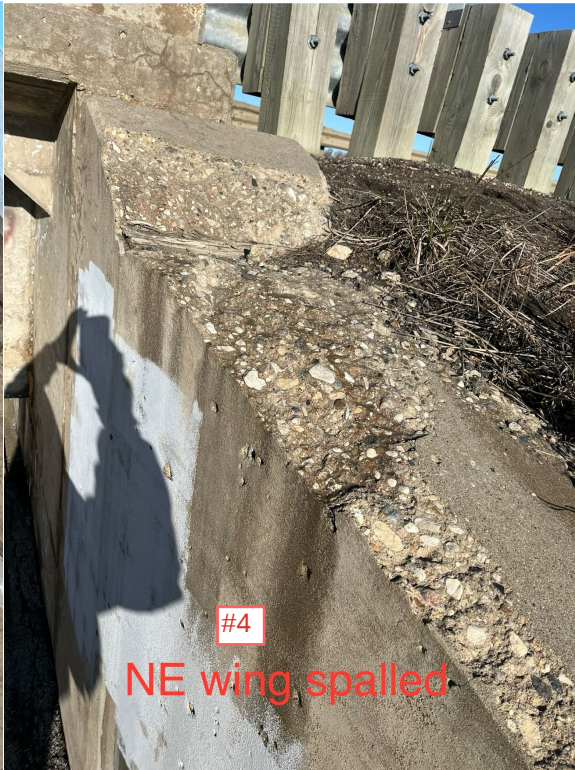
#4

NE wing spalled
