Experimental Study ND 2002-02

Performance of HBP vs. PCC Pavement

Final Evaluation

Project NH-8-013(030)380

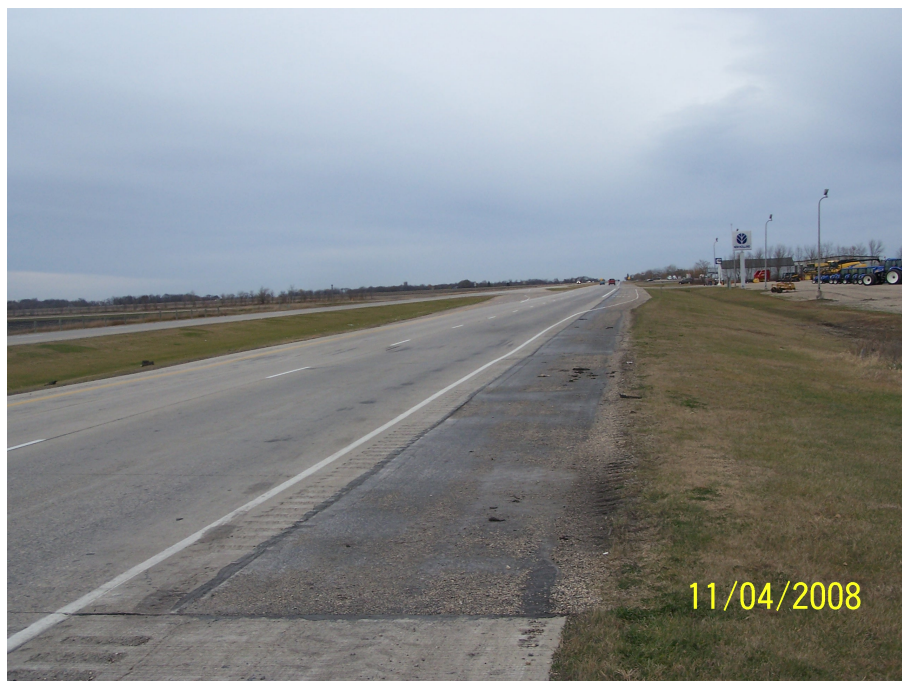
Segment 2 did not show any distresses on the PCC. The asphalt shoulders were starting to show some distress near an implement dealership. Other than the shoulder showing some distress Segment 2 had no other visible distresses.

Photo 1 – Asphalt shoulder near implement dealership at transition between Segments 2 and 3.

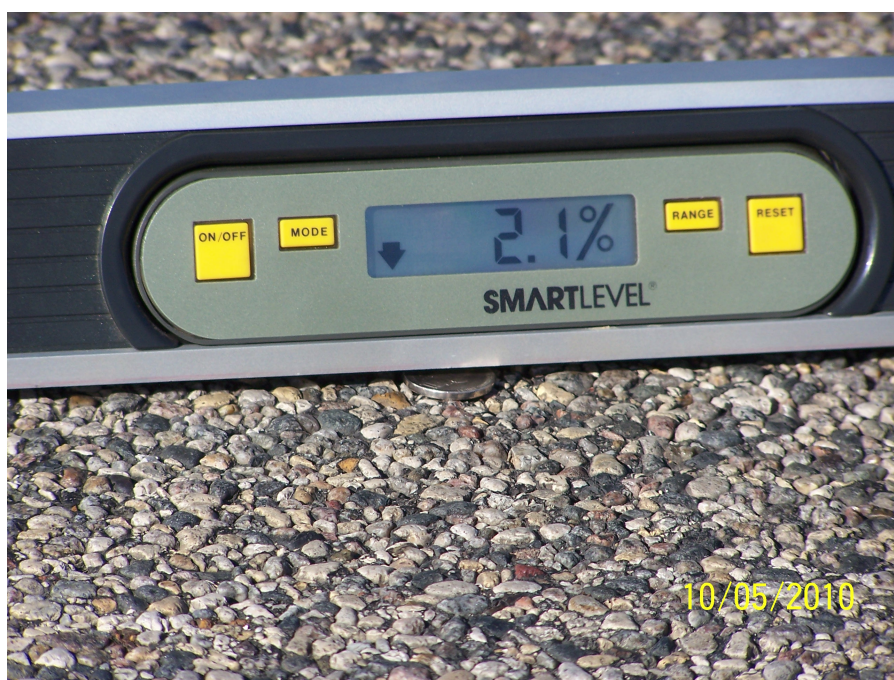
The fourth evaluation was conducted October 5, 2010. Segment 1 had noticeable wear in the chip seal which was installed in 2005. A majority of the wear in the chip seal is occurring in the wheel path. Materials and Research physically measured rutting using a seven foot metal straight edge. Rutting in the wheel path measured 1/16th to 1/8th of an inch and was checked every half mile throughout Segment 1. There were also 12 transverse cracks in Segment 1.

Photo 1: Rutting in a wheel path in the driving lane of Segment 1.

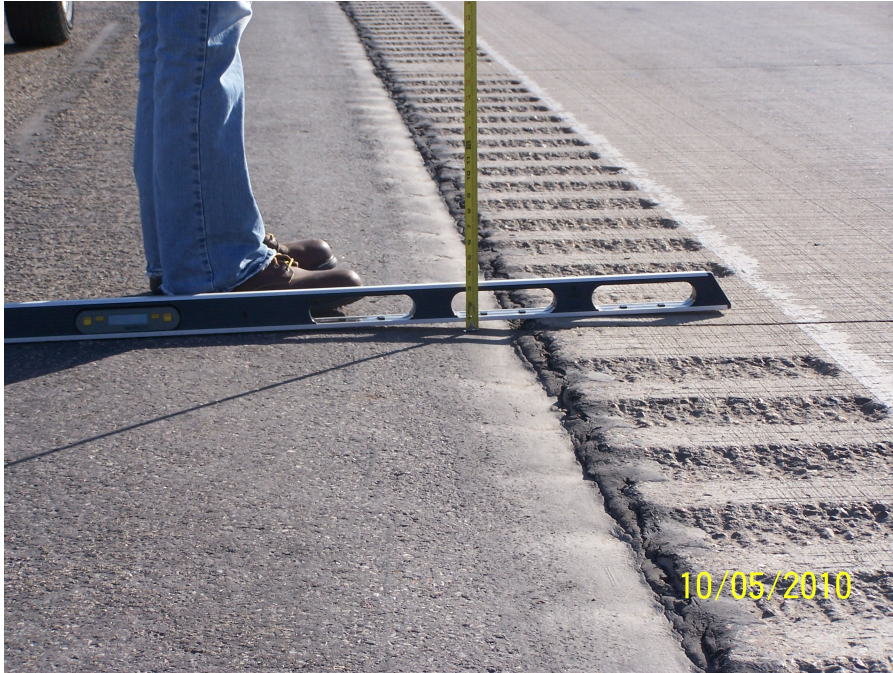
Segment 2 has a noticeable dip in the shoulders on each side of the box culvert located in this segment. It has two new transverse cracks near the transition from Segment 3 to Segment 2. The asphalt shoulders have settled approximately 1/2 inch throughout the section. A longitudinal crack is located 800' east of the Wild Rice Bridge in Segment 2.

Photo 2 – Settling of the asphalt shoulders in Segment 2.

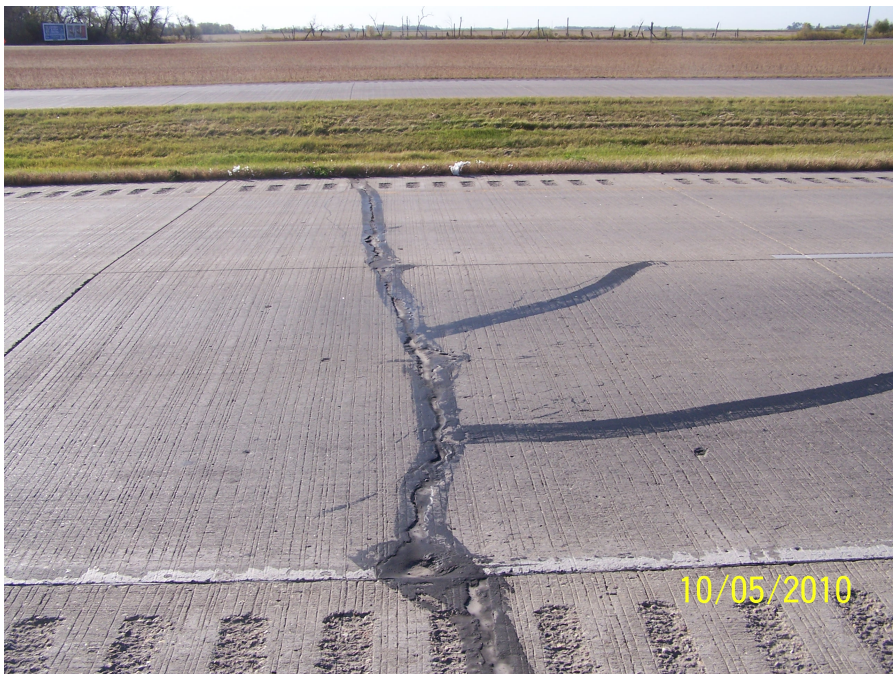
Segment 3 has one new transverse crack at station 20550+45 which was sealed. 4 small corner breaks and 3 edge line breaks have developed.

Photo 3: Distress located in Segment 3.

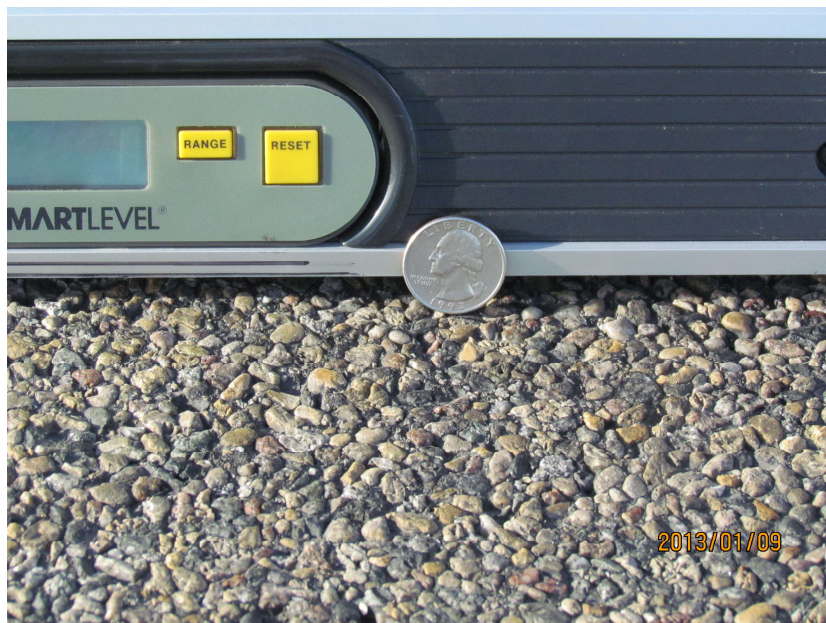
The fifth evaluation was conducted January 9, 2013. Segment 1 had noticeable wear in the chip seal which was installed in 2005. A majority of the wear in the chip seal is occurring in the wheel paths in both the driving lane and passing lane. Materials and Research physically measured rutting using a six foot metal straight edge every half mile throughout Segment 1. Rutting was observed in the driving lane, and there was a difference in the rutting from the right wheel path to the left wheel path. The rutting in the right wheel path ranged from 1/8th to 1/4th of an inch and the rutting in the left wheel path ranged from zero to 1/8th of an inch. Similar to the 2010 evaluation, there were also 12 transverse cracks observed in Segment 1.

Photo 1: Rutting in a right wheel path in the driving lane of Segment 1.

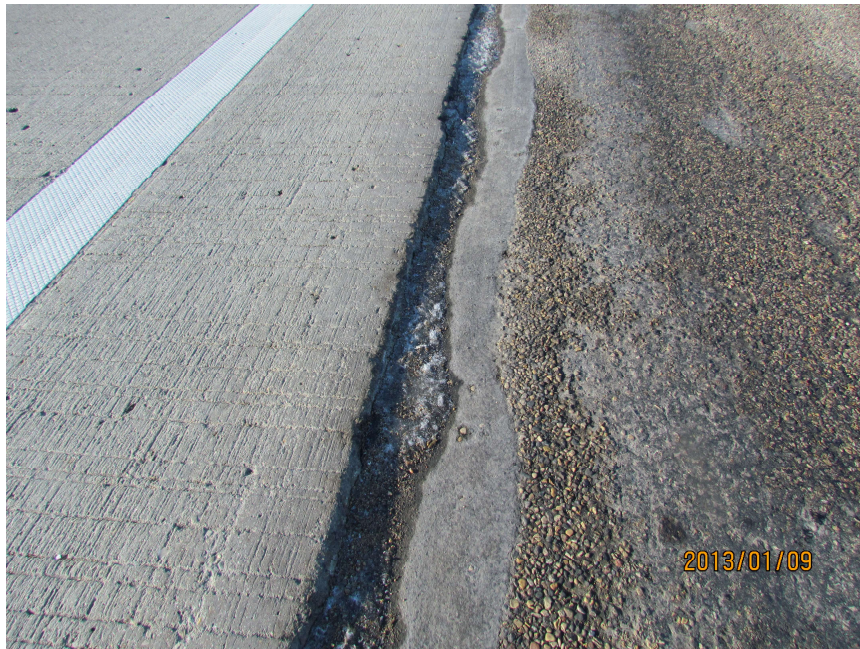
end of the Wild Rice Bridge in Segment 2. There was a HBP turning lane approximately at RP 386.6 that had settled about $\frac{3}{4}$ th of an inch below the PCC roadway, see photos 2 and 3.

Photo 3 – Settling of the asphalt turning lane in Segment 2
