NORTH DAKOTA  
DEPARTMENT OF TRANSPORTATION

Experimental Study ND 2013-03

*Spraywall Pipe Liner*  
**Evaluation**

SOIA-5-094(084)023

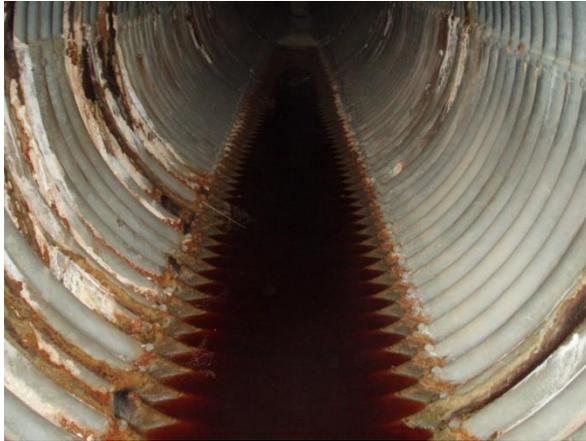
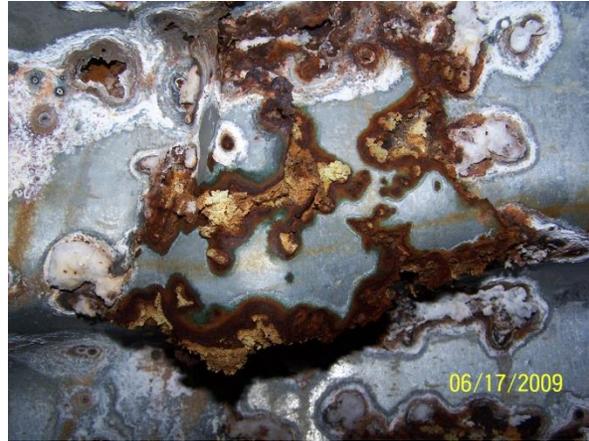
Photo - Deterioration of 90" Structural Steel pipe

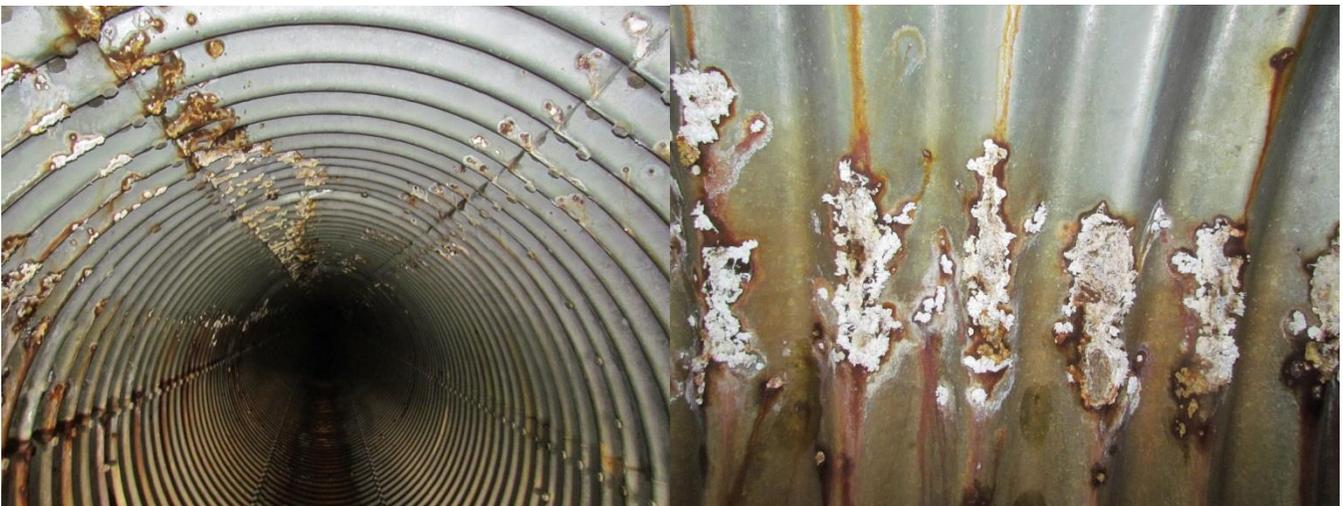
**Photo 1 – Deterioration and corrosion of steel pipe.**

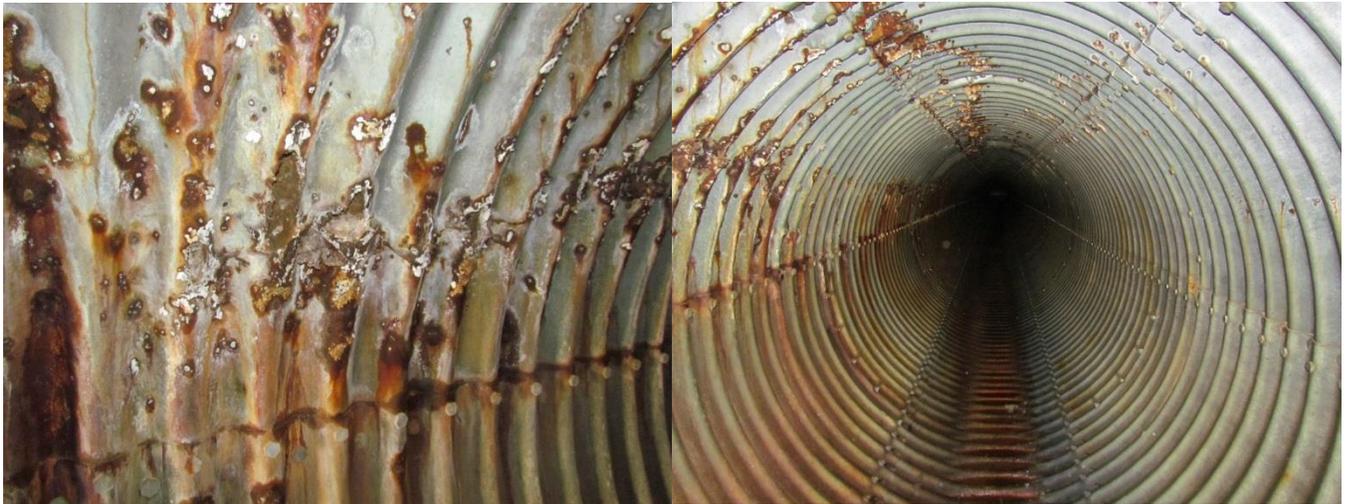
**Photo 2 – Deterioration and corrosion of steel pipe** In the project a rain event passed through area. When Subsurface arrived at the project location three to four inches of water still remained in the bottom of the pipe. The water was pumped through the pipe downstream to the end of the pipe. The remaining water in the bottom of the pipe corrugations were vacuumed to leave the pipe dry.

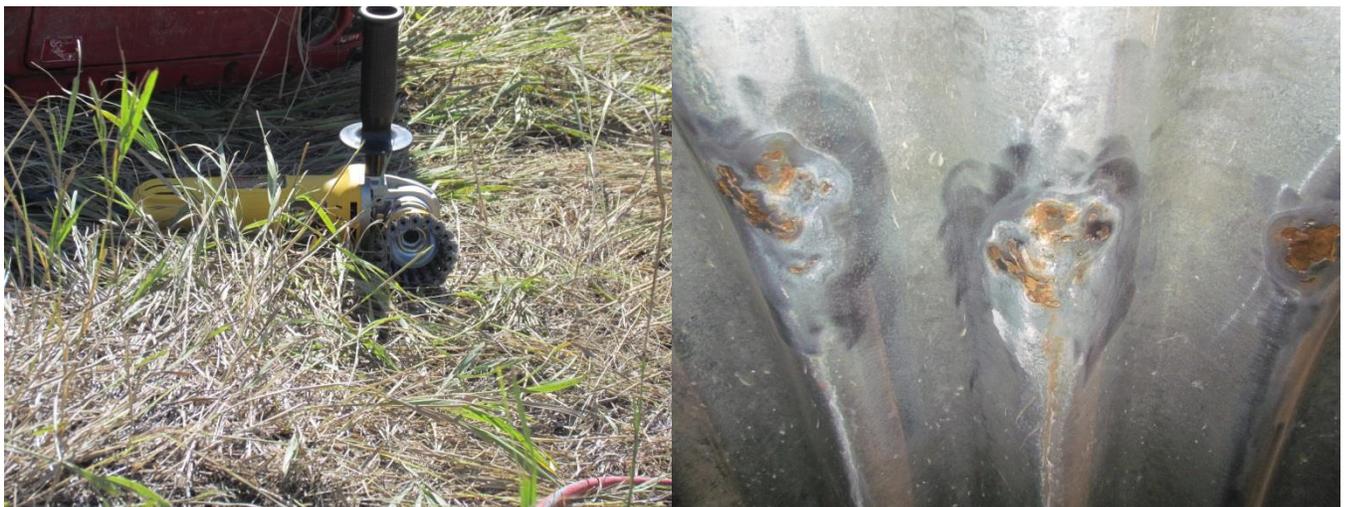
**Photo 3 – Grinder and deteriorated location after corrosion has been removed.**

Next the Subsurface crew began to remove the pipe corrosion and sealing up the deteriorated holes caused from corrosion. The corroded locations within the pipe were removed using a grinder attached with a cup wire brush as seen in Photo 3.

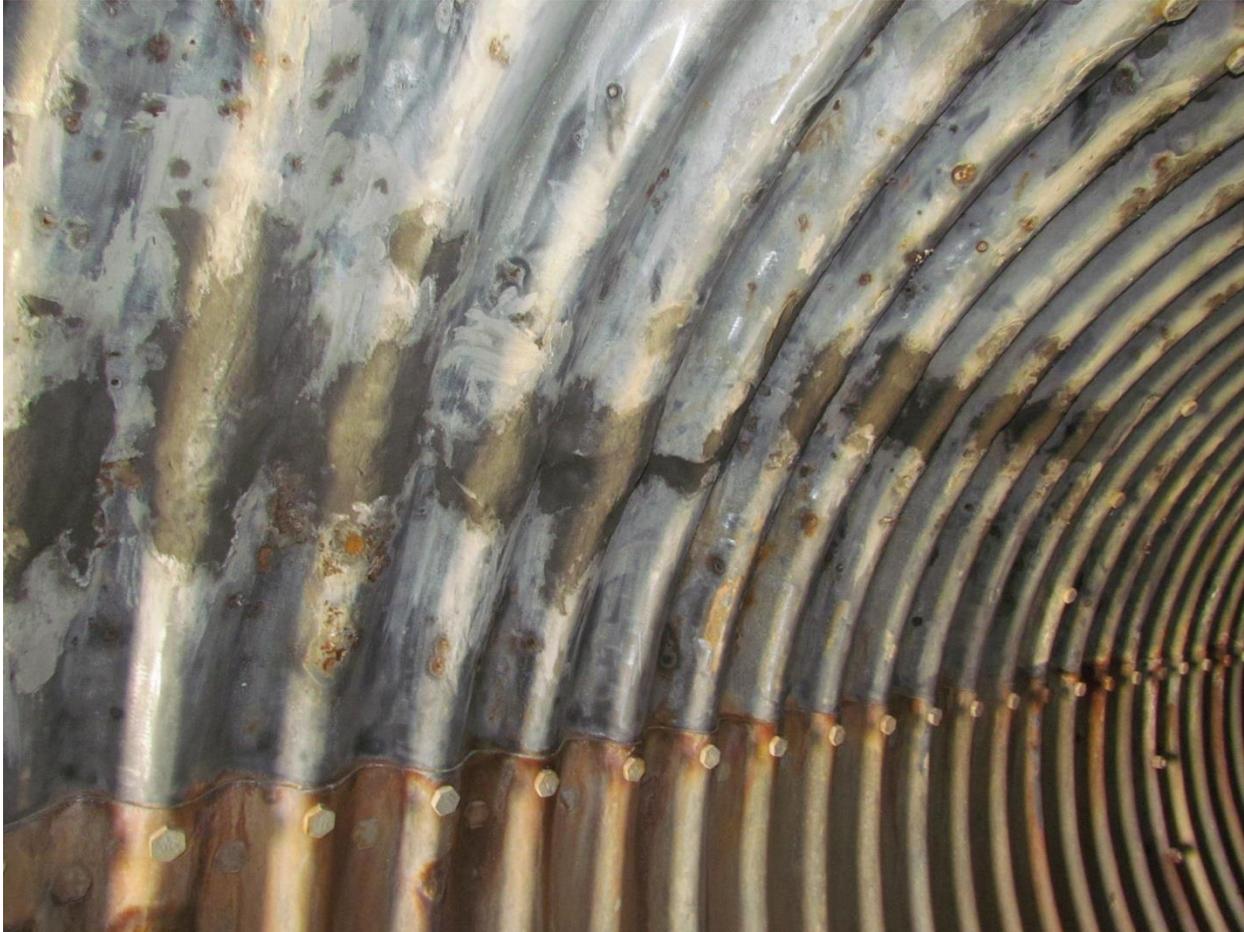
**Photo 4 – Deteriorated holes filled with mortar.**

After the corrosion was removed the locations with holes in the steel were filled with Speed Crete Blue Line, a rapid setting cement based mortar produced by The

Euclid Chemical Company. The mortar is to provide a clean dry substrate for the Spraywall. Example of this can be seen in Photo 4. The larger locations where the corrosion created a hole are filled with the mortar. The smaller locations where the

corrosion has not deteriorated completely through the steel where not filled with mortar, they provide adequate substrate for the Spraywall.

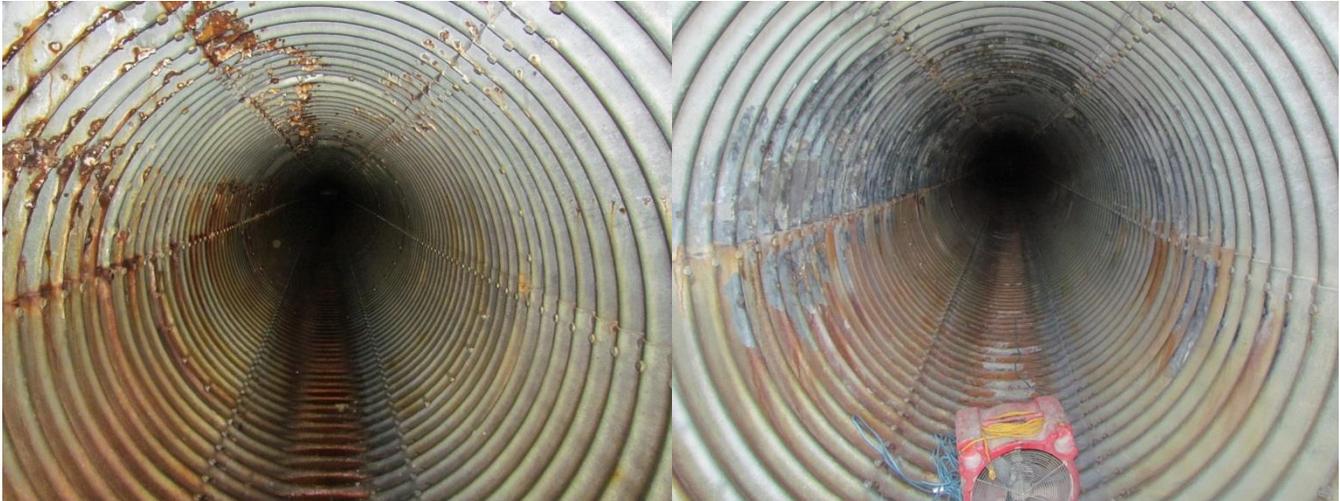
Photo 5 – Before and after pipe preparation

After the deteriorated locations were removed and the holes were filled with mortar the pipe was pressure washed to remove any debris. Heated air was then pumped into the pipe to warm and dry the pipe overnight prior to the installation of the Spraywall. The pipe was heated to approximately 75 degrees Fahrenheit. Photo 5 displays the pipe before and after the pipe preparation was completed.

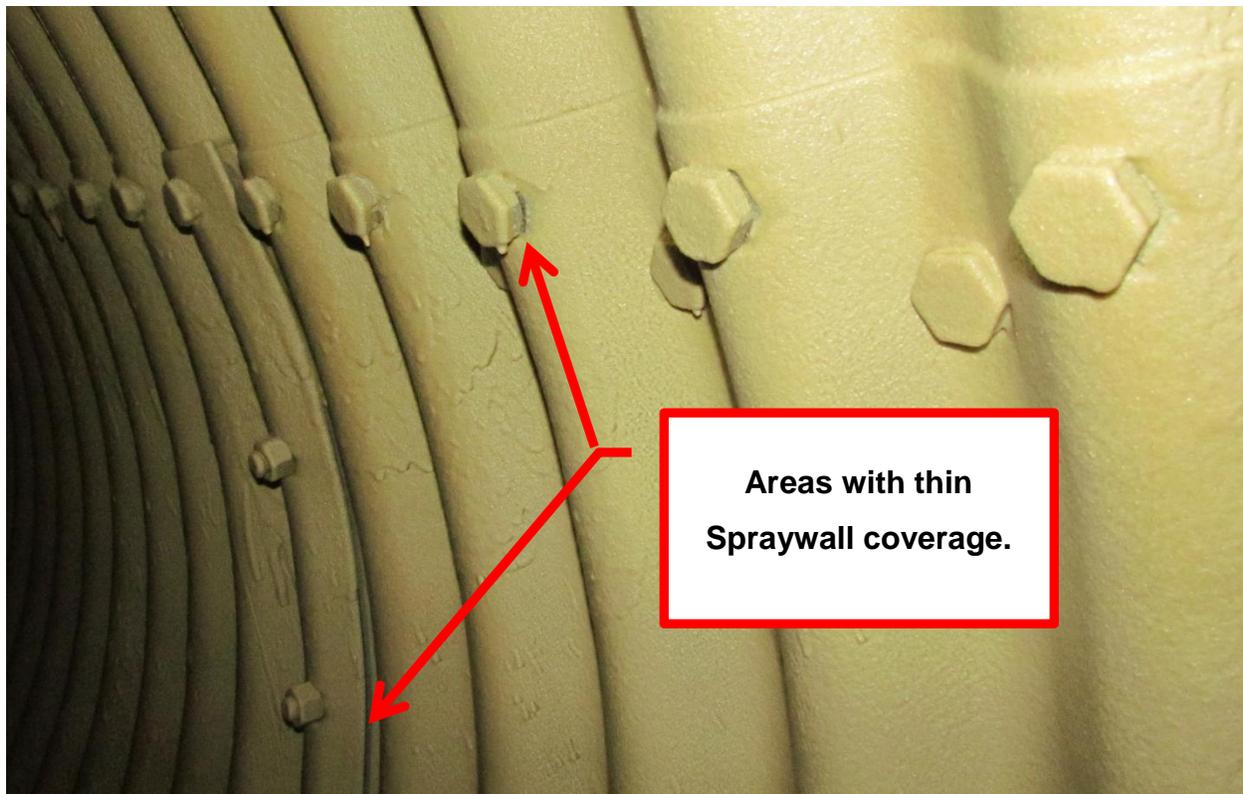
The coverage around the bolts and seams appeared very thin where there was a sharp angle on the substrate. Examples of these areas of concern can be seen in Photo 12.

**Photo 12 – Examples of locations with thin Spraywall coverage.**

The locations that appeared to have thin coverage of Spraywall were fixed using the SR 6100. In some of these locations a depth check was performed and the thickness of the Spraywall meet the design thickness of 500 mills in the majority of locations tested. The depth checks measurements can be seen in Appendix A.

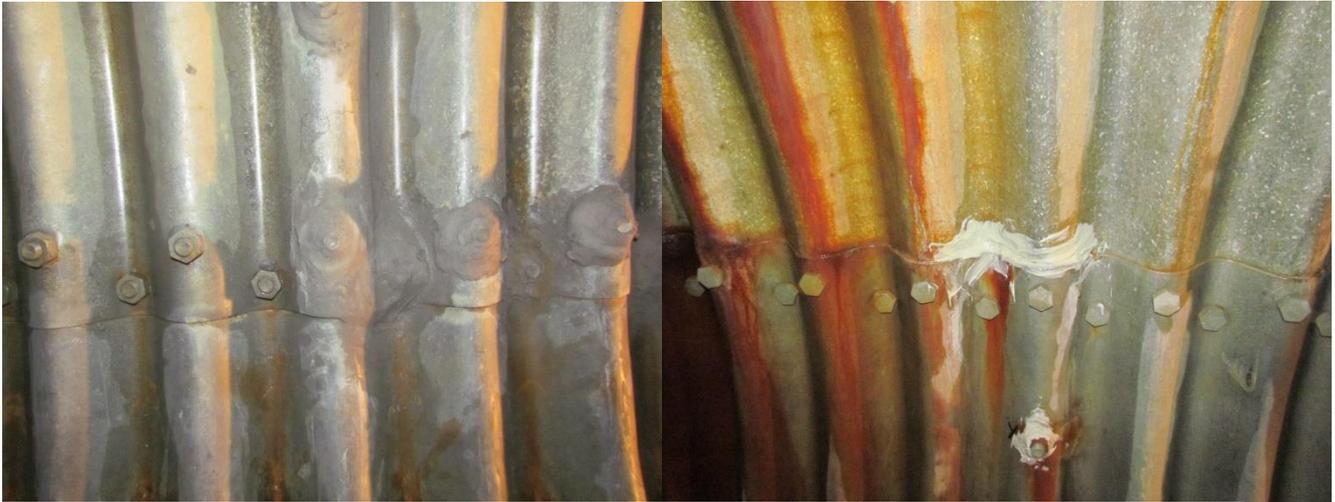
**Photo 13 – Quick set mortar and SR 6100 smoothing out sharp angles.**

The contractor's original concern is that they were using too much Spraywall material around the bolts and plate seams. The contractor used the quick set mortar and SR 6100, an epoxy from Sprayroq, in attempt to smooth out the sharp angles of the bolts and plate seams.

This method of smoothing out the sharp angles may remedy the sharp angles but it is very time consuming to complete the task. This method was abandoned and the Spraywall representative was approached for guidance on this problem. The Spraywall representative contacted other Sprayroq Certified Partners and it was determined that the contractor needed to adjust the technique used to spray the sharp angles. The contractor improved on the Spraywall application around the sharp angles after help was received by the Spraywall representatives.

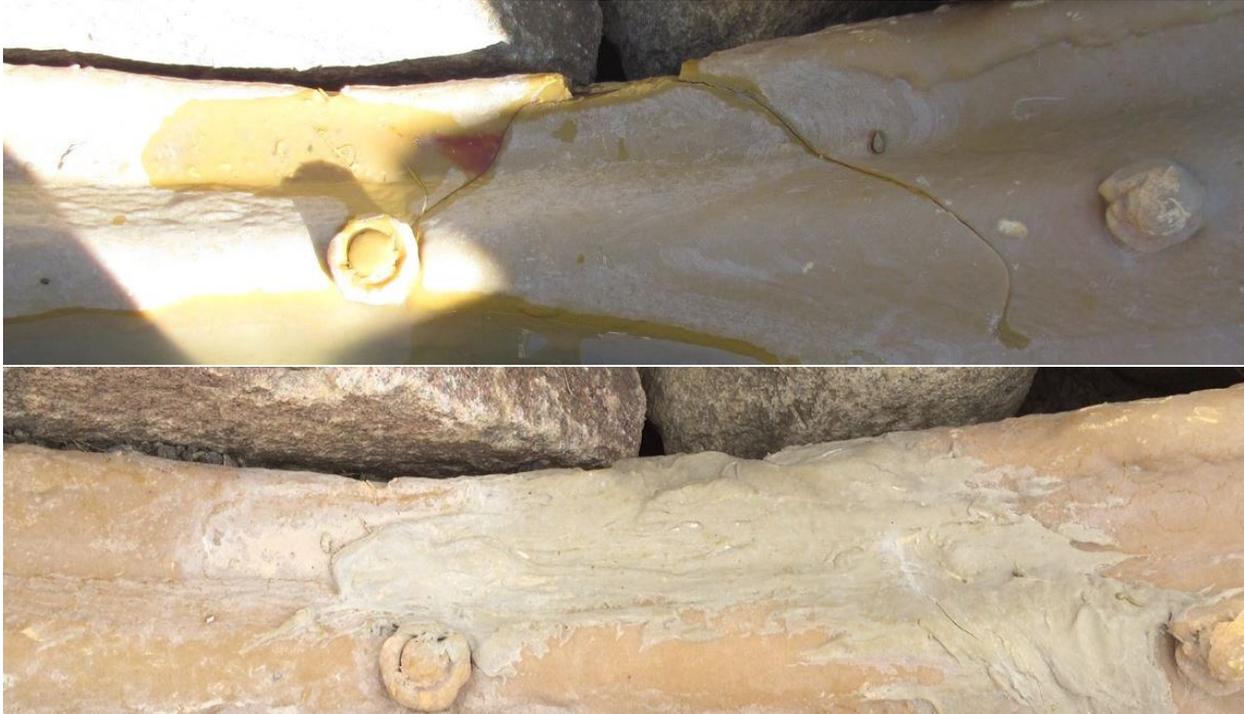
The crack on the bottom edge of the end section (refer to Photo 14) appears to have been created by installation of the adjacent rip rap. There is a chip on the edge of the liner and two cracks propagating at an approximate 45 degree angle from the chip.

**Photo 14 – A crack on the bottom edge of the end section. It appears the installation of riprap caused the damage.**

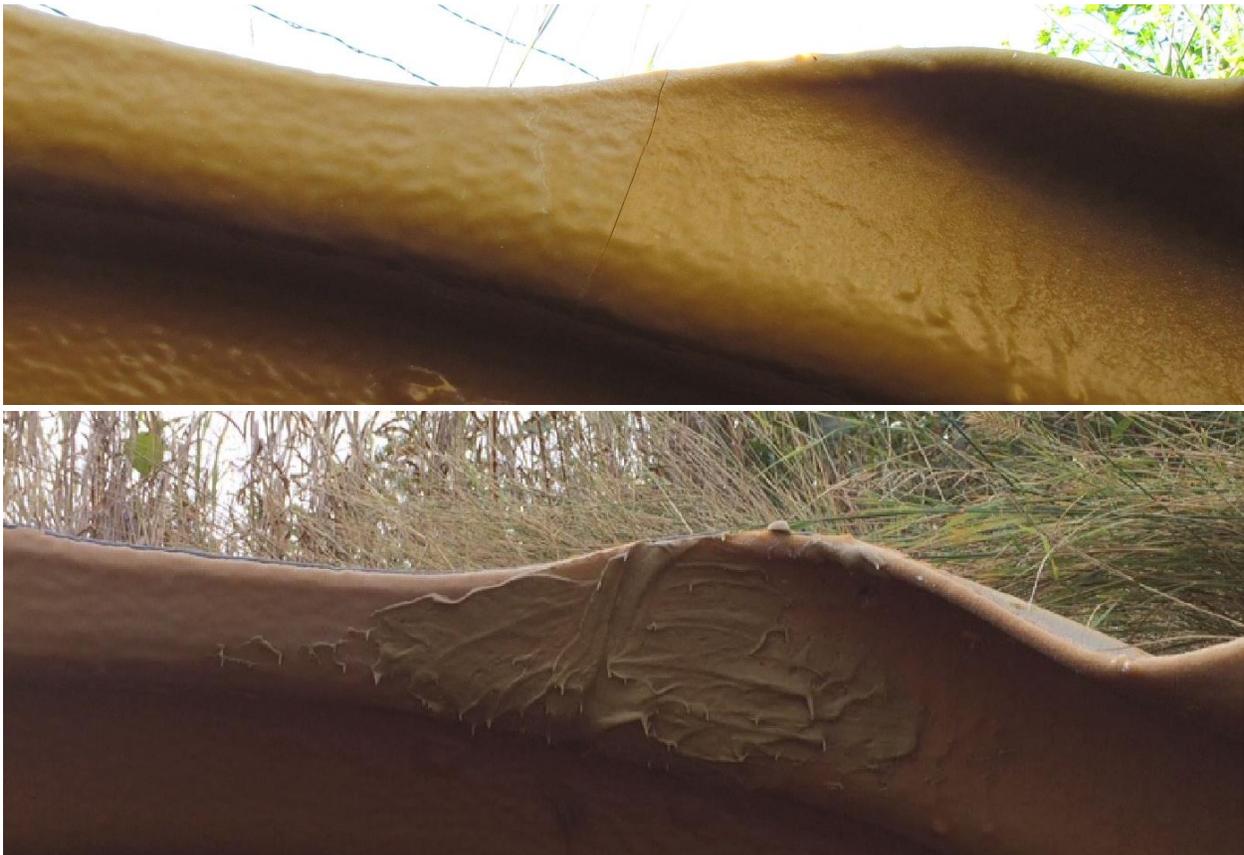
**Photo 15 – A crack at the top edge of the end section before and after the repair.**

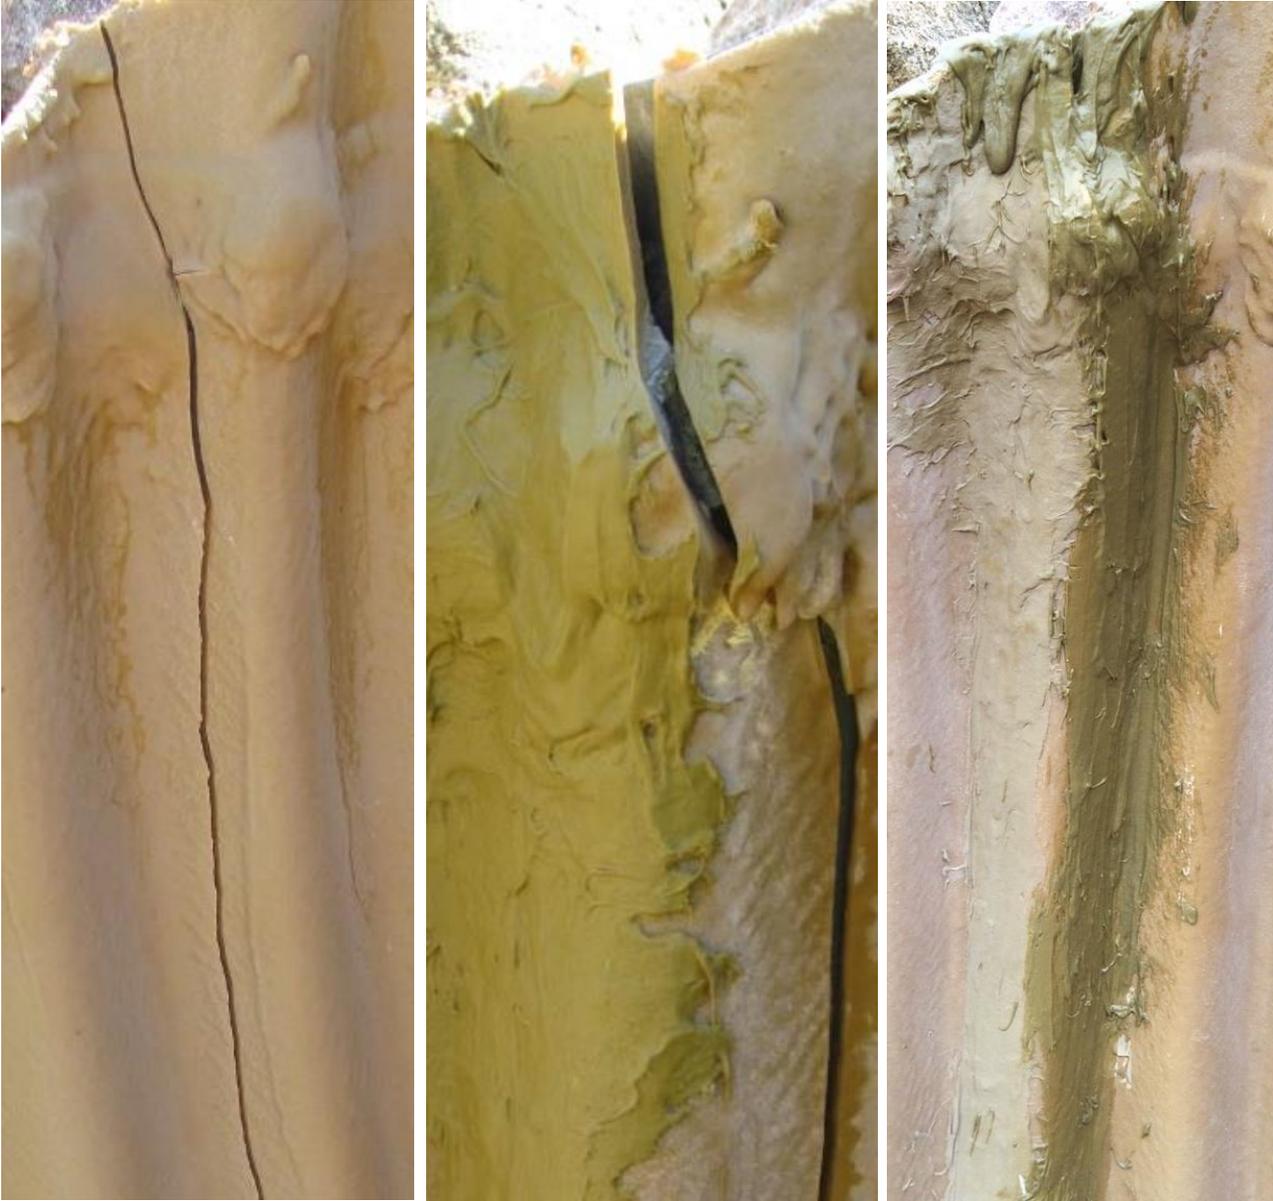
The crack on the side of the end section was the most severe crack (refer to Photo 16). The crack was repaired prior to May 26, 2015 and another crack appeared parallel next to the original crack. Subsurface then repaired the new crack prior to the August 28, 2015 evaluation. Along the edge of the end section where these cracks developed there is delamination between the end section and the Spraywall liner (refer to Photo 17). The gap between the end section and Spraywall liner were filled with Sprayroq epoxy SR 6100.

**Photo 16 - A crack at the side edge of the end section before and after the repair. After the repair was complete, another crack formed parallel next the repaired crack. The new crack was repaired Subsurface.**

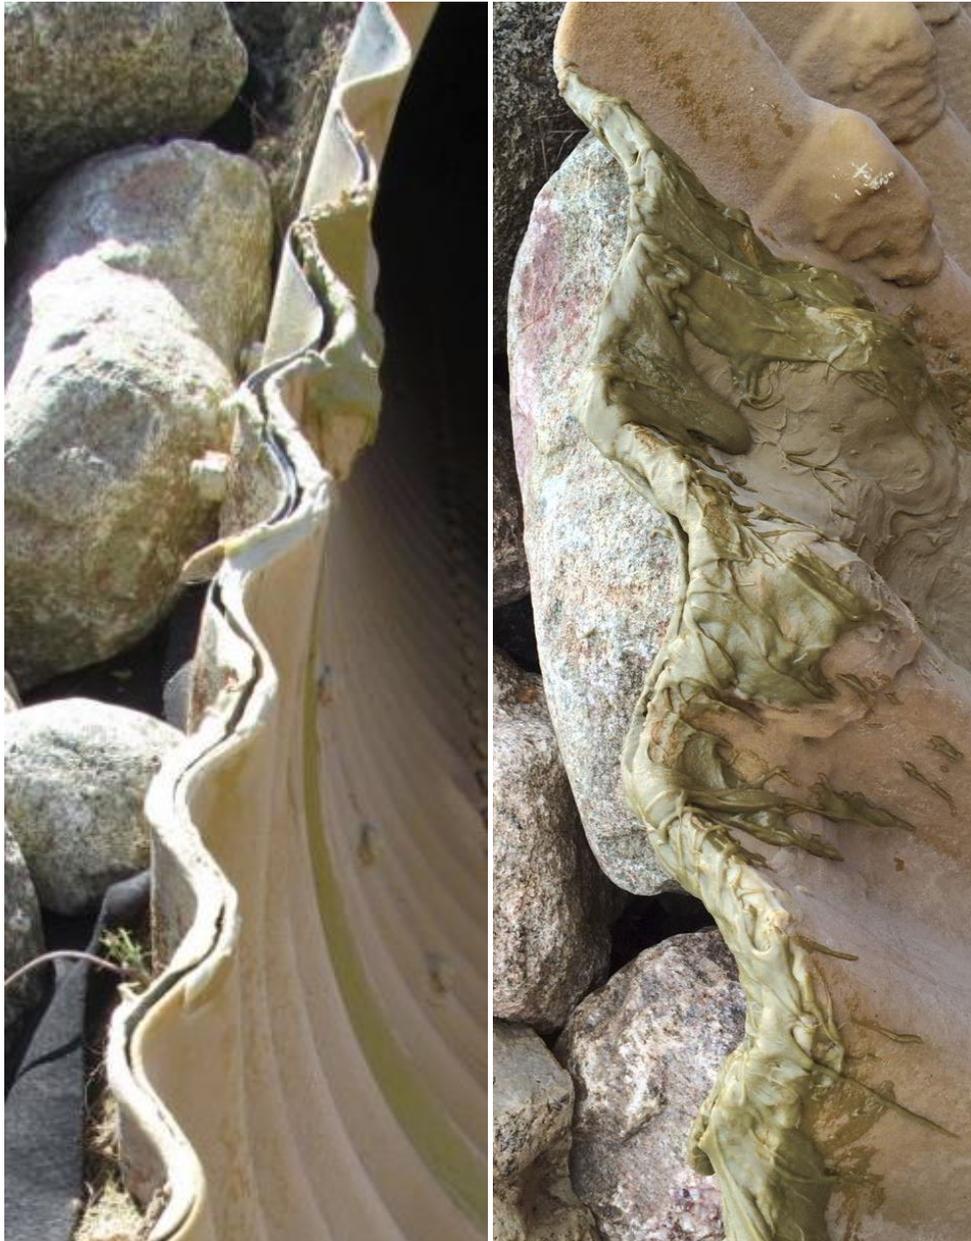
**Photo 17 – Delamination between edge of end section and Spraywall liner.**

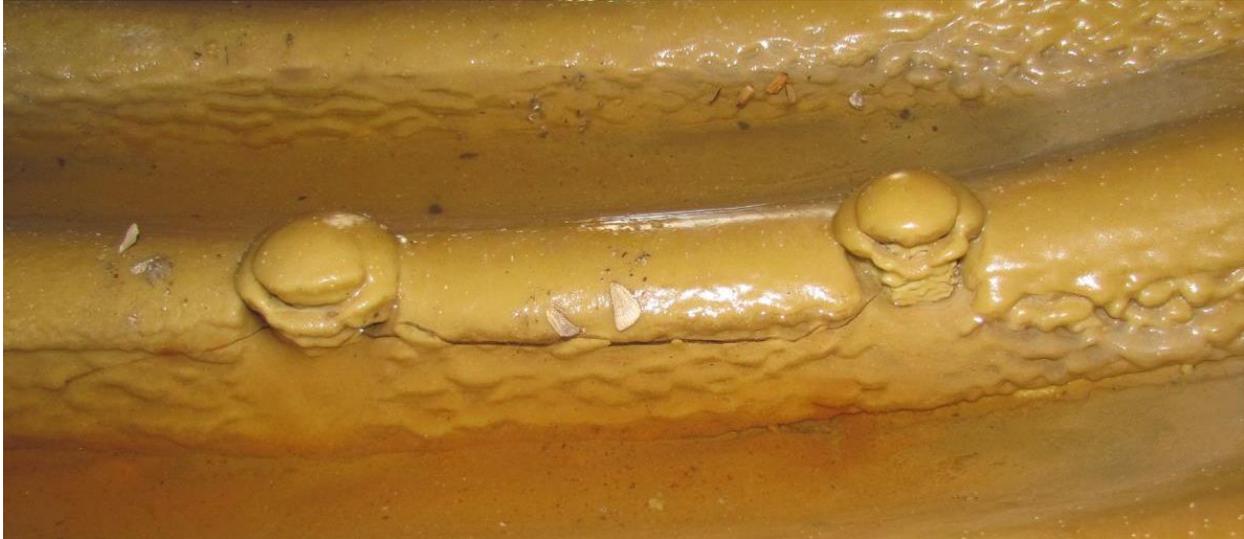
There was only one crack that was not on the outside edge Spraywall liner. This crack is on the floor of the pipe, 50' in from the end of the pipe. The crack is on a joint for the structural plate pipe (refer to Photo 18).

**Photo 18 – Crack on the bottom of pipe 50' in from end of pipe.**
