Experimental Study ND 92-02

**Evaluation of Stratagrid's A-100
Ability to Strengthen an Asphalt Overlay**

Final Report

Projects
ST-6-032(017)191 & NH-4-002(046)130

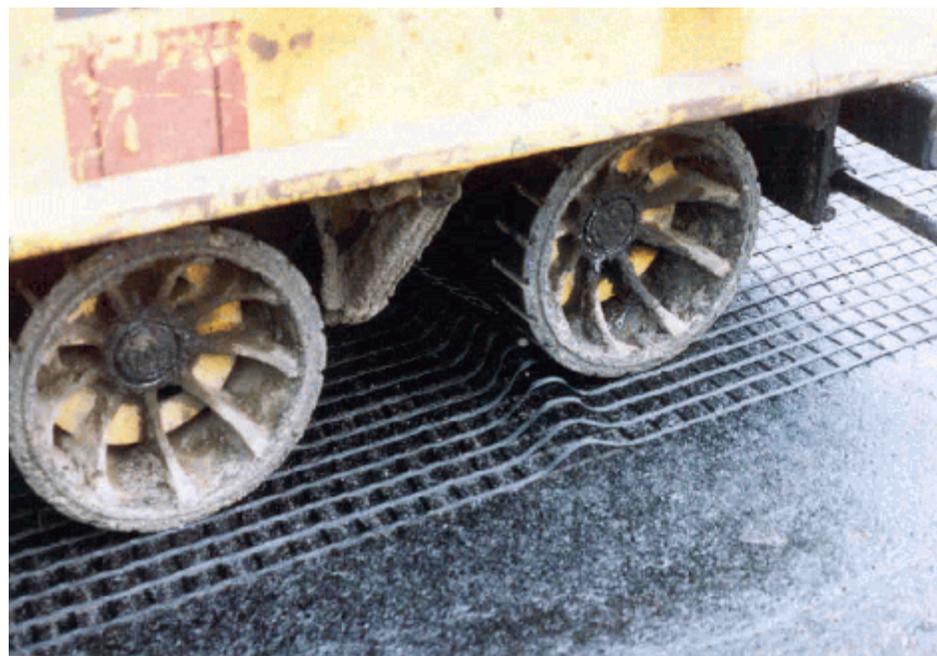
to back up from the end of the test section to the start of the test section. The trucks drivers were instructed to minimize sharp turns and sudden braking or acceleration movements while backing on the geogrid. It was important the geogrid was left lying flat and undisturbed. This was not the case when the overlay operation began. In photo 6 the geogrid is being lifted by the adhesive tack on the laydown machine wheels.

Photo 6. View of the geogrid being lifted by the laydown machine wheels.

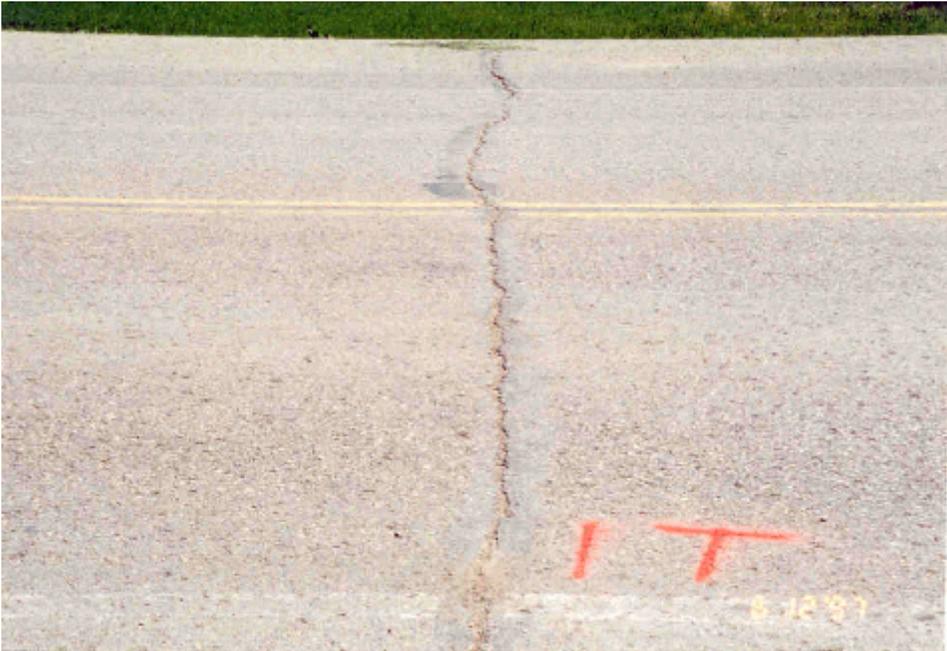
Photo 9 is a view of a typical transverse crack located in the test section.

Photo 9. View of a transverse crack in the stratagrid test section

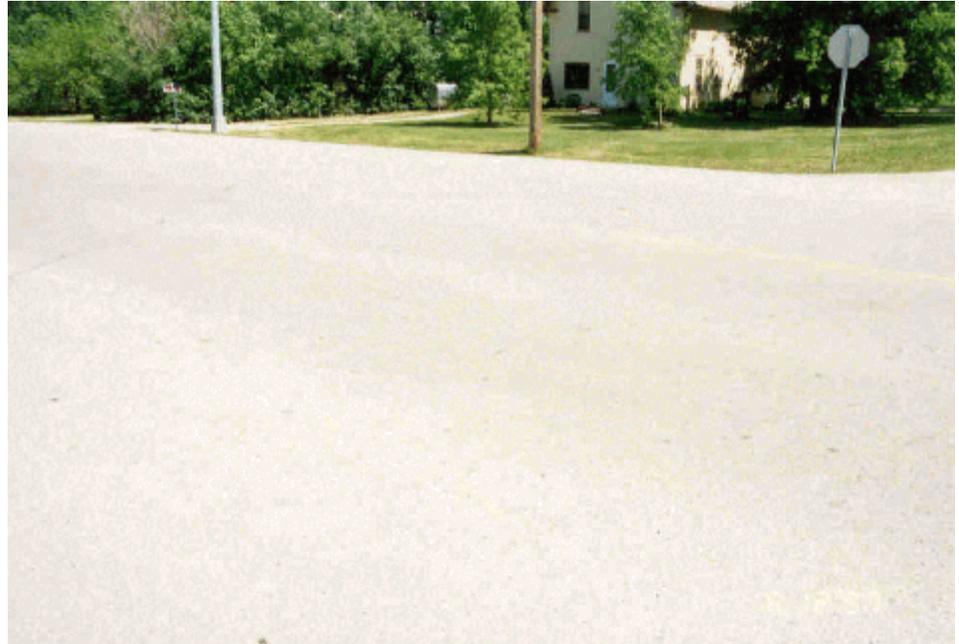
Photo 10 is an overview of an area located in the test section taken in 1997. Photo 11 is a view of the same area taken before the asphalt overlay and Stratagrid were applied. It would appear from these photos that the cracks shown in

Photo 10. Overview of an isolated area located in the test section

photo 11 have not all reflected through at this time. Also the test section appeared to

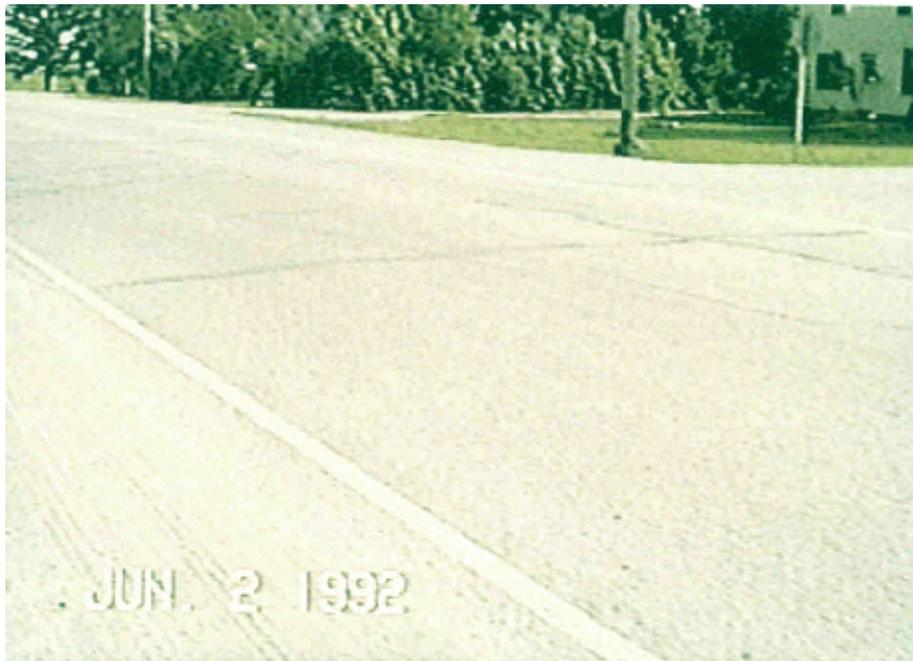
Photo 11. Similar view of the area shown in photo 10 taken before the asphalt overlay and stratagrid were laid down.

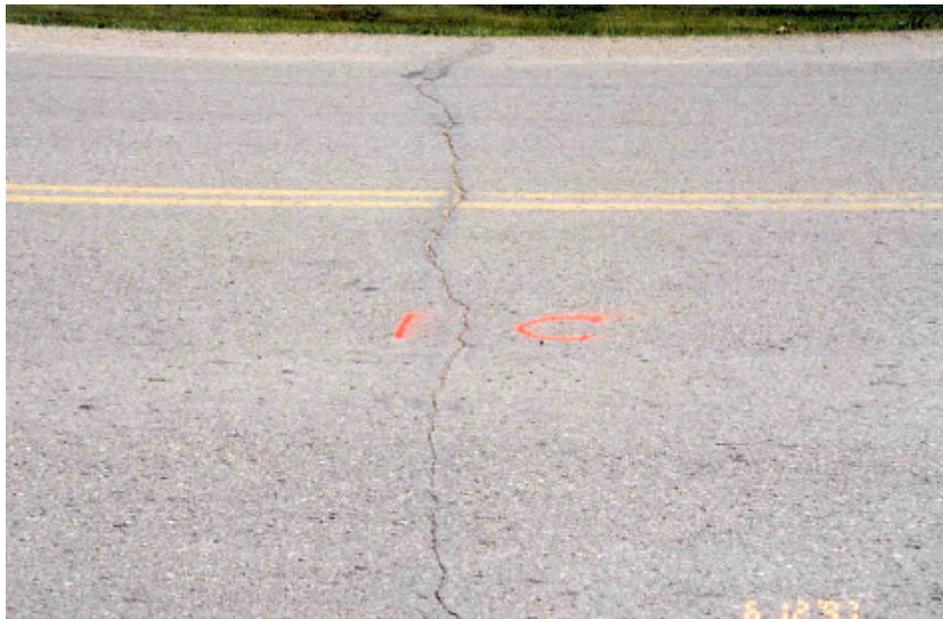
Photo 13. View of a typical transverse crack in the control section.

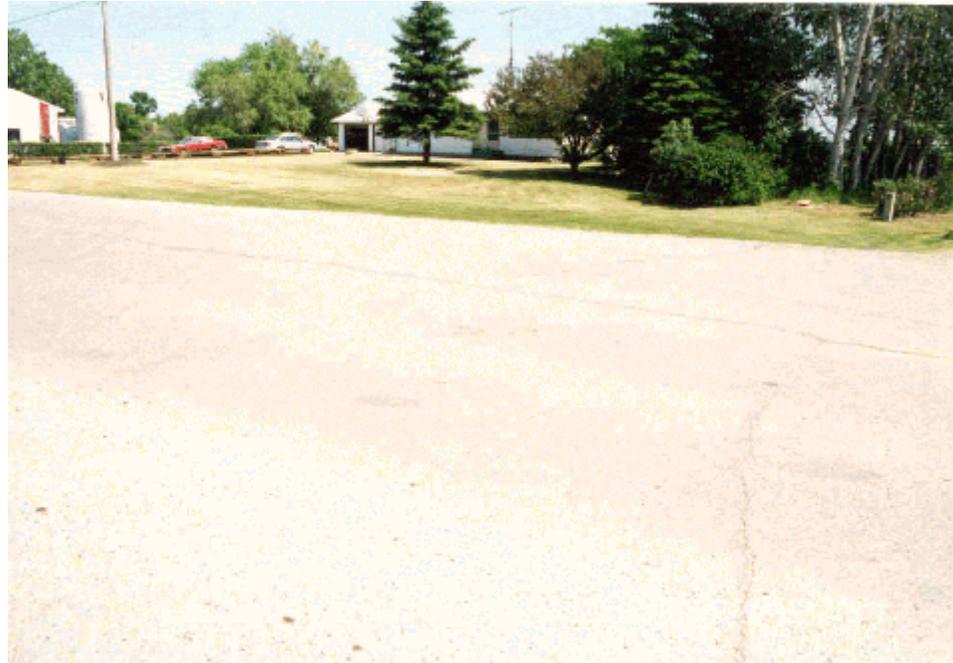
Photo 14 is an overview of an area suffering from a combination of longitudinal and transverse cracking located in the control section. Photo 15 is a view of typical longitudinal cracking. Upon viewing the preconstruction video, it would appear that most or all of the distresses in the control section had already reflected through.

Photo 14. View of an area displaying both transverse and longitudinal cracking in the control section.

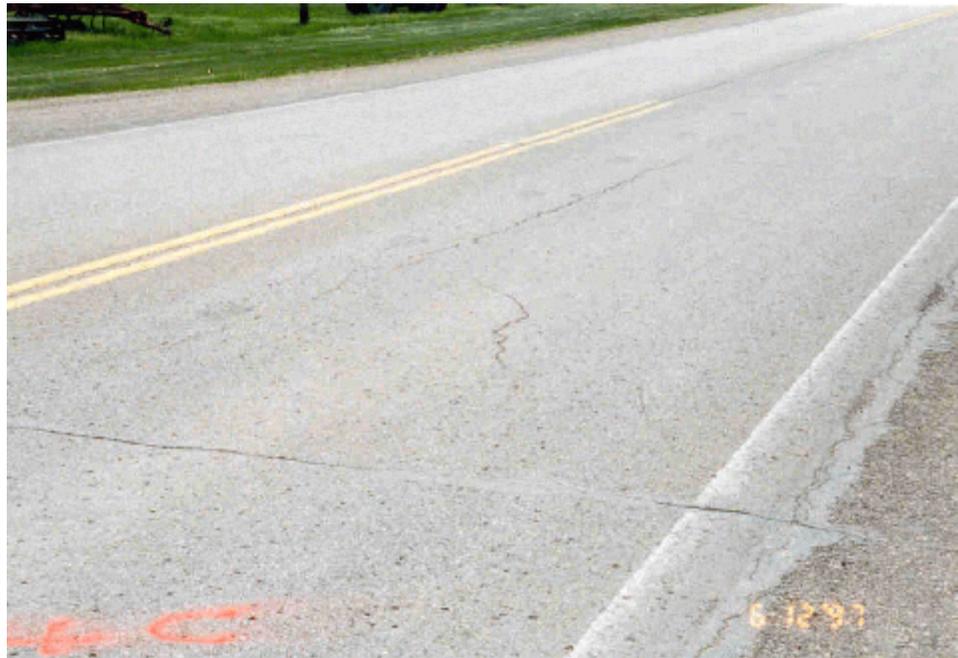
Photo 15. A view of typical longitudinal cracking occurring in the control section.

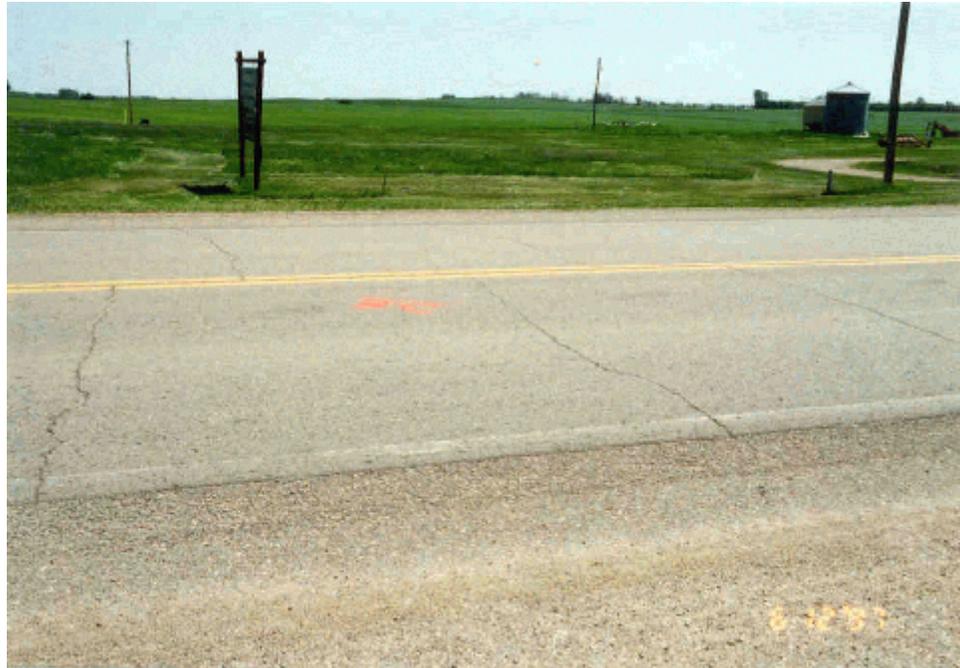
Part of the increase in transverse cracking in the control section is due to the type of cracking shown in photo 16. These cracks appear tighter and more closely spaced. They also rarely

extend across the entire roadway. Upon viewing the preconstruction video, it was difficult to locate any of these distresses prior to the overlay.

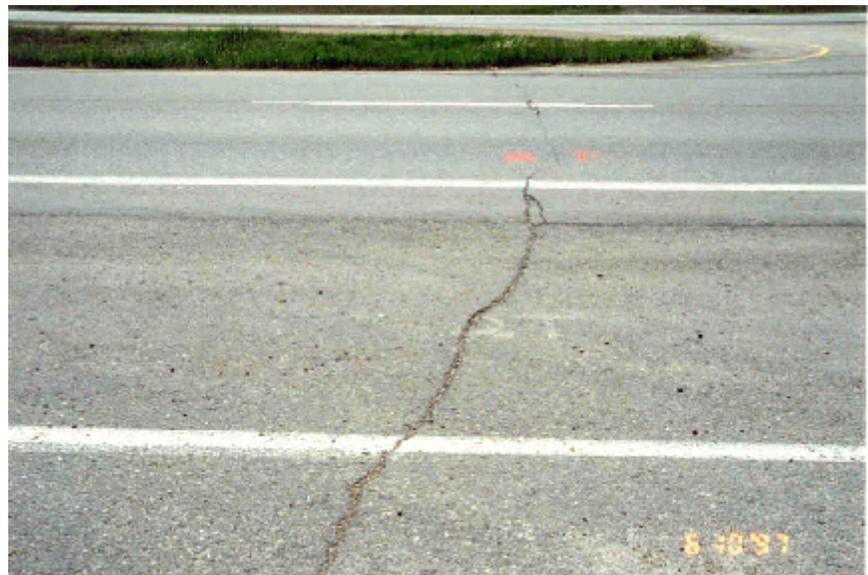
Photo 18. A view of a typical transverse crack located in the stratagrid test section.

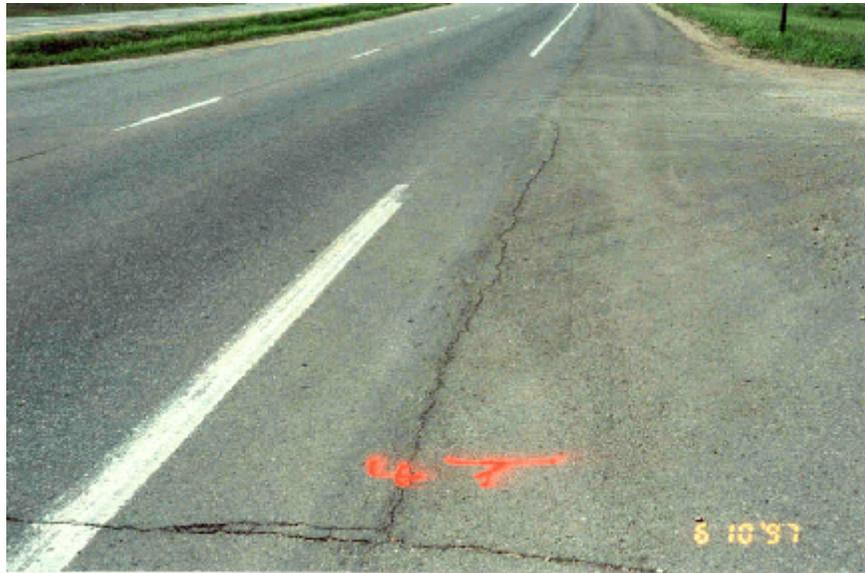
Photo 19 shows a longitudinal crack present in the shoulder (driving lane). Photo 20 shows one of several shoulder cracks present in the test section. These cracks have increased in length over the last two years but not to any significant amount. As was previously mentioned the

Photo 19. A view of a longitudinal crack located in the shoulder of the test section

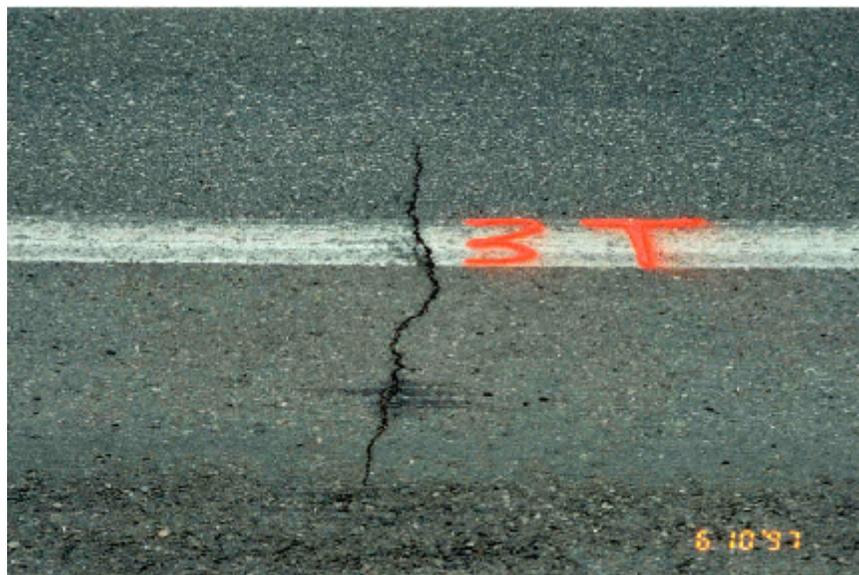
Photo 20. A view of a typical shoulder crack that is extending into the mainline.

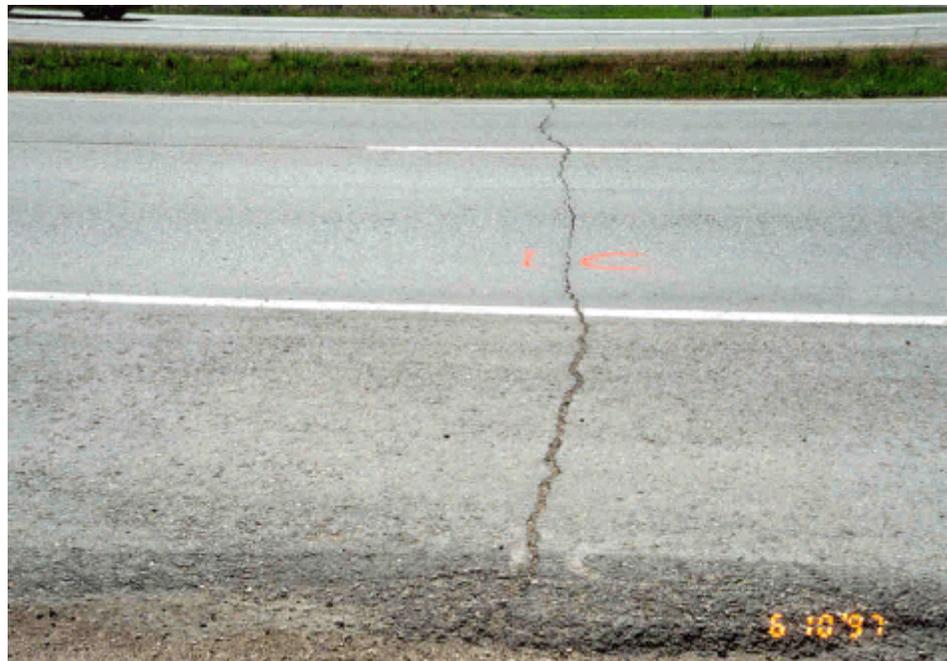
Photo 21 shows an overview of the east control section. The east control section registered 12 full transverse cracks and a 30' longitudinal crack in the shoulder. Photo 22 shows a typical crack located in the east control section.

Photo 22. A view of a typical crack in the east control section.

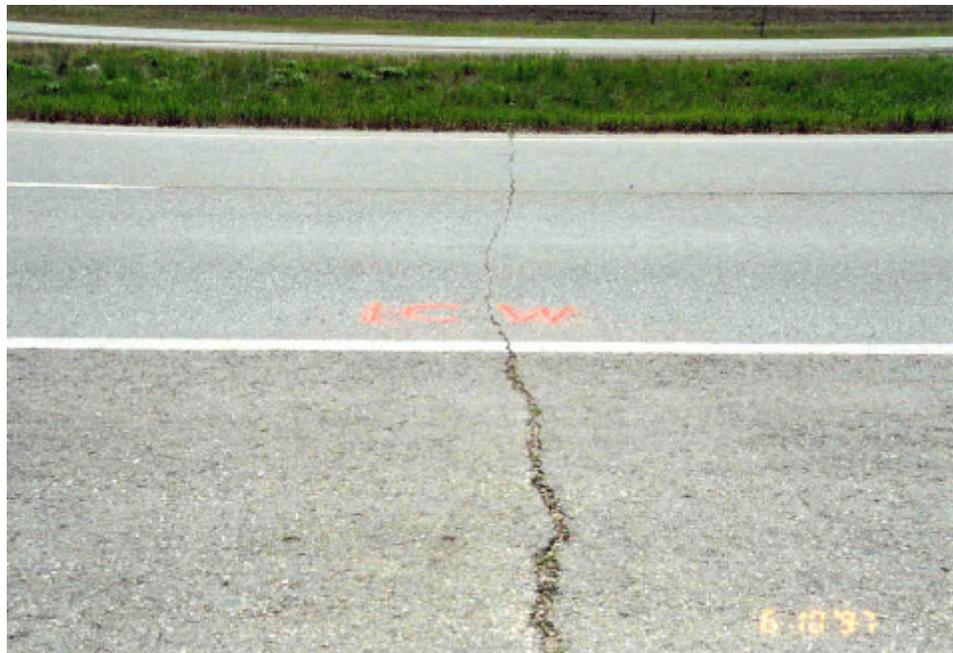
Photo 23 shows an overview of the west control section. The west control section registered eight full transverse cracks and a 30' longitudinal crack in the passing lane. Photo 24 shows a typical crack located in the west control section.

Photo 24. A view of a typical crack in the west control section.
