**NORTH DAKOTA
DEPARTMENT OF TRANSPORTATION**

Experimental Study ND 95-03

Dowel Bar Retrofit for Load Transfer

Final Report

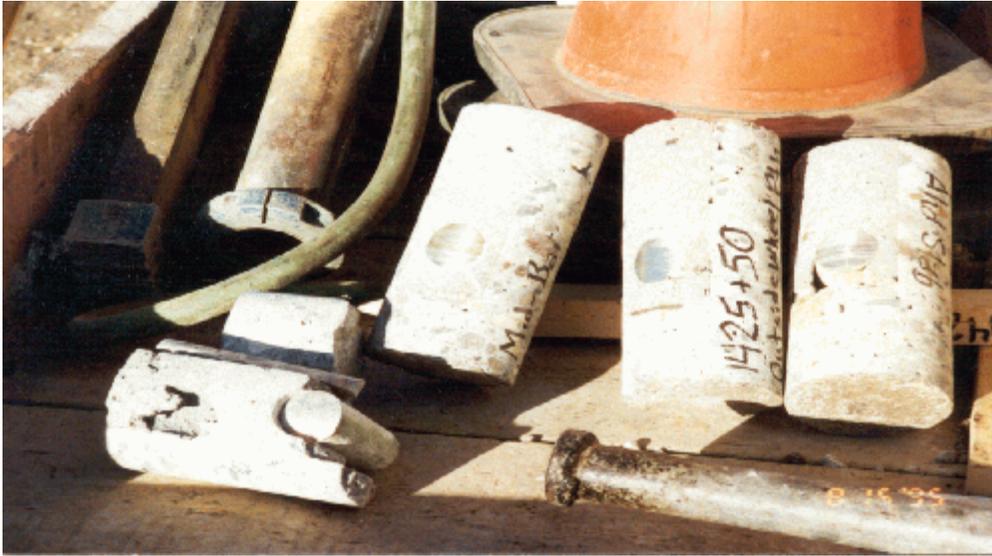
Several cores were taken shortly after the test sections were constructed. It was determined from the cores taken that insufficient vibrating of the mix had caused voids under the dowel bars.

Photo 1 provides a view of these voids which were evident in the sections where the Patchroc 10-60 mix was used.

Photo 1. View of several cores taken by the Grand Forks District

It was determined that the contractor would redo any areas with less than 50% load transfer. The contractor ended up replacing 120 dowels or about 2% of the total dowels. All of the replacement dowels were located on stations that used Patchroc 10-60.

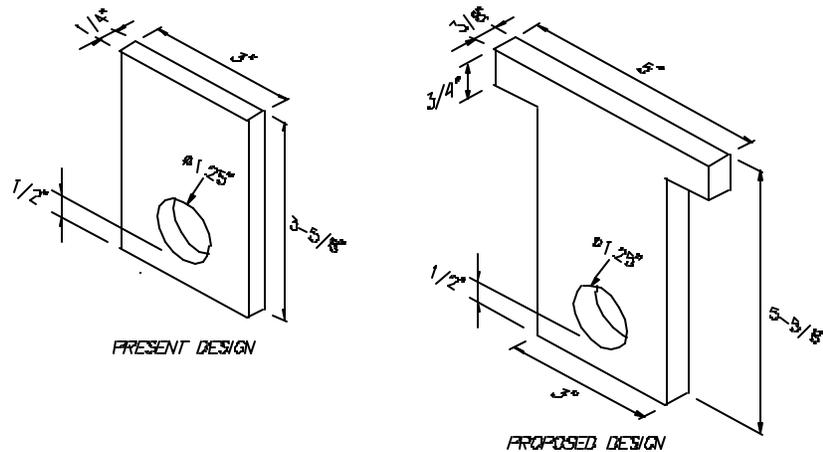
The core board design used in the Grand Forks project did not perform well. While placing the patch mix, the core board was failing to stay vertically stable. It was recommended that the core board be redesigned to include extensions on the upper portion of the core board. The extensions on the upper portion of the core board would extend into and parallel to the existing joint. This would insure the core board would run parallel in the joint and would not tilt when the sawed slot is filled with Patchroc 10-60 mix.

The Fargo District recommend that the Department of Transportation redesign the foam core boards to a T shape for future projects. They recommended a change in the thickness of the board to 3/8" thick, run the core board to the top of the slab, and have the contractor remove excess sealant where the extensions will set in the joint. Figure 1 shows the proposed change.

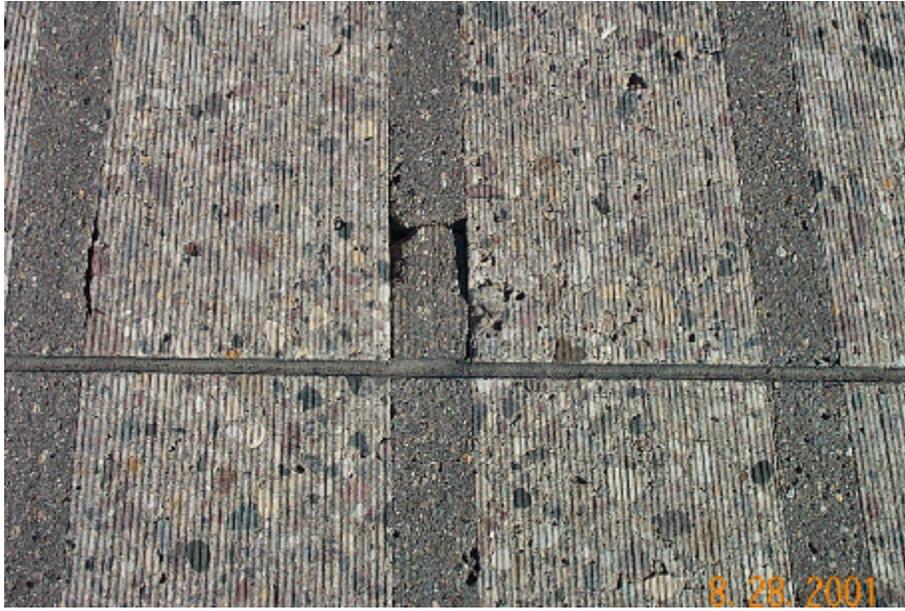
One kind of distress that was prevalent is shown in photo 3. There were several dowel bar slots experiencing this type of distress. In many cases the mix located between the adjacent joint and the transverse crack is loose. It is believed this type of distress is the result of poor consolidation of the mix around the dowel bar.

Photo 3. Typical distress detected during 2001 evaluation (A portion of the test sections containing Patchroc 10-60 patching material)

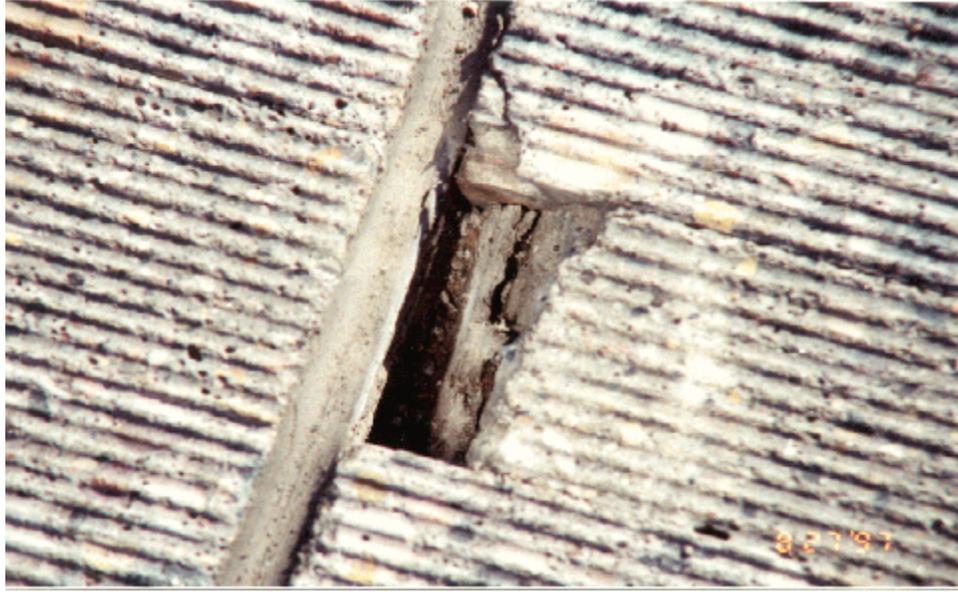
Distress related to core board failures as shown in photo 4 is also detected on one side of the joint and extends outward approximately 1" to 2". It is believed that as the patch mix was being placed the weight of mix would bend the core board over. The original core board design is shown back in Figure 1. Once the core board was forced to yield one way or the other, the patch mix would then be free to cover the core board. This condition left the core board sitting on a slant or in some cases horizontal with upwards to 2" of mix being placed on top the foam core board. When traffic was allowed to pass over the roadway, the corresponding loads may have forced the mix to shear at these areas since there was no support underneath the mix.

Photo 4. A view of a typical distress caused by a core board failure

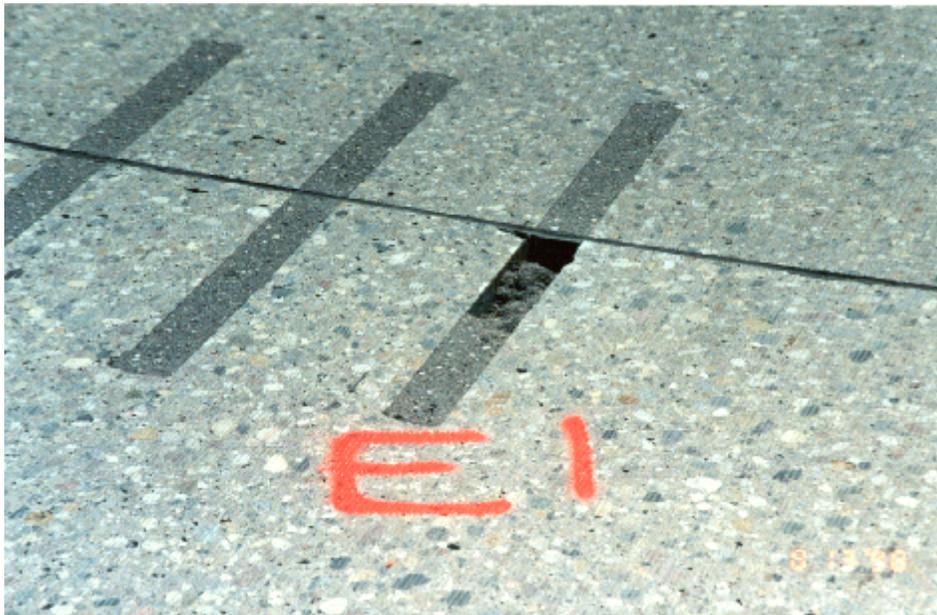
Another type of distress observed in the test section containing the Patchroc 10-60 relate to the performance of the mix. Photos 5 and 6 depict views of typical dowel bar slots in the Patchroc 10-60 section that is experiencing deterioration of the mix. Photo 5 depicts the most common failure, deterioration near the panel joint. Photo 6 provides a view of a failure some distance from the panel joint.

Photo5. Patchroc 10-60 mix deterioration near panel joint

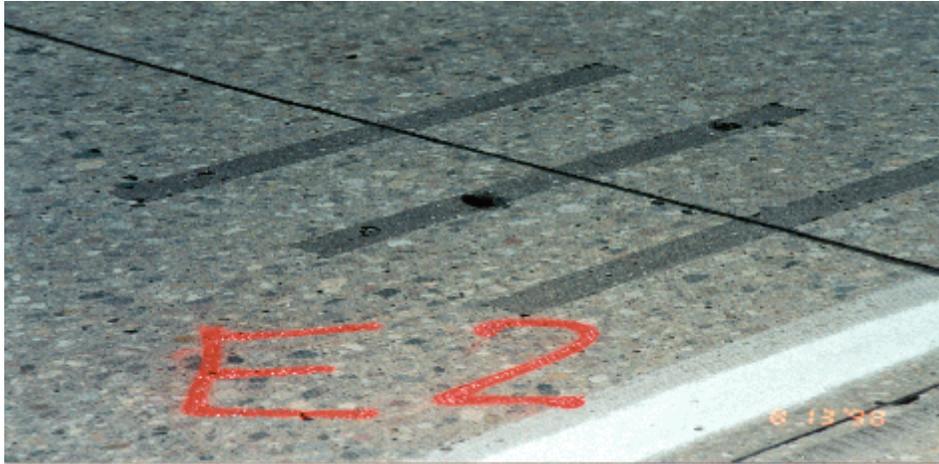
Photo 6. Patchroc 10-60 section experiencing mix deterioration

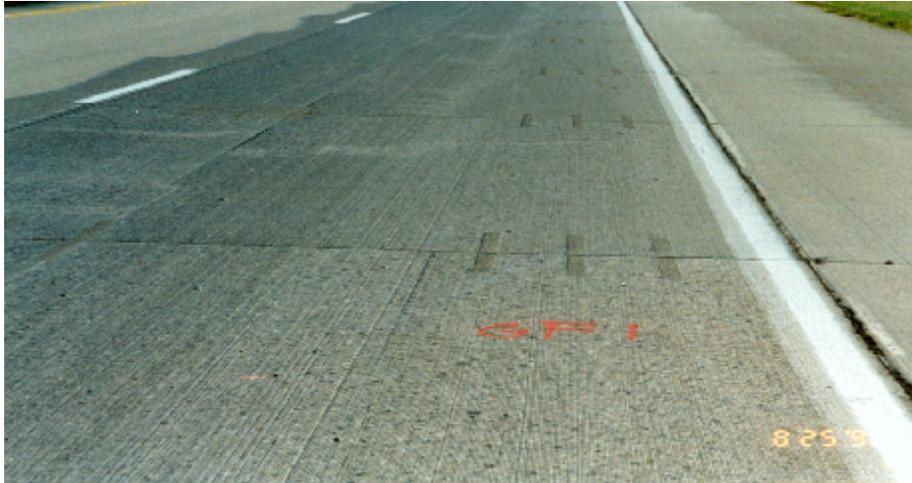
Photo 7 shows an overview of several sets of dowel bars slots located in the outside wheelpath of the Patchroc 10-60 section which are affected by deterioration of the mix. Notice in photo 7 that the traffic has worn down the material in the slots. They are now recessed relative to the surrounding pavement surface. This can also be seen by a slight shadow shown on the left edge of each slots in photo 7. Also notice that the inside lane does not appear to be as severe.

Photo 7. Dowel bars slots located in the outside wheel path of the Patchroc 10-60 section

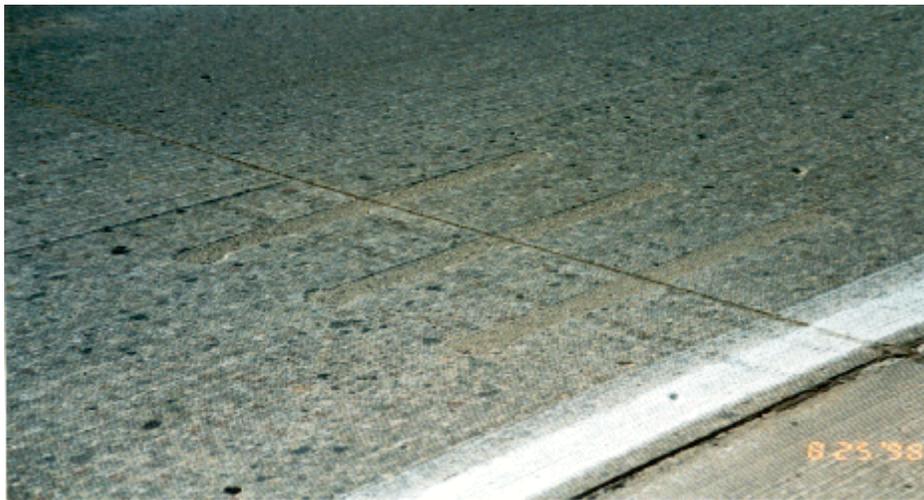
Photo 8 is a close-up view of some of the dowel bars slots affected by the mix problem

Photo 8. Close-up view of photo 7 dowel bars slots affected by mix problem

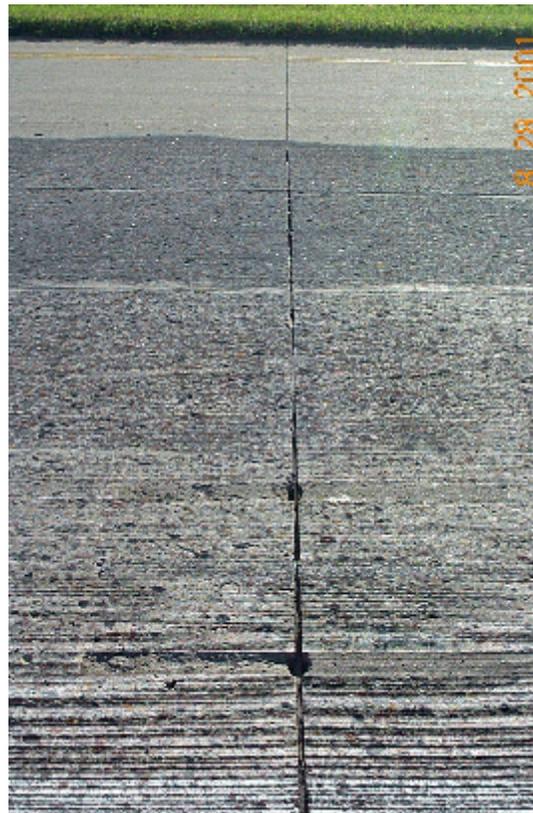
Another type of distress that is present in the Patchroc 10-60 test section is shown in photo 9. Notice the distresses present on near both sides of the joint and also the severe raveling of the mix. The distress (Patchroc material missing) located at the joint is believed to be a bonding issue. The special provision calls for caulk to be placed in the bottom of the slot and the sides along the joint so patch material does not enter the joint. If care is not taken, some

Photo 9. Note the severe raveling and the debonding along the joint.

of the caulk will end up on the sides of the slots and create a bonding problem. The severe raveling of the mix is a durability problem within the mix itself. A similar type of distress has been detected in the Fargo District.

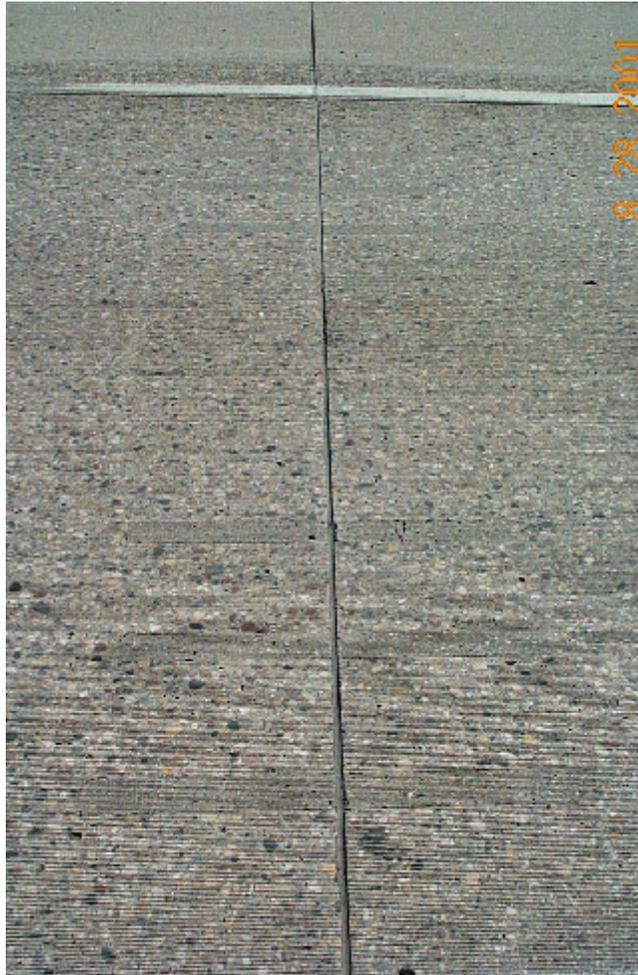
Photo 10. Typical retrofitted joint where 3U18 mix was used. Note the shrinkage crack in the 3rd joint.

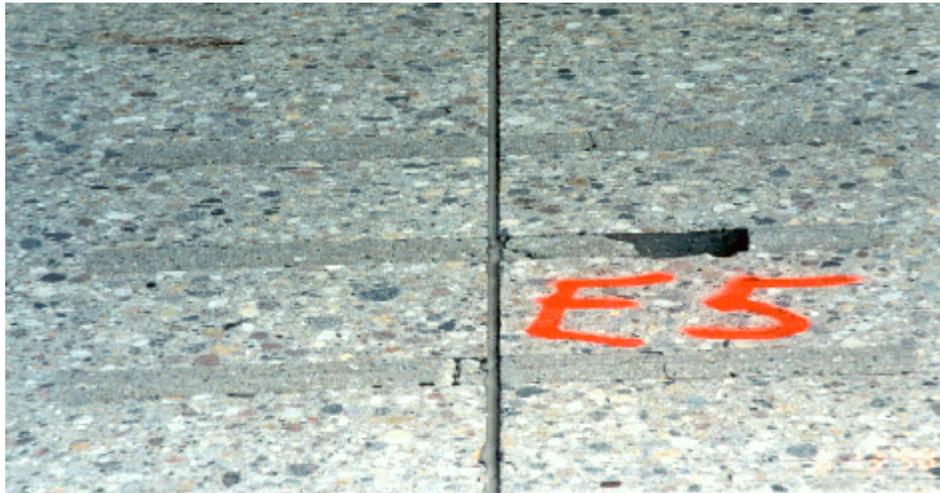
Photo 11 shows dowel bar slots affected by several types of distresses including the shrinkage cracks. Notice how the transverse cracks do not follow any distinctive pattern as to how far away from the joint they exist. Photo 11 also illustrates a view of a large piece of patch mix that is missing from the slot. The dowel bar is exposed and has to some extent rusted. At a glance it appears that the mix may have been improperly vibrated and the consolidation did not occur around the dowel bar causing the concrete to break out.

Photo 11. Dowel bar slots filled with 3U18 patch mix affected by several types of distresses including the shrinkage cracks.

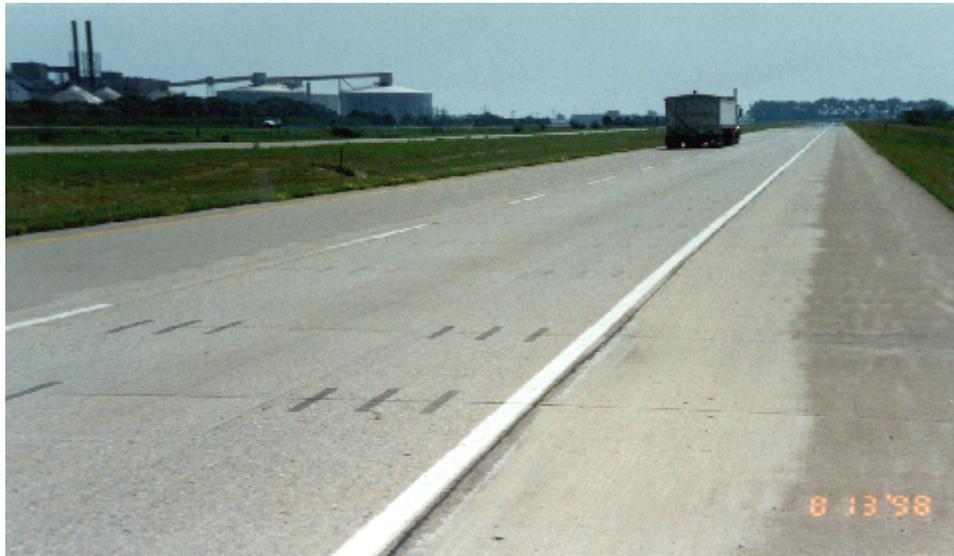
Mix problems whether construction related or within the mix itself is prevalent in both mixes. However, the 3U18 mix is not experiencing the eroding or raveling of the mix as seen the Patchroc 10-60 sections. It appears the 3U18 material is performing better than the Patchroc 10-60 material from a standpoint of durability. Photo 12 shows a view of the border between the two different patch mixes. In the foreground is the slots containing the Patchroc 10-60 material and the later the 3U18 material. At a glance it would appear, from an aesthetic standpoint, that the color of 3U18 material blends into the existing PCC much better than its counterpart.

Photo 12. View of both dowel bar patch materials. Patchroc 10-60 material in foreground, followed by the 3U18 material

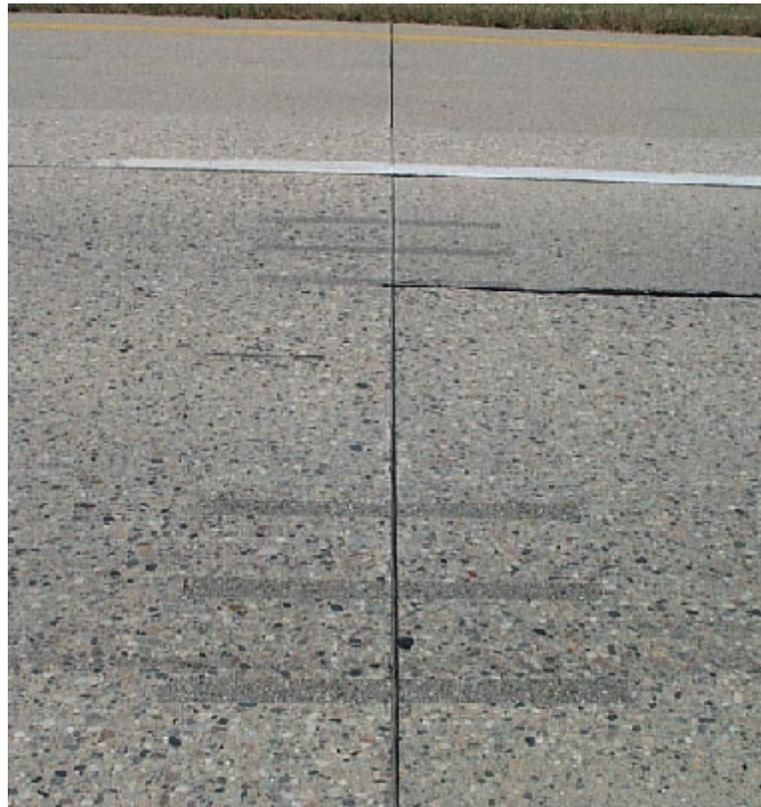
Photo 13. Typical dowel bar retrofitted joint that appears to be performing well. The longitudinal crack has not caused distress to the dowel bar patch mix.

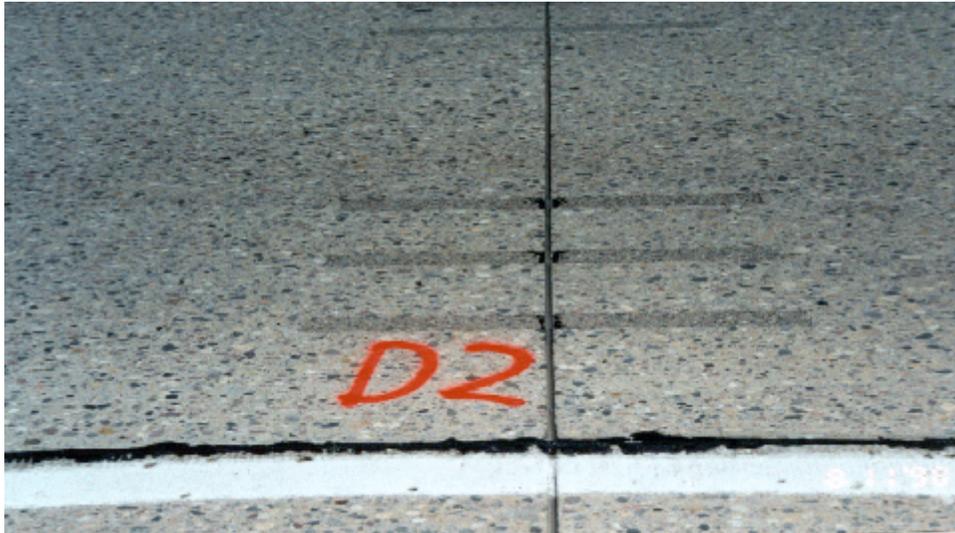
Photo 14 shows a view of several distresses that are believed to be the result of excess silicone caulk on the slot walls prevented bonding between the existing concrete and the patching material.

The bond failure is causing high stresses in a small area near the joint resulting in spalling. The types of distresses shown in photo 14 are sometimes confused with distresses that are related to core board failures (usually affecting only one side of the joint).

Photo 14. View of several distresses that are believed to be the result of excess silicone caulk on the slot walls prevented bonding between the existing concrete and the patching material.

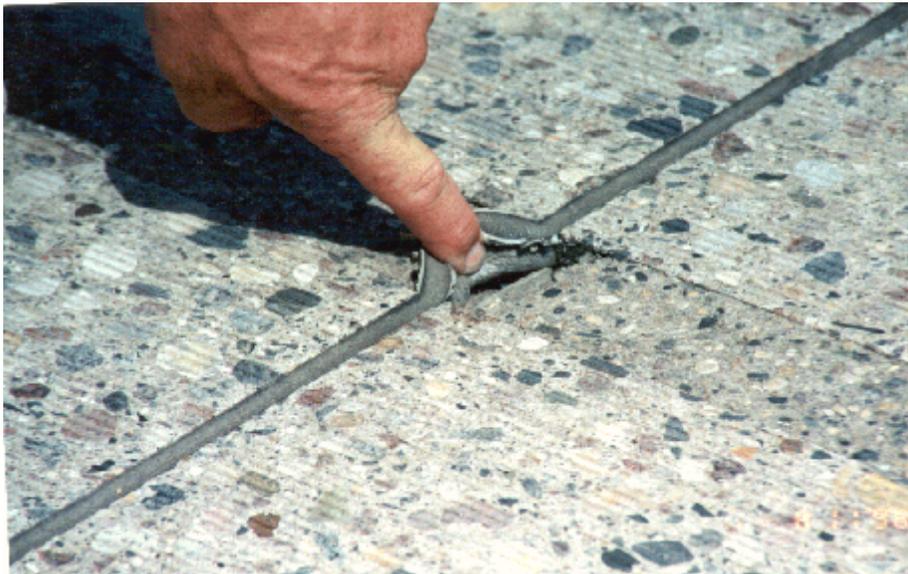
Photo 15 shows the core board in an upright manner.

Photo 15. A close-up view of one of the dowel bar slots in photo 14.

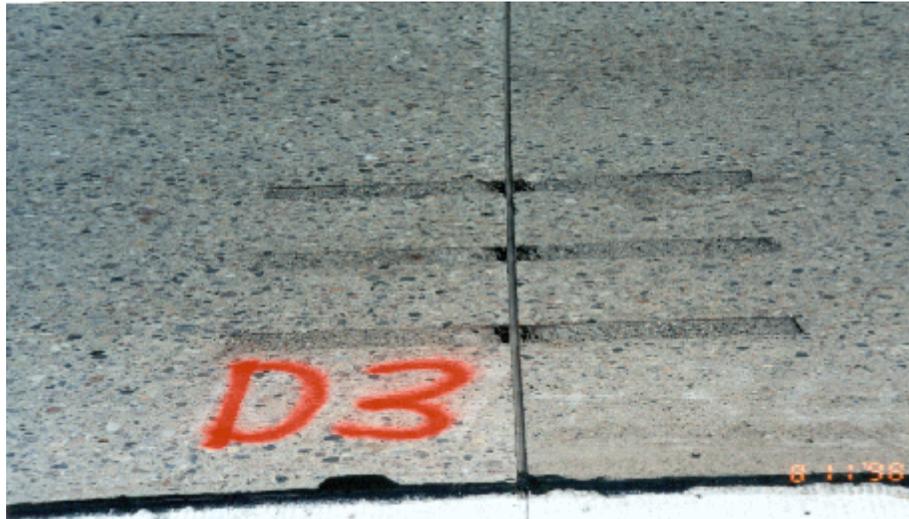
Photo 16 indicates an area that is experiencing mix problems in the dowel bar slots. Also in photo 16, traffic has wore down the material in the slots to a point where it is no longer the same elevation as the existing concrete.

Photo 16. An area that is experiencing mix problems in the dowel bar slots.

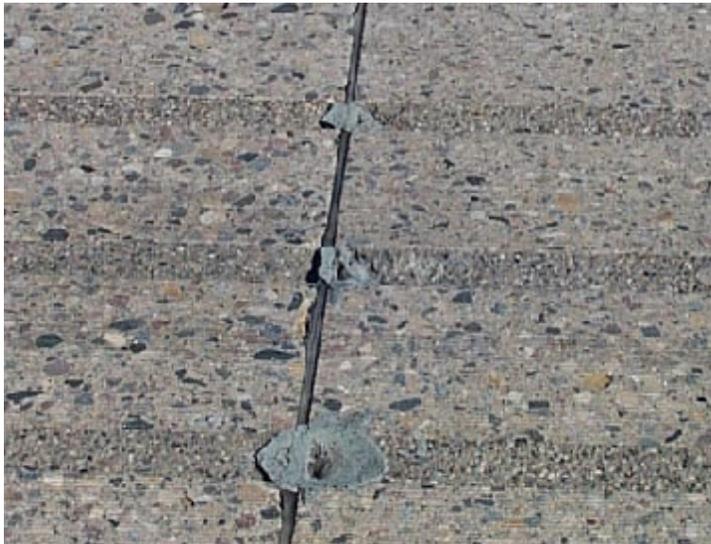
Photo 17 shows a view of dowel bar slots where an effort has been made to repair the mix that has eroded away from the slot. It is not determined at this point if this type of repair will be successful in keeping the distresses from worsening.

Photo 17. Dowel bar slot that was filled with a sealer in an attempt to seal out water and prevent further distresses from occurring.
