**NORTH DAKOTA
DEPARTMENT OF TRANSPORTATION**

Experimental Study ND 96-01

**Evaluation of "Wasser" Single Component
Moisture Cured Polyurethane Paint
for Bridge Maintenance Overcoating**

Project IM-1-094(017)156

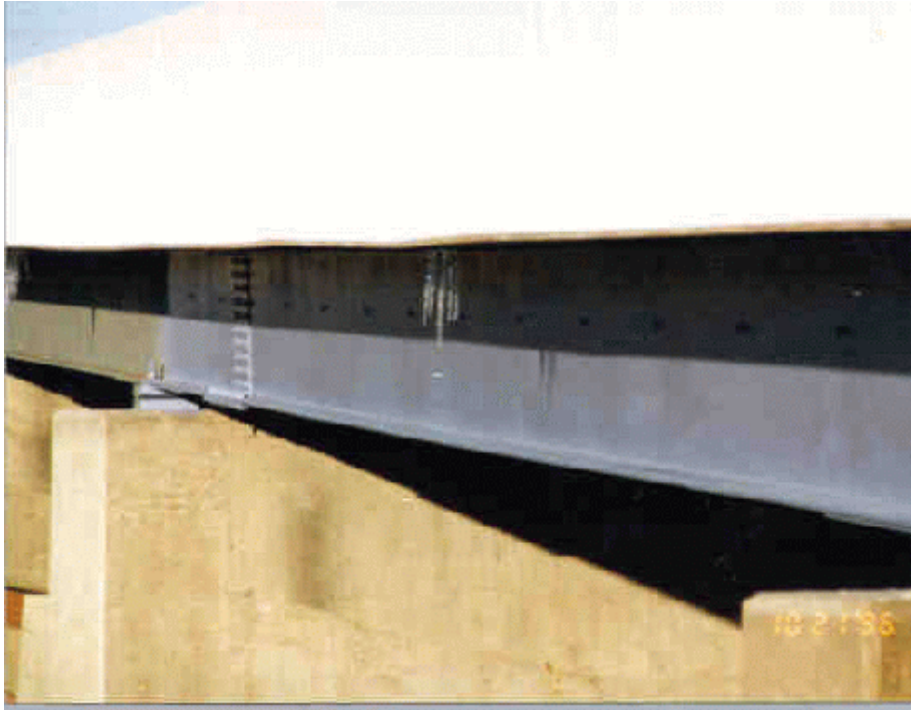
Photo 11: View of exterior beam with prime coat applied during cold weather.

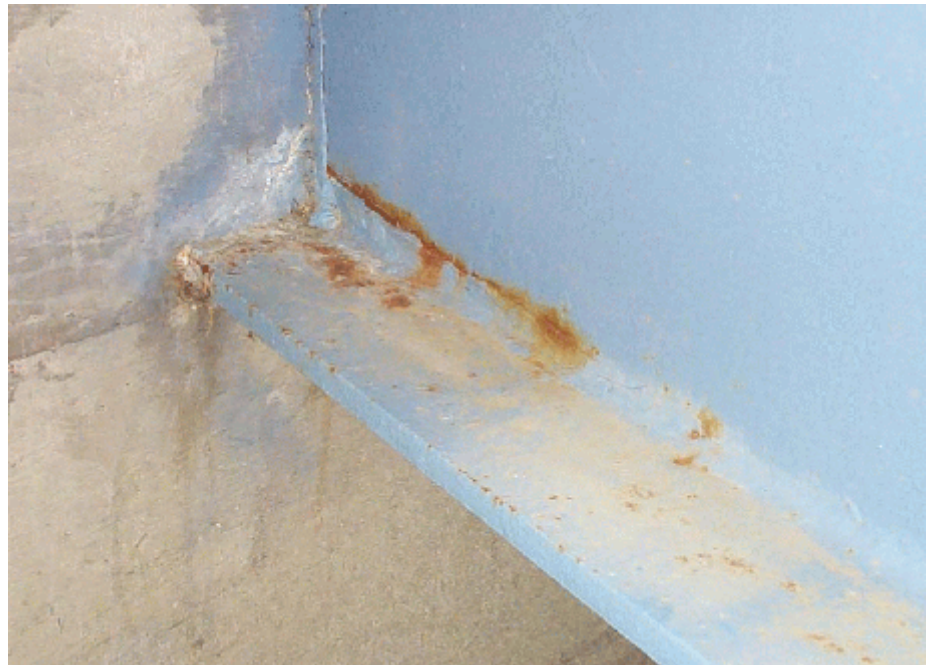
A damaged section on the west end of on the westbound structure was also noted (south beam). Photo 17 shows the damaged area. It appeared as if the paint had cracked along the top of the flange area which allowed moisture to enter.

Photo 17: Damaged south beam on westbound structure.
