**Evaluation of Portland Cement Concrete
as a Rehabilitation Option for
Overlaying an Existing Asphalt Roadway**

Final Evaluation Report

Project NH-2-052(012)244

April 2009

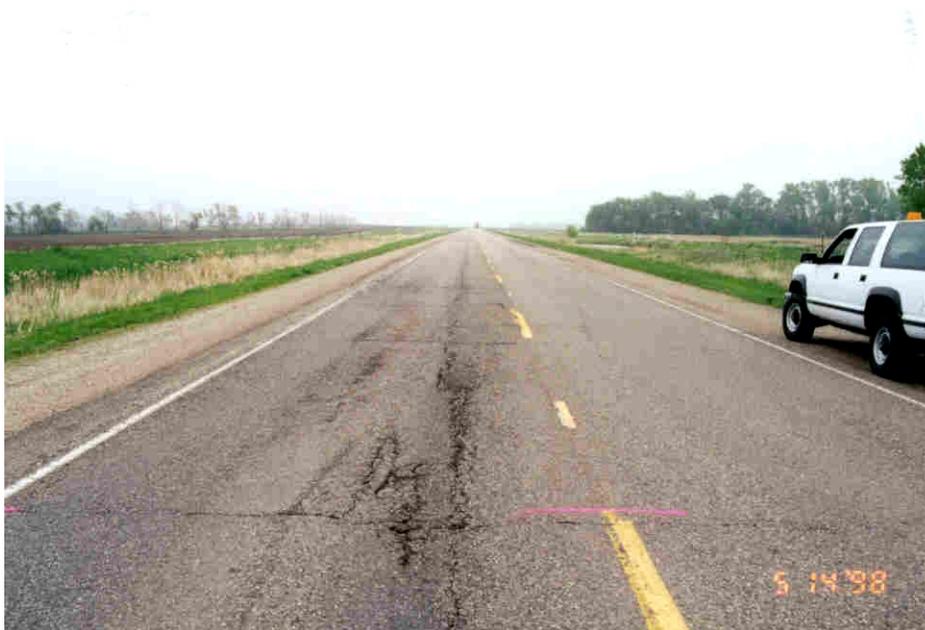
The roadway in question was experiencing distresses such as longitudinal and transverse cracking, rutting (1/8" to 3/8") and shoving pavement, and depressed transverse cracks. This segment of roadway was listed as poor for the ride and the international roughness index. Photo 1 depicts a segment of US 52 with a severely depressed longitudinal crack. One of the rehabilitation options for this roadway was to mill the existing asphalt and overlay with new HBP. However, this option was not considered since the existing cracks would eventually reflect through the new pavement.

Photo 1 - Overview of distressed areas on a segment of US 52.

The option of mining and blending the existing asphalt and base together and overlaying with HBP was chosen. First, 9" of asphalt was milled and removed, then, aggregate was placed on the remaining roadway structure and blended together to achieve a 14" base. A 5" layer of HBP was placed on the blended base section.

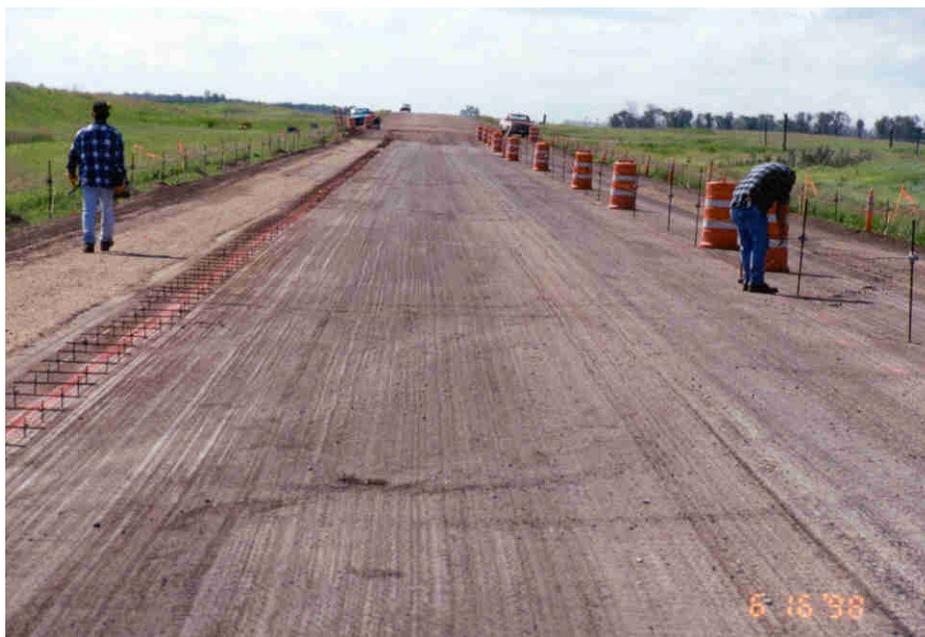
Photo 2 depicts the surface after the milling was concluded. Upon further examination there appeared to be some loose particles and dust still present on the surface. On the left side of Photo 2 tie bars are visible which are located between the impending shoulder and mainline.

Photo 2 - HBP surface after milling was concluded.

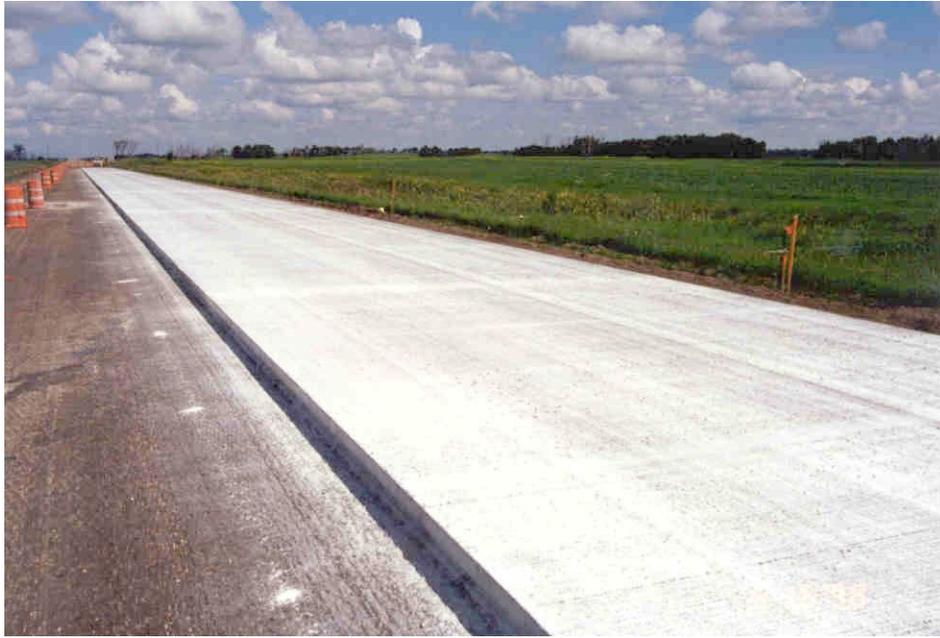
Photo 3 depicts an overview of the finished slab in the northbound lane of section 1 (5" PCC). The contractor commented that during the construction of the 5" PCC slab he had to lower the tie bars. This was necessary since the paver was hitting the top ends of the bars leaving them sticking out of the slab after the paver passed over them.

Photo 3 - Overview of finished slab in the northbound lane of section 1 (5" PCC).

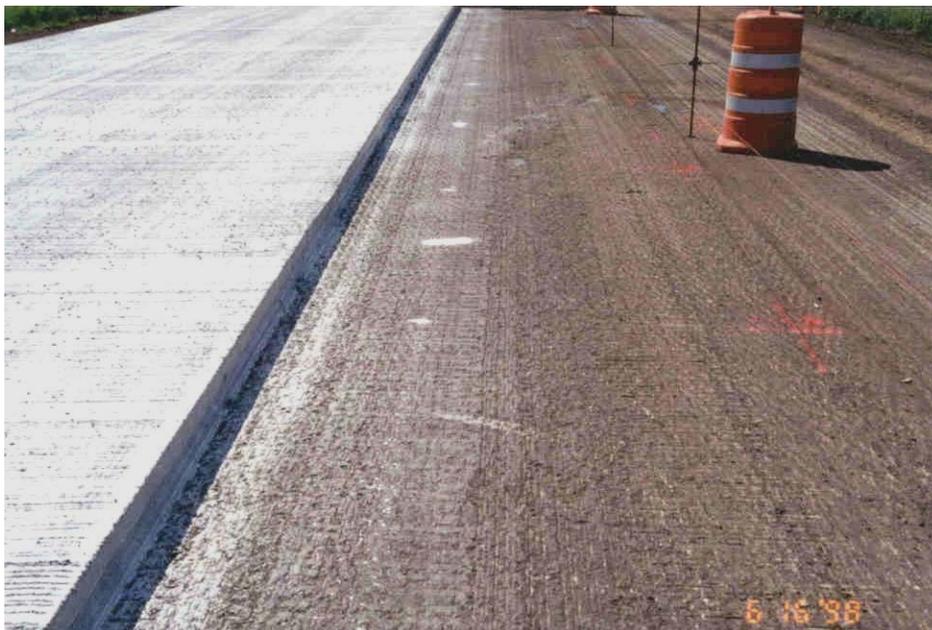
Photo 4 depicts excess curing compound that was sprayed where the southbound lane would be constructed.

Photo 4 - View of excess curing compound sprayed where the southbound lane would be constructed.

The NDDOT personnel were concerned the over-sprayed curing compound would hamper the bonding effect between the PCC and the existing asphalt. The contractor agreed to remove the compound from the surface prior to placing the slab. The contractor finished all three test sections in the northbound lane by mid to late afternoon. Although precise times were not kept, the placing of the 6" slab required a little more time than the 5" slab because of the increase in the volume of PCC. The contractor commented that the job would have progressed at a faster rate if the ready mix trucks could have kept up to the paver.

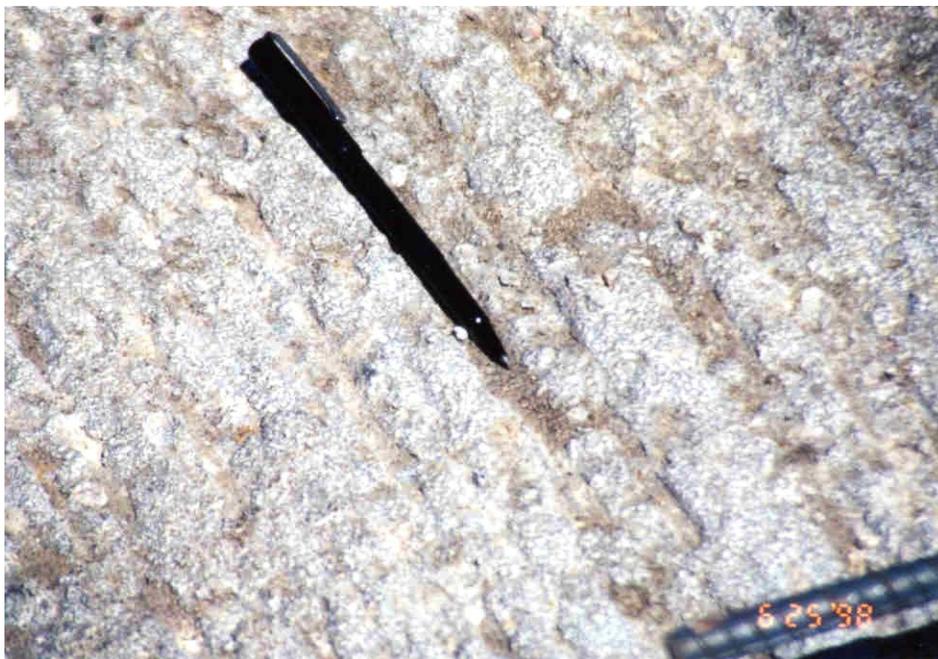
Photo 6 shows a close-up view of small particles and dust that remained on the milled surface that were not blown off prior to paving.

Photo 6 - Small particles found on the HBP prior to paving.

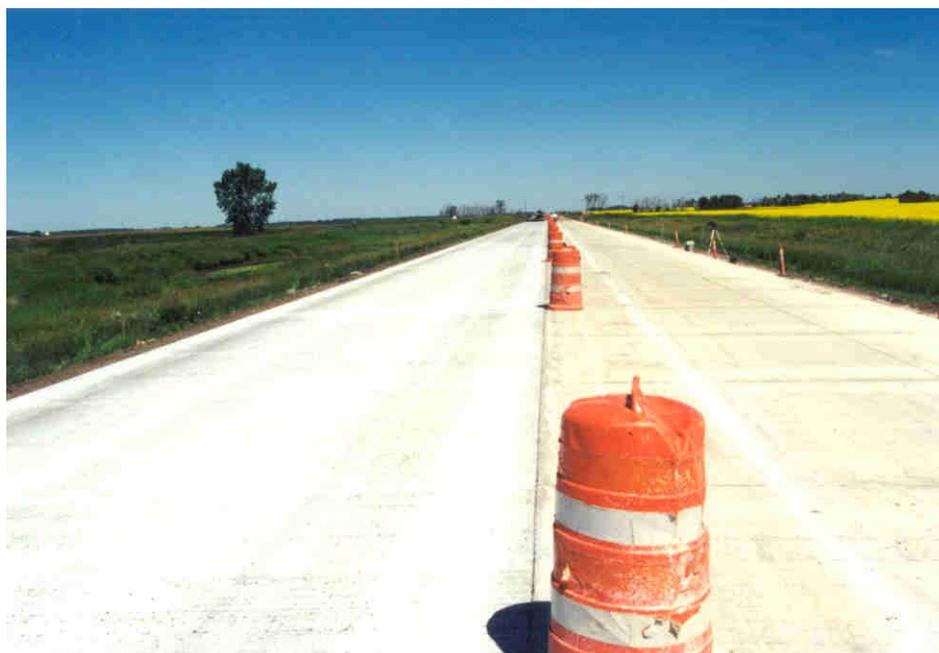
Photo 7 depicts an overall view of test section 1. A representative of the Materials and Research Division visited the site a few weeks after construction. The test sections were free of distresses except for a longitudinal crack located in the northbound lane near the beginning of test section 1. Photo 8 depicts a view of this distress which spans approximately 40'.

Photo 7 - Overall view of test section 1.

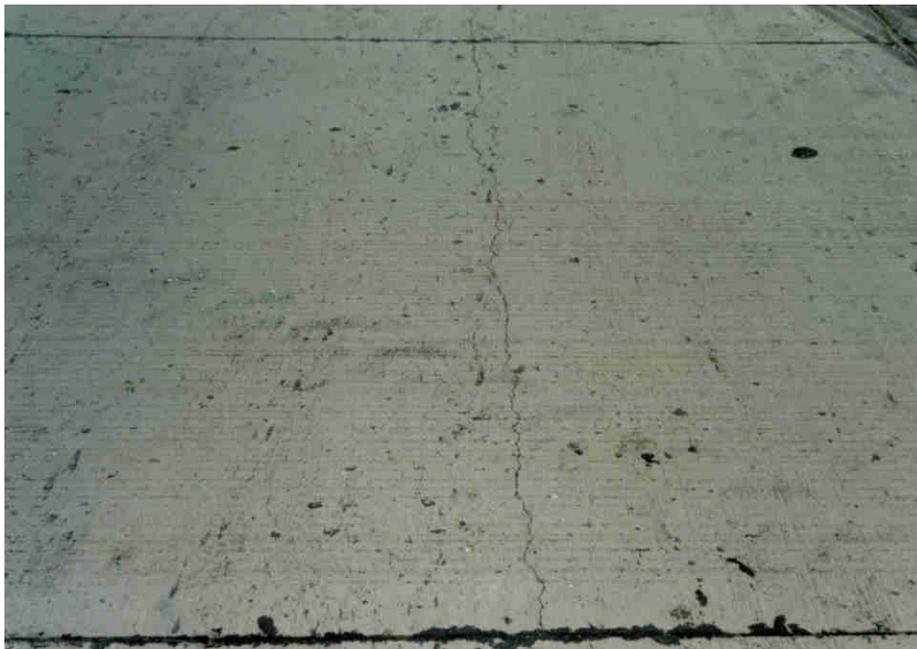
Photo 8 - Longitudinal crack in test section 1 after construction.

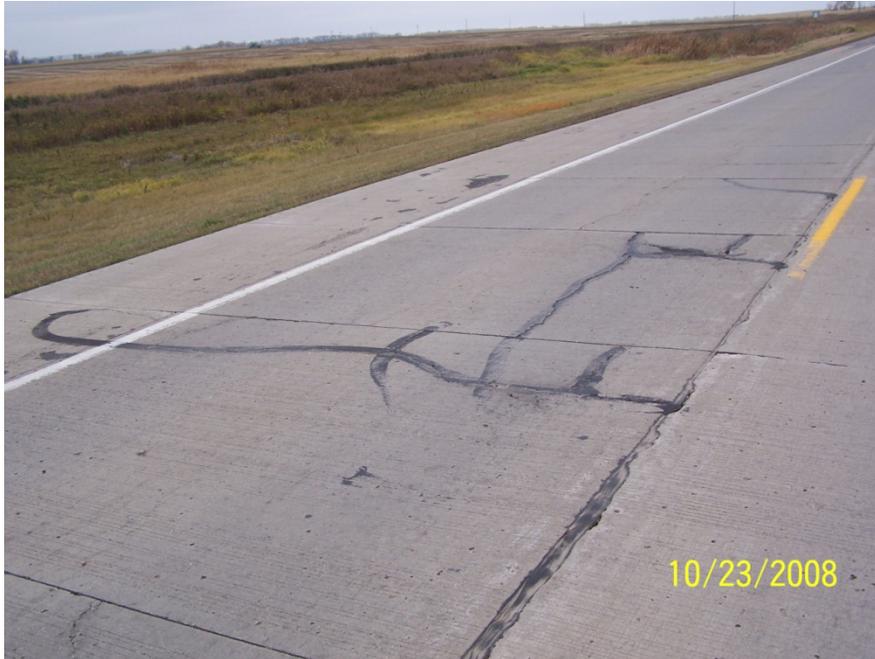
The review team located approximately 220 feet of low to medium severity longitudinal cracking in this section. Ten corner breaks were noted, one with low severity spalling. There were also 4 transverse cracks noted. Some of the transverse cracks were located on the same panels that had longitudinal cracks. This gave the concrete a 'block cracking' appearance indicating a failure of the underlying asphalt and/or subgrade. This distressed area is shown in Photo 9. Most of the transverse joints had light spalling. The joint sealant was losing contact with portions of the PCC panels due to spalling. The longitudinal joints also had low and medium severity spalling. The areas of medium spalling have been repaired with an asphalt material. Photo 10 shows the condition of a typical longitudinal and transverse joints as well as areas of spalling and spalling repair.

Photo 9 - Longitudinal and Transverse cracks in test section 1

During a post construction evaluation of the white topping test section, it was discovered that some cracks had begun to form. In the summer of 1999 the Valley City district performed some preventive maintenance on the longitudinal cracks. This process consisted of using a router to saw ½" of PCC adjacent to the cracks, and filling the void with the polymer sealant CRAFCO 231. The Valley City District has since resealed the longitudinal cracks with an asphalt binder.

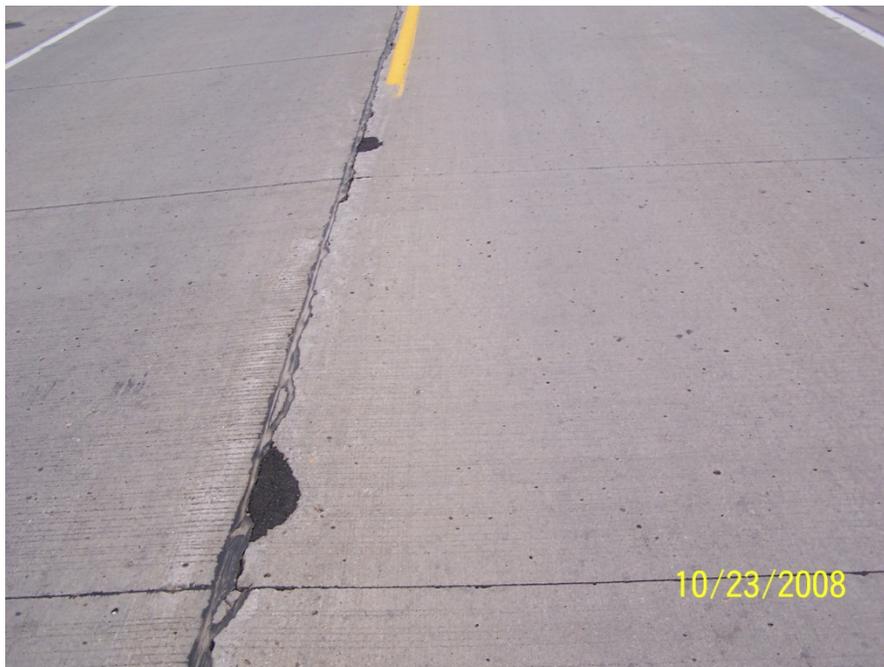
Photo 10 – Typical longitudinal and transverse joints.

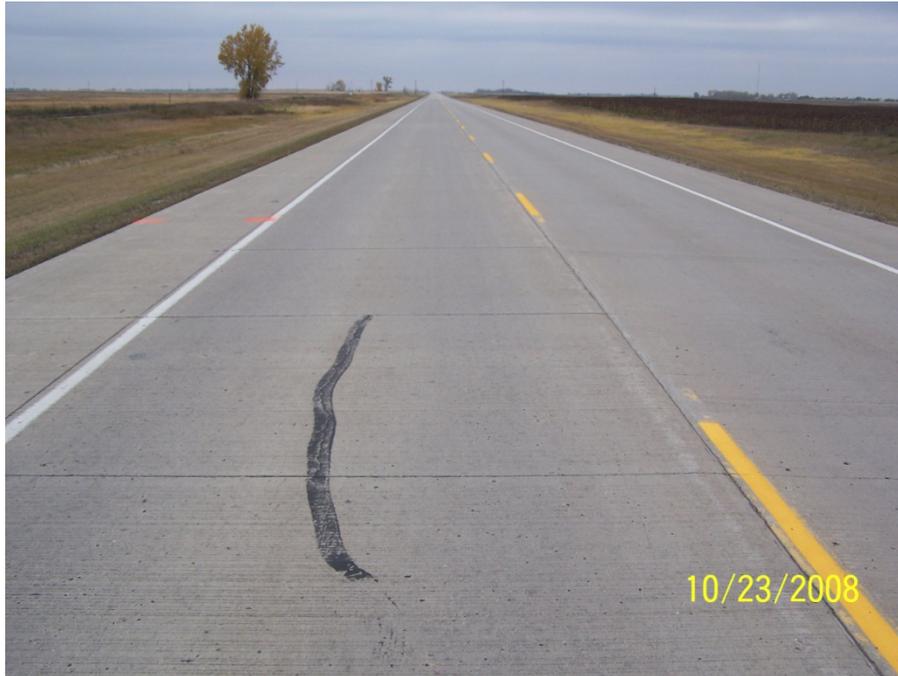
Test Section 2 is composed of 6" PCC with 11.5' joint spacing on 11" of HBP. The overall pavement condition is performing well. Photo 12 below shows an overview of test section 2.

Photo 12 – Overview of Section 2, 6" PCC overlay

At the time of evaluation section 2 had some low severity spalling occurring at transverse joints and also the centerline longitudinal joints. There was also approximately 15 feet of longitudinal cracking. Longitudinal and transverse joints along the shoulder are performing very well. The shoulders in this section show no signs of distress. The distresses noted in each evaluation are provided in the following table:

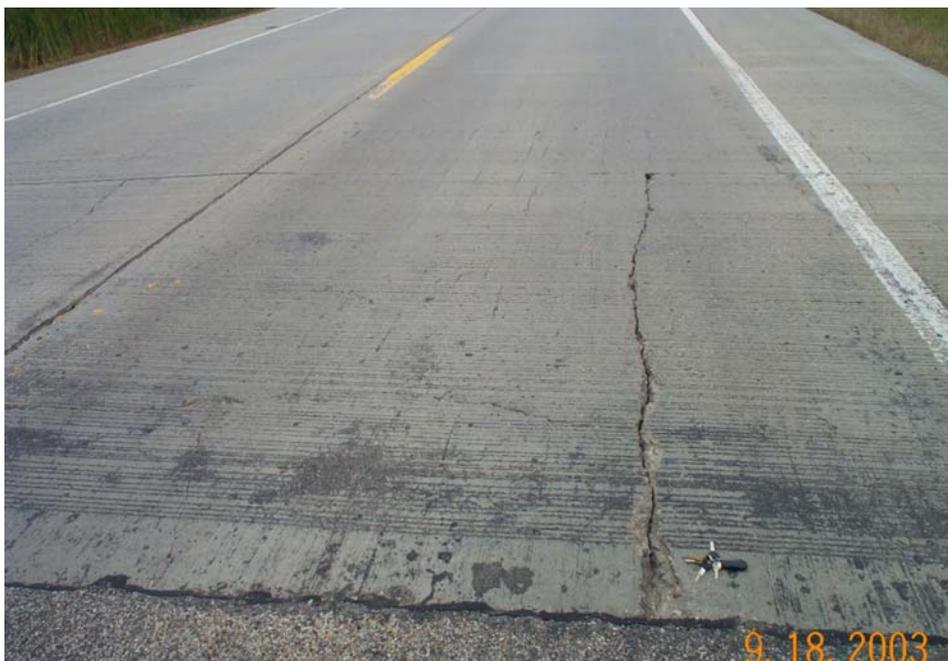
The review team located approximately 140 feet of low severity longitudinal cracking that occurred in Section 3. This section had some low severity spalling occurring at transverse joints and also the centerline longitudinal joint. There were also four corner breaks in this section which still appeared to be very tight. There was an area of 'block cracking' located at the transition of test section 3 and the control section. Photos 14, and 15 show a progression of the distresses at this transition from 2003 to 2008.

Photo 14 - Longitudinal crack in test section 3 looking north on 9/18/03.

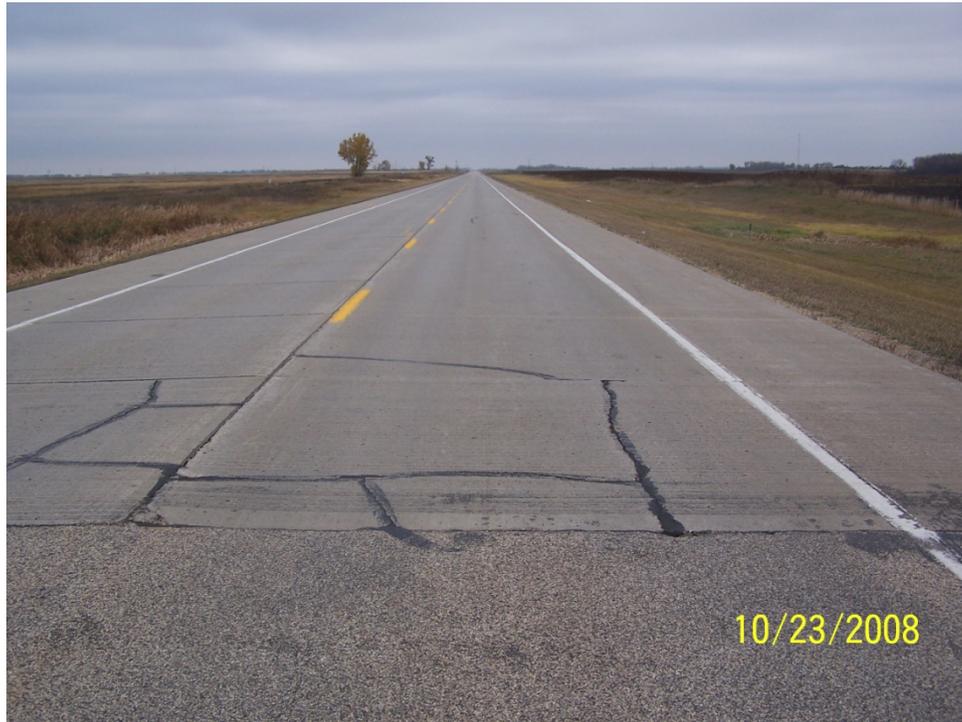
Photo 15 – Block crack in test section 3 looking North on 10/23/08

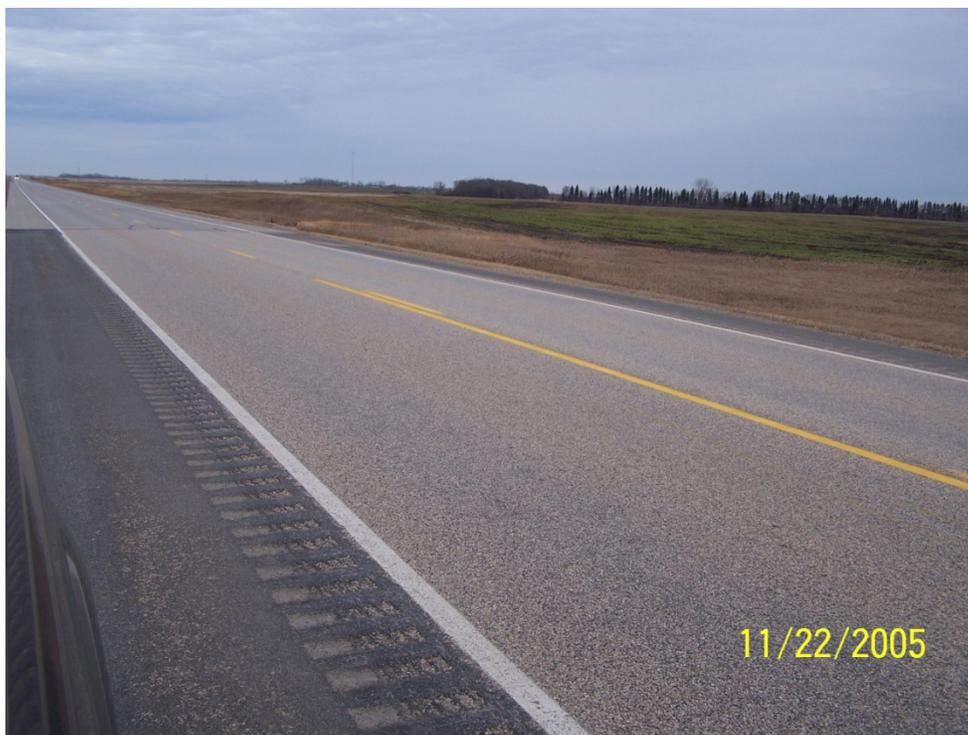
The review team also inspected the asphalt control section located directly south of the whitetopping test site. The section appeared to be in good condition. Photo 16 shows the general condition of the control section. Some bleeding had occurred in the north bound lane.

Photo 16 - Overview of Control Section looking North

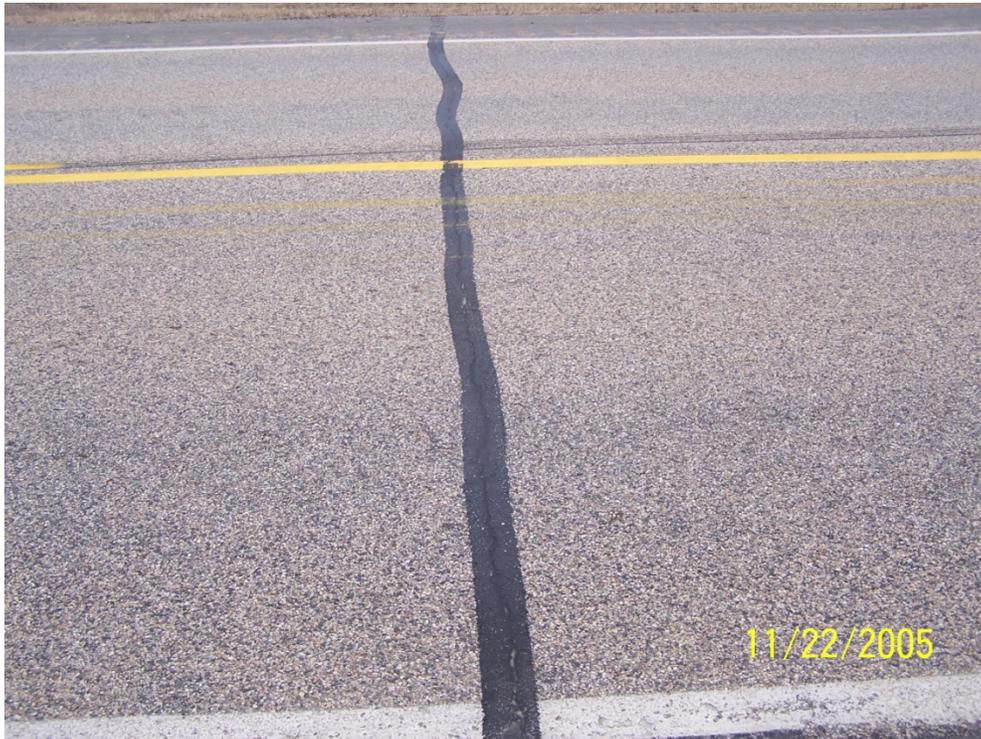
Four transverse cracks were identified within the control section. Minor rutting has occurred, ranging from 1/16" to 1/8". Also, a 40 foot longitudinal crack had formed along centerline near the field approach.

Photo 17 - Transverse Crack in Asphalt Control Section
