Experimental Study MR 08-01

**Evaluation of American Polymer's  
*Graffiti Solution System® (GSS)***

**Construction Report**

August 2008

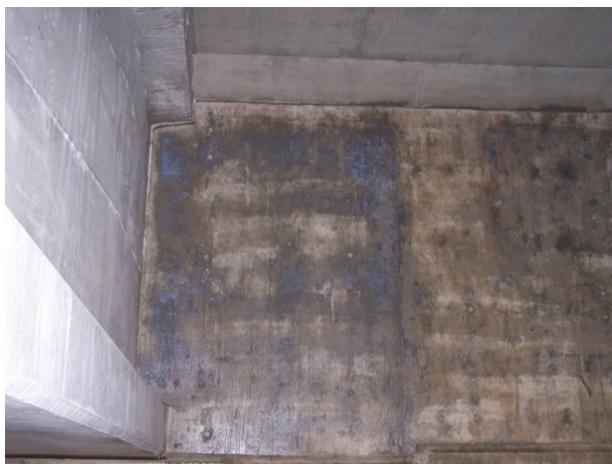
**Photo 8: Blue tinted residual moisture**

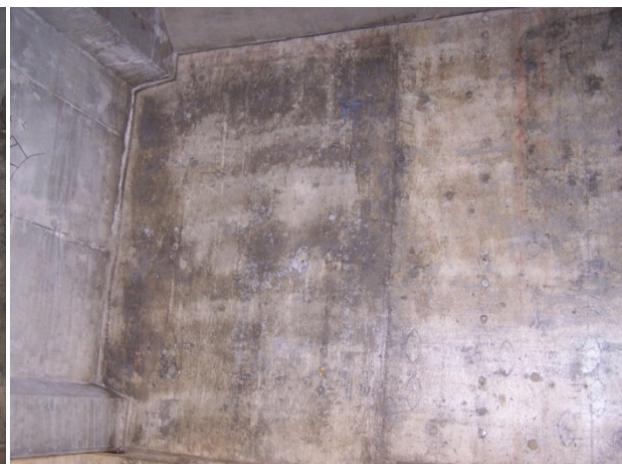
**Photo 9: Diminished blue tint ≈10 min later**

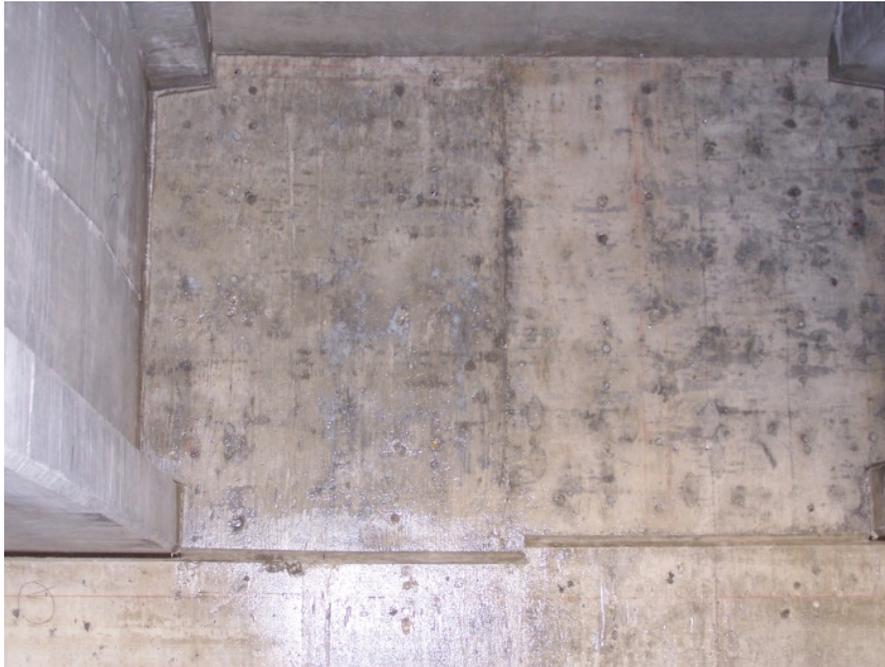
The first clear top coat application took 21 minutes on an area of 408 ft<sup>2</sup>, an application rate of 19.43 ft<sup>2</sup>/min. Once again it was applied in a cross-hatched fashion with a clean roller-brush for backrolling. At this point it was noticed that there was still some blue from yesterday indicating residual moisture. See Photo 16.

**Photo 16: Faint blue on one wall**

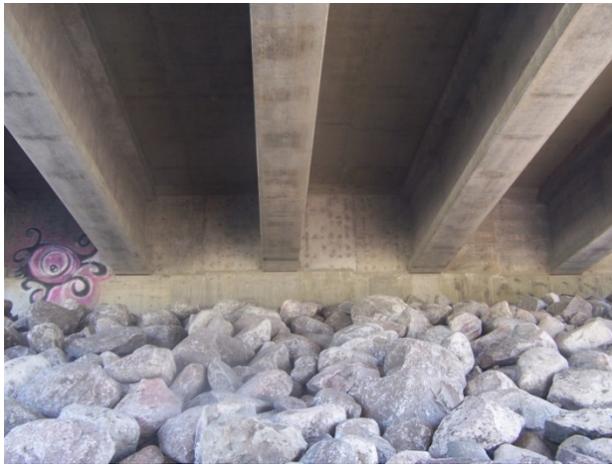
**Photo 20: Before Product Application**

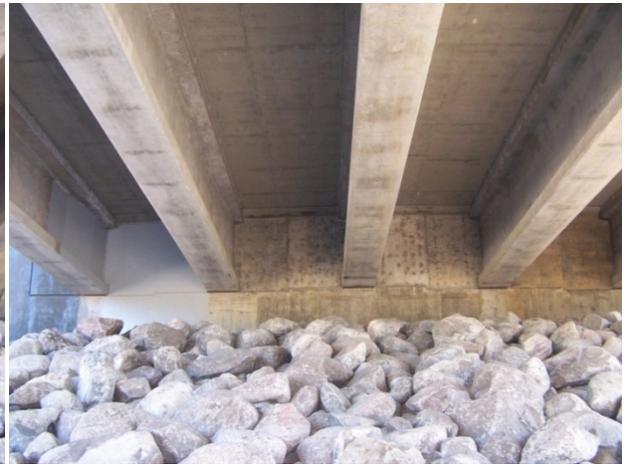
**Photo 21: After Product Application**

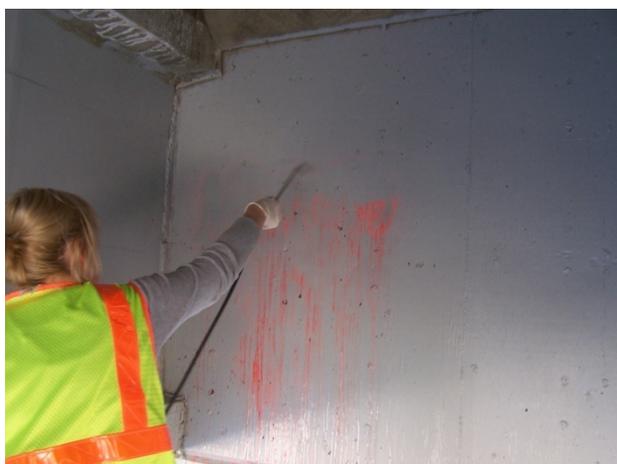
Photo 28: Rinsing with low-pressure

Next, water was sprayed on with a Hudson hand-pump sprayer. See Photo 28. This did remove most of the graffiti, yet a faint dark shadow still appeared. See Photo 29. It appeared as though more *Erasol*® along with additional brushing and a water sprayer with higher pressure would likely remove the graffiti completely. Since *Erasol*® neutralizes on contact with water, further work couldn't be done on the wet surface and the area was left to dry. Materials & Research personnel agreed to return the following week with a higher pressure water source.

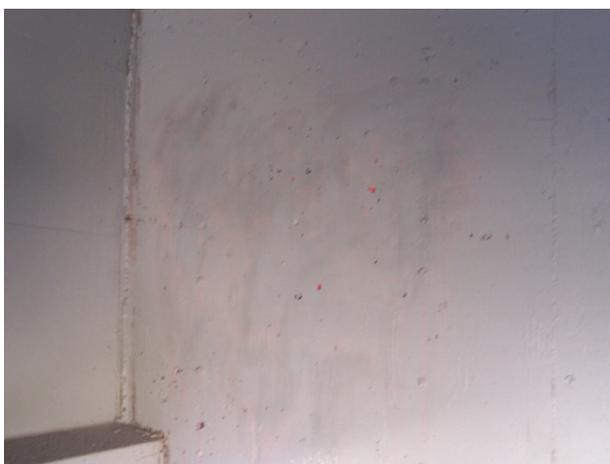
Photo 29: Graffiti removed

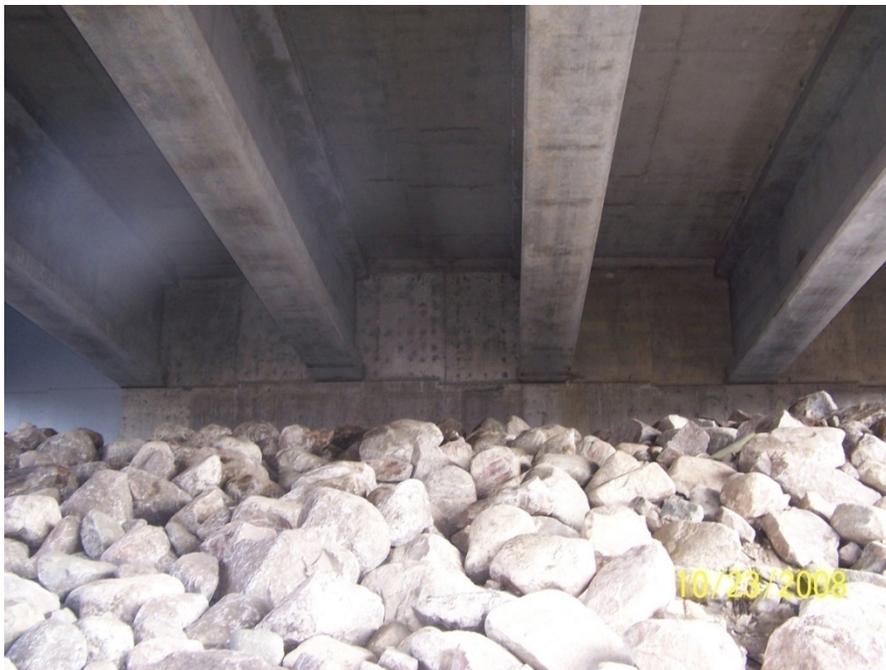
After the graffiti appeared to be fully lifted, Kent Leysring used the culvert washer to spray the wall with moderately pressurized water. The graffiti was completely removed. This process occurred on all 4 sections on the abutment, entirely removing the graffiti. See Photos 30-32.

**Photo 32: After graffiti removal**

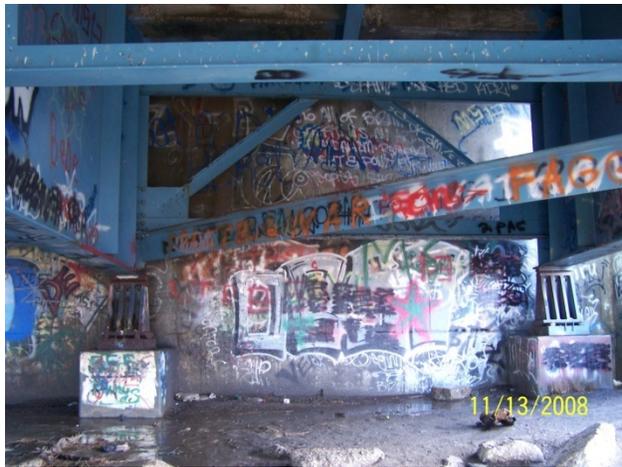
At the suggestion of Jim Colling, M & R personnel went down beneath the Expressway Bridge to observe the vandalism done there. The concrete abutments and piers, as well as parts of the steel substructure, were heavily covered with graffiti. See Photos 33 & 34.

**Photo 33: Portion of Expressway Bridge abutment**

The *Erasol*® product was tested on some old graffiti and a small portion did come off, but it was obvious that a coating underneath the graffiti was needed for the *Erasol*® product to work. In the case of this bridge, a pigmented version of the *GSS*® coating could be used to cover the current graffiti, as well as to allow for easy future graffiti removals.

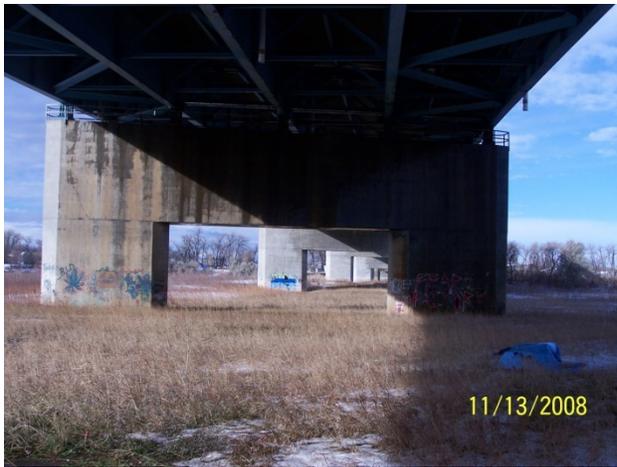
**Photo 34: Expressway Bridge piers**
