Experimental Study ND 07-01

**High Density Polyethylene Pipe**

**4th Evaluation**

Project AC-HPP-NH-5-012(031)054

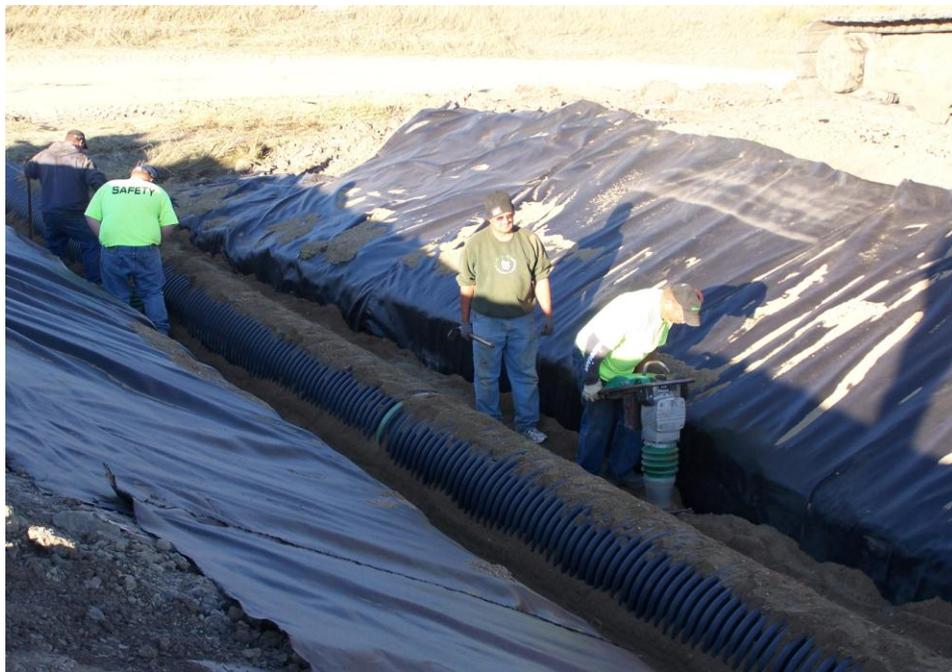
**Photo 1: Centerline HDPE pipe being installed**

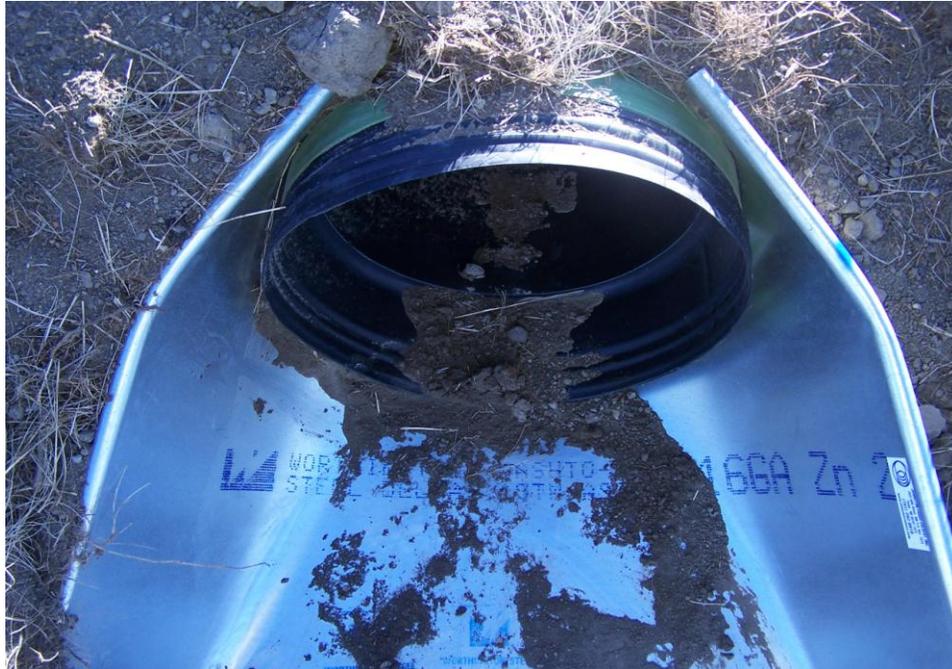
**Photo 2: metal end section of HDPE pipe.**

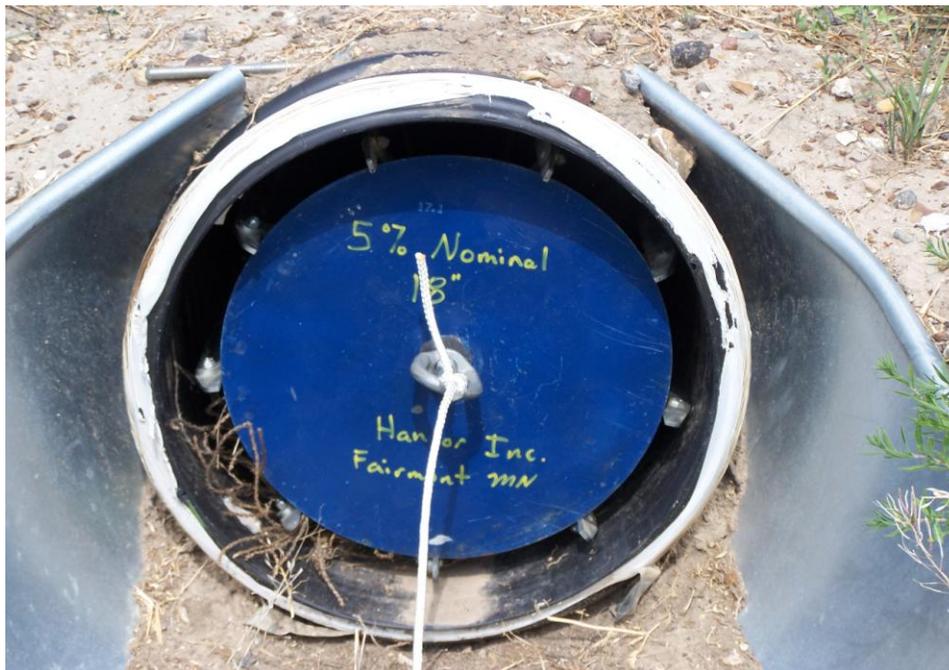
**Photo 3: Mandrel at the end of an 18" HDPE Pipe**
