Geotechnical Evaluation Report

CERP-0221(085) PCN 24082
CR 21, North of Bayshore Resort
Barnes County, North Dakota

Re: Geotechnical Evaluation
CERP-0221(085) PCN 24082
CR 21, North of Bayshore Resort
Barnes County, North Dakota

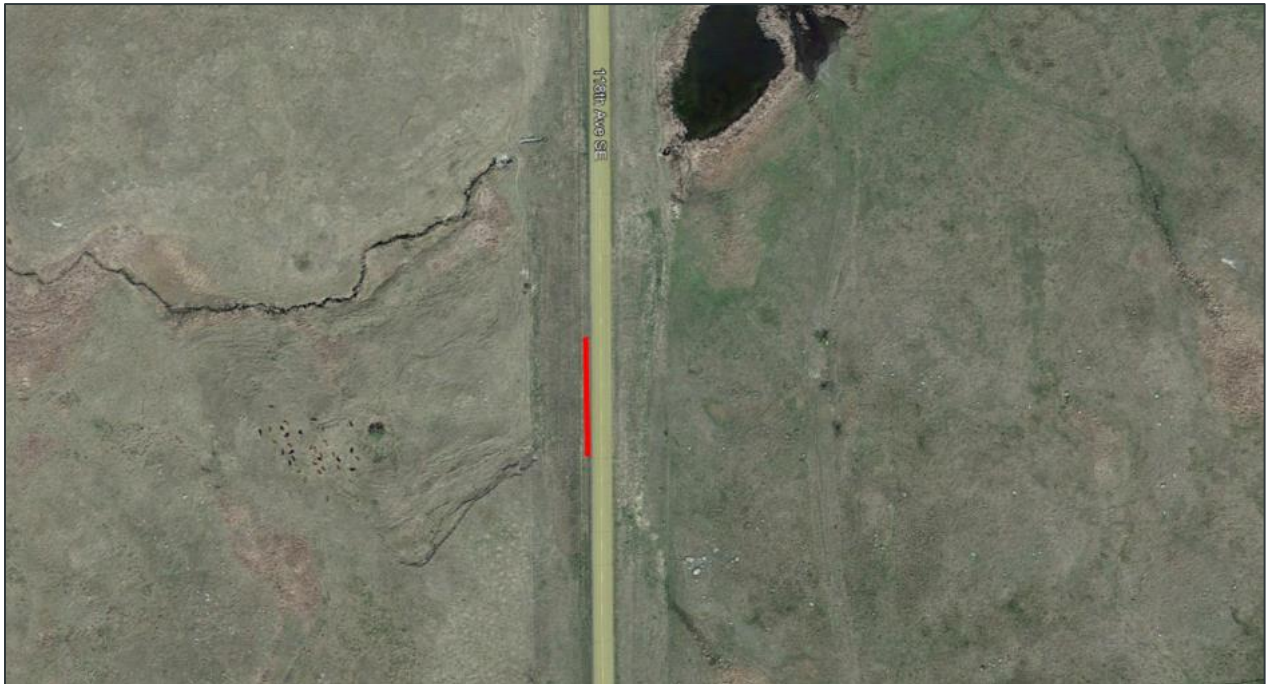
Photograph 1. Site in 2016

The photograph below shows an aerial image of the site. More recent photographs are available but have lower detail. The red line approximately indicates the area where the shoulder is distressed.

Our Analysis indicates the shoulder distress is due to movement of the landslide mass below the slope. The scarp is visible in the air photo above as the dark line south and to the west of the red line. The landslide mass moves as a relatively thin layer of material downslope.

We discussed limiting the improvement to stabilizing the road shoulder and making the improvement resilient enough to tolerate future slope movements. We considered a soil nail wall, but concluded since the landslide movement is skew to the roadway, the soil nail elements could develop shear forces they are not designed to support. We therefore evaluated a soldier pile wall with lagging, and a sheet pile wall in greater detail.

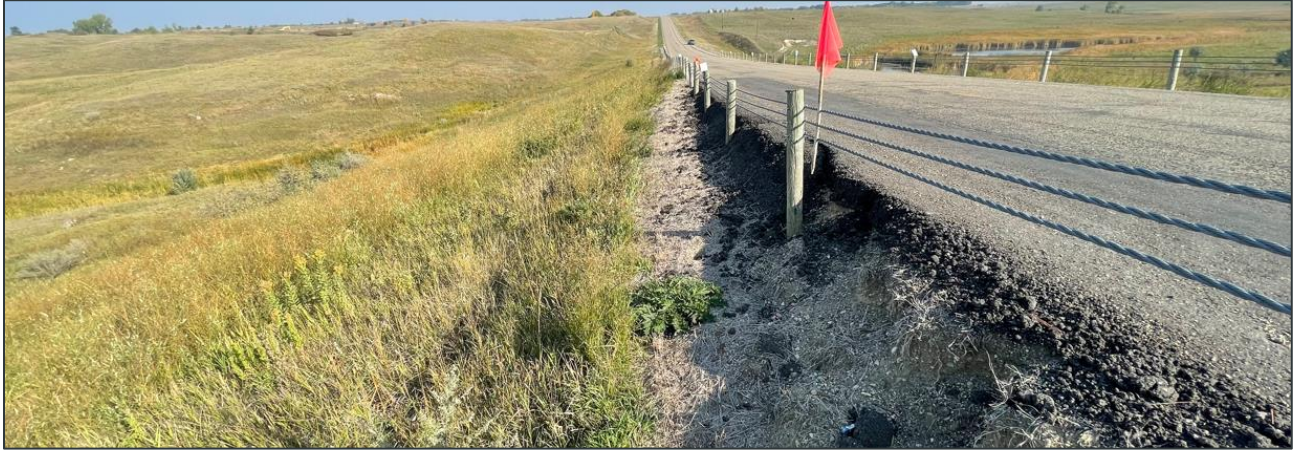
Photo 1. Located on West side of Embankment Looking North

As can be seen in Photo 1 below, an instability has impacted the west slope of the embankment. There are signs that additional pavement has been placed on the south bound lane to compensate for pavement deformation, though the extent of the patching was not apparent, due to recent surface improvements. Currently, the shoulder has slumped downward about 3 feet below the surface of the road. The distress along the road is approximately 200 feet long.

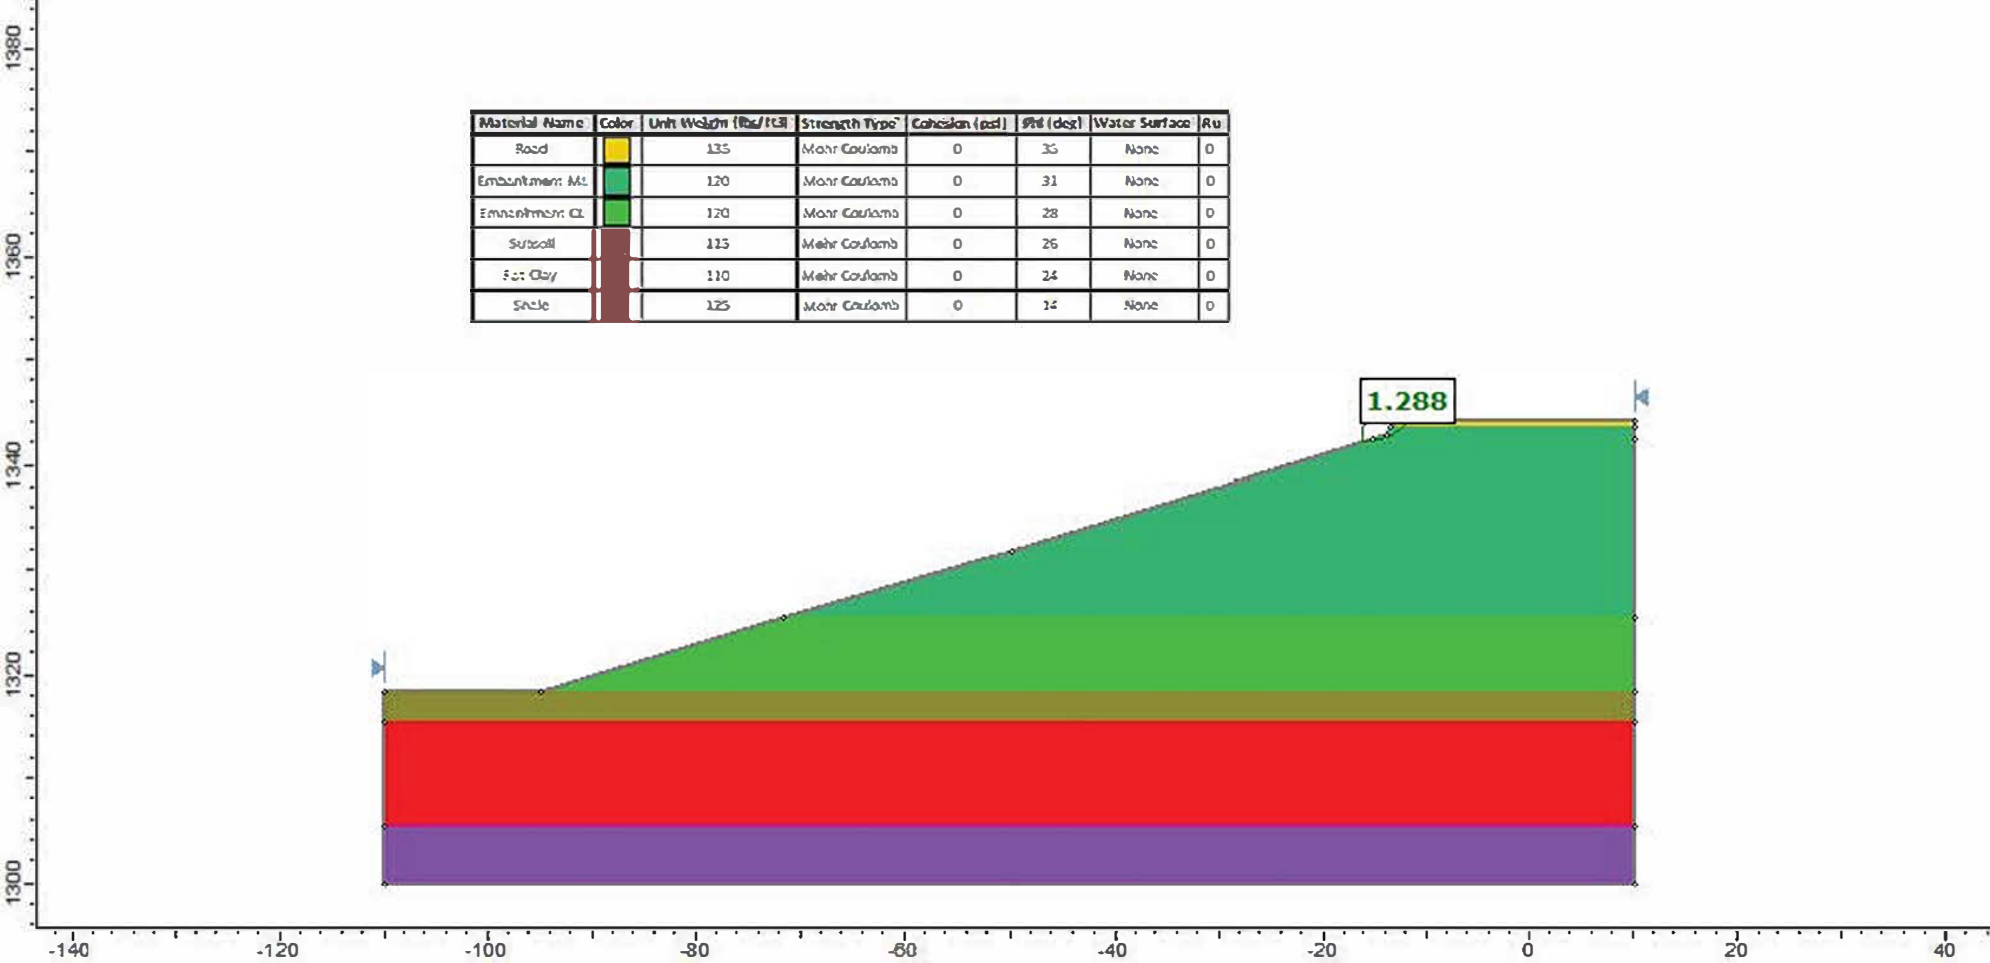
We found that the existing slope had a safety factor that was slightly less than one through the steep shoulder, and was slightly greater than one below. For reference, permanent slopes typically are required to have a safety factor of 1.3 to 1.5 for long term stability. We chose to isolate the shoulder from the slope below using a sheet pile structure.
