SPRAYWALL PIPE LINER

Office of Project Development (OPD)
Conference

Kyle Evert
NDDOT - Materials & Research
Division

PROBLEM – DETERIORATED PIPE WEST RIVER ROAD INTERCHANGE

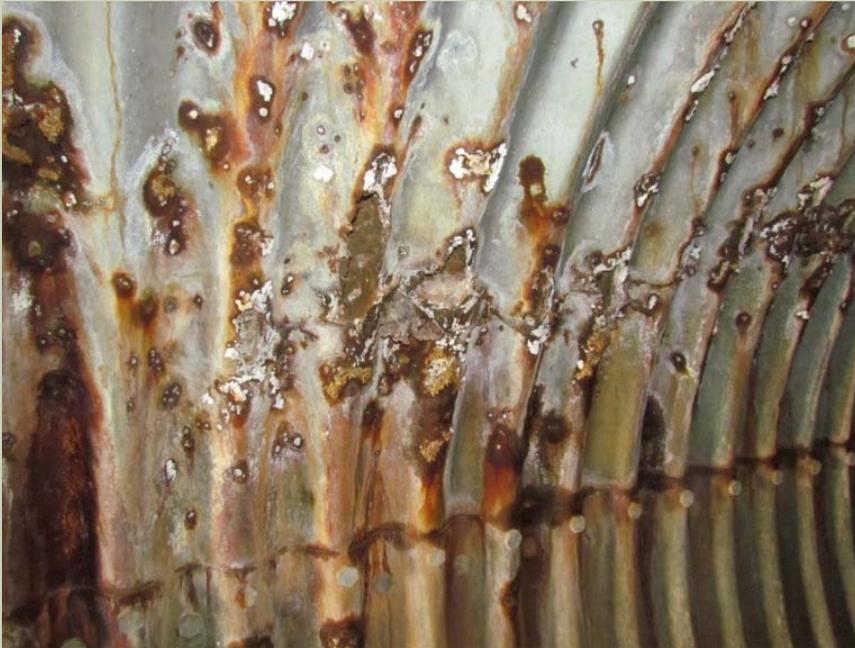
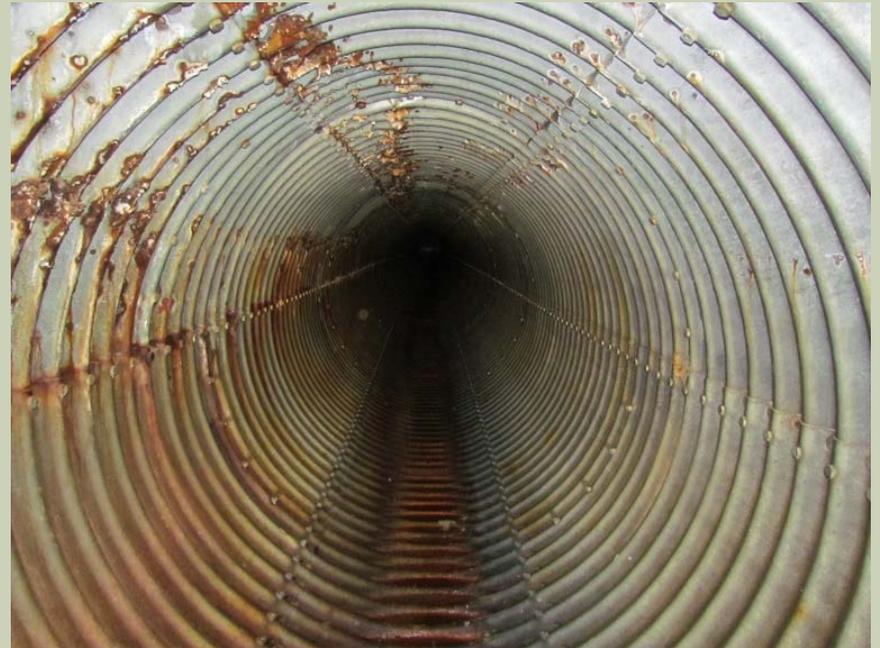
PIPE CONDITION

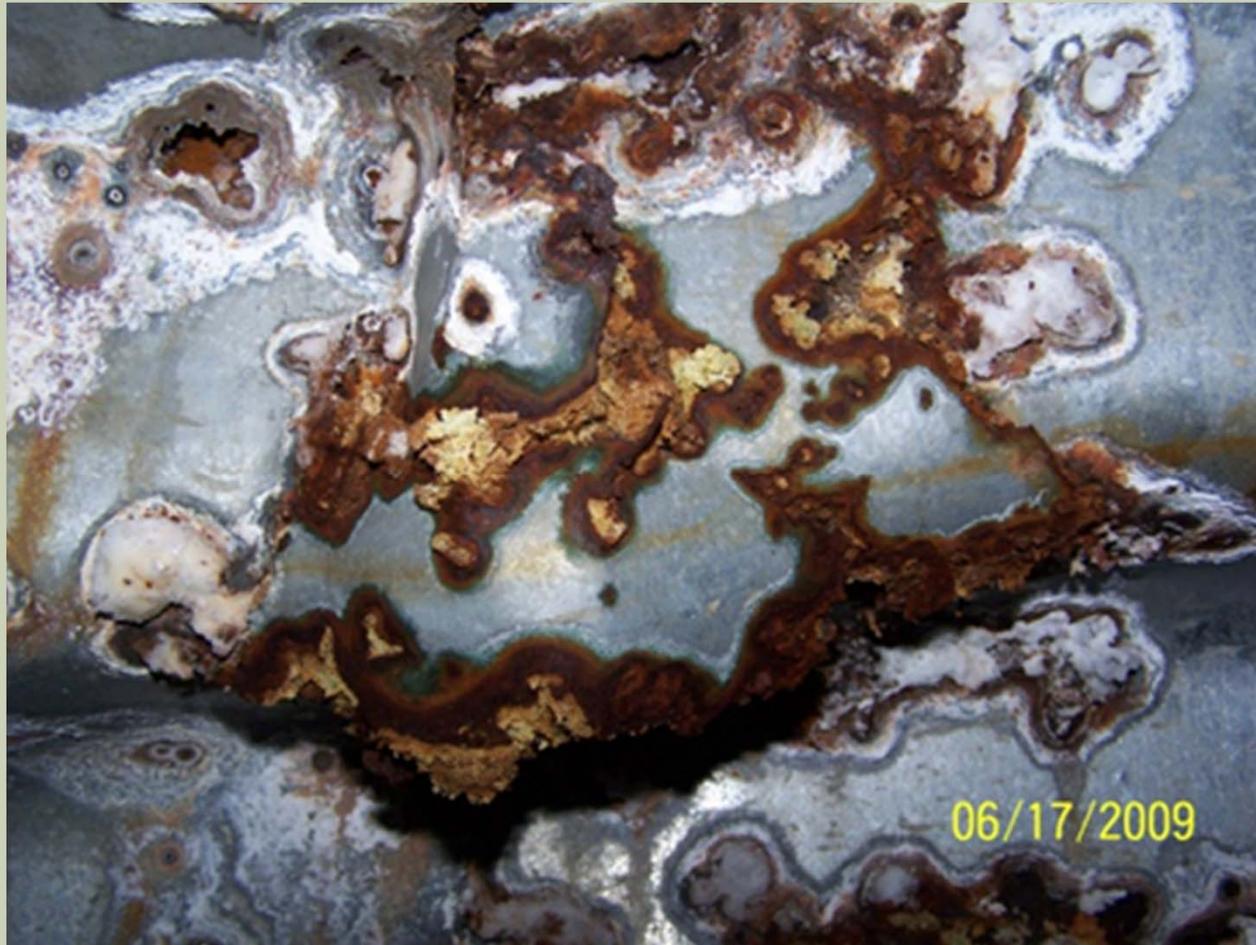
PIPE CONDITION

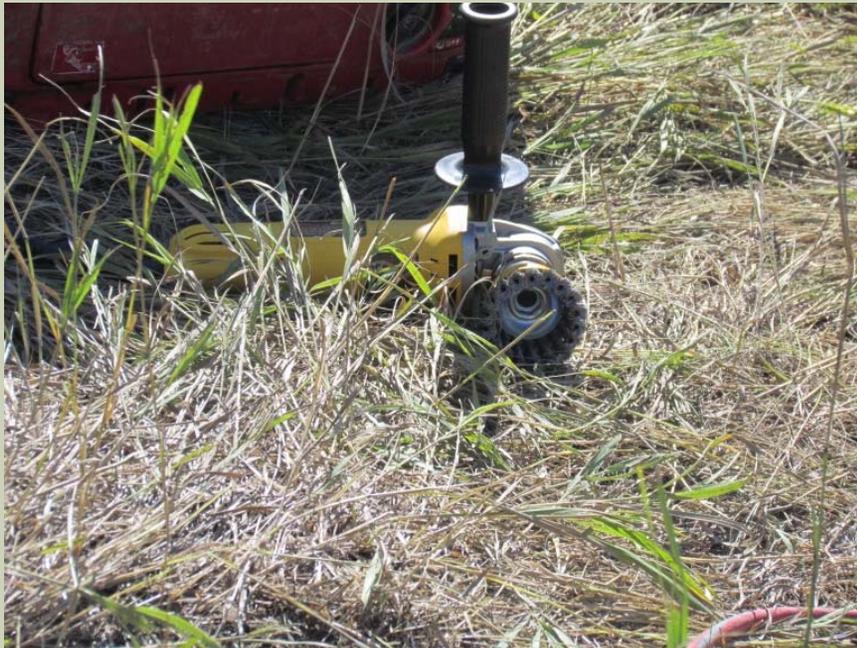
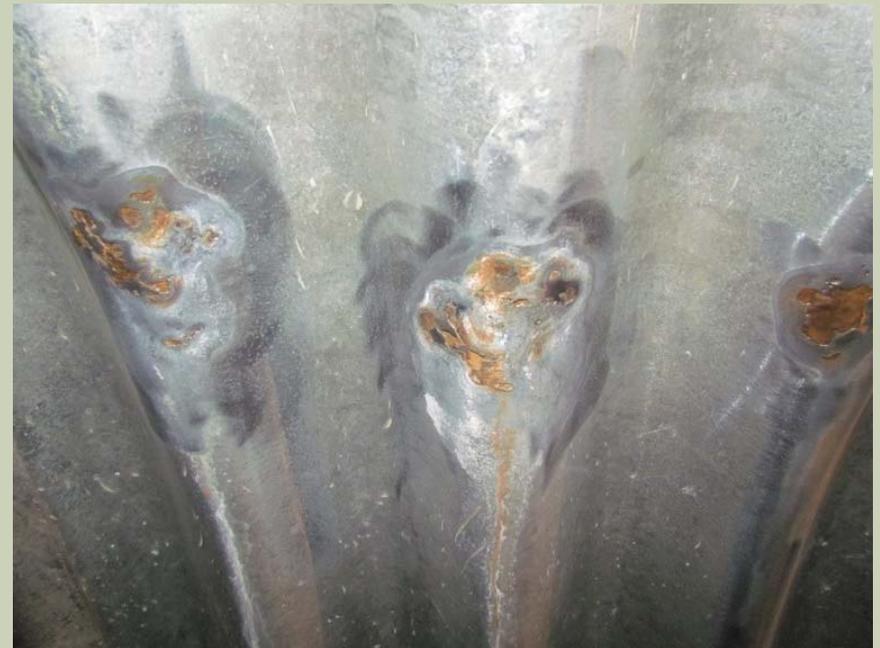
REMOVING THE CORROSION

- Dewatered the pipe
- Removed the corrosion
- Sealed deteriorated holes caused by corrosion
- Heated the pipe to optimal temperature for SprayWall installation

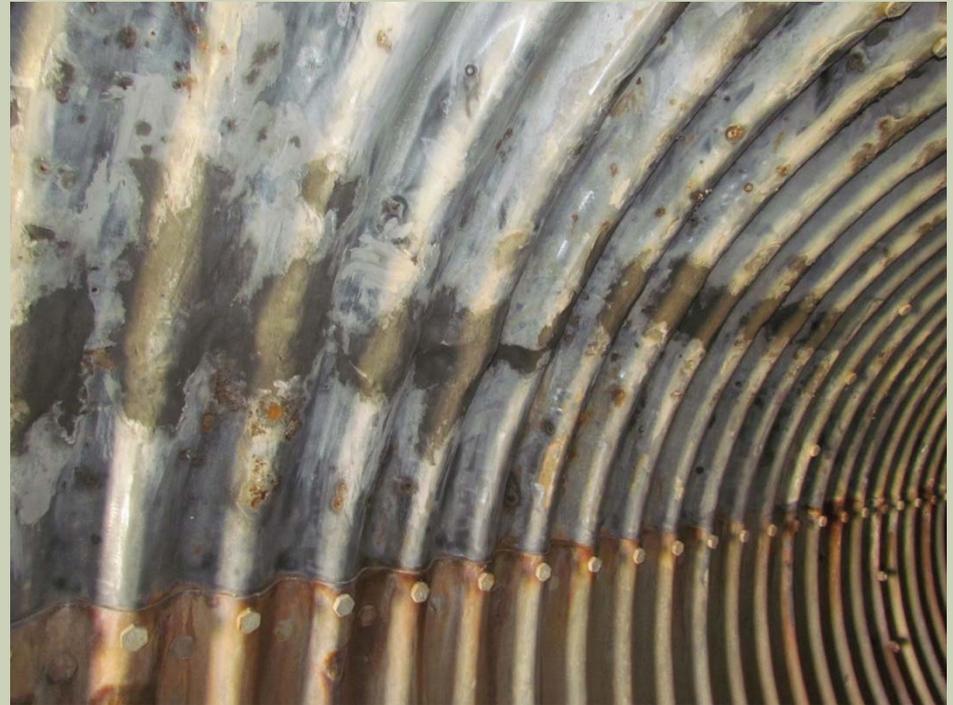
SEALING DETERIORATED HOLES

- Speed Crete Blue Line
 - a rapid setting cement based mortar
 - Applied and finished with hands
 - Filling holes provides profile for Spraywall

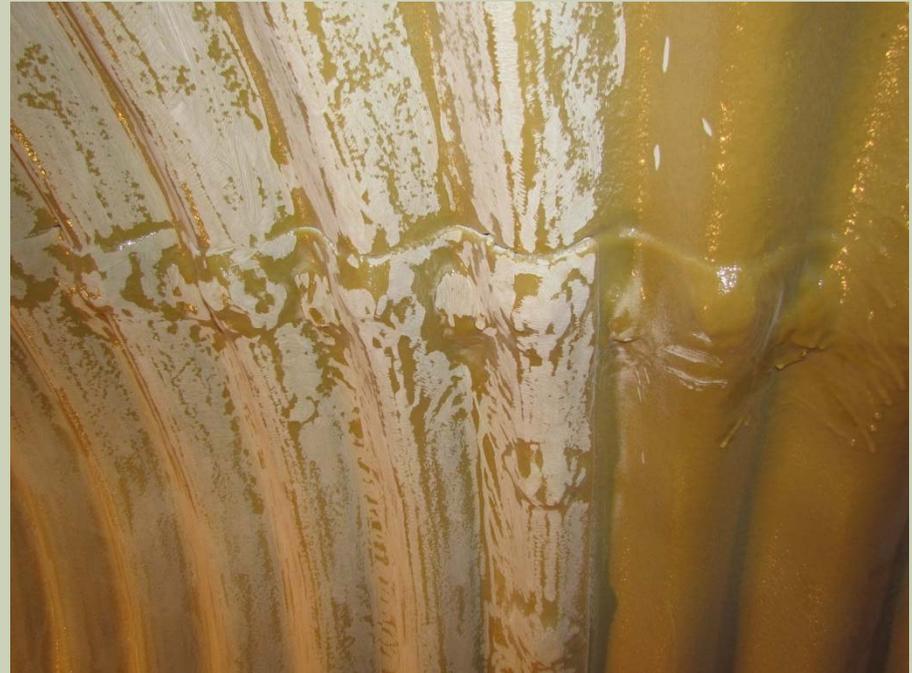
SPRAYWALL OVERLAP

- If unable to complete in one day, an overlap transition is used.
- Existing Spraywall Liner scuffed with wire brush to ensure adhesion.

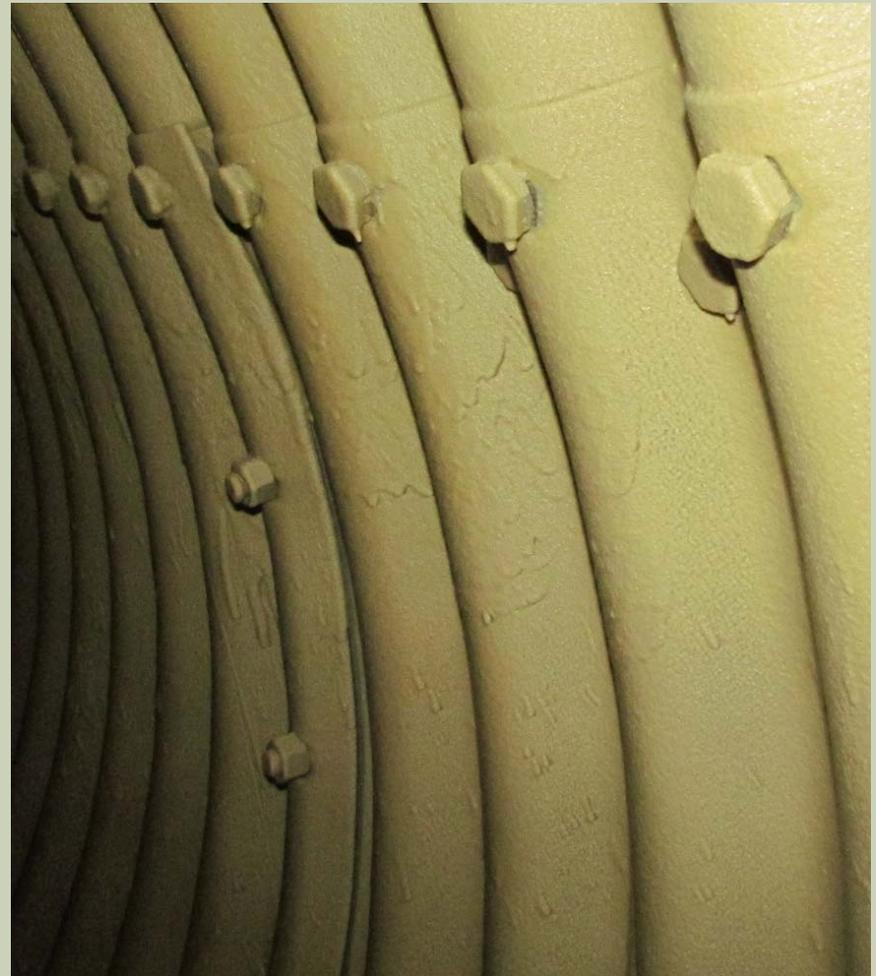
SPRAYWALL INSTALLATION ISSUES

- Getting proper coverage around sharp angles
 - Contractor had adjust spraying technique
- The Spraywall components were setting up within the hose and spray nozzle.

- Components sensitive to pressure.
- Longer length of hose requires more pressure.
 - Pipe entrance location was difficult to get Spraywall pumping equipment next too.
 - Hose length = 400'
 - Optimal length = 300'
- Required additional time to finish project.

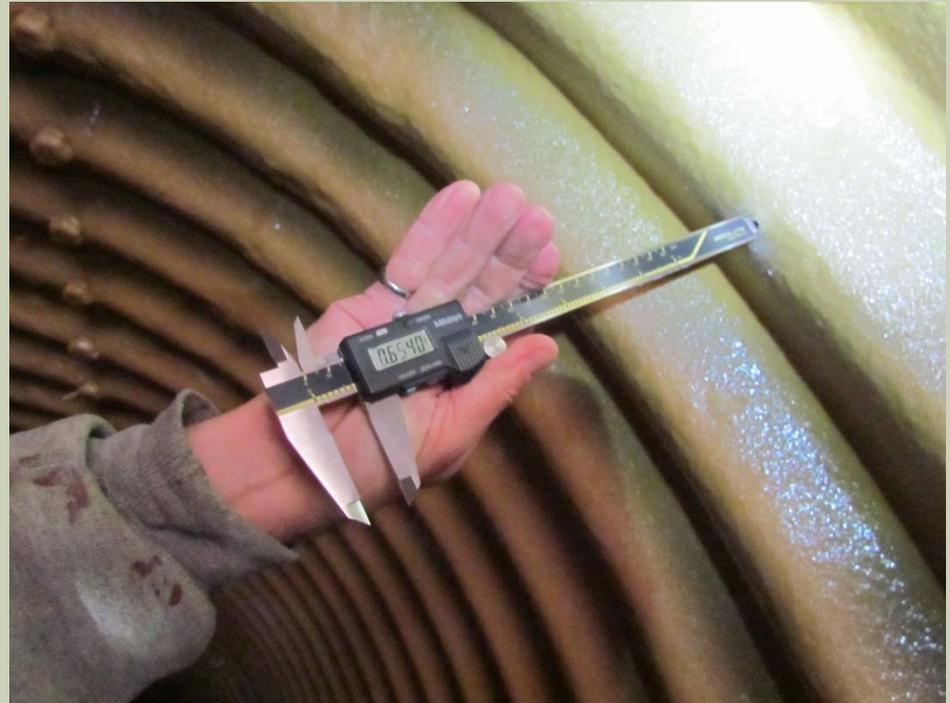
THICKNESS OF LINER

Depth Checks	Mils
Average	652
Standard Deviation	226
Max	1,133
Min	316

- Contractor and Materials & Research performed depth checks.
- Drilled hole into liner and measured depth with caliper.
- Holes Repaired with SR 6100, an epoxy from Sprayroq

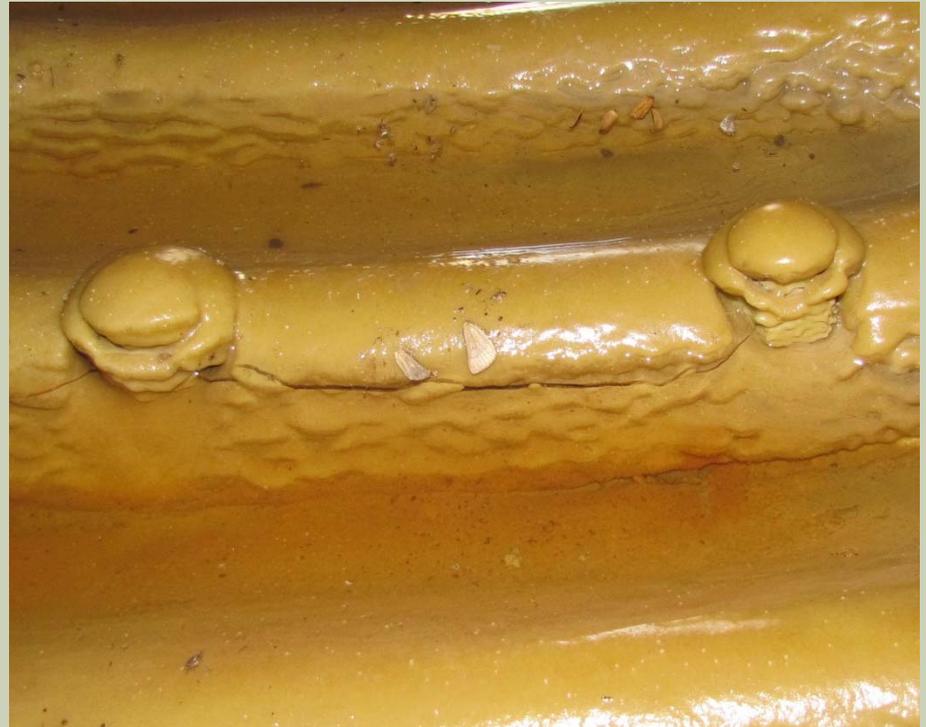
FIRST ANNUAL EVALUATION

- 1 small crack within pipe
- 2 cracks on pipe entrance
- Liner scraped away from bolts at entrance

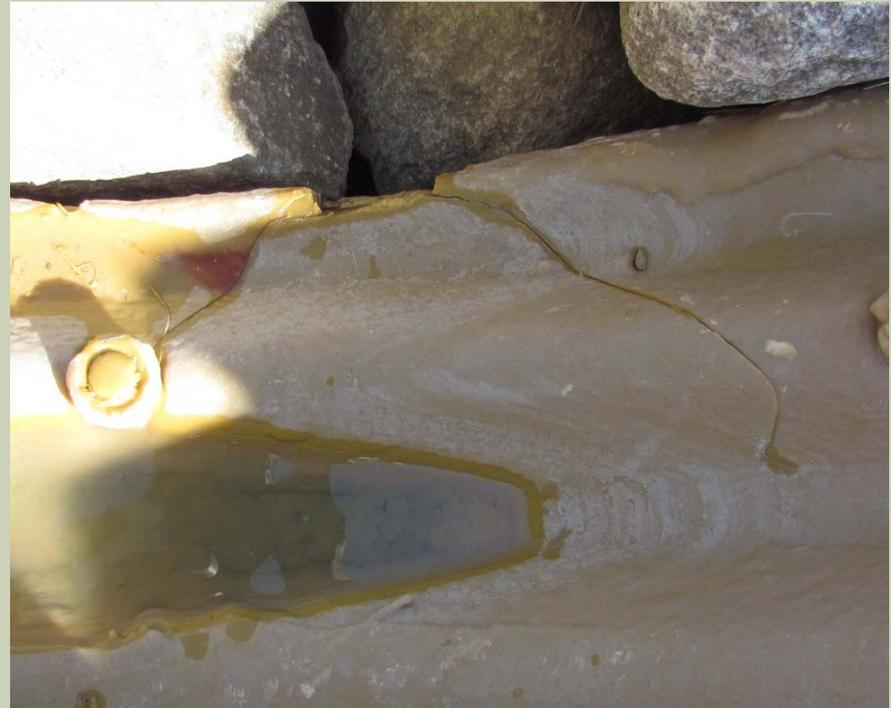
ENTRANCE DAMAGE

- The damage on the bottom of entrance appears to be caused by the rip rap installation.

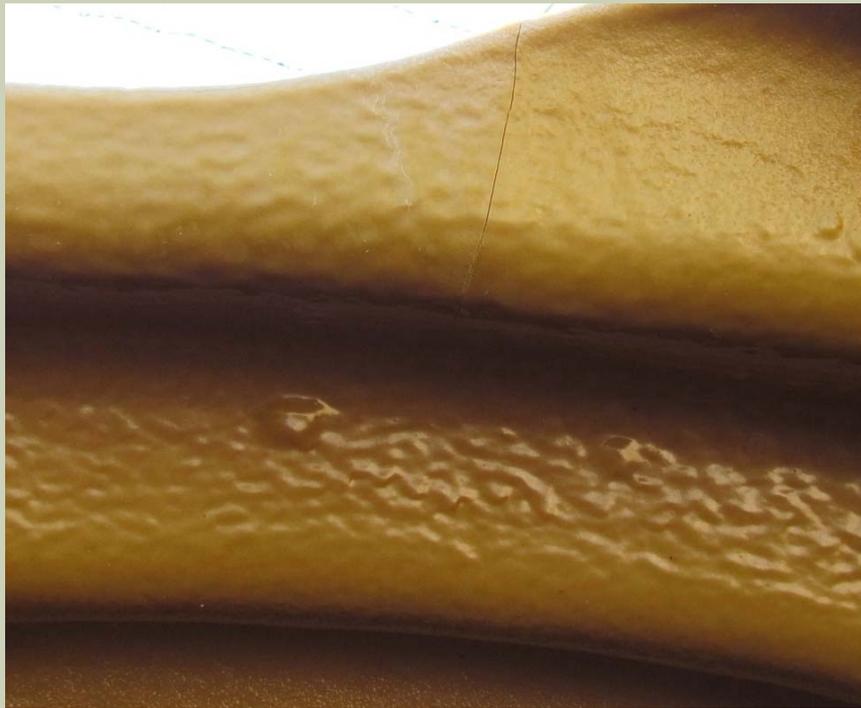
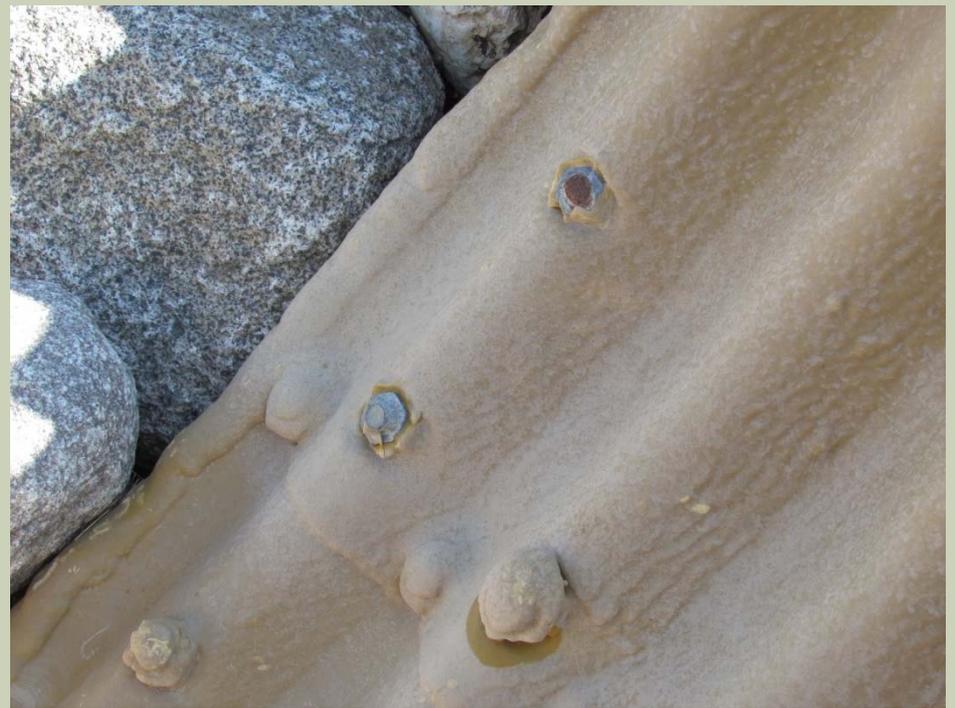
ENTRANCE DAMAGE
