RP 34 to Christine - NB

SCOPING REPORT

Location: RP 34 to Christine - NB

Reference Point: RP 34.000 to RP 44.126 – 10.126 miles

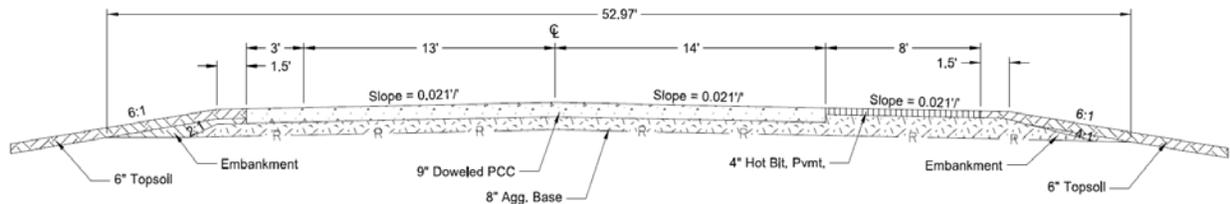
Proposed Typical Section:

Proposed typical section used for estimating purposes only.
