Route:00008 Log:3.882

District 65, Adams County

SOUTH JCT. US 12

IDENTIFICATION	
(1) State Names	North Dakota
(8) Structure Number	0008-003.883
(5) Inventory Route	00008
(2) Highway Agency District	65
(3) County Code	Adams, North Dakota

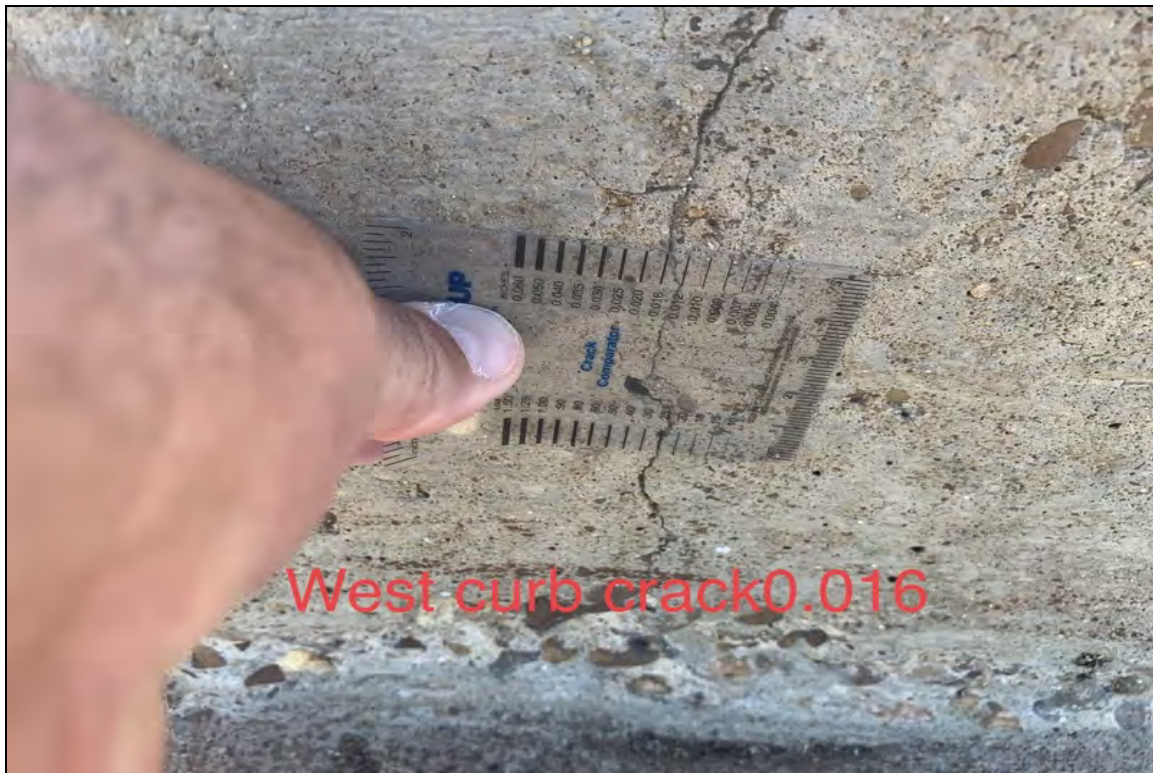
West curb crack .016

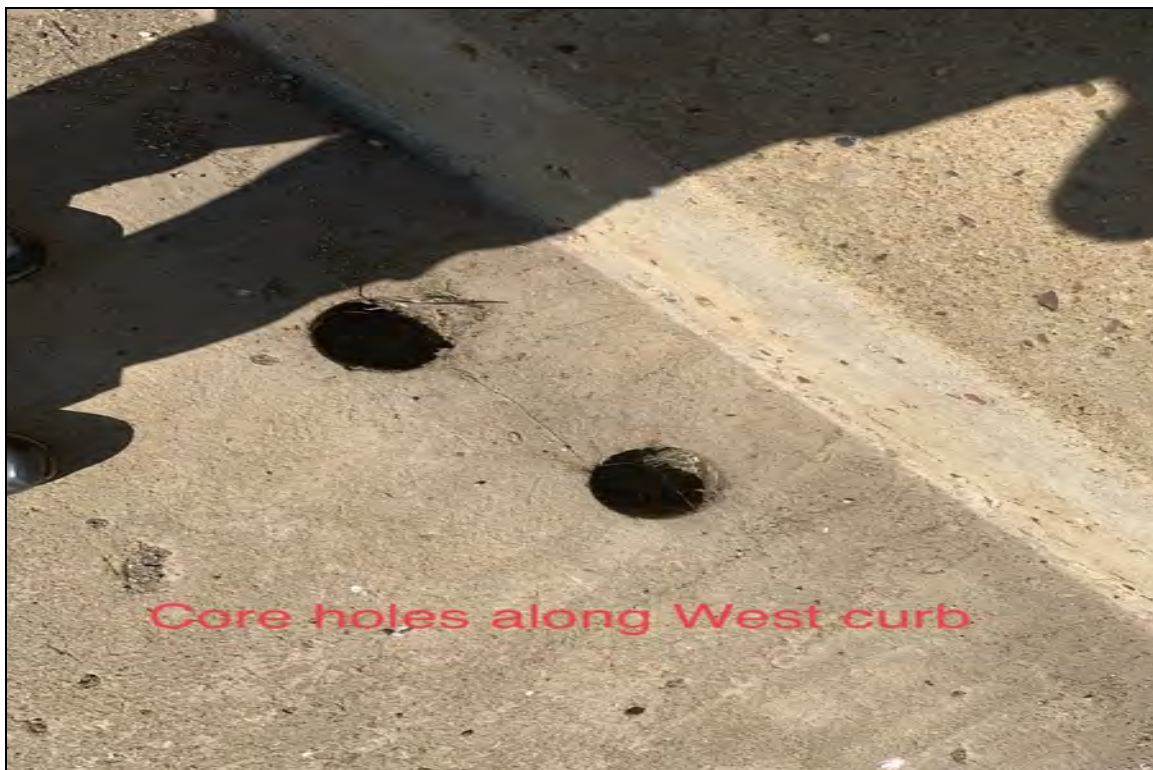
Core holes along west curb

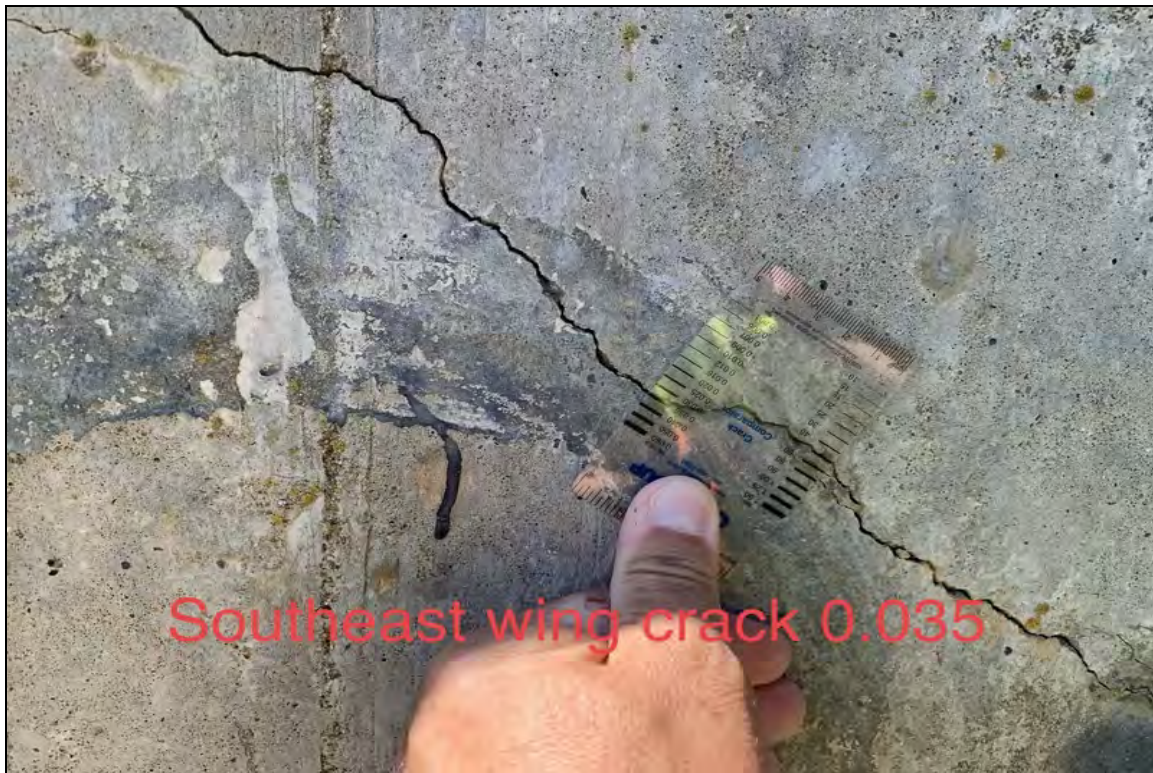
SE wing crack.035

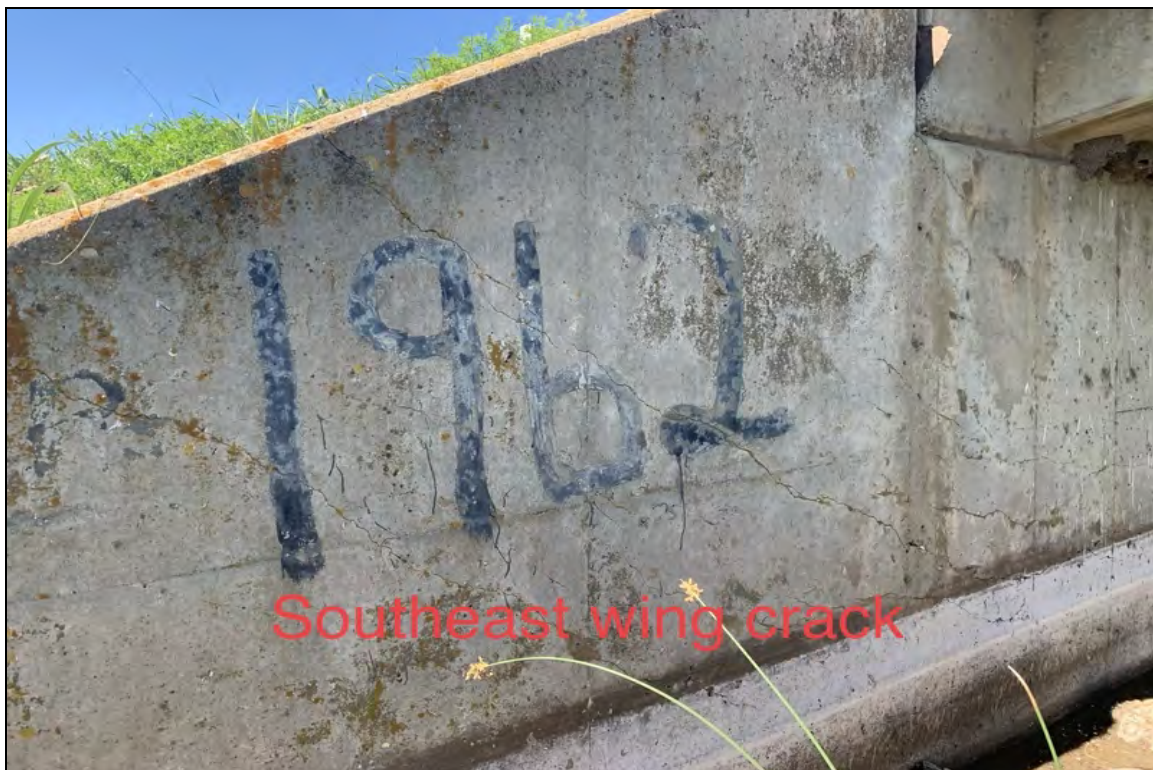
SE wing crack

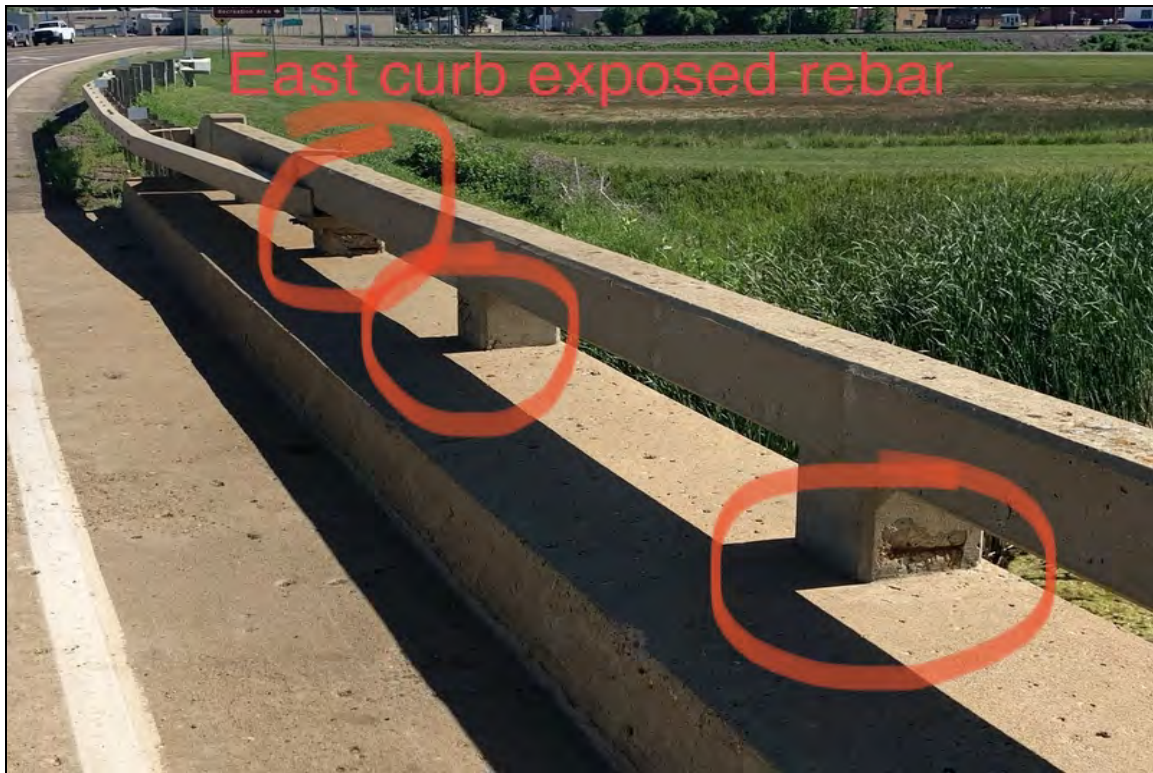
The East bridge rail has three posts at the north end of the structure with exposed rebar with section loss. 15July2020

East curb exposed rebar on pedestals

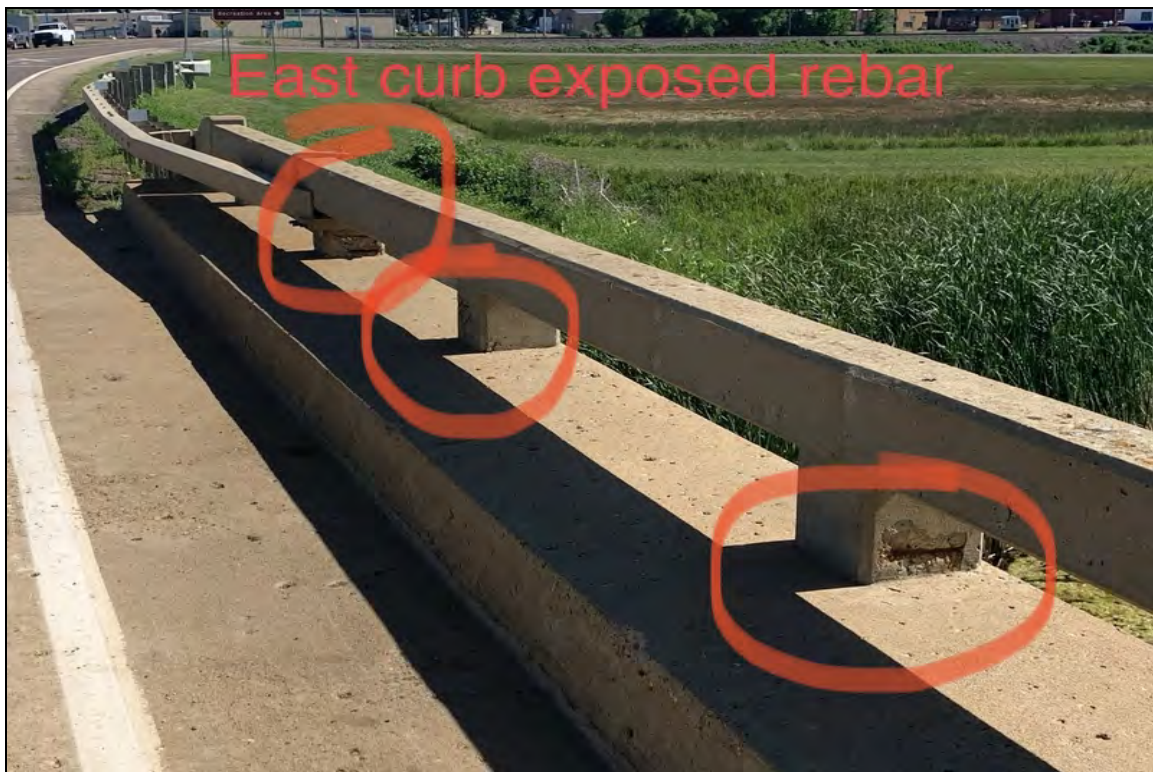
East curb exposed rebar on pedestals

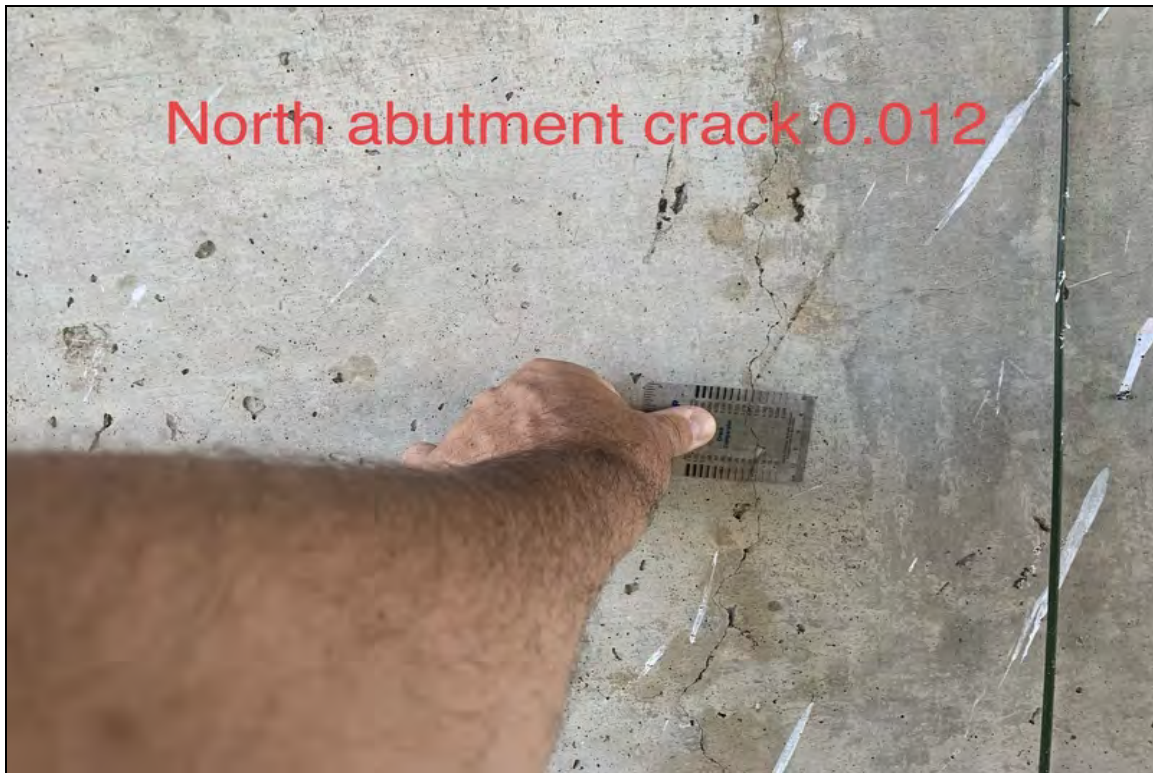
North abutment crack .012

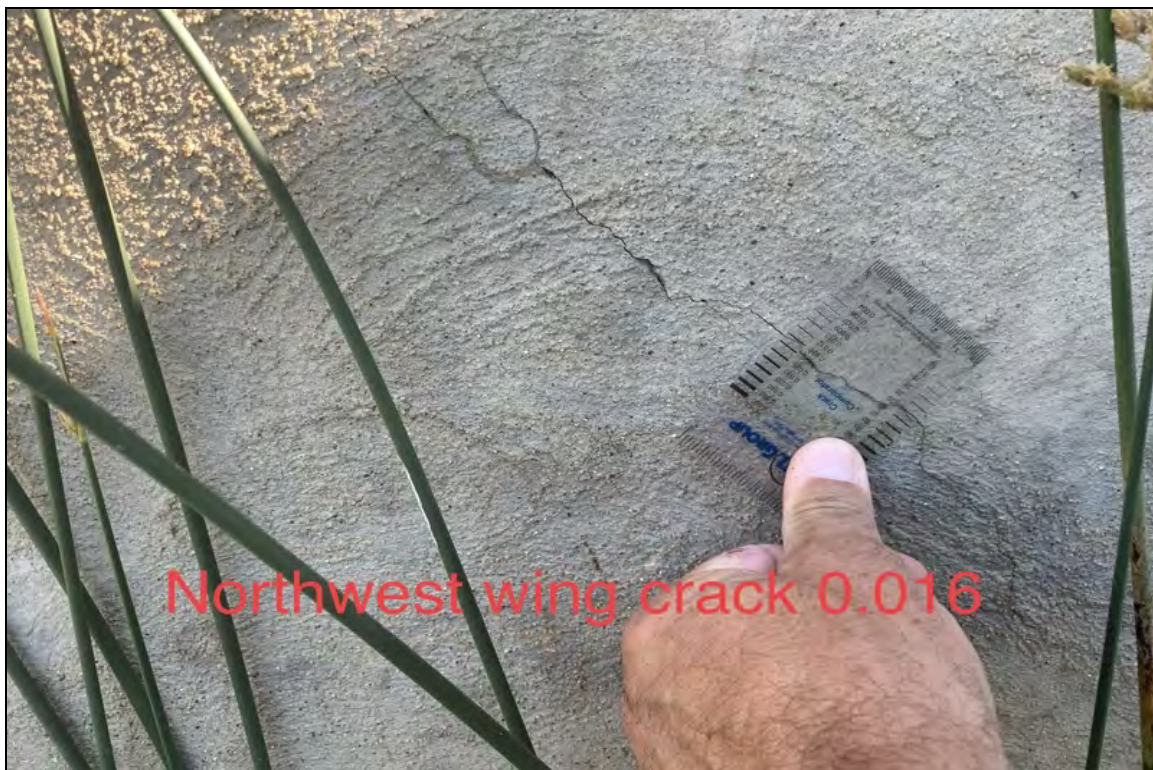
NW wing crack .016

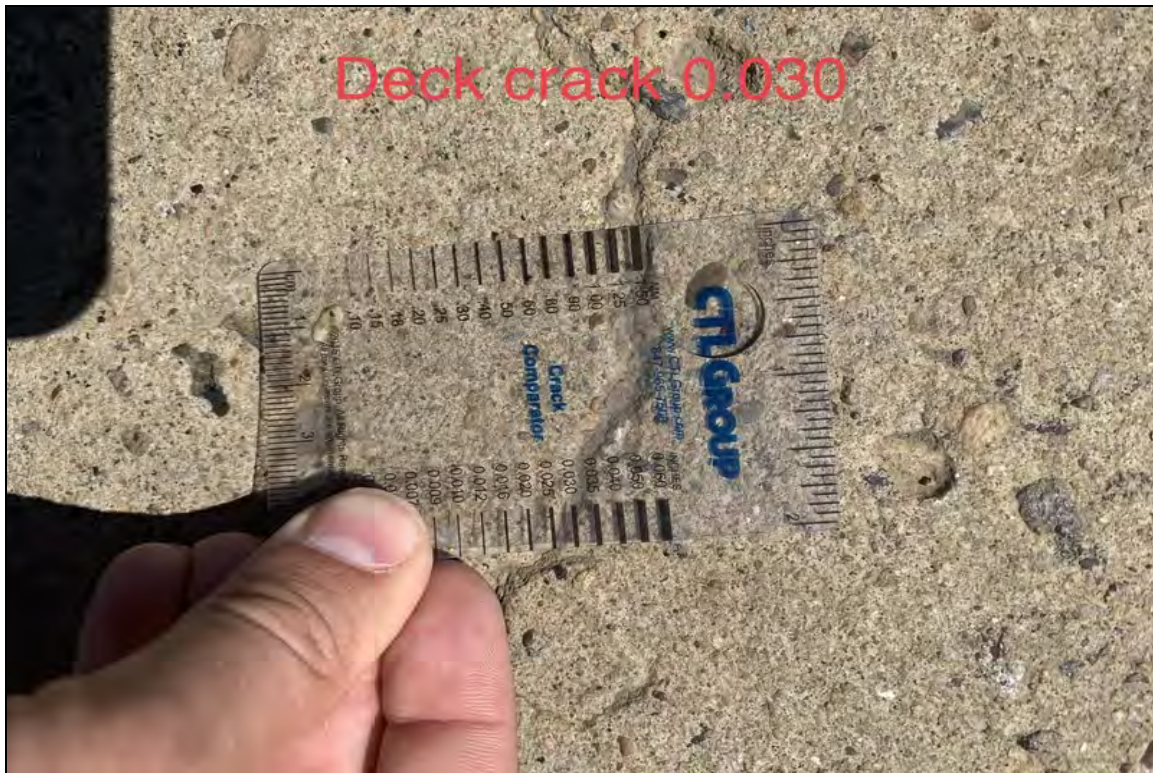
Numerous cracks on deck.

Deck crack .030

There is cracking and spalls on the deck and curb that could be sealed. Recommendation is to overlay the deck due to the numerous pop outs and map cracking. 15JULY2020

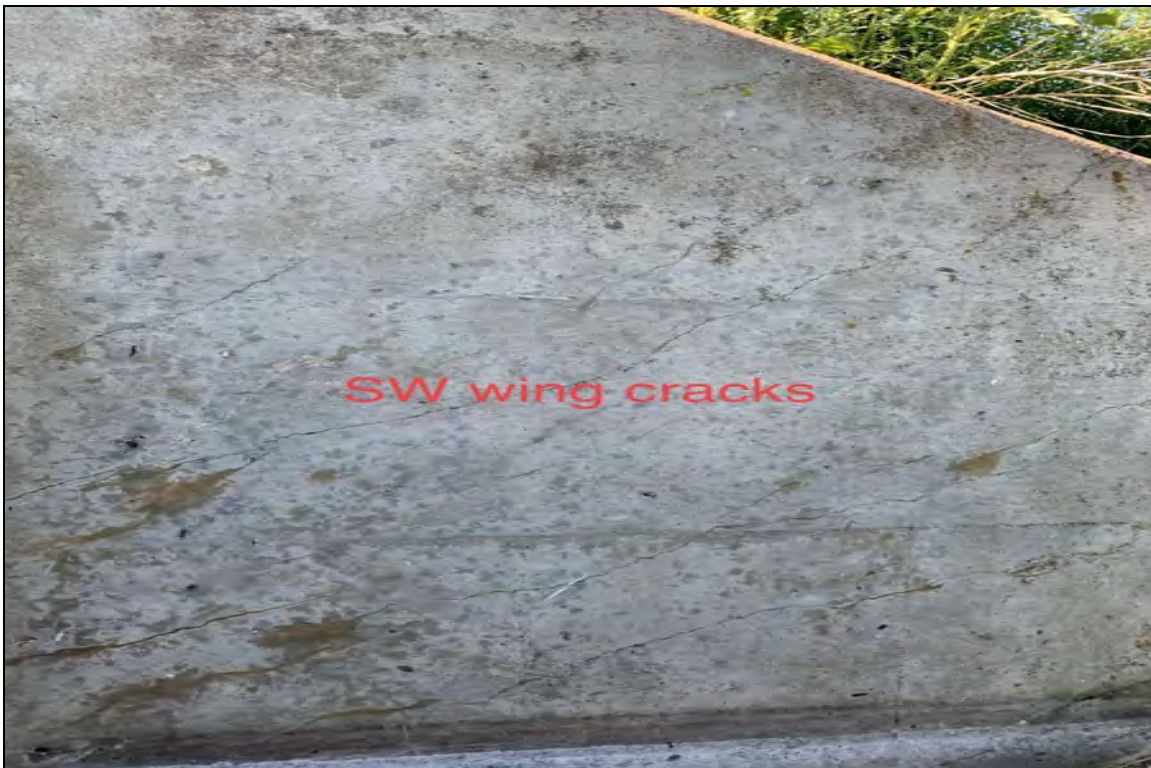
10/4/2017 - SW & SE wings cracking.

SW wing cacks

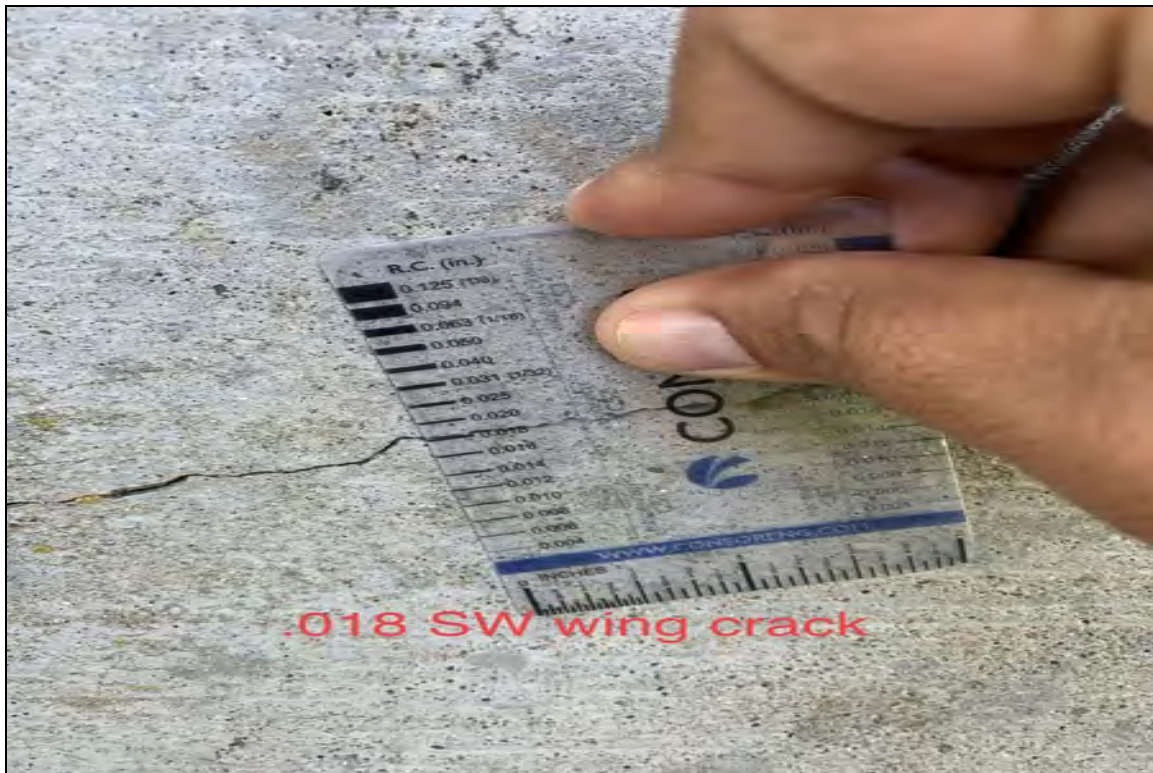
.018 SW wing cracks

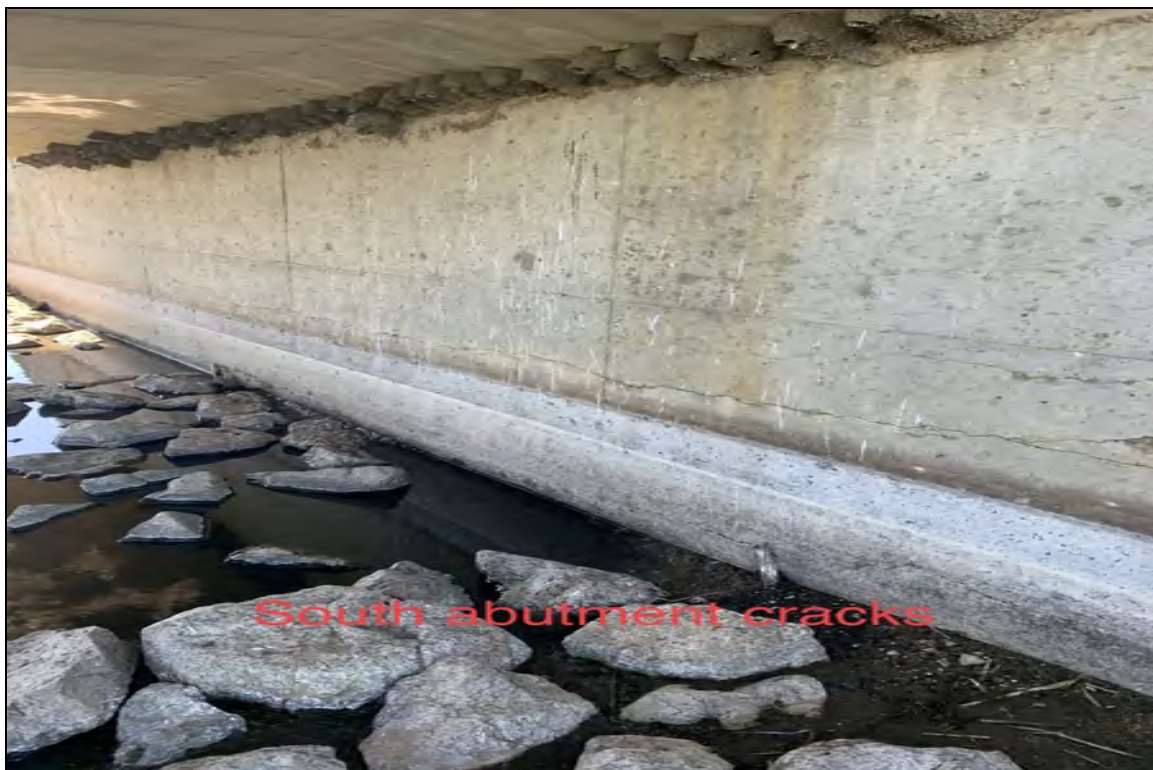
Horizontal crack across south abutment.

South abutment cracks

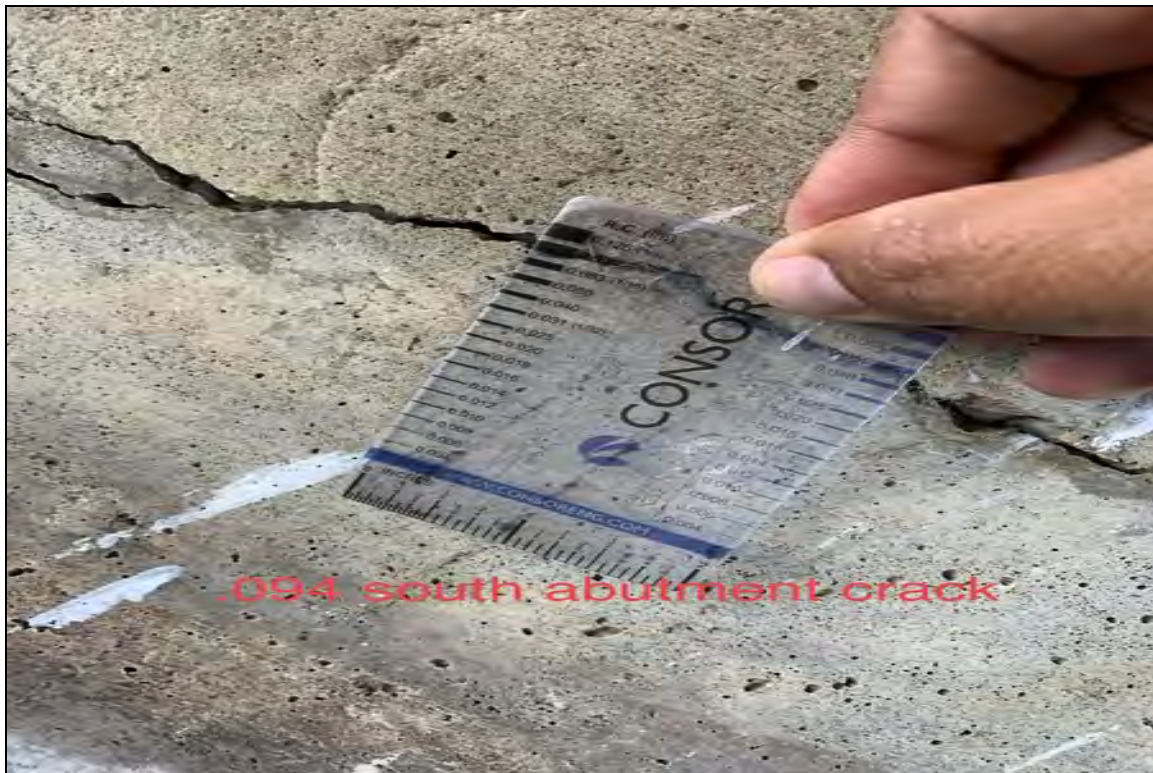
.094 south abutment crack horizontal

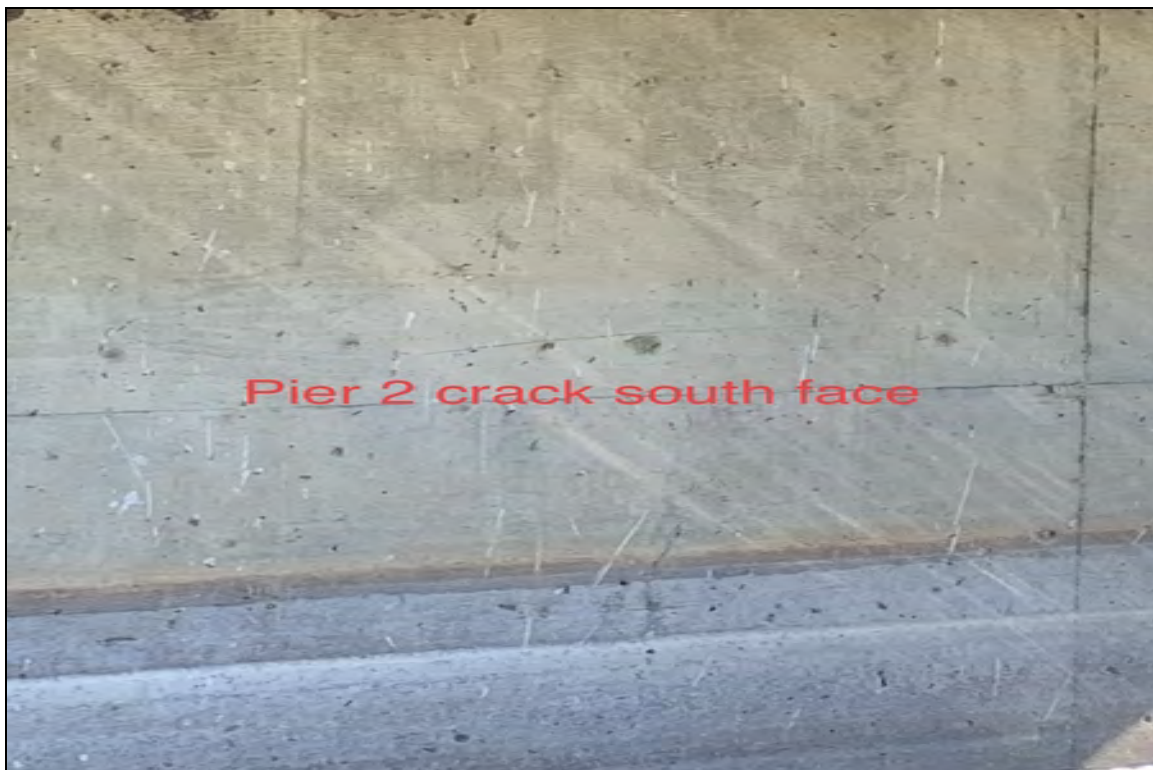
Pier 2 crack sout hface

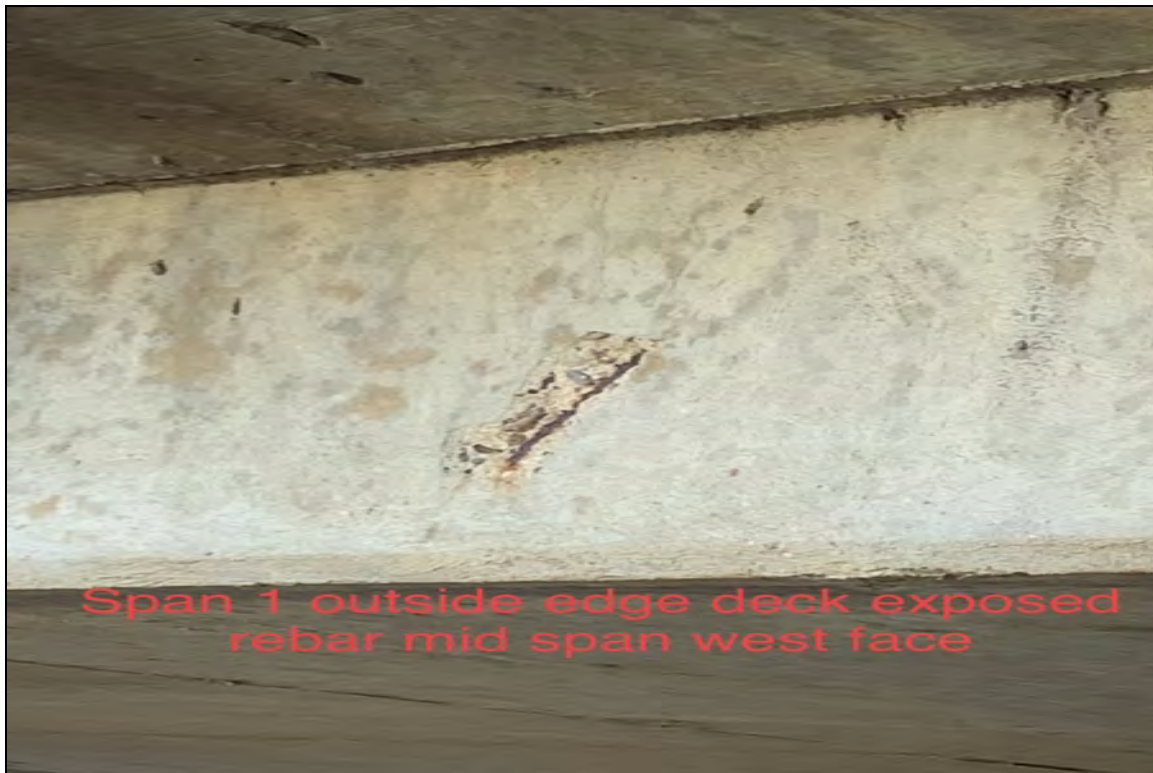
Span 1 outside edge deck exposed rebar mid span west face

Span 1 west outside edge of deck exposed rebar mid span

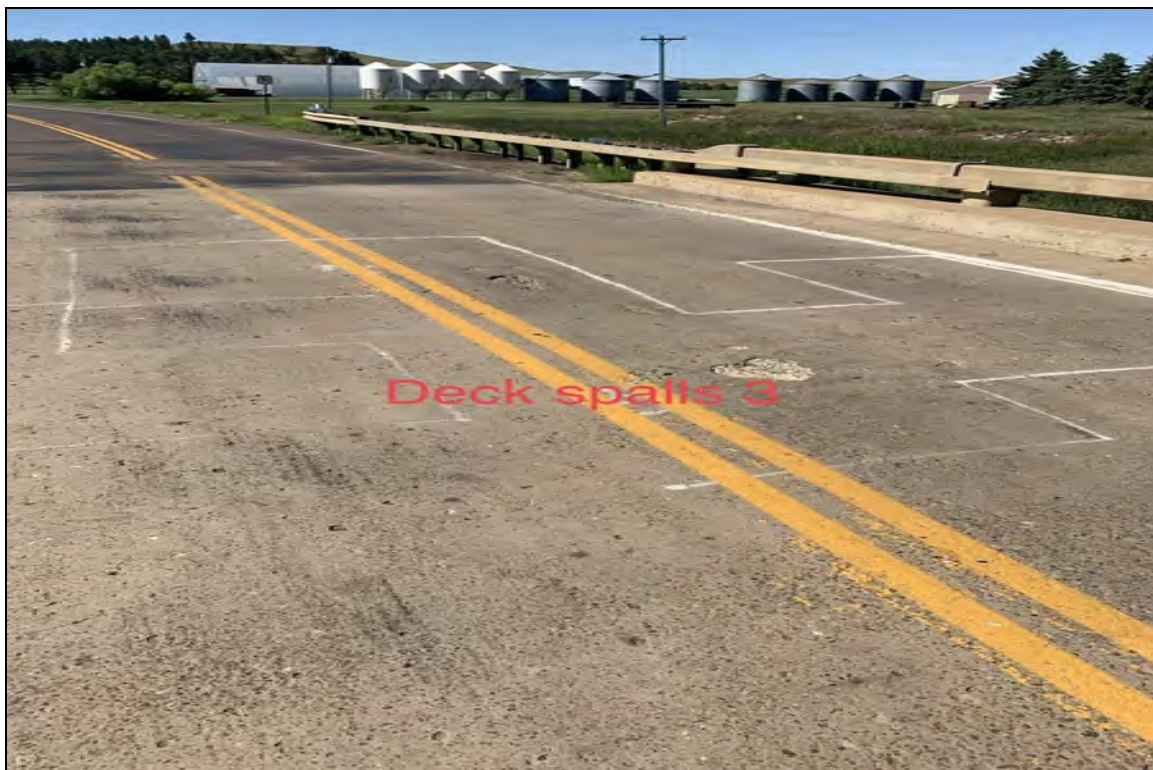
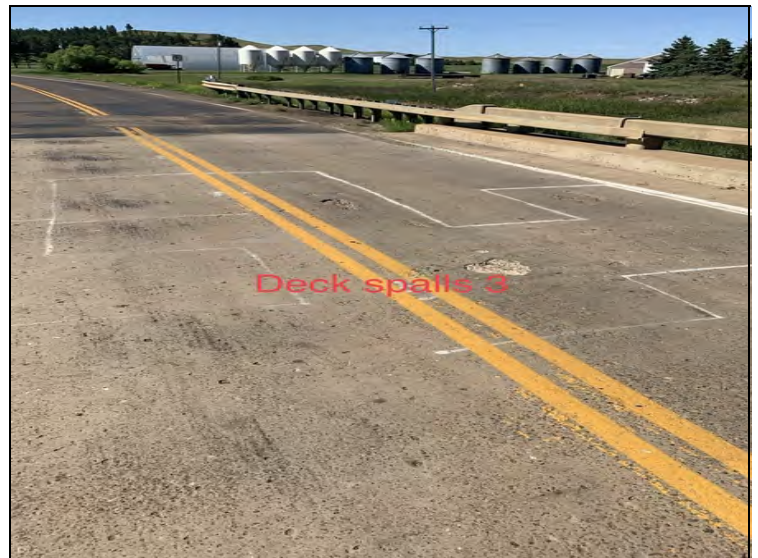
Deck spalls 3

Deck spalls 3 spots

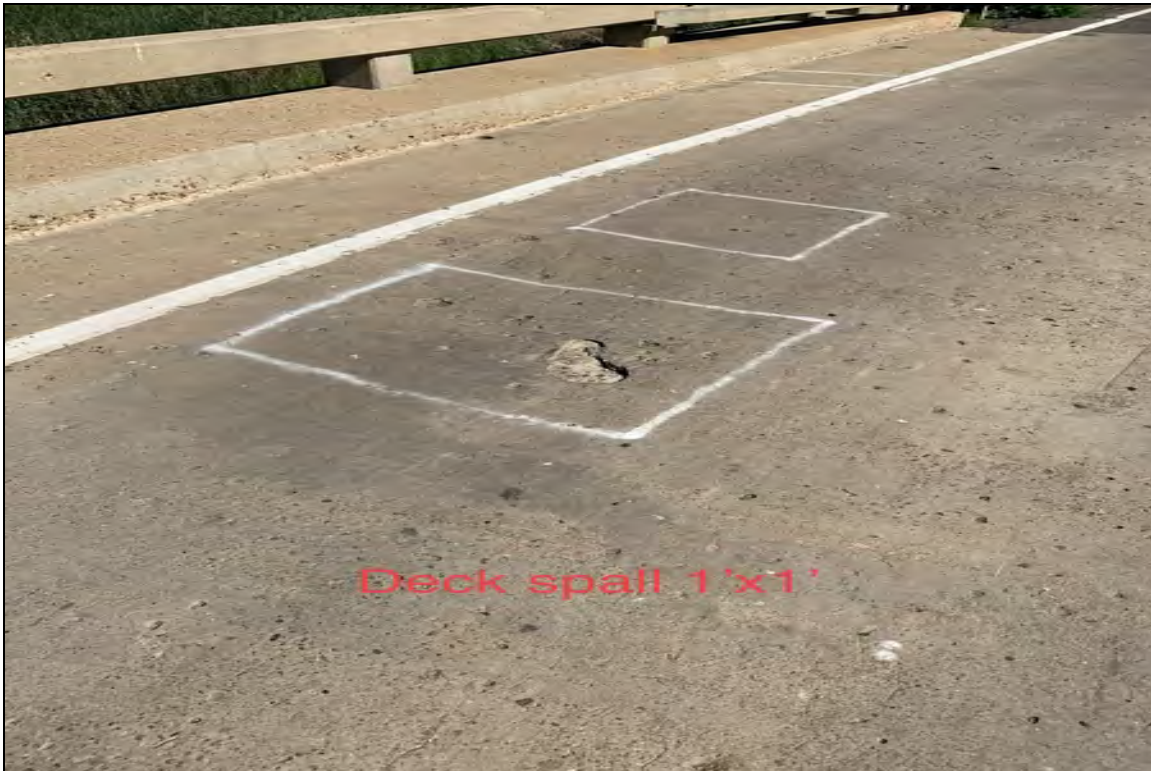
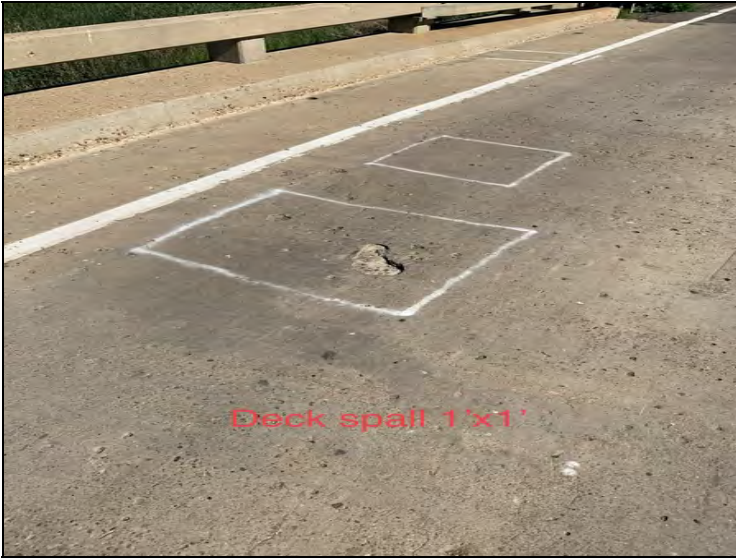
Deck spall 1'x1'

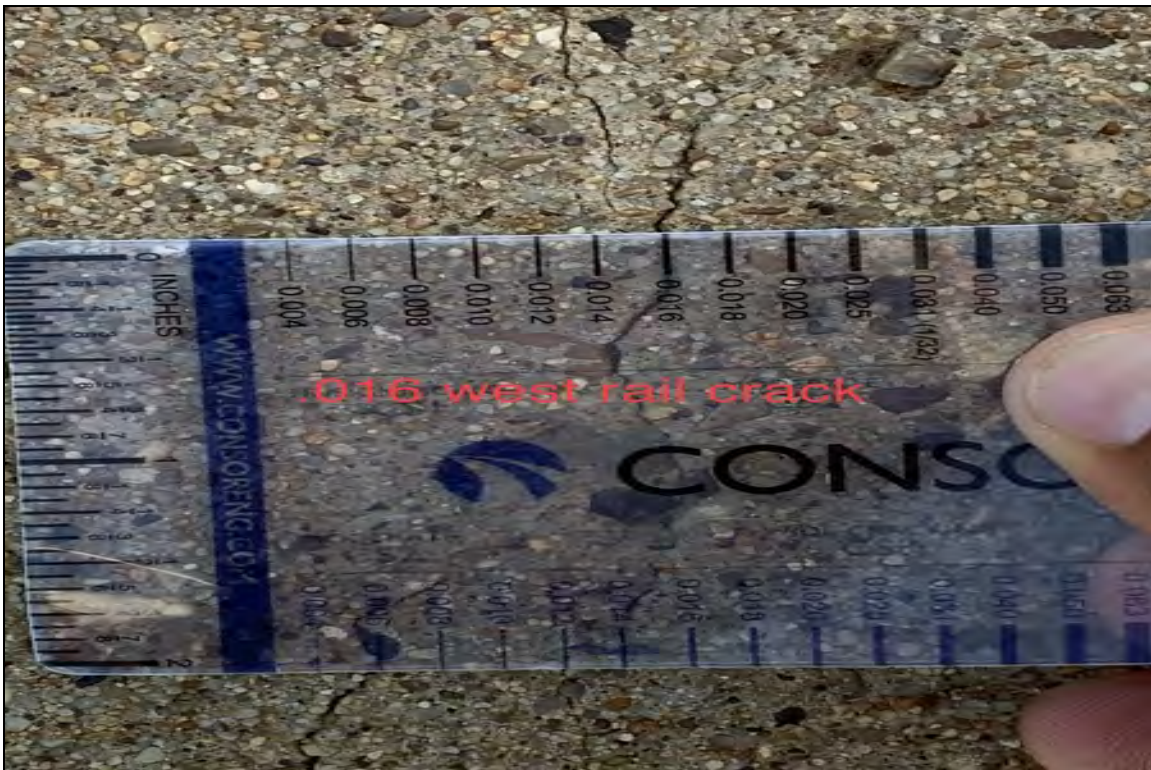
.016 west rail crack

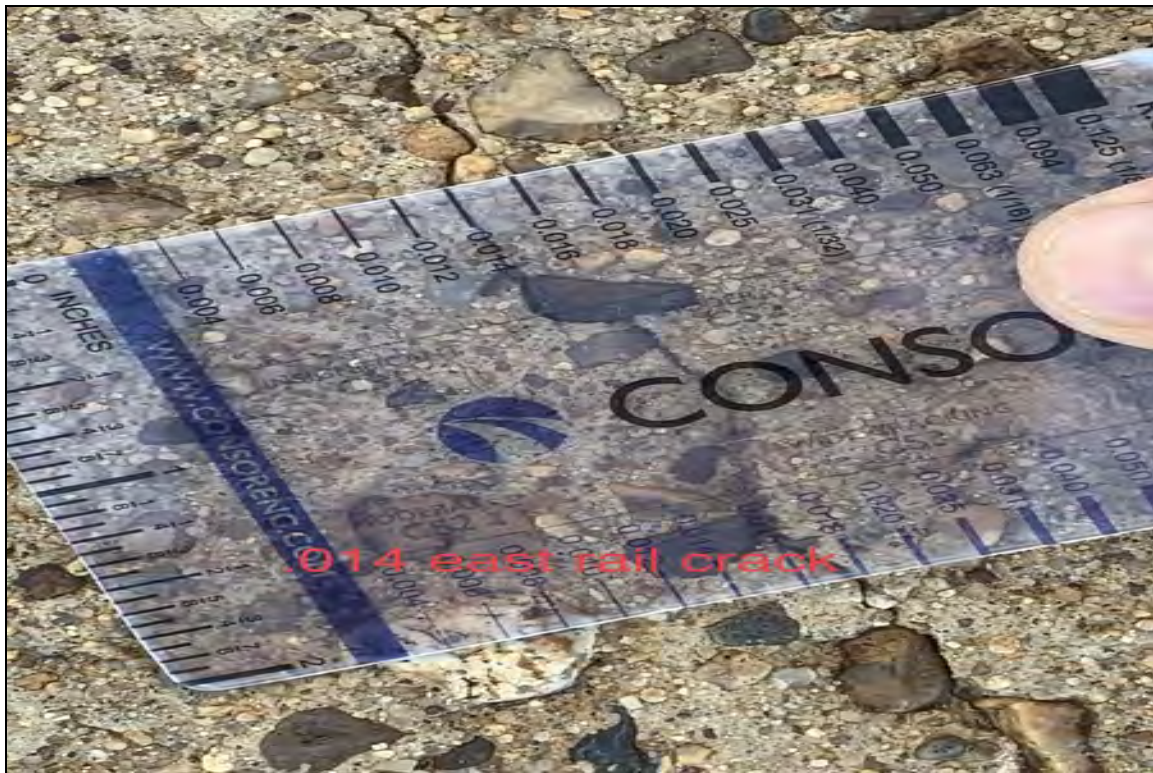
.014 east rail crack
