| IDENTIFICATION | |
|---|---|
| (8) Structure Number | 0022-081.376 |

| CLASSIFICATION | |
|---|--|
| (90) Inspection Date | 09/2020 |

**Bridge #0022-081.376(Routine)
ND HIGHWAY 22 over RUSSIAN SPRING CREEK
Location: 9 NORTH OF I-94**

Team Lead: Jake Mertz, **Inspection Date:** September 01, 2020

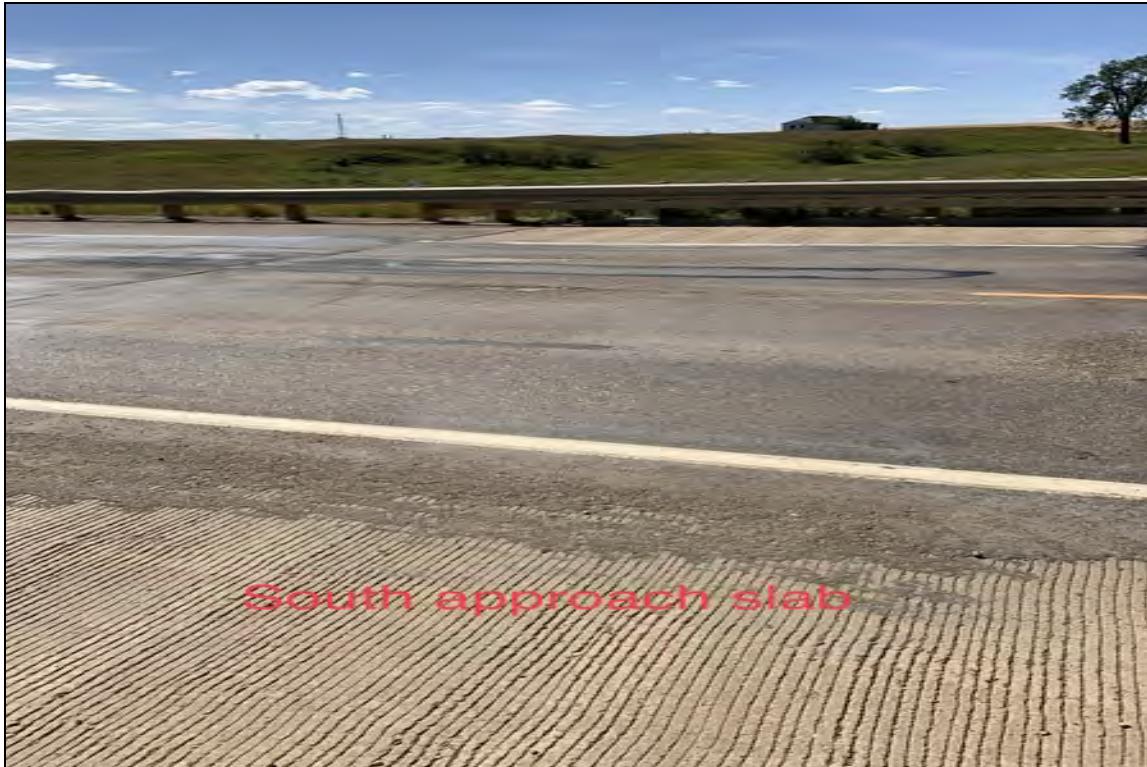
10/19/2009 - Approach slabs covered by asphalt.

South approach slab covered with asphalt

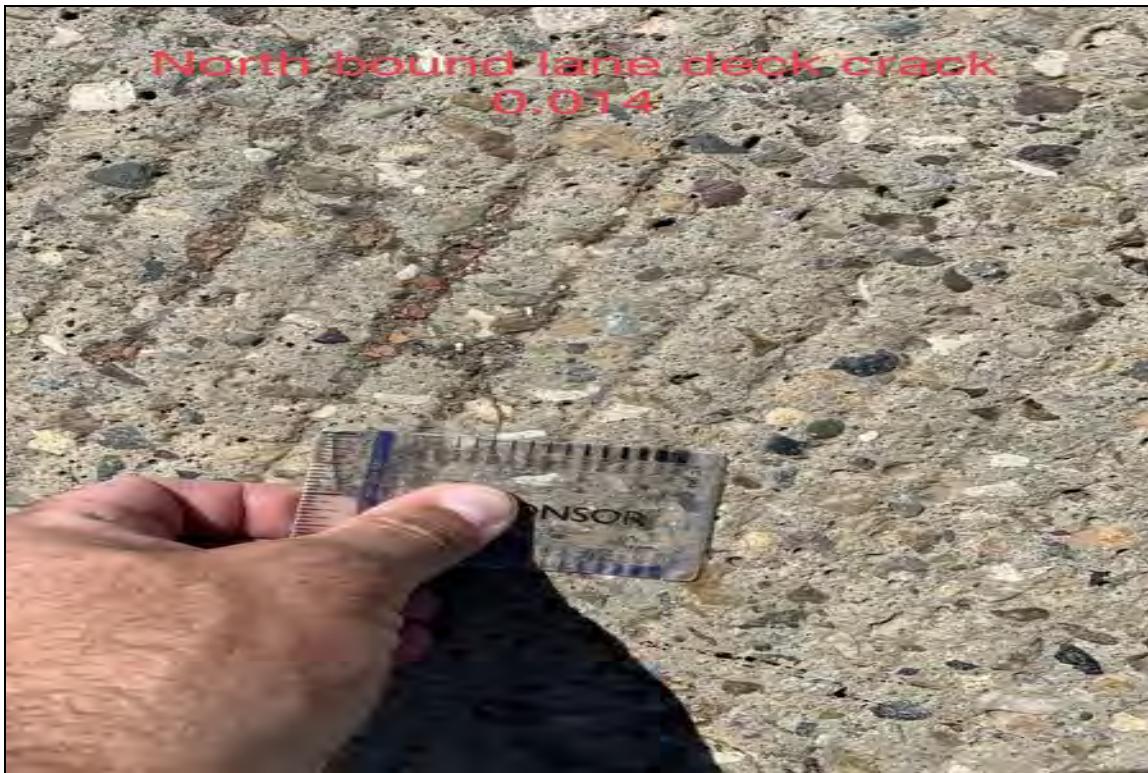
| ELEM | DESCRIPTION | UNITS | TOTAL | CS1 | CS2 | CS3 | CS4 |
|---|---|---|---|---|---|---|---|
| | There are two cracks in the Northbound lane that are diagonal and at the north and south ends of the structure. These cracks are 0.014 in width. 1September2020 | | | | | | |

North bound lane deck crack .014

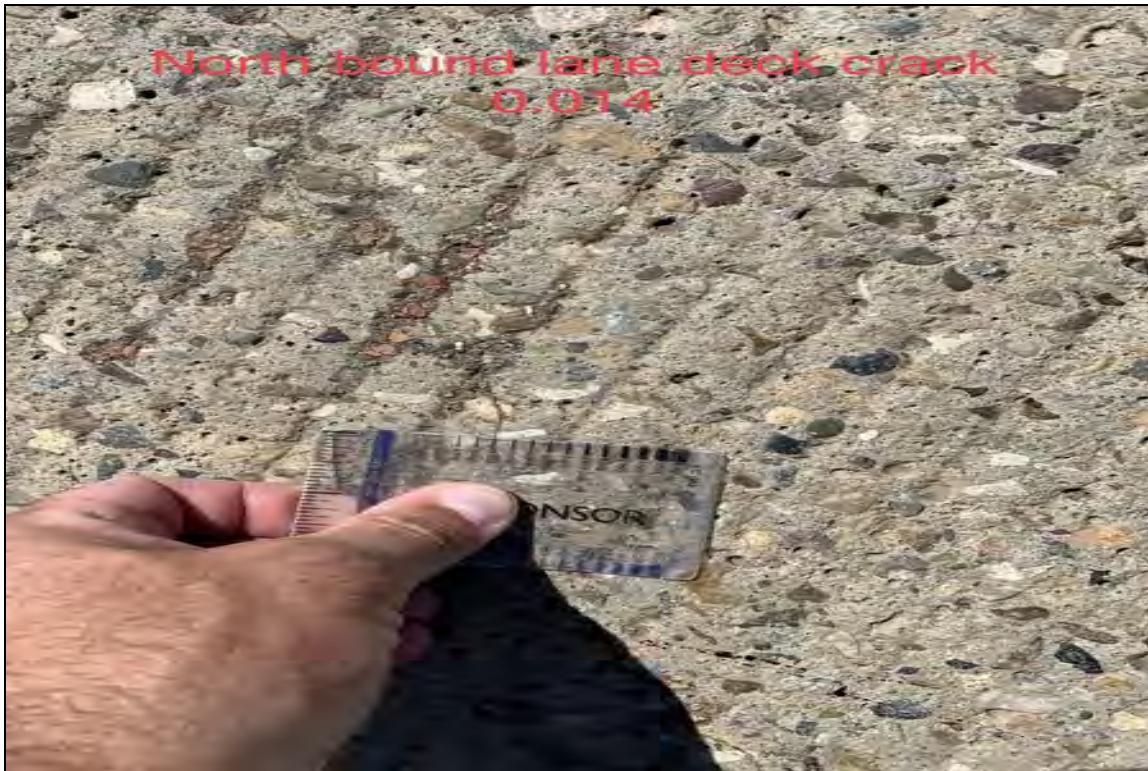
North bound lane deck crack .014

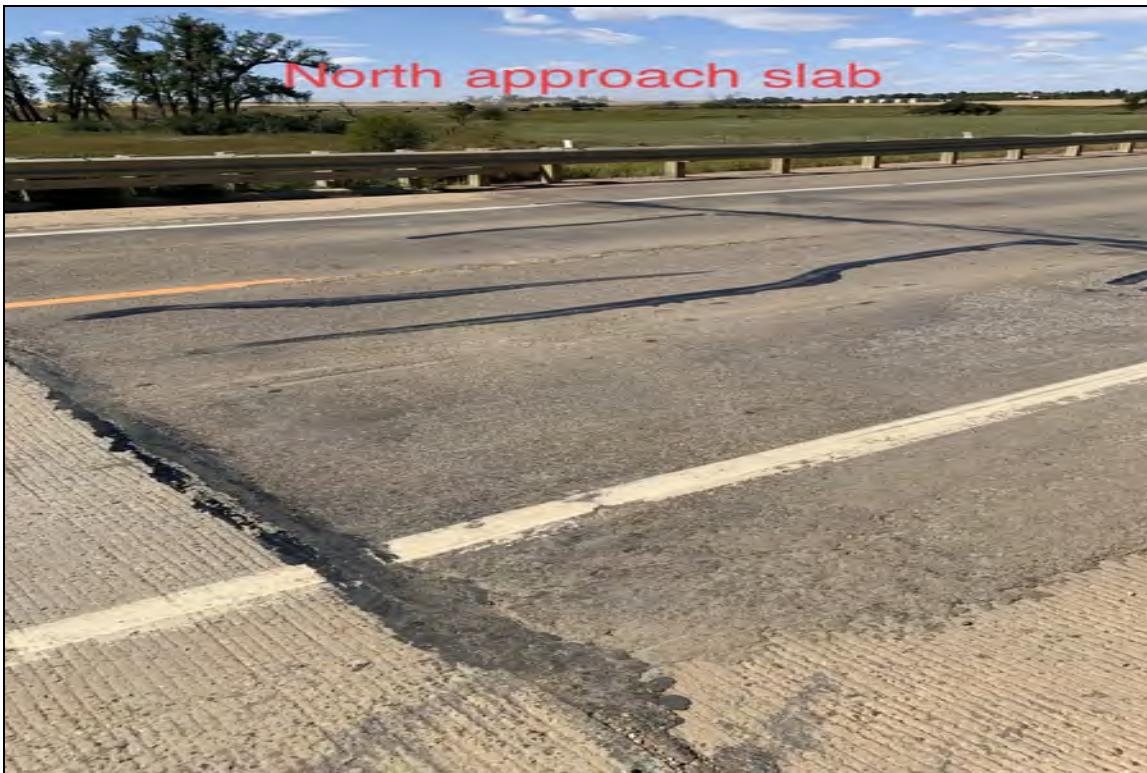
North approach slab coved with asphalt

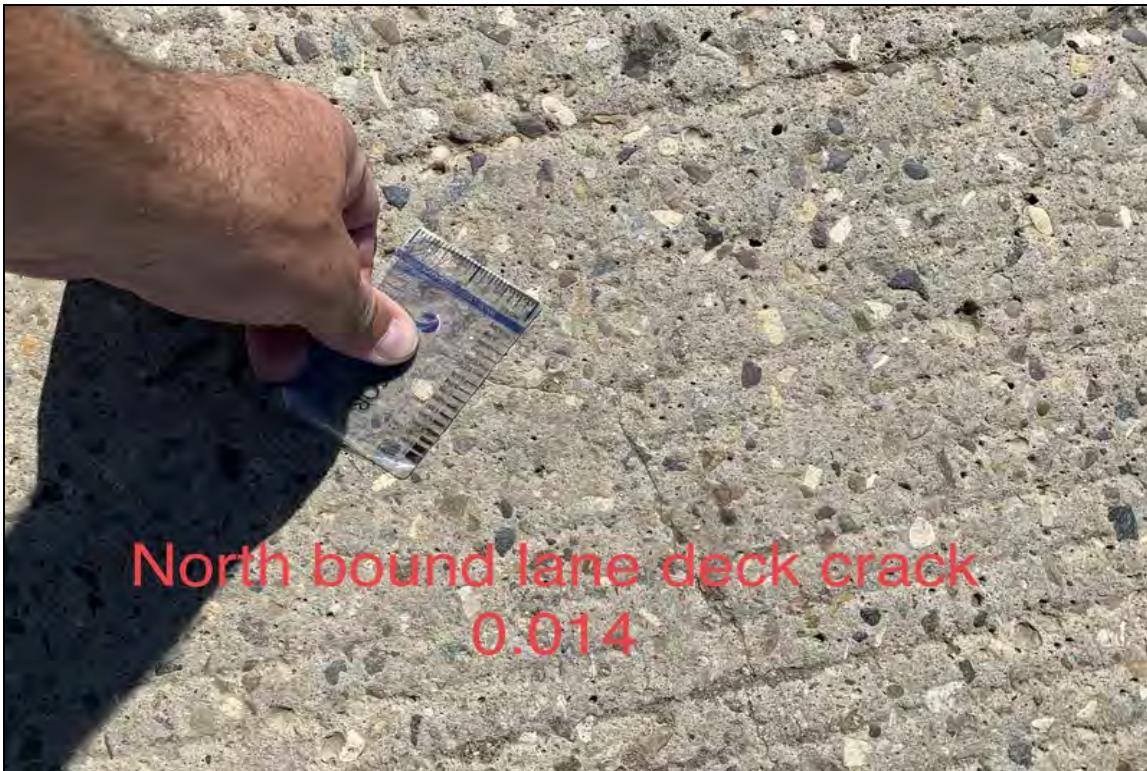
North bound deck lane crack .014

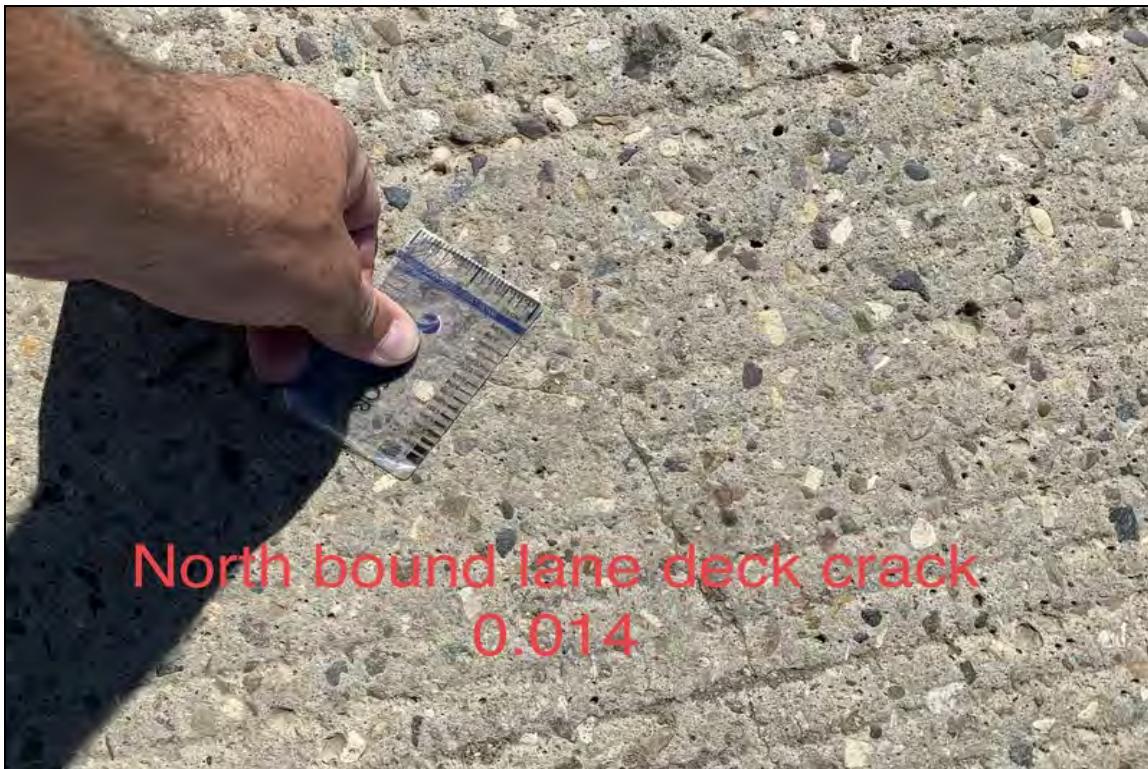
North bound deck lane crack .014

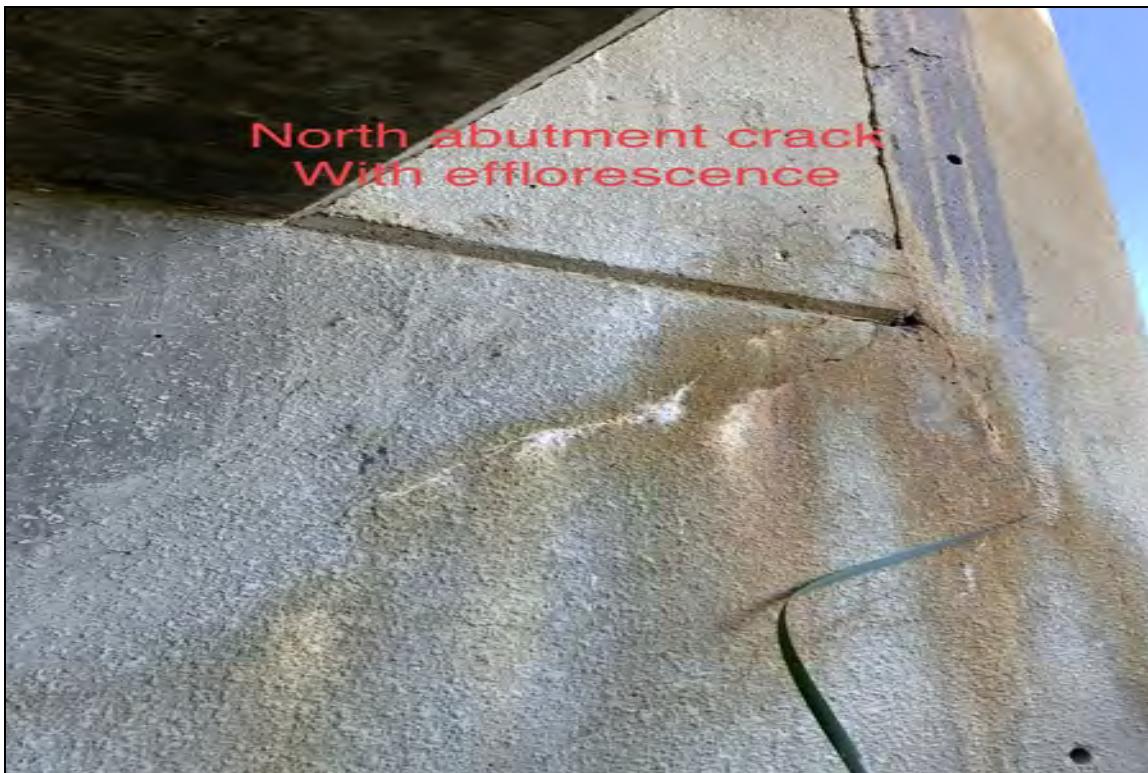
| ELEM | DESCRIPTION | UNITS | TOTAL | CS1 | CS2 | CS3 | CS4 |
|---|---|---|---|---|---|---|---|
| | staining present at the cracks on the abutments - 6/5/2019 | | | | | | |

North abutment crack with efflorescence

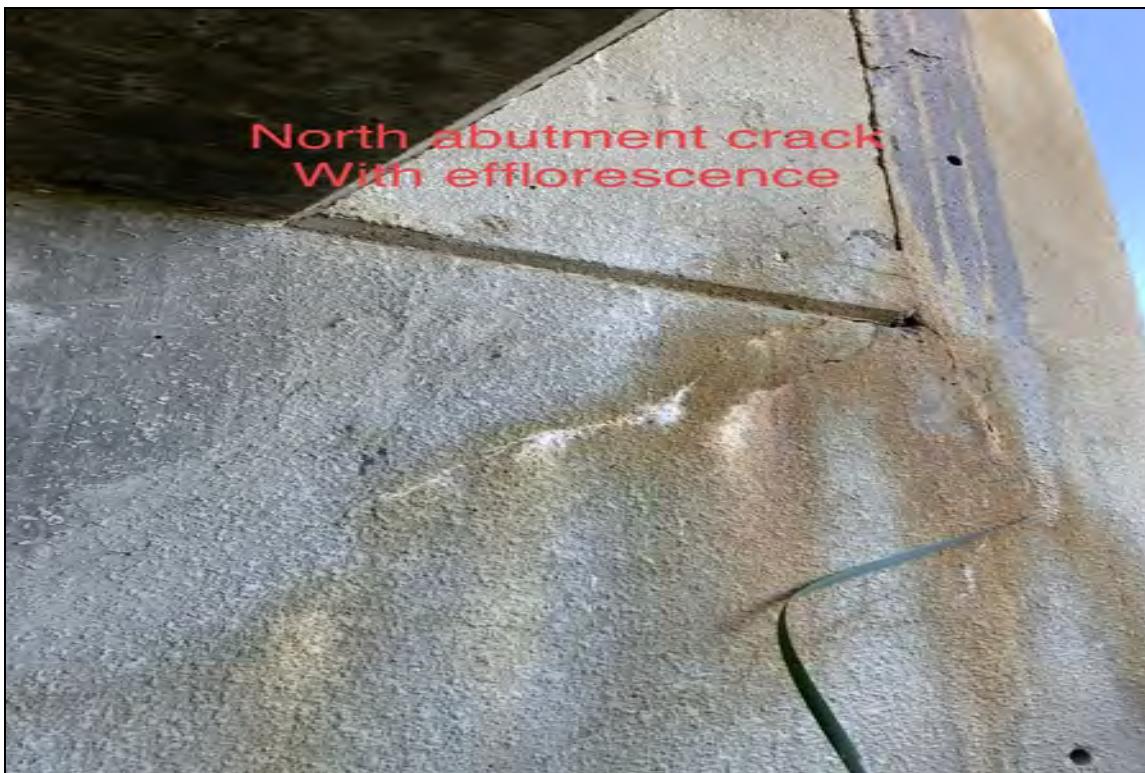
North abutment crack with efflorescence

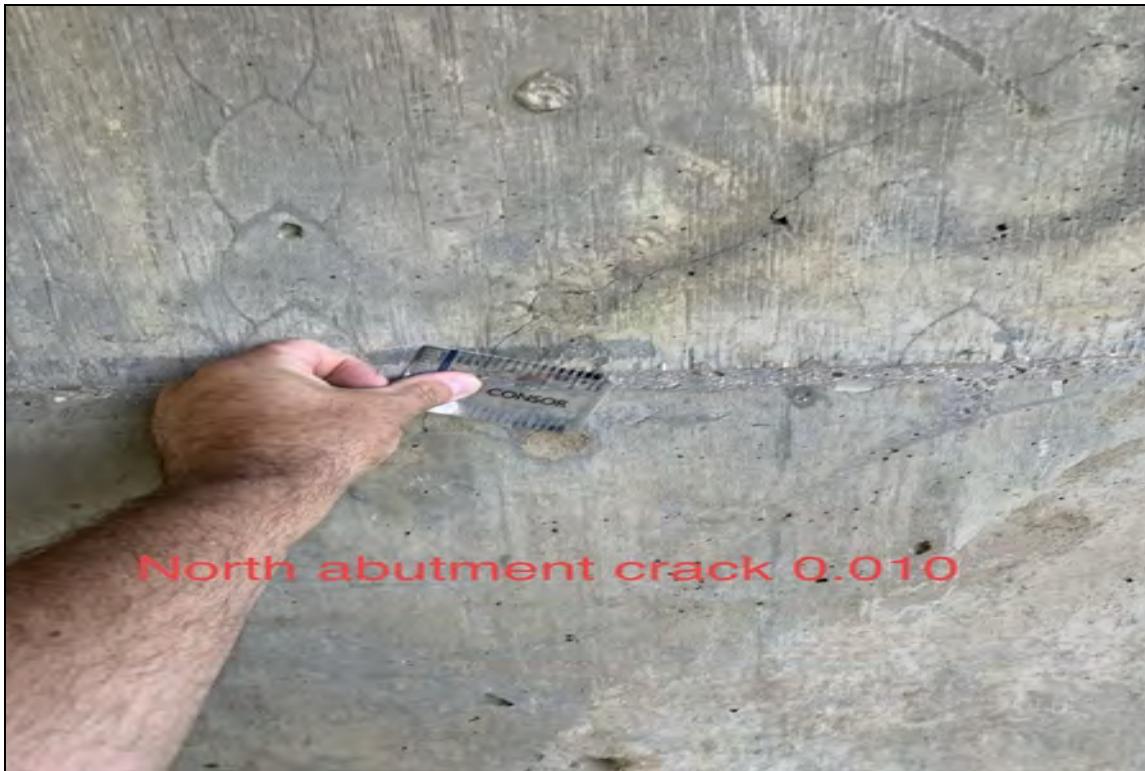
| ELEM | DESCRIPTION | UNITS | TOTAL | CS1 | CS2 | CS3 | CS4 |
|---|---|---|---|---|---|---|---|
| | The North abutment has approximately 5 cracks that average approximately 0.010 in width. The South abutment has approximately 5 cracks that range from approximately 0.004 to 0.006 inn width. 1September2020 | | | | | | |

North abutment crack .010

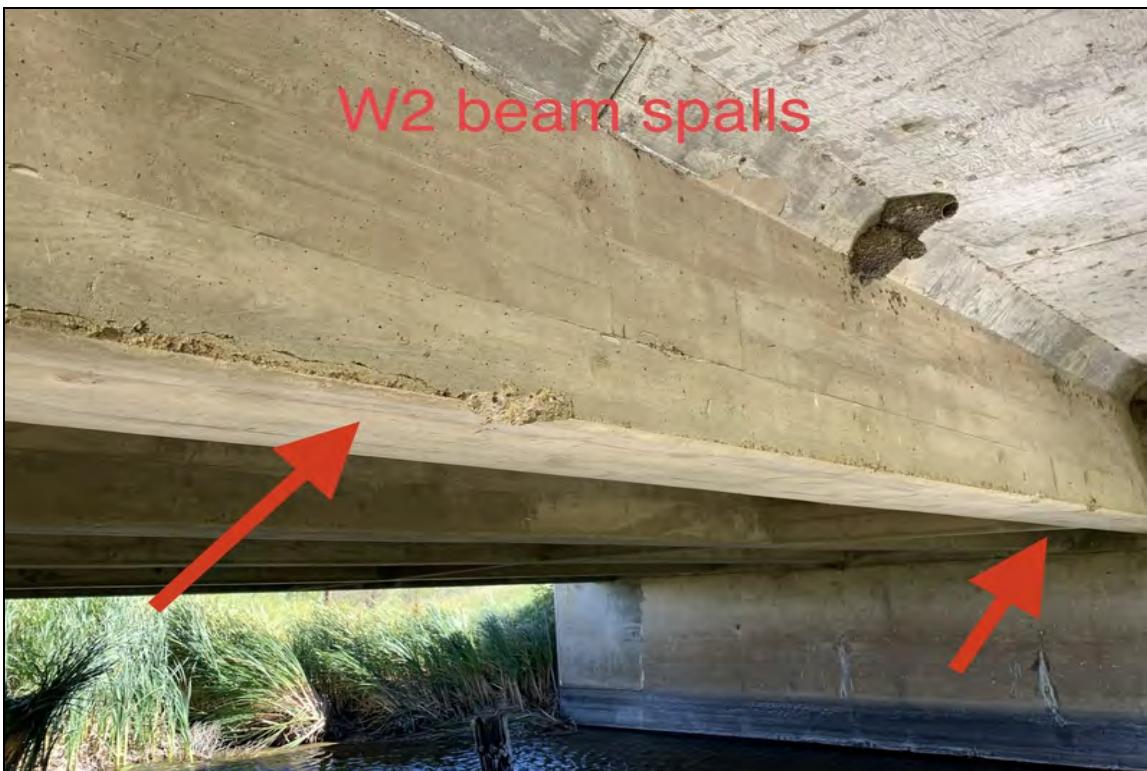
| ELEM | DESCRIPTION | UNITS | TOTAL | CS1 | CS2 | CS3 | CS4 |
|---|---|---|---|---|---|---|---|
| | The E2 beam has a spall approximately 5 inches by 3 inches in size. This is located approximately 15 feet to the North of the South abutment. The W2 beam has 3 spalls that are 6 inches by 6 inches, 3 inches by 3 inches and 1 foot by 4 inches. These are located respectively at 20 feet, 18 feet and 5 feet to the South of the North abutment. 1September2020 | | | | | | |

W2 beam spalls

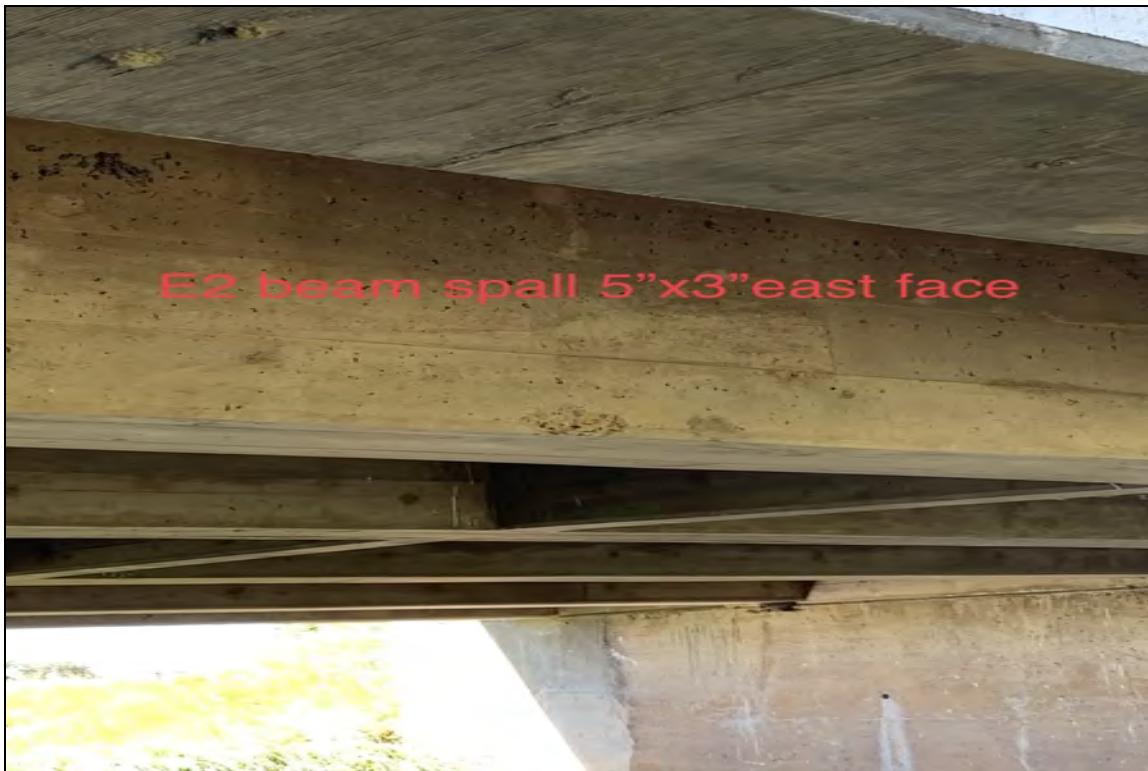
E2 beam east face 5"x3"

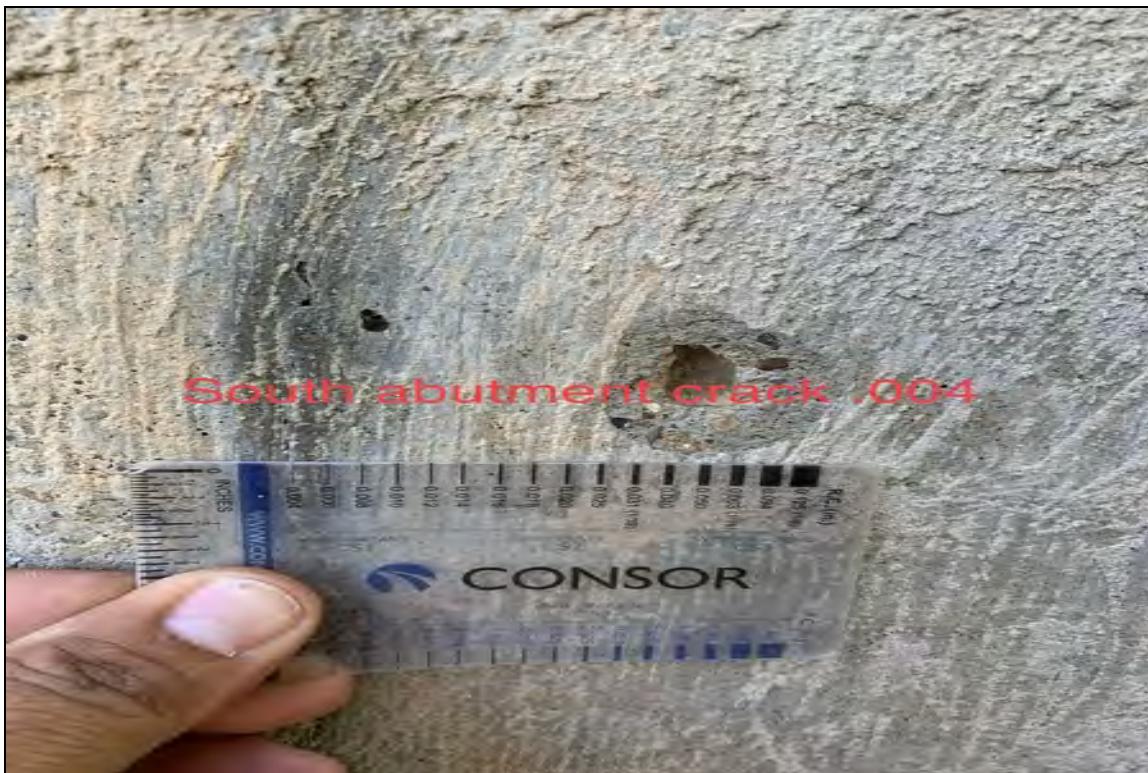
South abutment crack .004

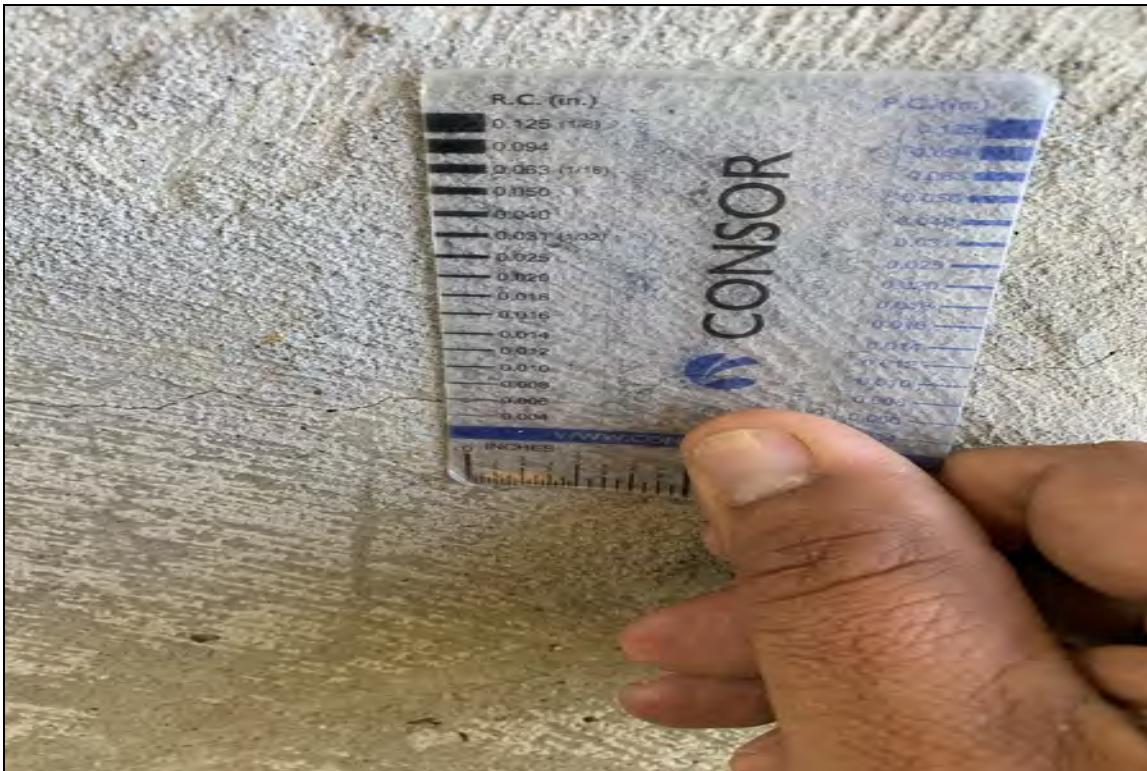
South abutment crack.oo6

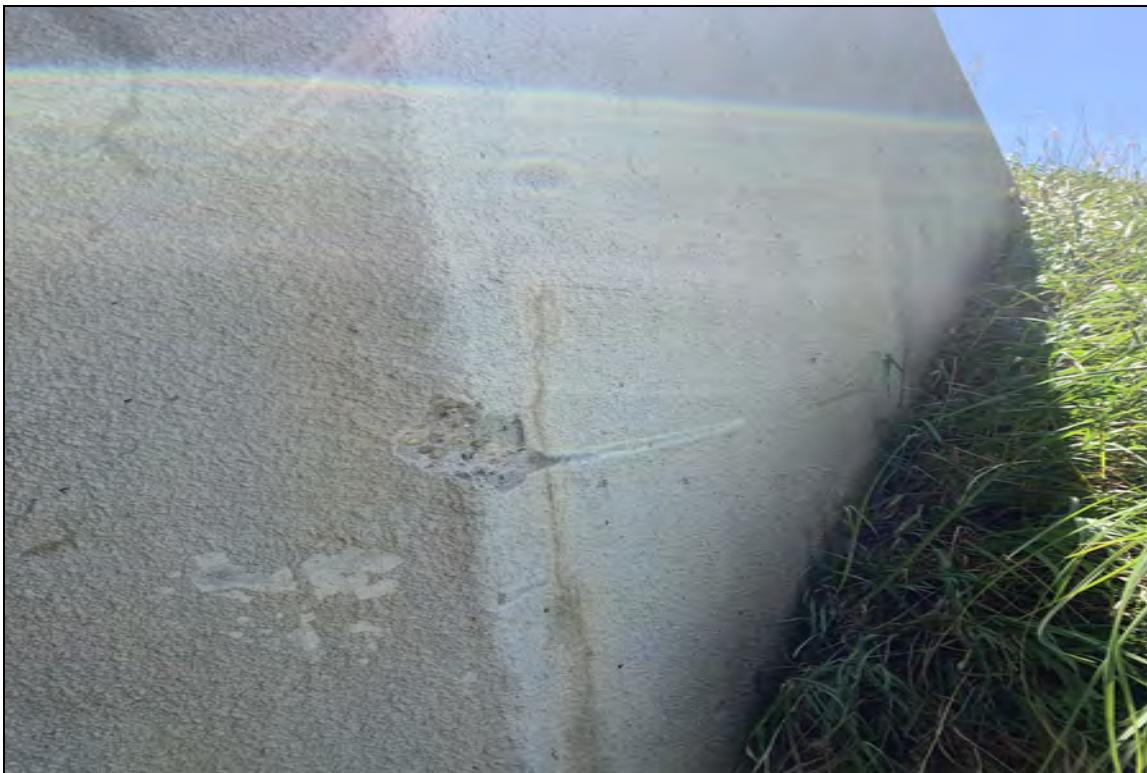
SW wing minor spall 5"x5"

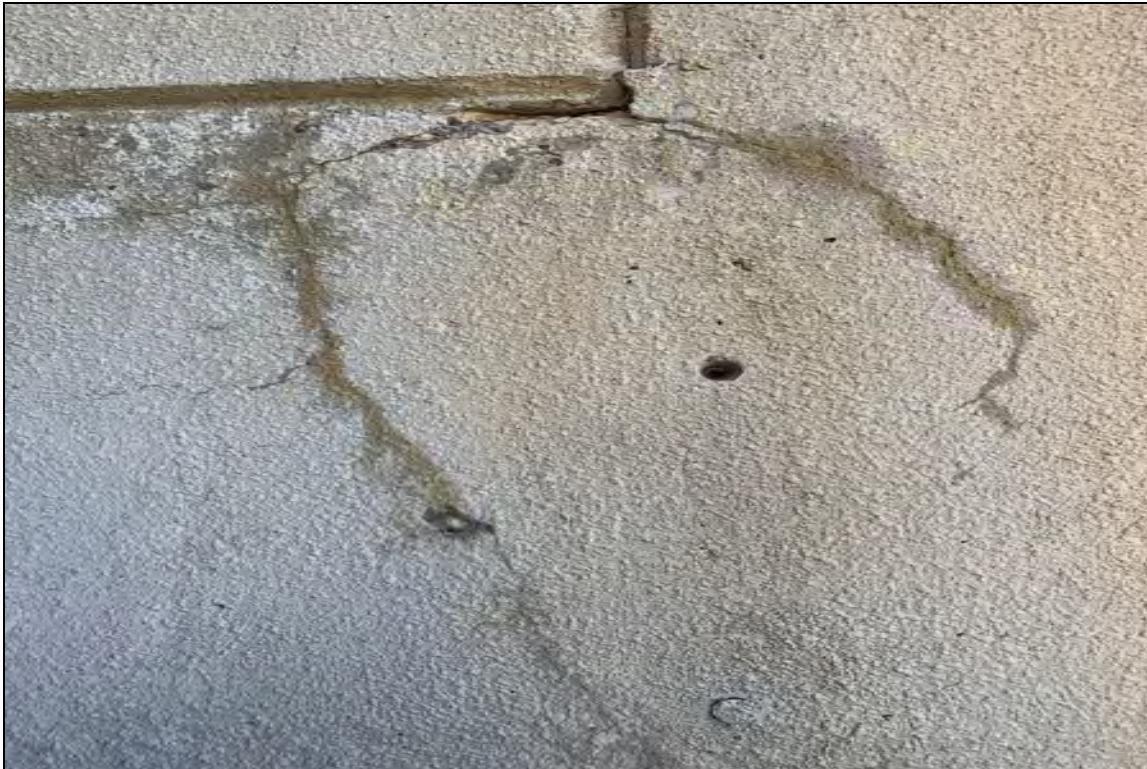
South abutment west end cracks under backwall
