9 NORTH OF US 83

IDENTIFICATION	
(1) State Names	North Dakota
(8) Structure Number	0041-008.742
(5) Inventory Route	00041
(2) Highway Agency District	61
(3) County Code	McLean, North Dakota

(4) Place Code	0
(6) Features Intersected	PAINTED WOODS CREEK
(7) Facility Carried	ND HIGHWAY 41
(9) Location	9 NORTH OF US 83
(11) Mile Point	8.74 mi
(12) Base Highway Network	Yes

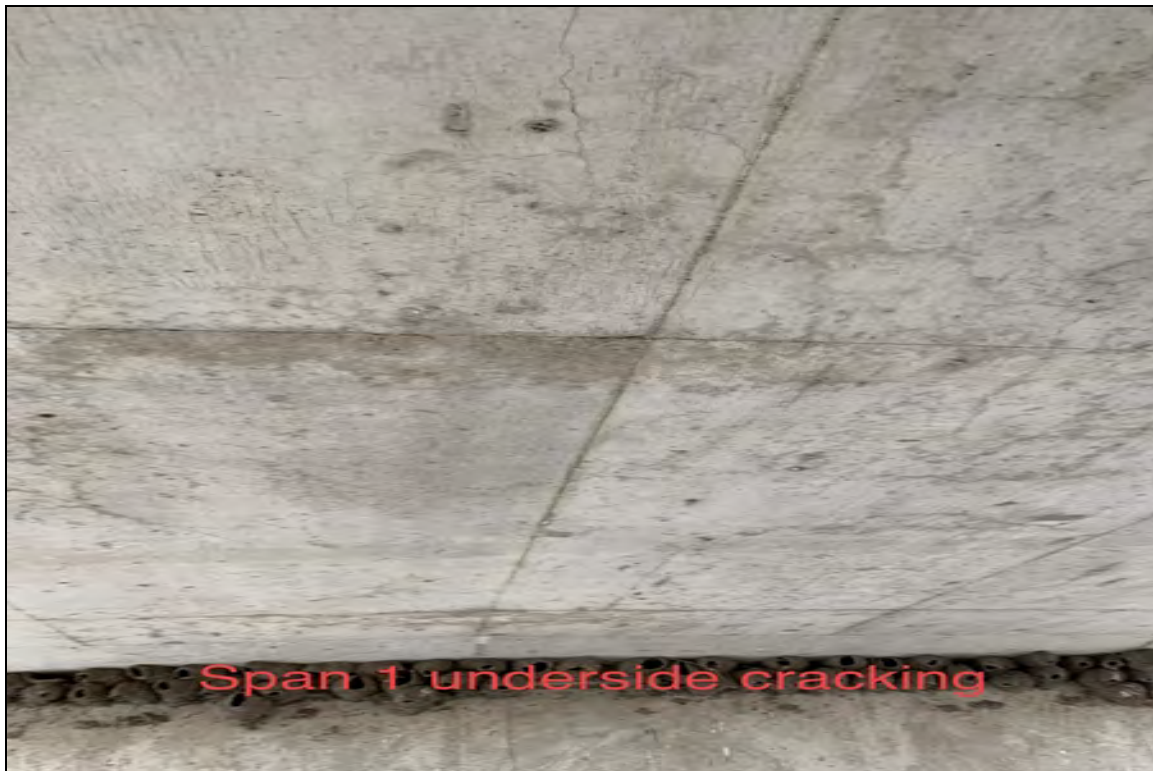
Span 1 underside cracking

Span 1 underside deck cracking

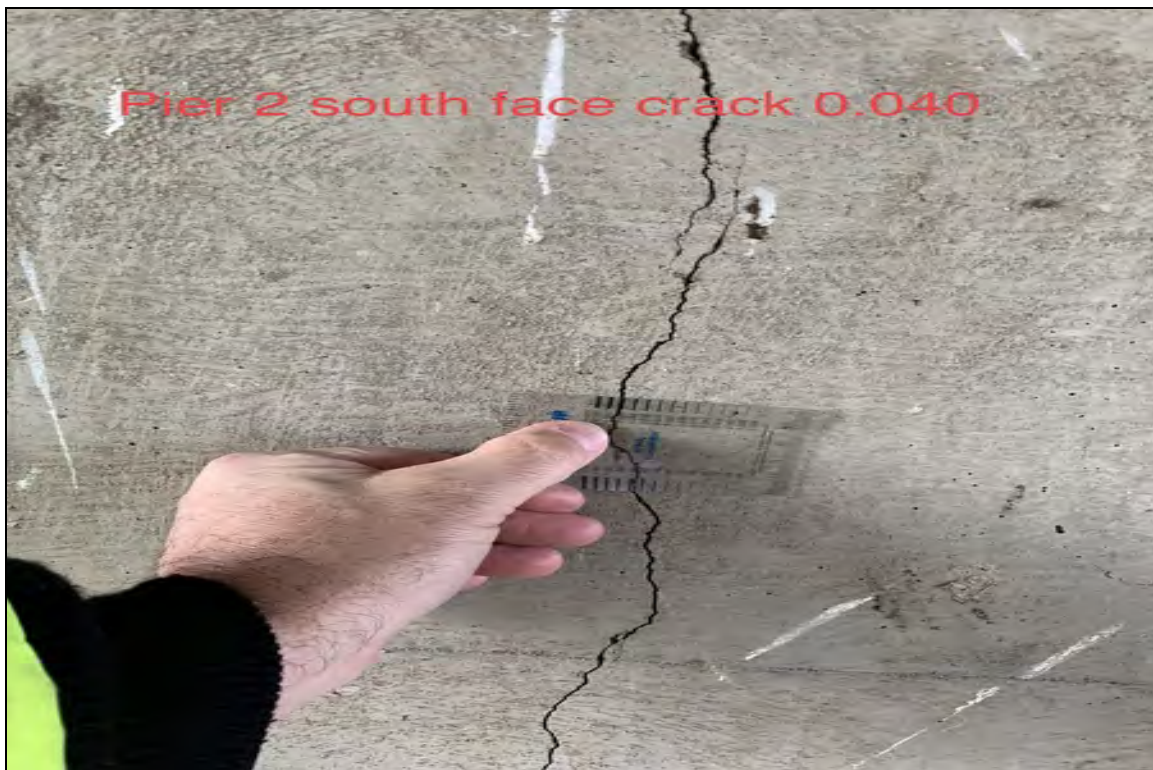
Pier 2 south face crack 0.040

Pier 2 south face crack .040

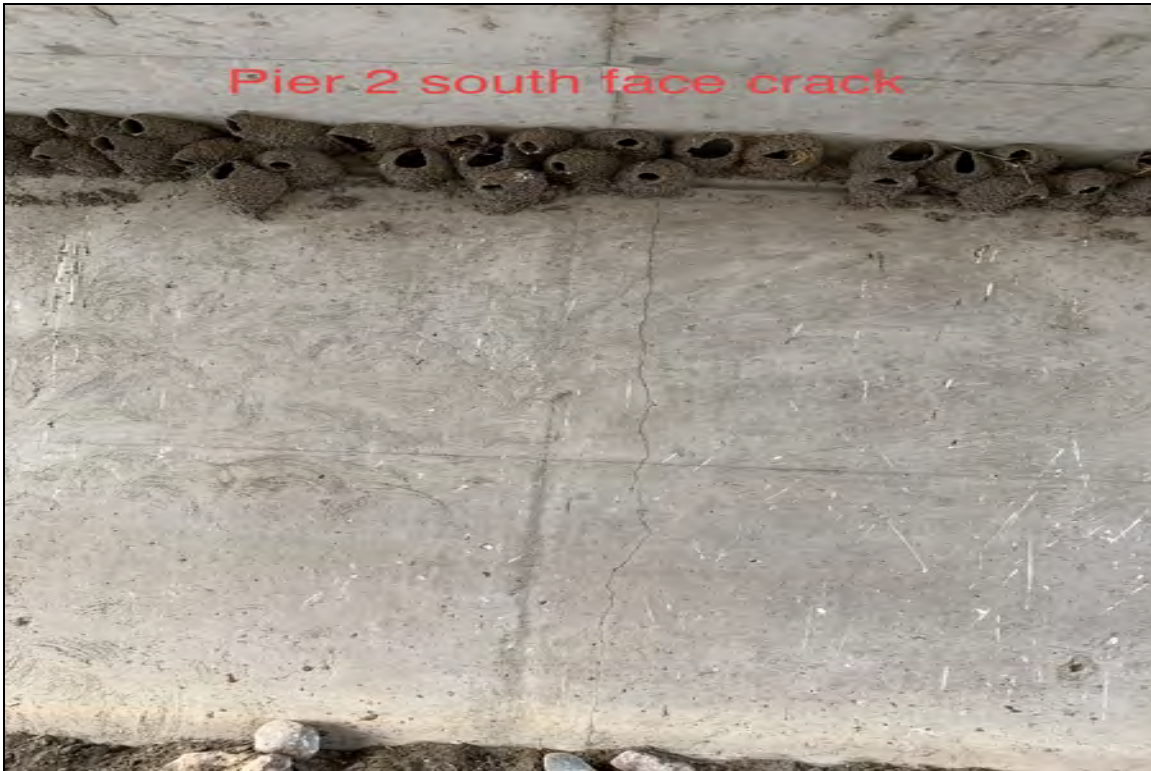
Pier 2 south face crack

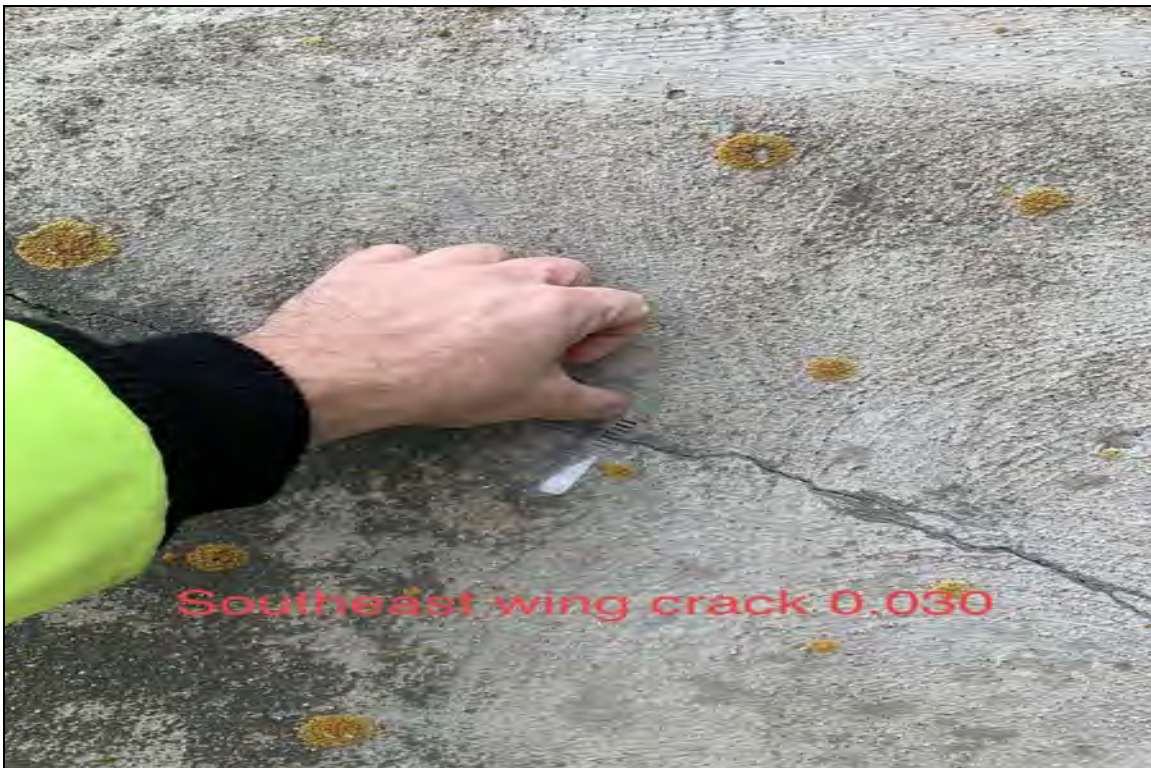
SE wing crack .030

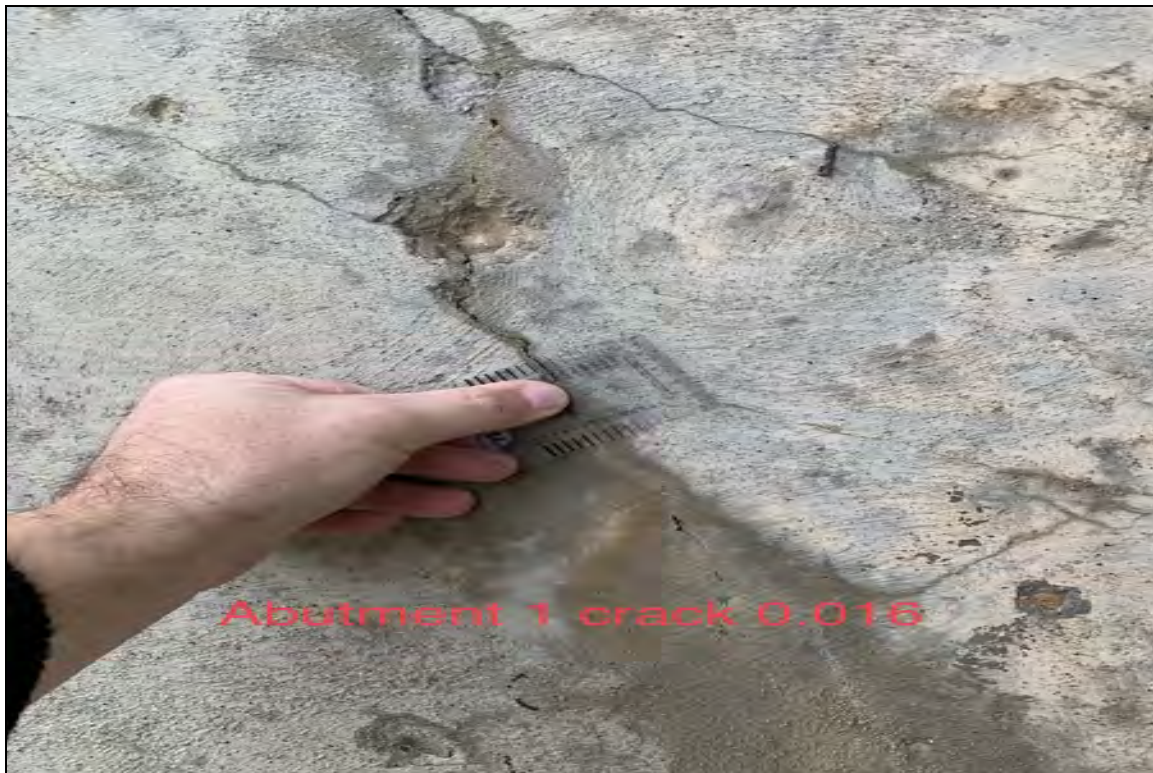
Abutment 1 crack .016

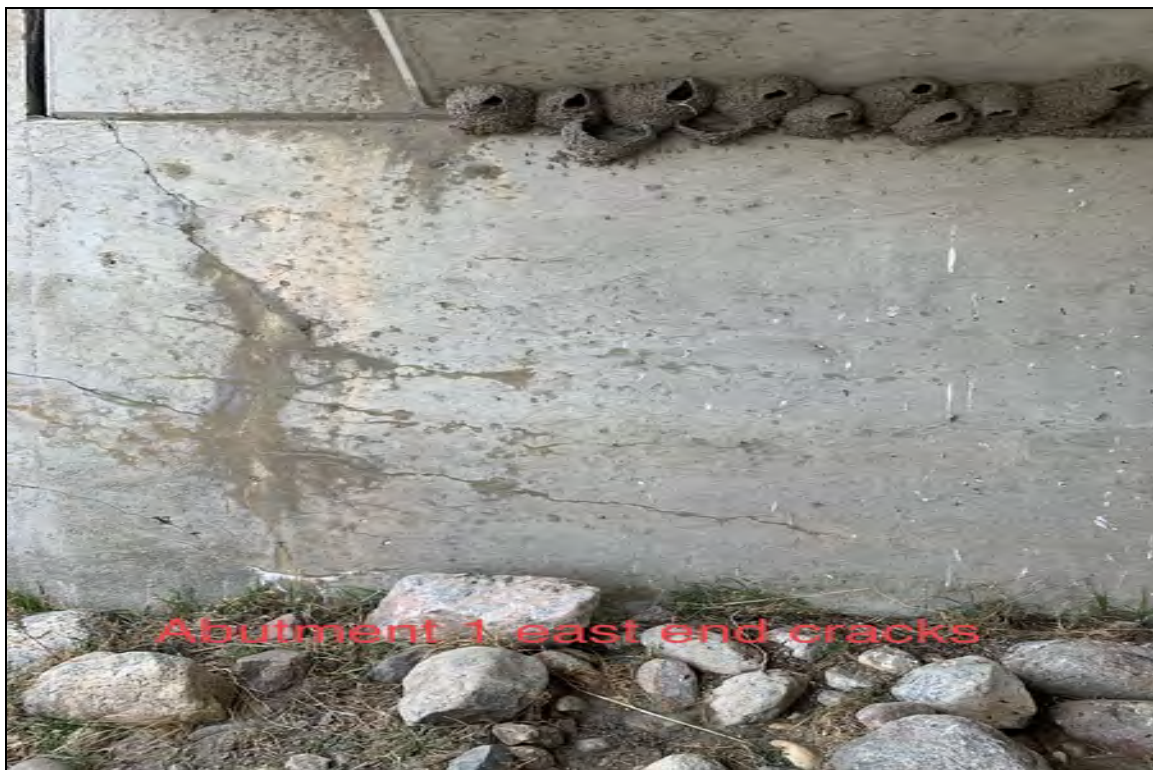
Abutment 1 east end cracks

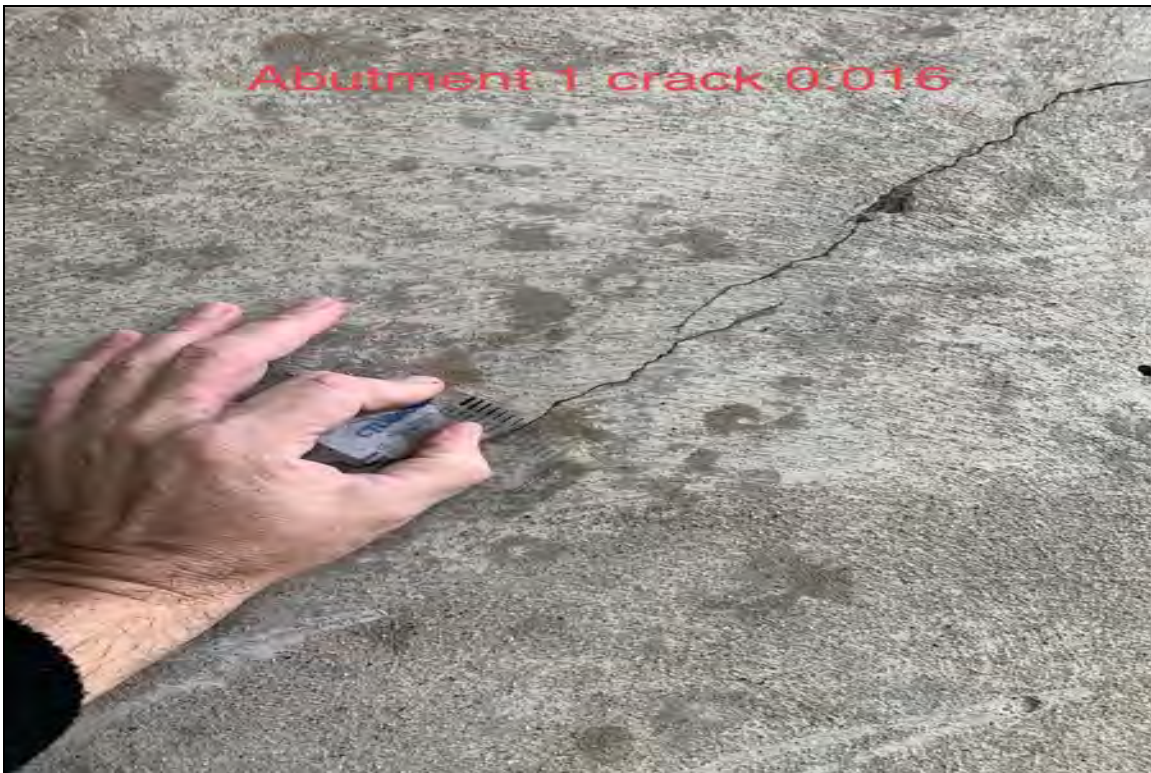
Abutment 1 crack 0.016

Abutment 1 crack .016

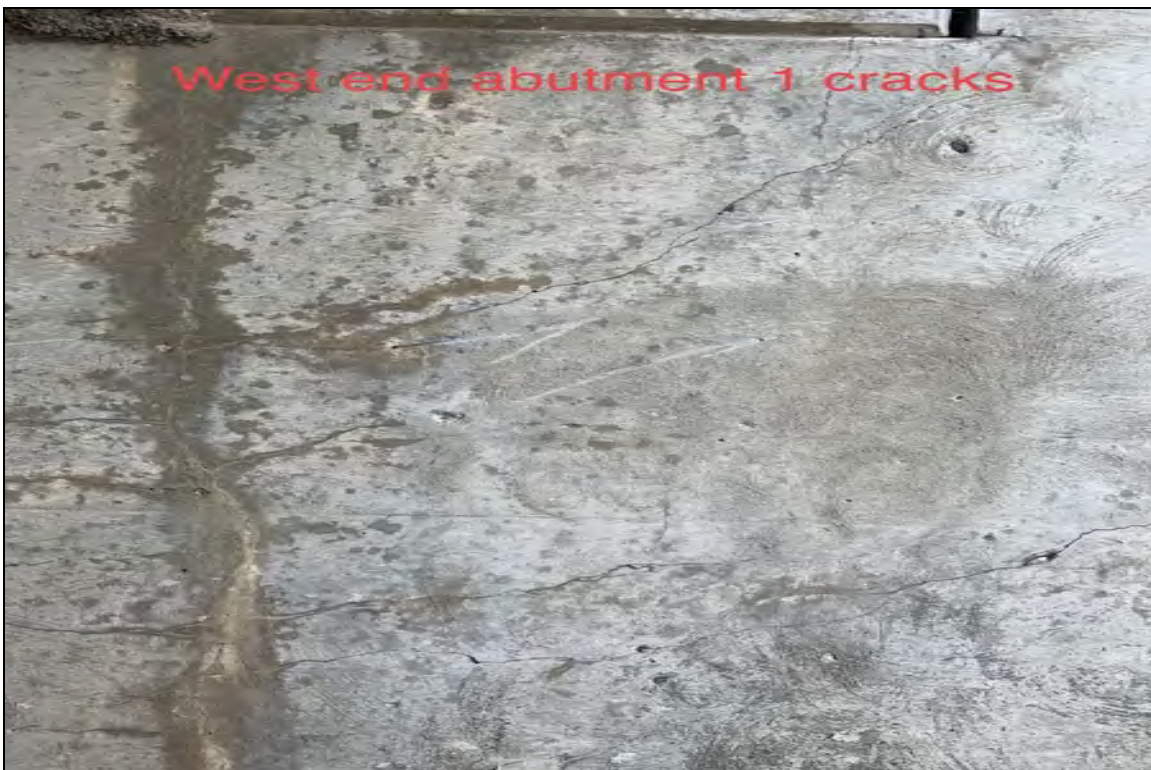
West end abutment 1 cracks

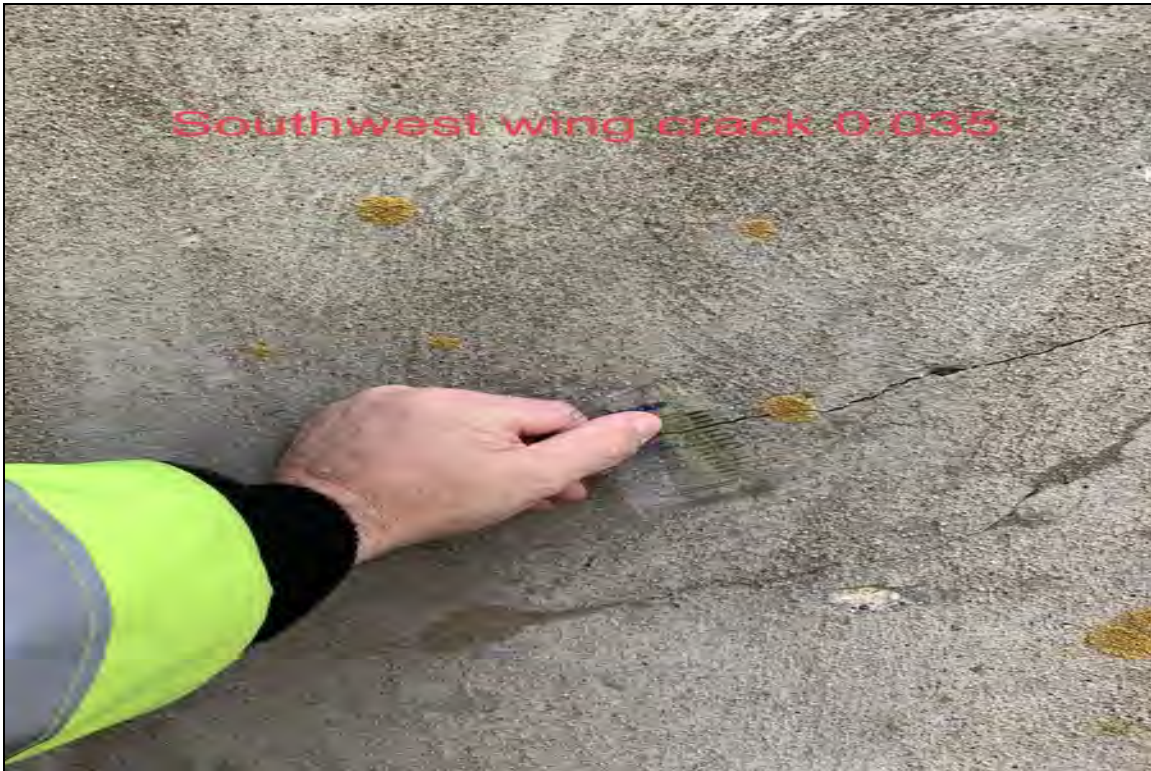
SW wing cracks .035

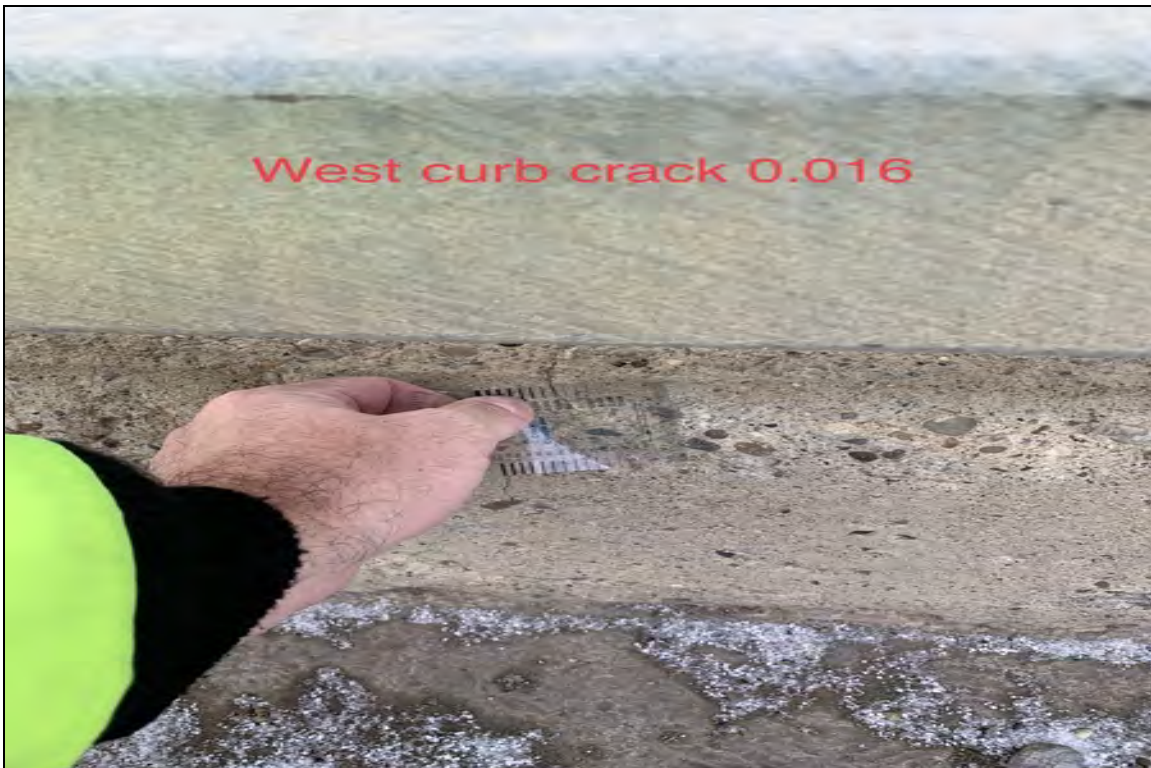
West curb crack .016

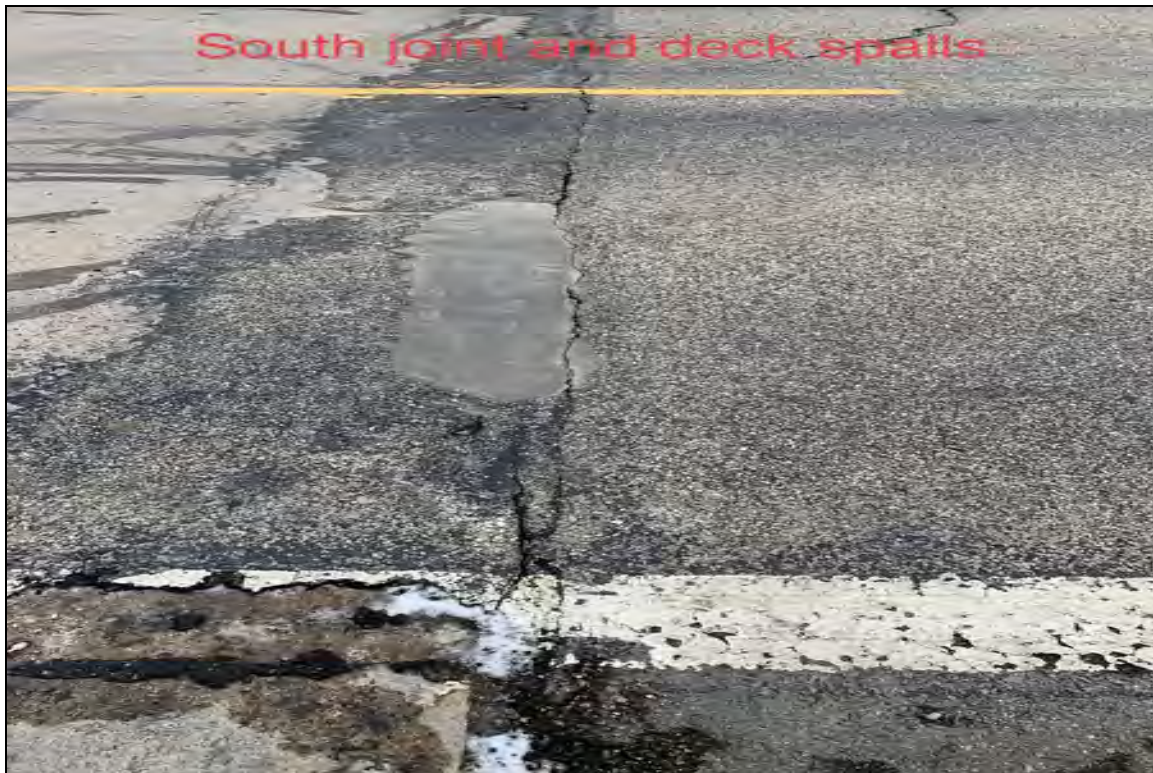
South joint and deck spalls

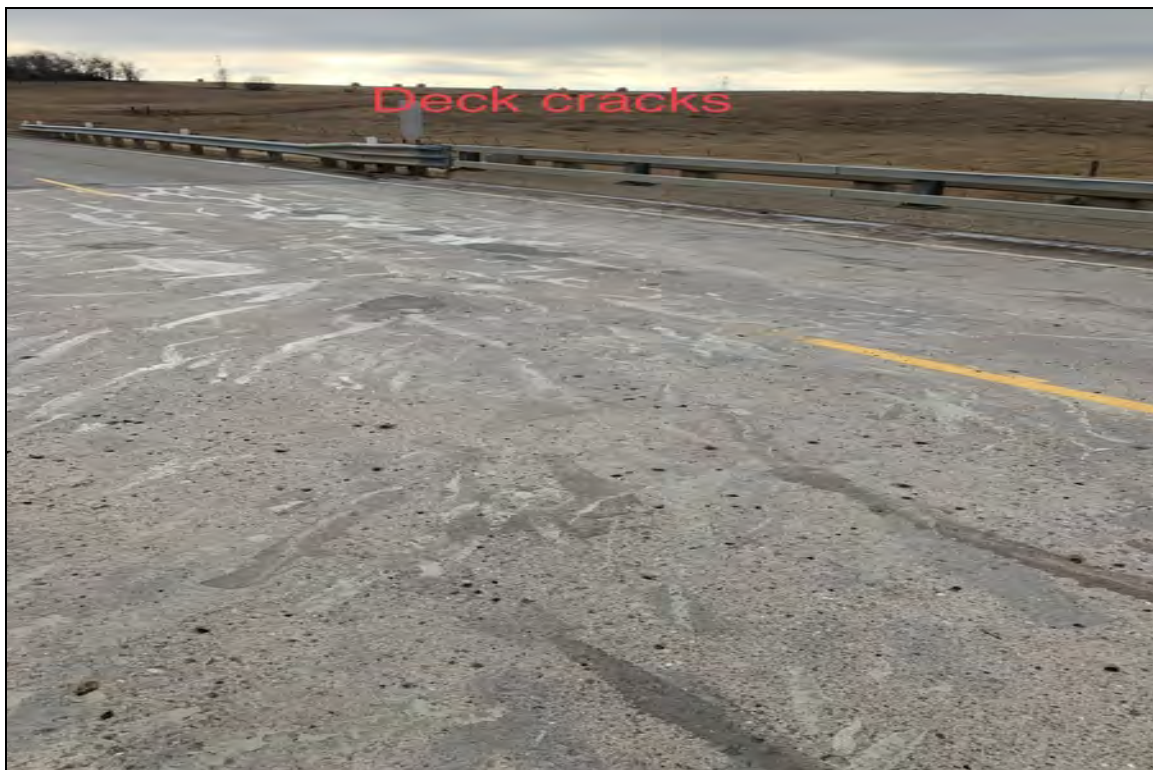
Deck cracks

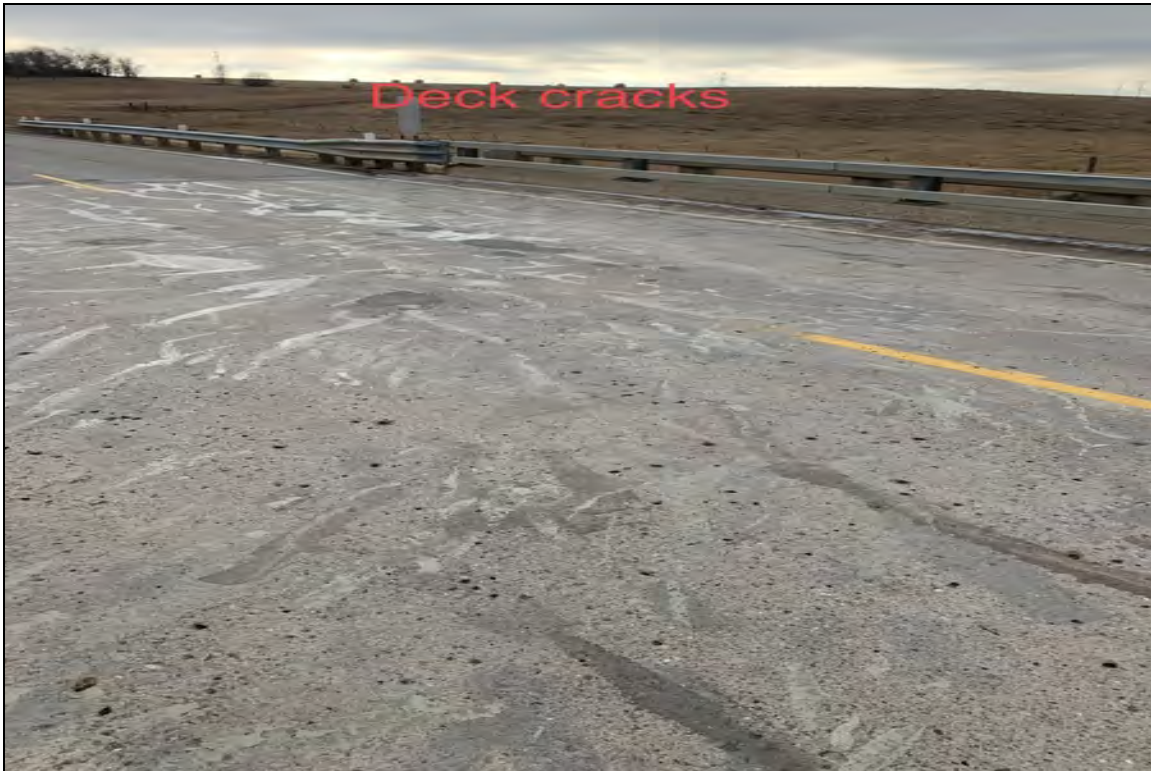
Deck cracks

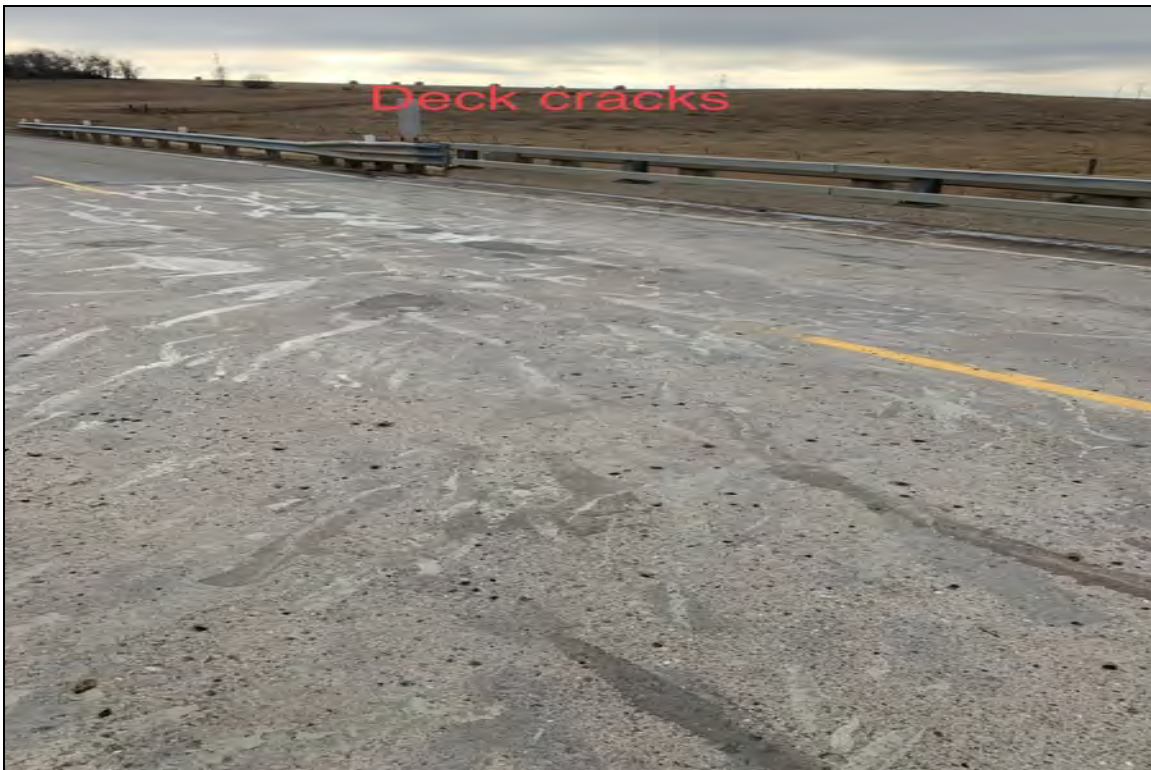
Deck cracks

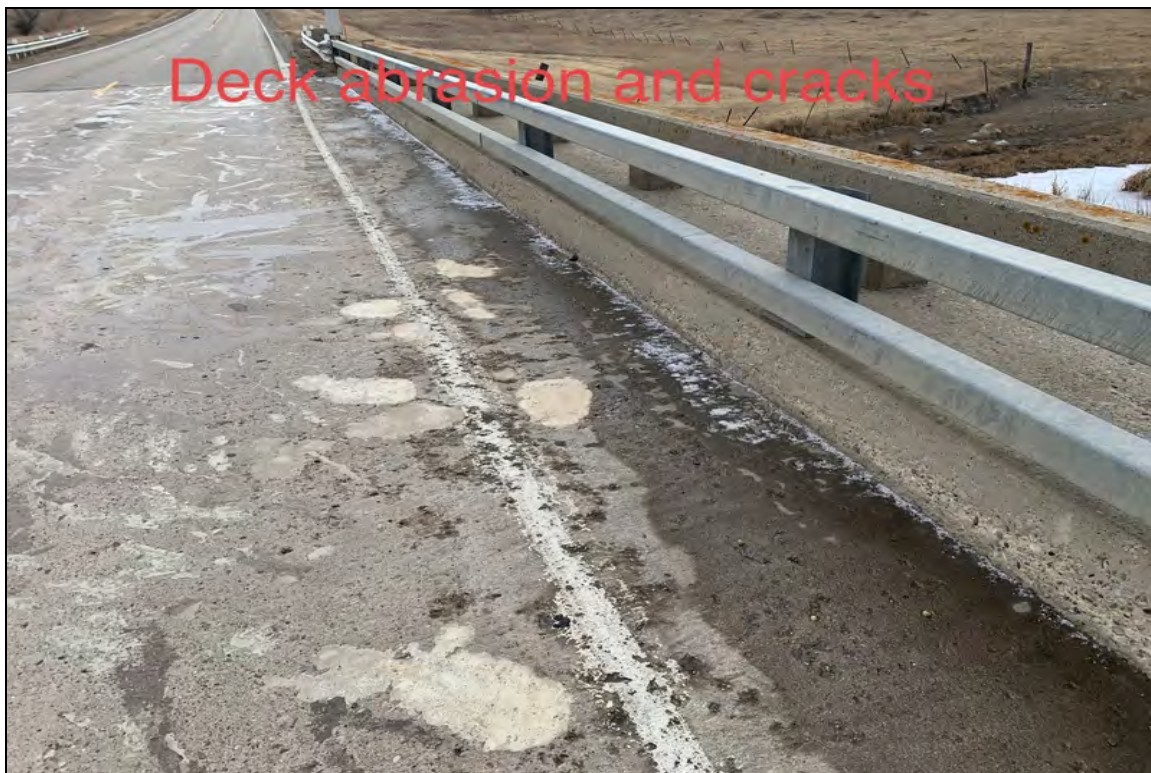
Deck abrasion and cracks

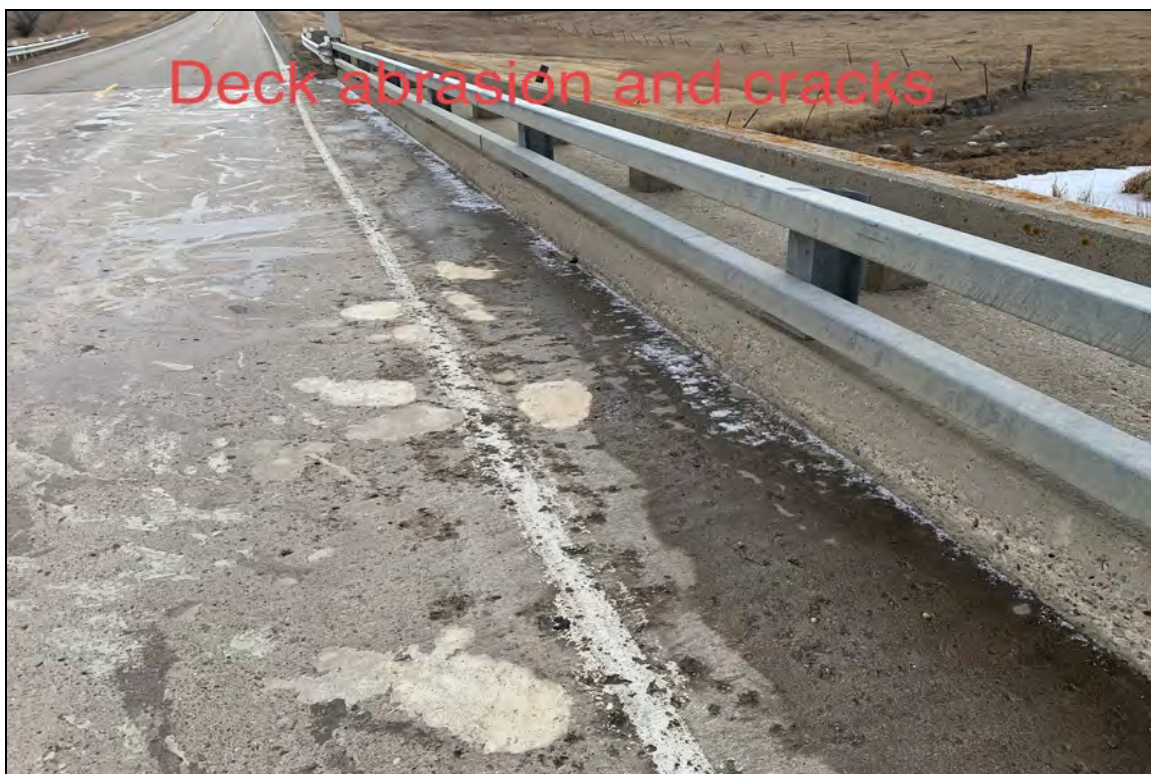
Deck abrasion and cracks

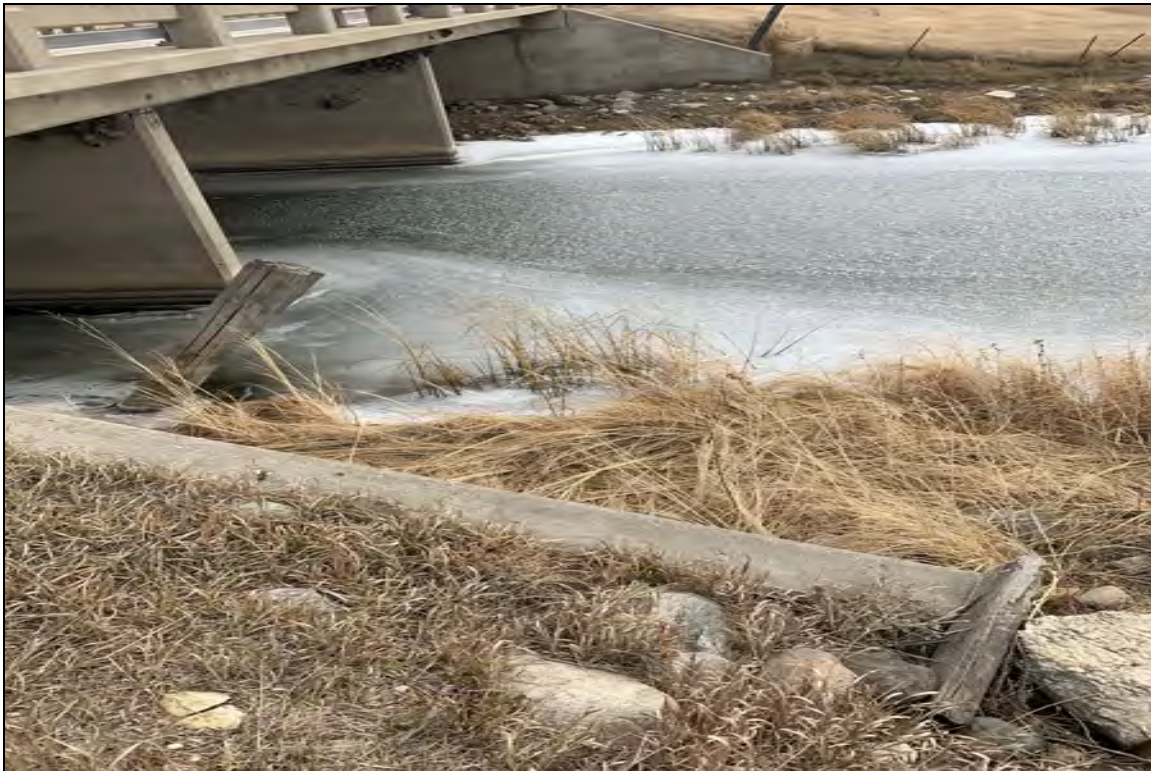
Channel profile not completed do to iced over channel 11/16/2020

Iced up channel

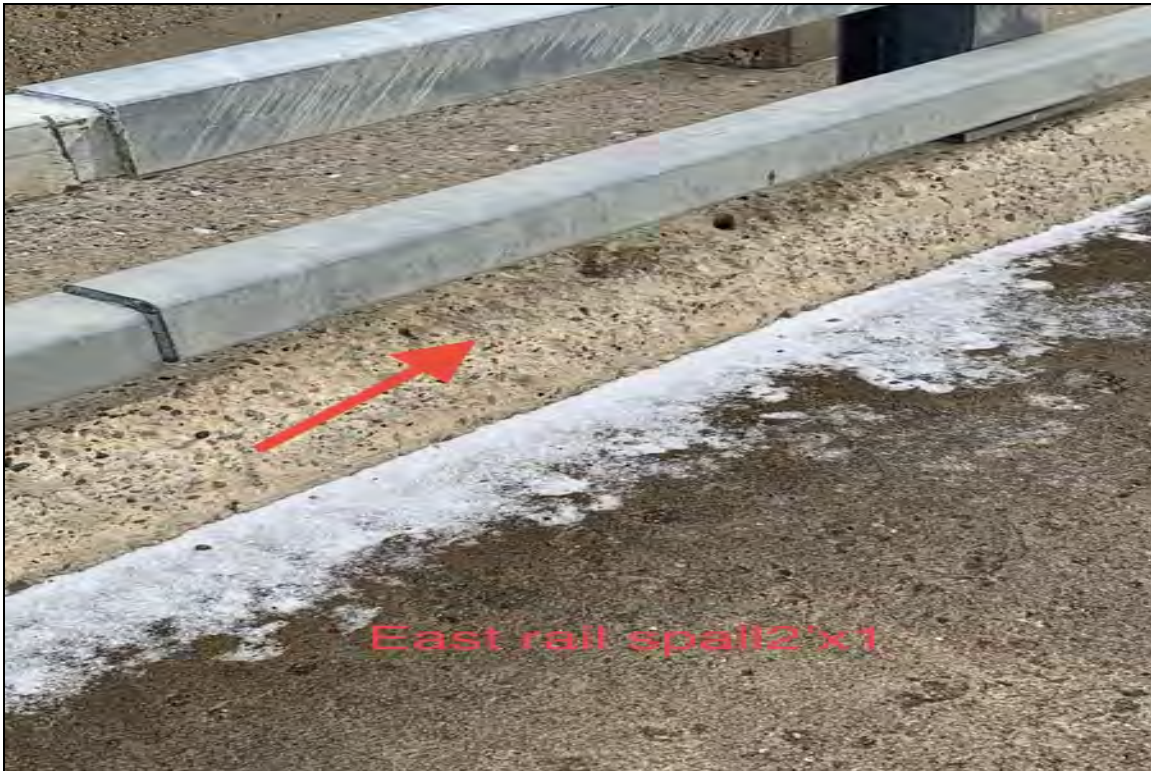
East curb spall 2'x1'

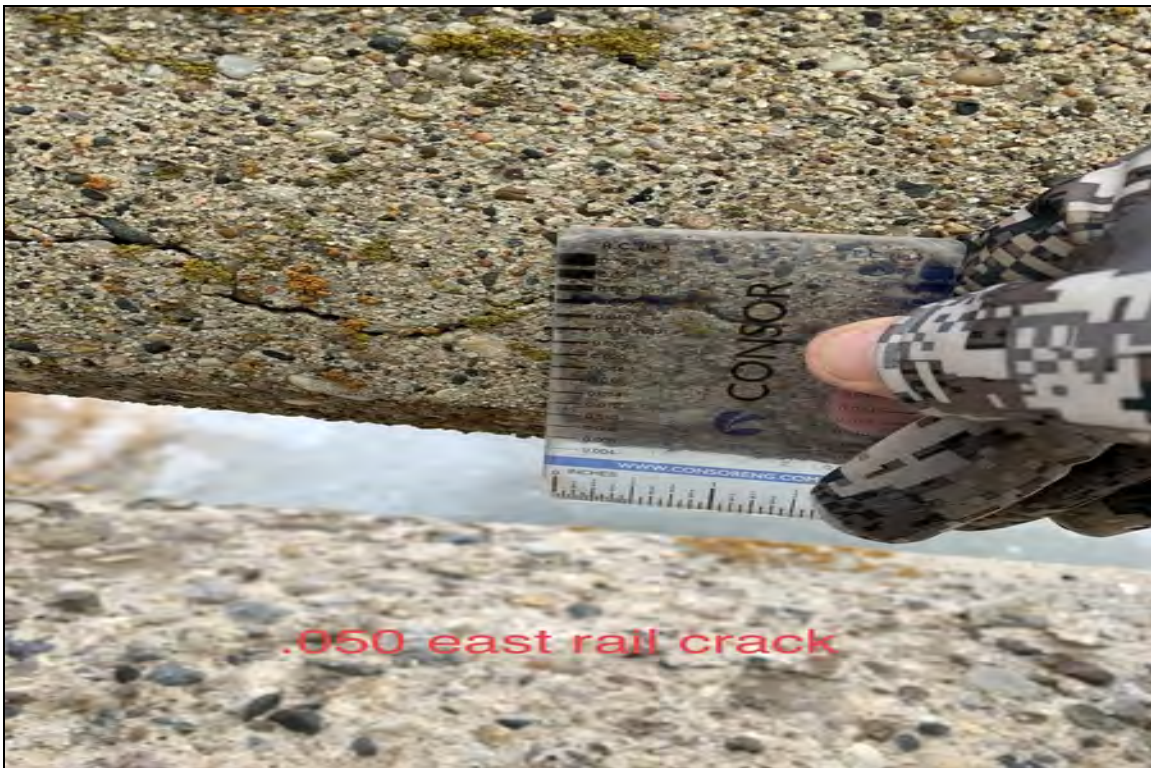
.050 east rail crack

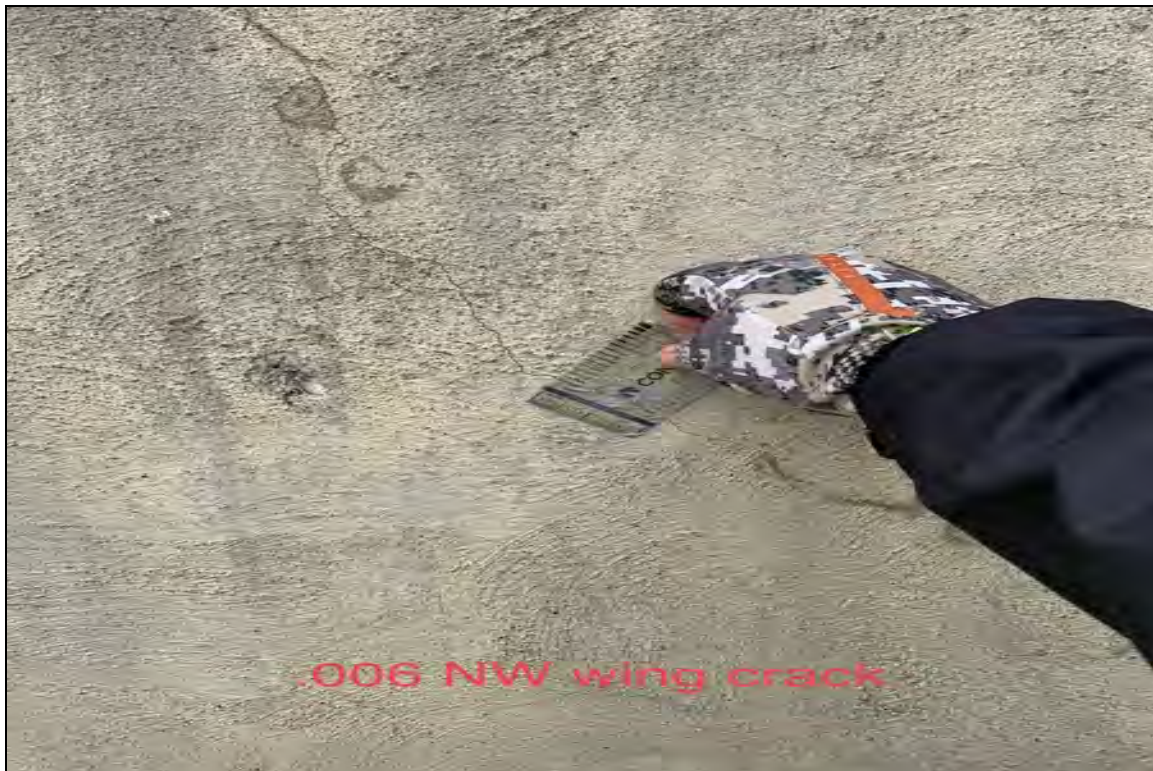
.006 NW wing crack

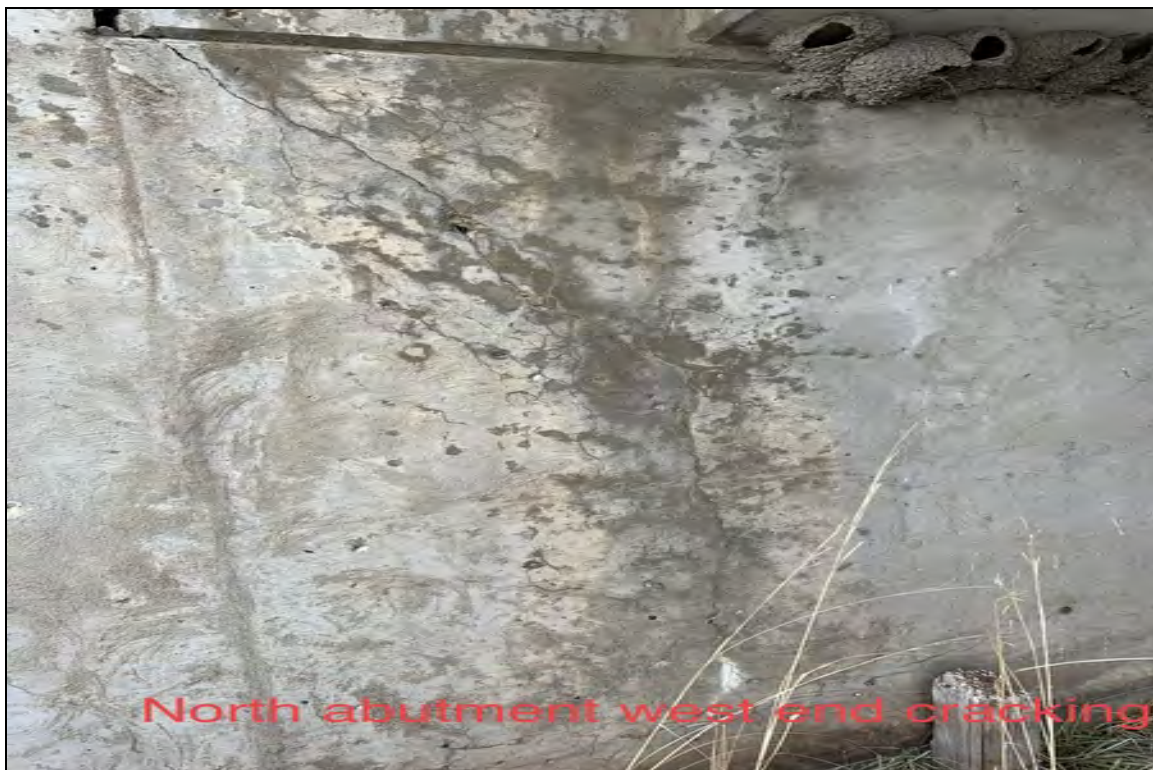
North abutment west end cracking

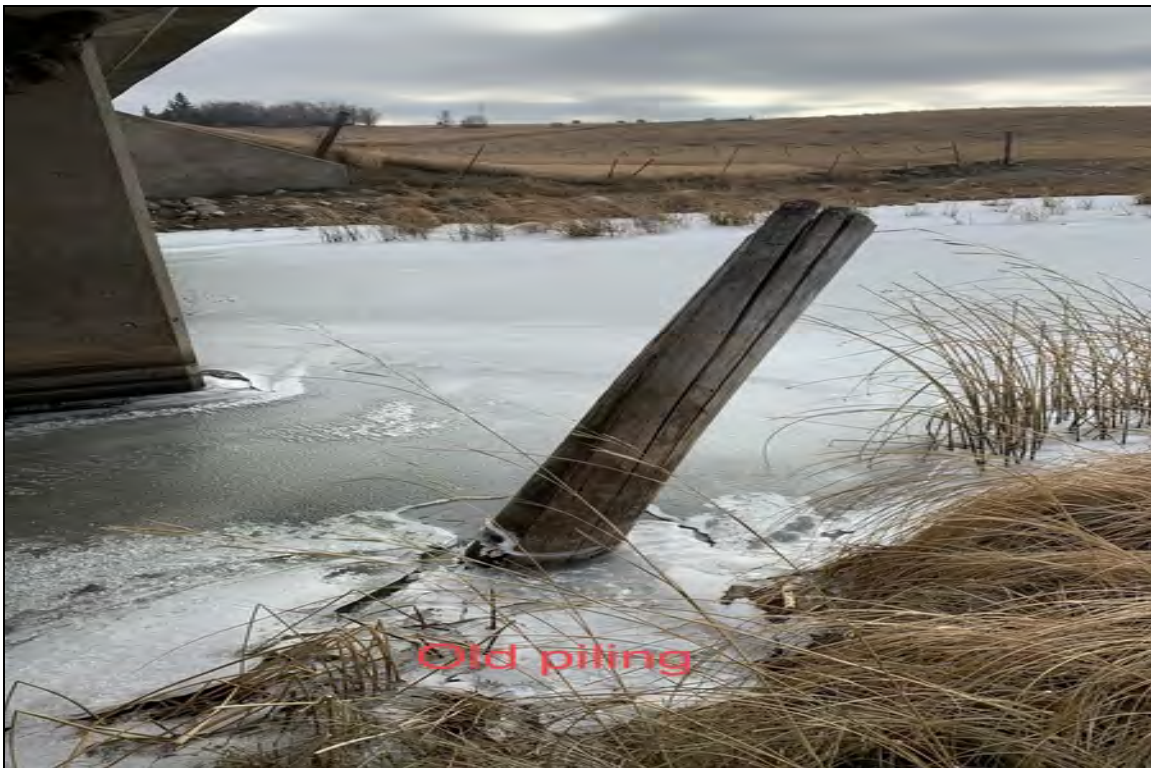
Old piling

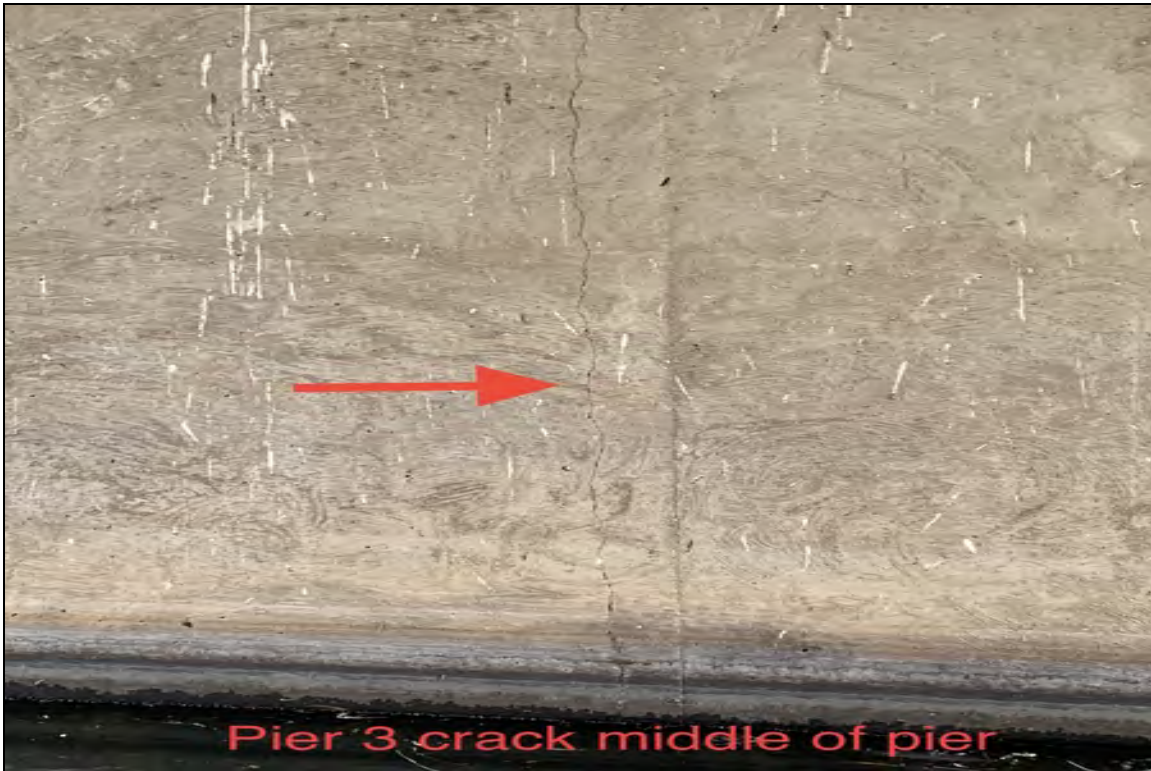
Pier 3 crack middle of pier

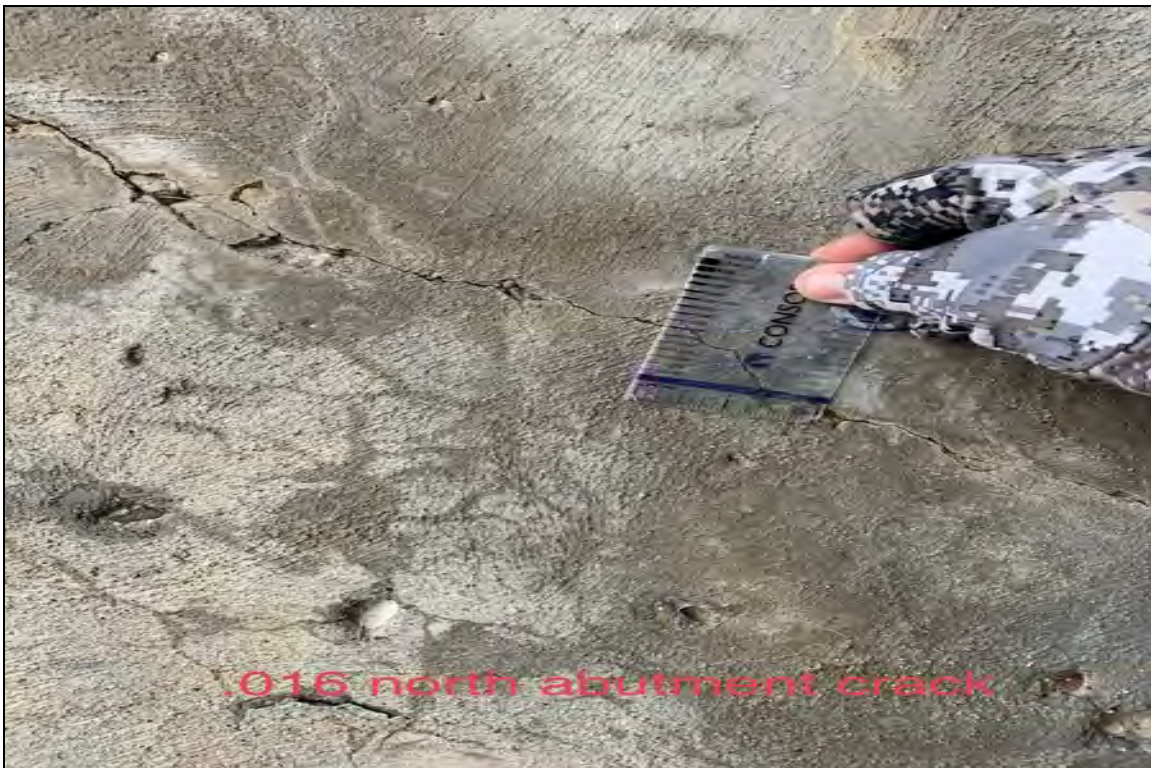
.016 north abutment crack

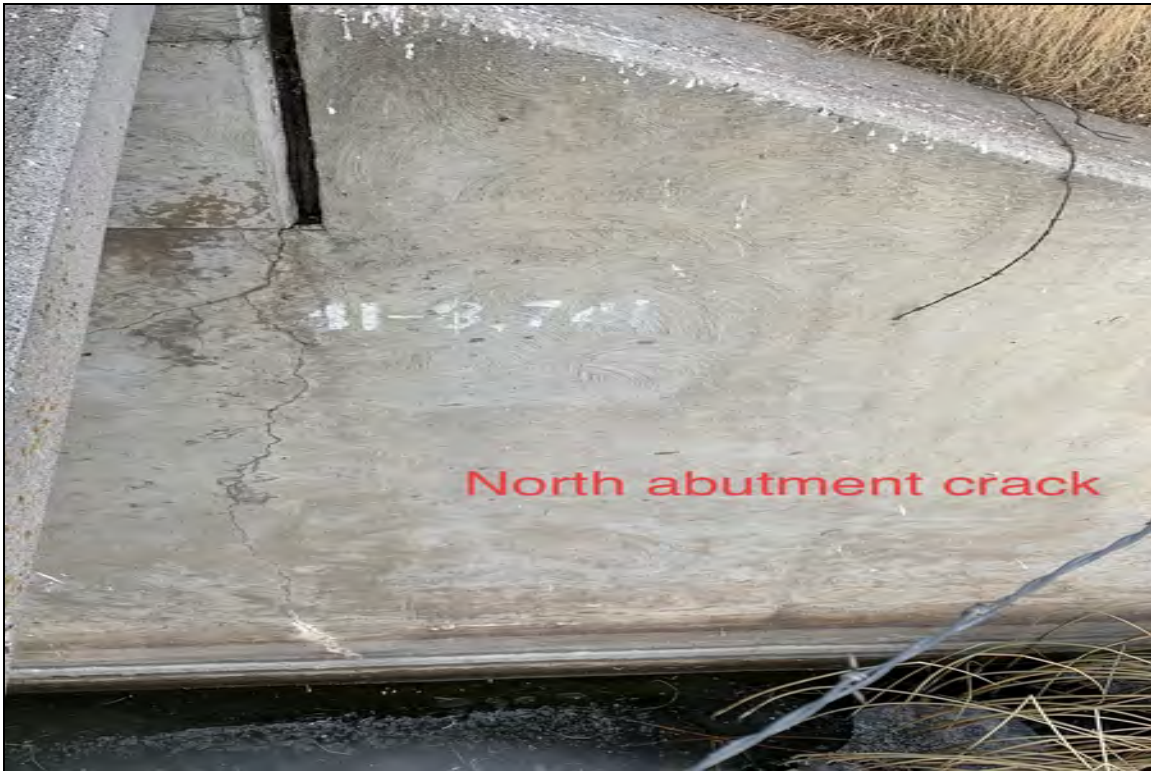
North abutment crack east end

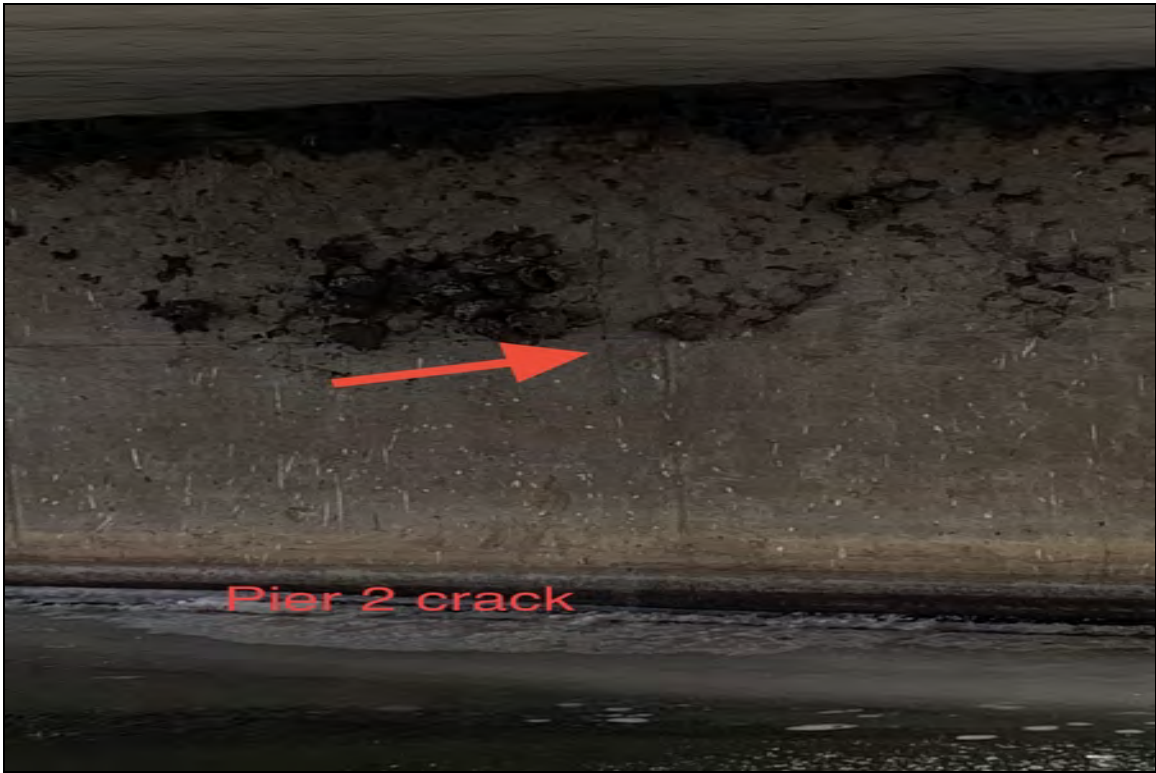
Pier 2 crack
