### STRUCTURE INVENTORY AND APPRAISAL SHEET

ITEM 10-145-08-1 02 HIGHWAY DISTRICT **GRAND FORKS** CAVALIER MAINLINE ON 03\_ COUNTY GINV. ROUTE FEATURES INTERSECTED OB STRUCTURE NO. 09 LOCATION CNTY HIWAY PEMBINA RIVER 145-08-1 5 EAST OF VANG BYPASS DETOUR LENGTH OWNERSHIP FUNCTIONAL 4 MILES 22 26 COUNTY AGENCY LOCAL 27 YEAR BUILT 28 LANES ON STRUCTURE BUILT 1919; NO RECONST 29 30 ADT 20 1987 YEAR OF ADT DESIGN LOAD APPROACH ROADWAY WIDTH 31 UNKNOWN 32 12 FEET O DEG 34 SKEW 34 SKEW
36 TRAFFIC SAFETY FEATURES
41 STRUCTURE OPEN, CLOSED OR POSTED
42 TYPE OF SERVICE
43 MAIN STRUC. TYPE
45 NO. SPANS IN MAIN UNIT
46 NO. APPROACH SPANS
47 TOTAL HORIZ. CLEARANCE
48 LENGTH OF MAX SPAN
49 STRUCTURE LENGTH
50 SIDEWALK WIDTHS
51 BRIDGE RDWY. WIDTH - CURB TO CURB
52 DECK WIDTH 0111 POSTED HIGHWAY OVER WATERWAY STEEL THRU TRUSS 15.8 FEET 100 FEET 130 FEET NONE NONE 15.8 FEET 17.8 FEET 14.06" NOT APPLICABLE 51 52 DECK WIDTH MIN. VERT. CLEARANCE OVER BRIDGE ROWY

# TRUSS BRIDGE REPORT

CO. BRIDGE NO. 1415-8.1
COUNTY CAUGITEY LOCATION North Olga Township FEATURE CROSSED PEMBINA ROVER YEAR BUILT	BRIDGE NO
FEATURE CROSSED PENDING ROVER YEAR BUILT	DATE INSPECTED 23 Ava 72
THROUGH TRUSS PONY TRUSS L= 13

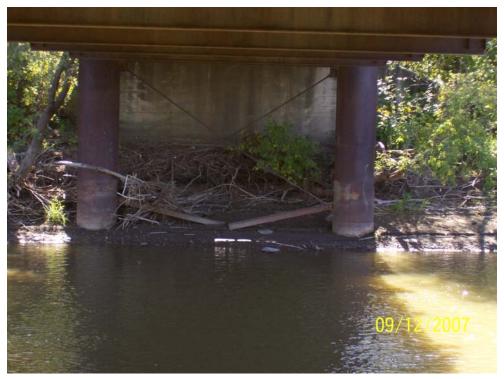
**South pier crossframe – bottom struct fractured**

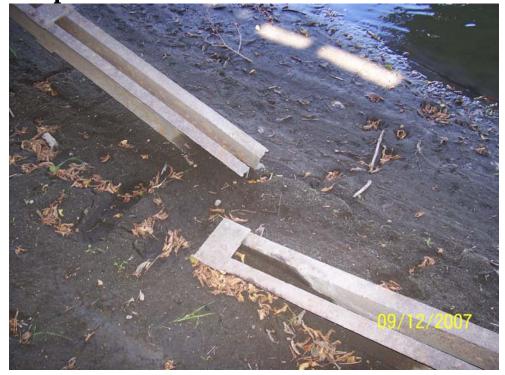
South pier cross-frame bottom strut fractured

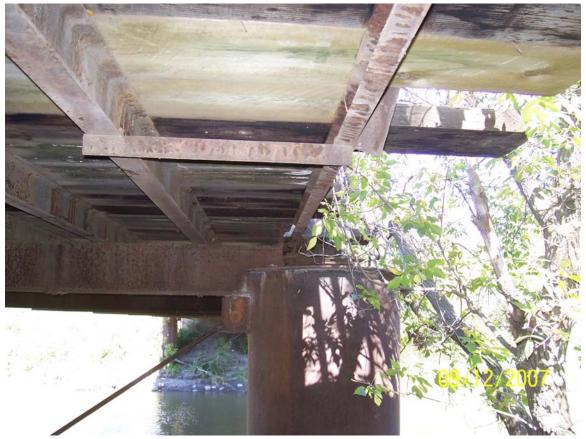
All 4 exterior channels on approach spans bent.

**Alert Code 2:** Southwest abutment wing badly cracked and leaning inward. Outside stringers both approach spans leaning out due to rail damage.

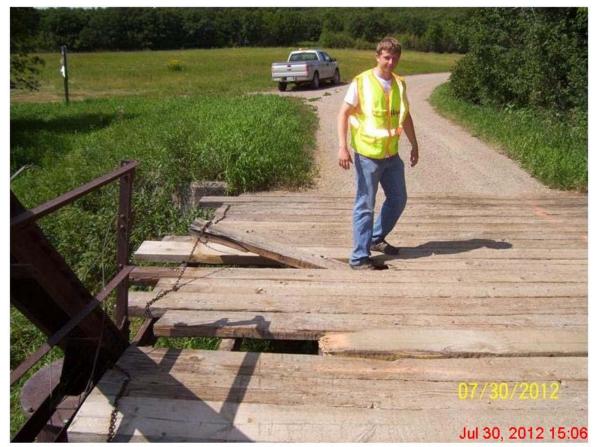
10-145-08.1 Broken Planks on Bridge Deck

9/16/14 - 300 ft of new bridge planks at various locations.

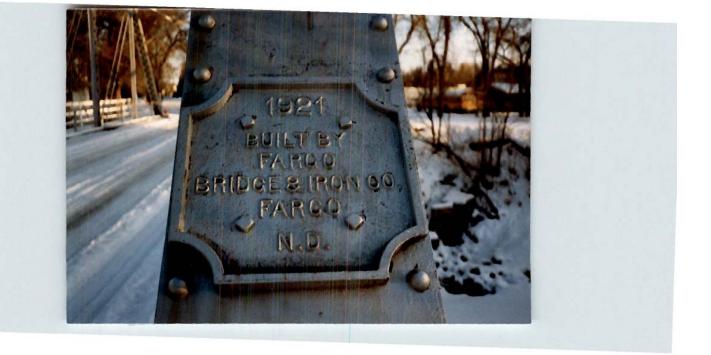
BRIDGE NUMBER 25-106-40.0  DATE OF PHOTO 1/4/89  DIRECTION  COMMENTS Manufacturers plate  Thus bridge
