Experimental Study ND 2002-02

**Performance of HBP vs. PCC Pavement**

**Fifth Evaluation**

Project NH-8-013(030)380

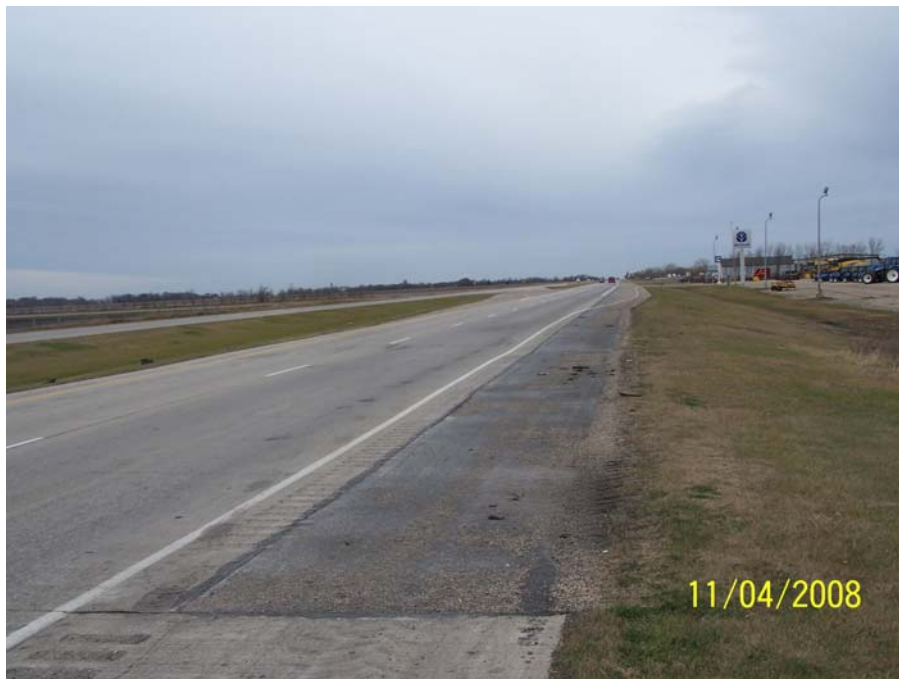
Segment 2 did not show any distresses on the PCC. The asphalt shoulders were starting to show some distress near an implement dealership. Other than the shoulder showing some distress Segment 2 had no other visible distresses.

**Photo 1 – Asphalt shoulder near implement dealership at transition between Segments 2 and 3.**

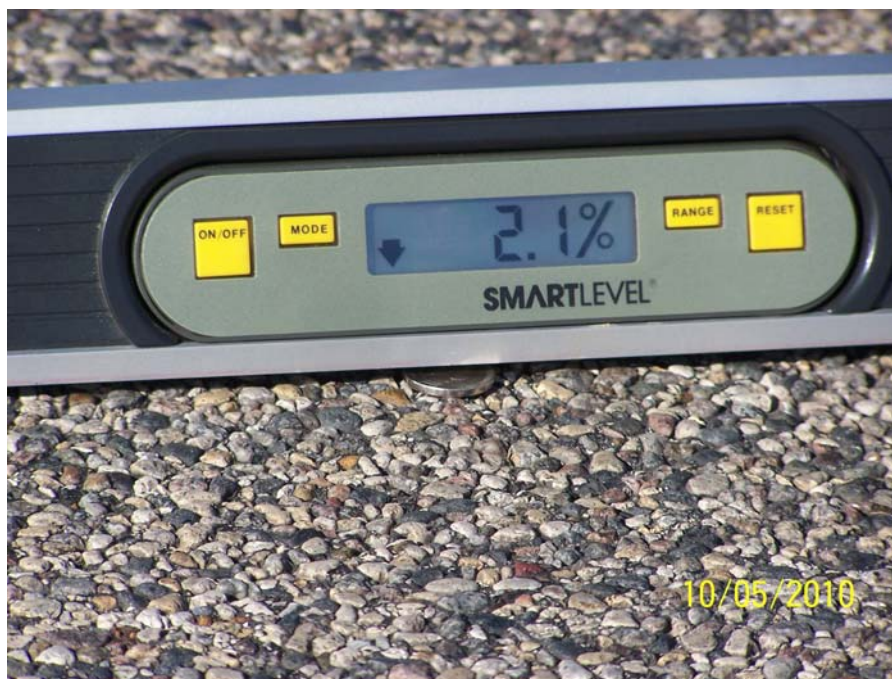
The fourth evaluation was conducted October 5, 2010. Segment 1 had noticeable wear in the chip seal which was installed in 2005. A majority of the wear in the chip seal is occurring in the wheel path. Materials and Research physically measured rutting using a seven foot metal straight edge. Rutting in the wheel path measured 1/16<sup>th</sup> to 1/8<sup>th</sup> of an inch and was checked every half mile throughout Segment 1. There were also 12 transverse cracks in Segment 1.

**Photo 1: Rutting in a wheel path in the driving lane of Segment 1.**

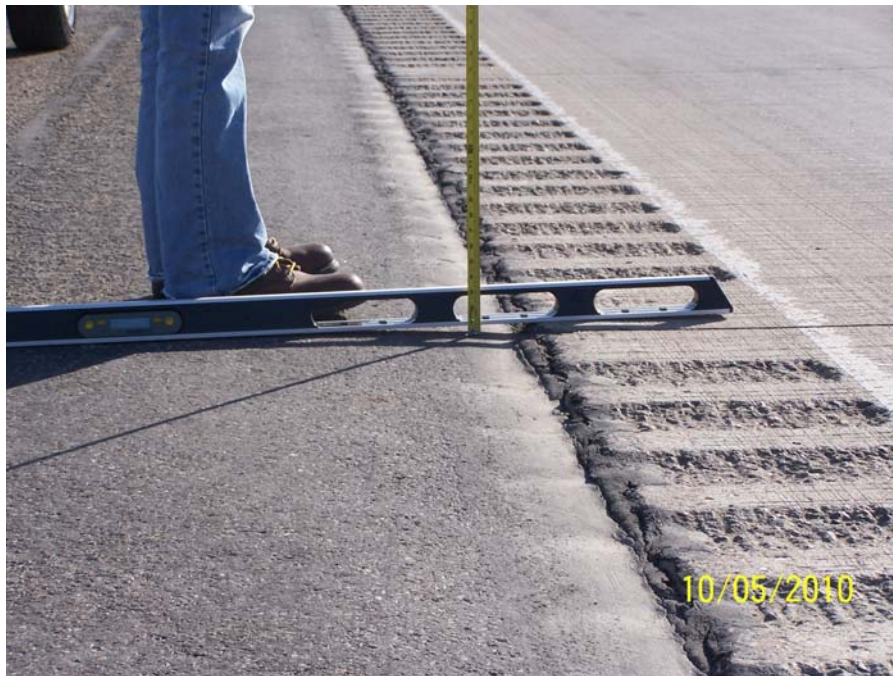
Segment 2 has a noticeable dip in the shoulders on each side of the box culvert located in this segment. It has two new transverse cracks near the transition from Segment 3 to Segment 2. The asphalt shoulders have settled approximately ½ inch throughout the section. A longitudinal crack is located 800' east of the Wild Rice Bridge in Segment 2.

**Photo 2 – Settling of the asphalt shoulders in Segment 2.**

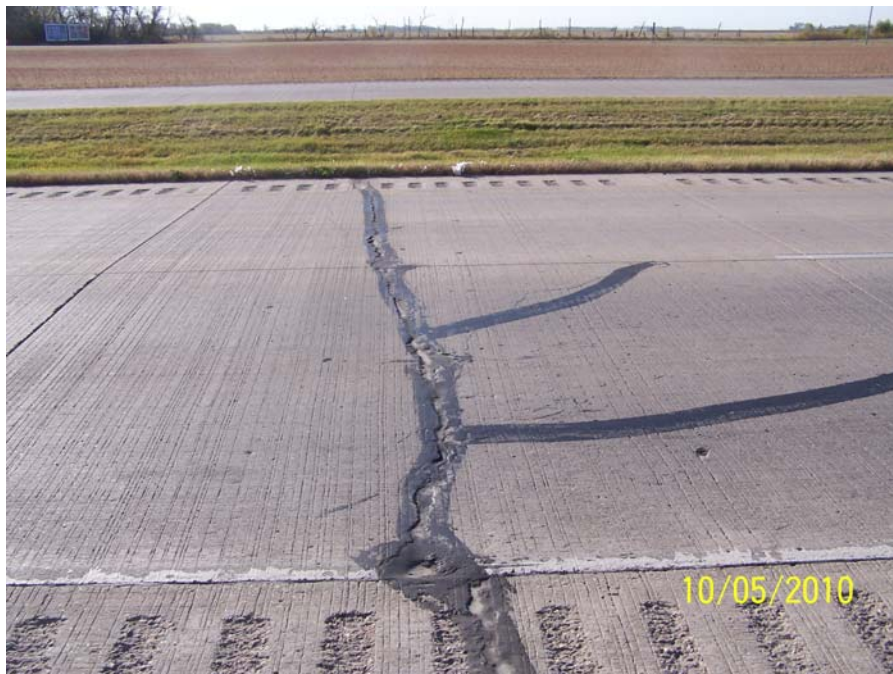
Segment 3 has one new transverse crack at station 20550+45 which was sealed. 4 small corner breaks and 3 edge line breaks have developed.

**Photo 3: Distress located in Segment 3.**

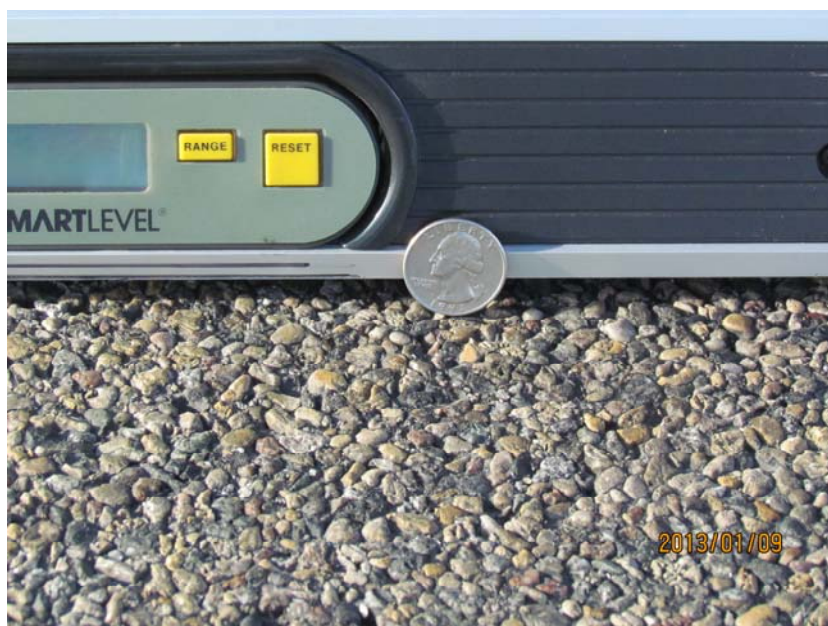
The fifth evaluation was conducted January 9, 2013. Segment 1 had noticeable wear in the chip seal which was installed in 2005. A majority of the wear in the chip seal is occurring in the wheel paths in both the driving lane and passing lane. Materials and Research physically measured rutting using a six foot metal straight edge every half mile throughout Segment 1. Rutting was observed in the driving lane, and there was a difference in the rutting from the right wheel path to the left wheel path. The rutting in the right wheel path ranged from  $1/8^{\text{th}}$  to  $1/4^{\text{th}}$  of an inch and the rutting in the left wheel path ranged from zero to  $1/8^{\text{th}}$  of an inch. Similar to the 2010 evaluation, there were also 12 transverse cracks observed in Segment 1.

**Photo 1: Rutting in a right wheel path in the driving lane of Segment 1.**

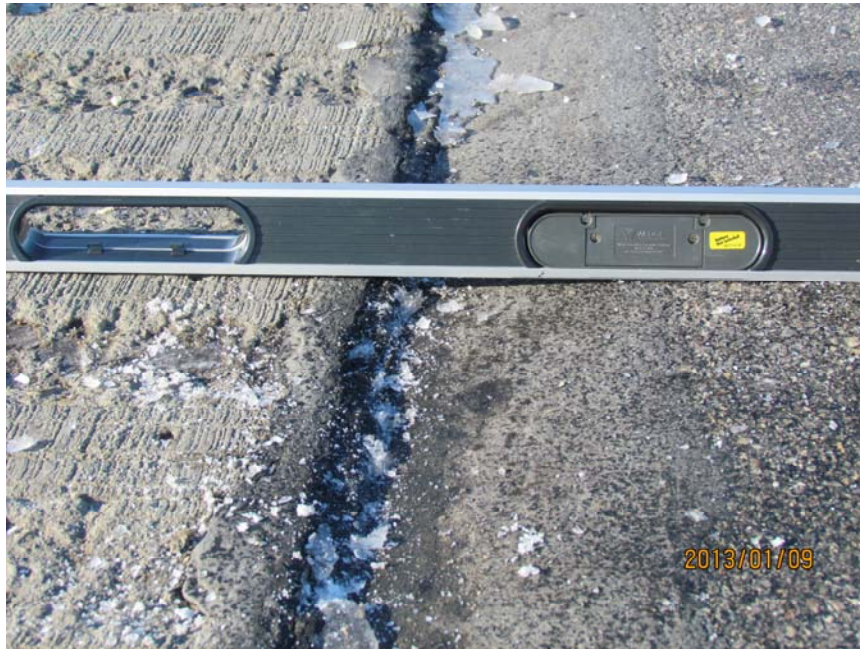
Segment 2 has a noticeable dip in the shoulders on each side of the box culvert located in this segment as in the 2010 evaluation. It has two transverse cracks near the transition from Segment 3 to Segment 2 as in 2010. The asphalt shoulders have settled approximately  $1/2$  inch throughout the section. One new longitudinal crack was observed about 900' east of the Wild Rice Bridge, along with the longitudinal crack observed in the 2010 evaluation. There was also one new transverse crack located near the east

**Photo 2 – Settling of the asphalt shoulders in Segment 2**

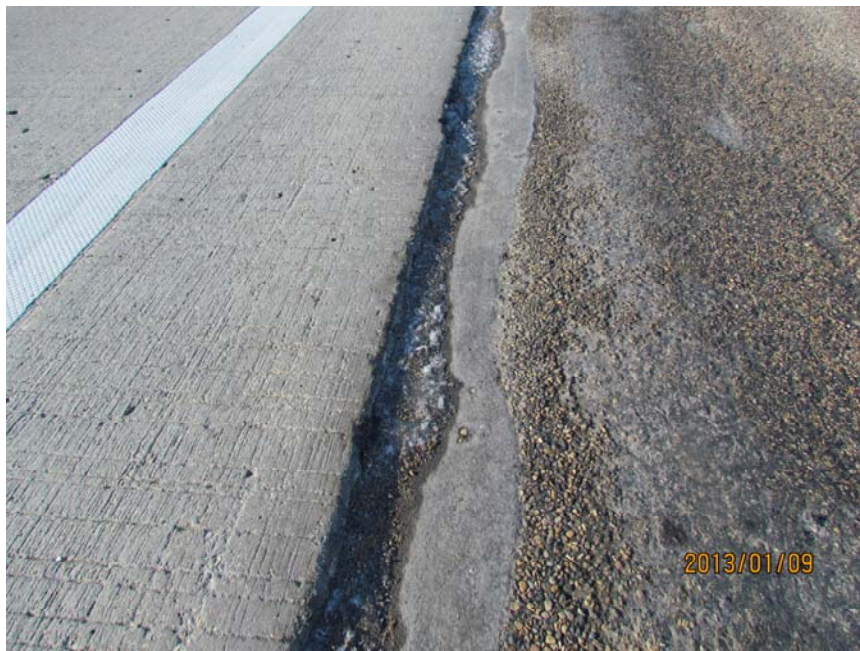
end of the Wild Rice Bridge in Segment 2. There was a HBP turning lane approximately at RP 386.6 that had settled about  $\frac{3}{4}$ <sup>th</sup> of an inch below the PCC roadway, see photos 2 and 3.

**Photo 3 – Settling of the asphalt turning lane in Segment 2**

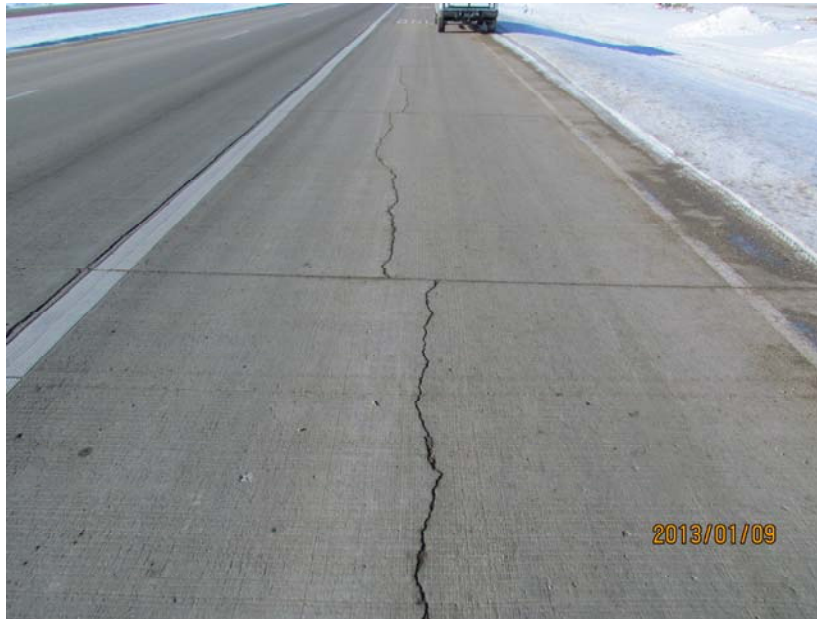
Segment 3 had the one sealed transverse crack as observed in 2010. There were also 5 edge line breaks and 5 small corner breaks observed throughout the section. At a turning lane located approximately at RP 388.4 it was observed that there is a new unsealed longitudinal crack spanning approximately 300' over the 330' turn lane.

**Photo 4 – Longitudinal crack in turning lane in Segment 3.**
