Experimental Study MR 97-01

**Practice of Unsealed Joints in New
Portland Cement Concrete Pavements**

Final Evaluation Report

January 2009

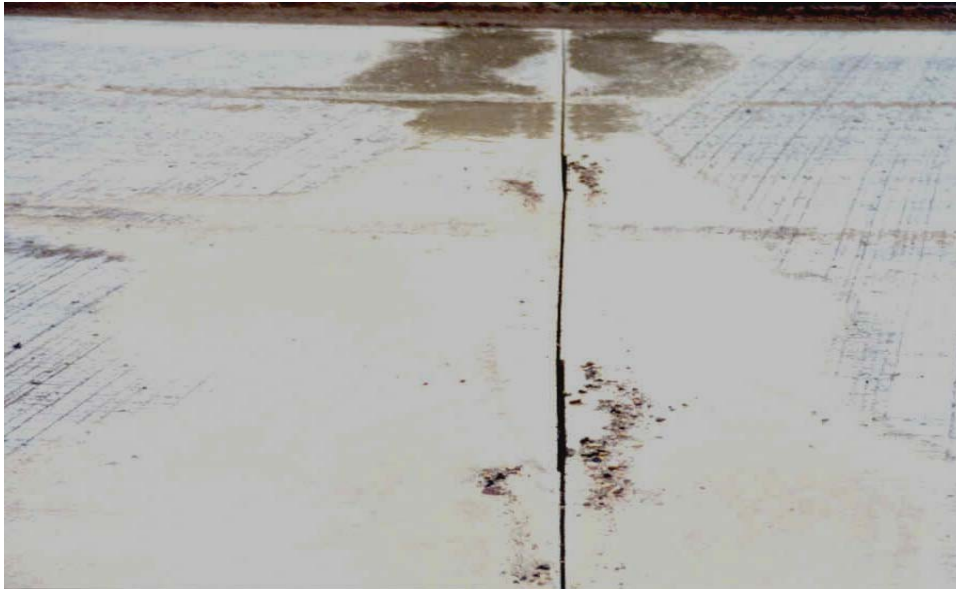
This condition is shown in photo 7. It appears from photo 7 that the individual saws were not completely in line while overlapping one another's cutting path. Notice also in photo 7 that the overlapping is causing medium sized chips to be dug out of the

PCC. The condition depicted in photo 7 has occurred in nearly every joint sawed and is present within each joint as many as three times.

Photo 7 - Extra wide segment caused by the contractors gang saws being out of alignment.

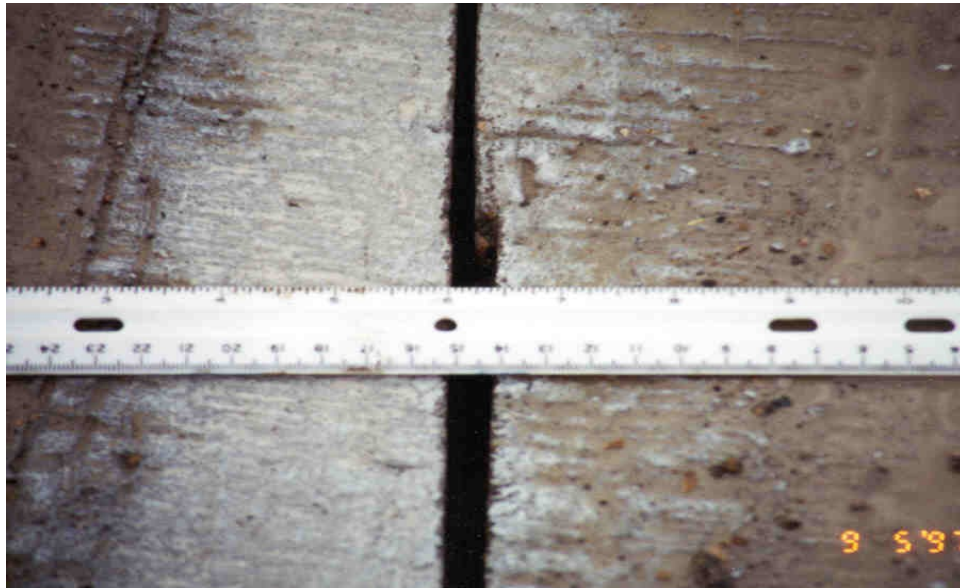
The extra width caused by the overlapping saws has been registered as wide as 1/2", as shown in photo 8. Project engineer Morris Evens (NDDOT) brought the sawing problems to the attention of the contractor.

Photo 8 - Some of the widened segments are as much as 1/2" wide.

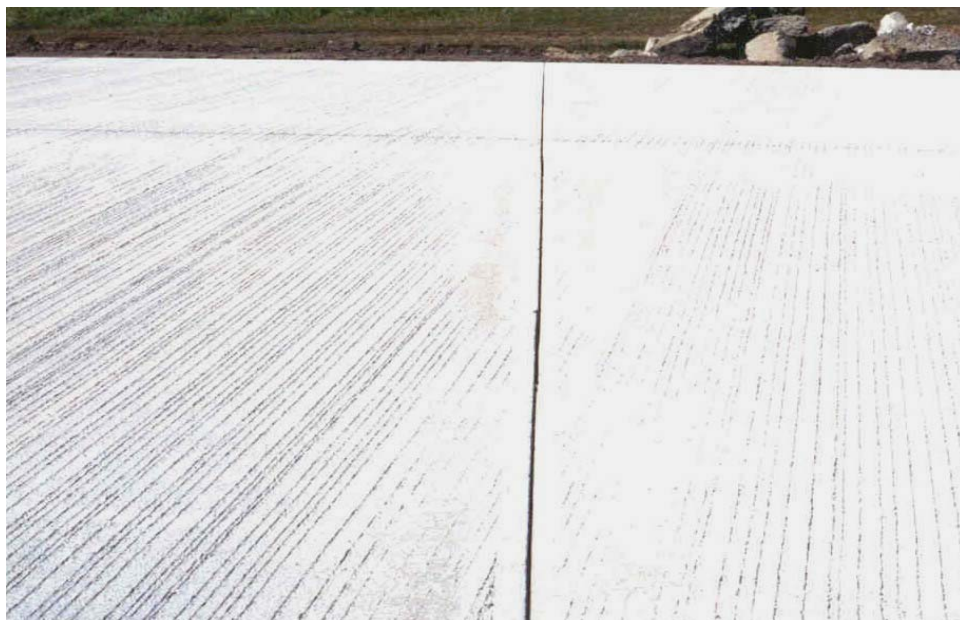
Photo 9 - Typical unsealed joint.

Photo 9 also depicts a view of a segment of the joint that appears wider than the rest of the joint. This extra wide segment of the joint is similar to the condition present in the Grand Forks test section and is present in virtually every joint. Photo 10 depicts a

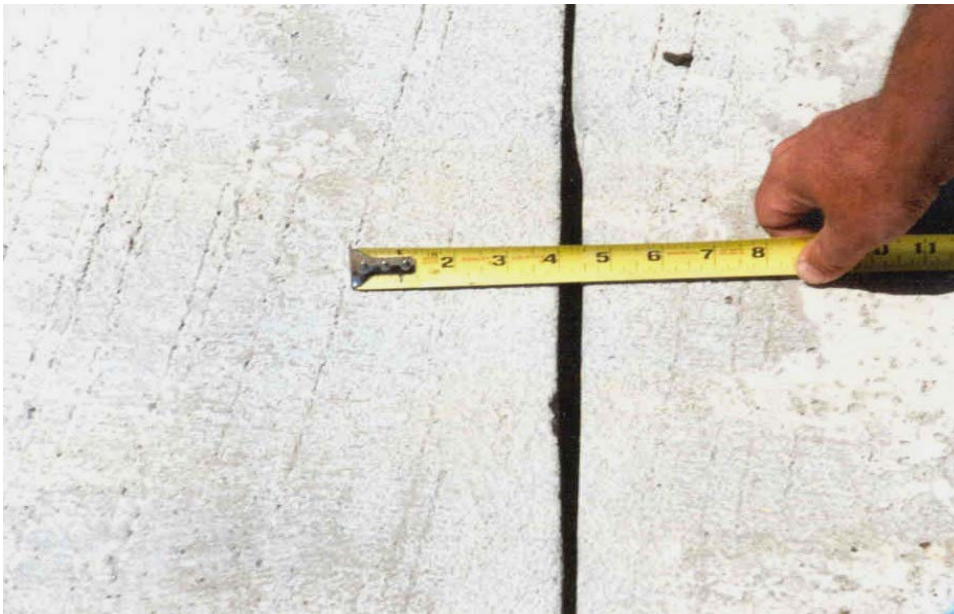
close-up view of one these extra wide segments. It appears that the extra wide segments are also at least 1/2" wide.

Photo 10 - Close-up view of an extra wide segment.

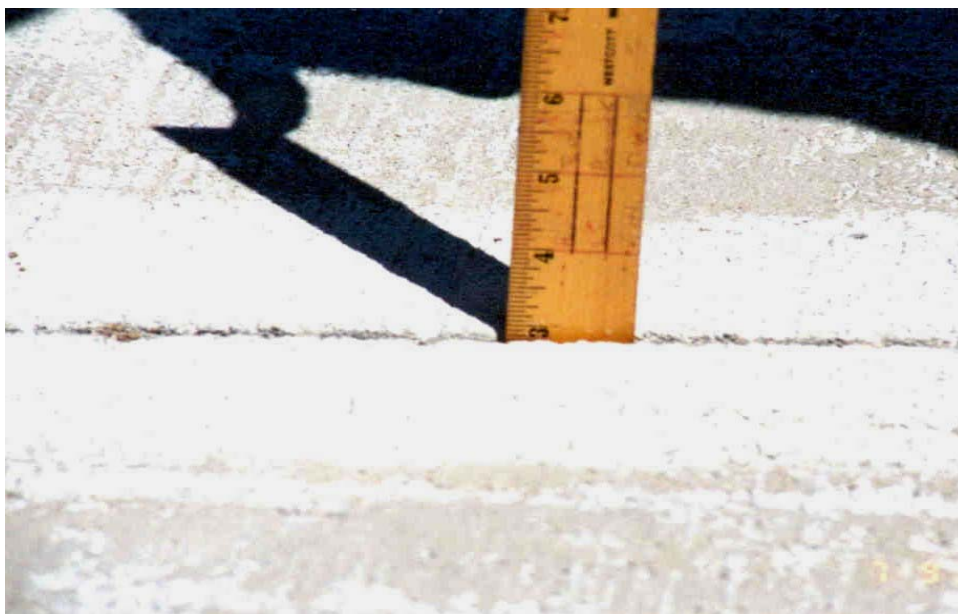
Insufficient depths were also recorded during initial observations at the Jamestown test section. Photo 12 shows the saw depth in the joint in question to be approximately 3". As previously mentioned, the planned saw depth on project IM-2-094(007)256 was T/3. The PCC pavement thickness on project IM-2-094(007)256 is 10".

Photo 12 - Saw depth of joint in question to be approximately 3".

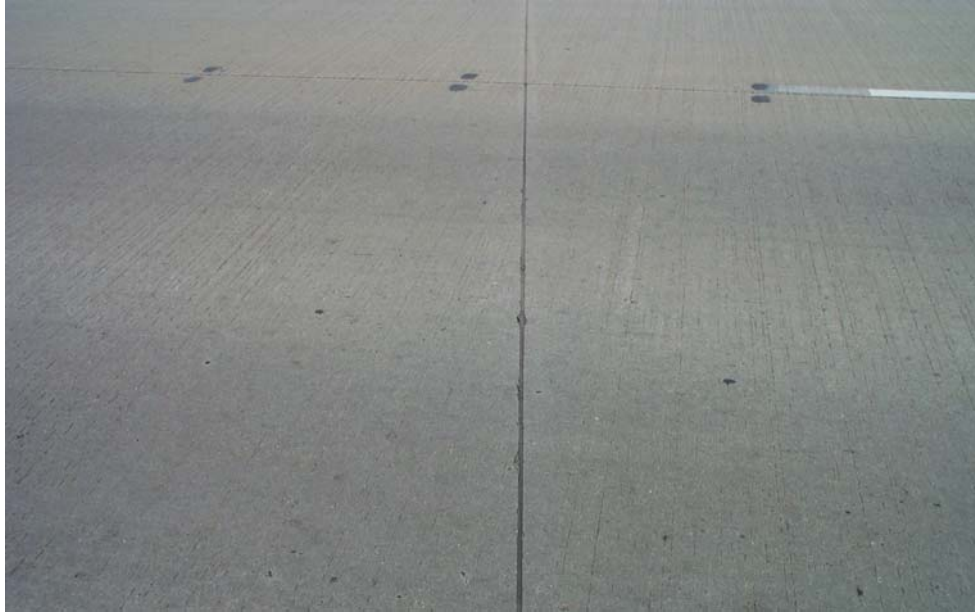
Photo 13 - Typical spalled joint in the sealed (control) section.

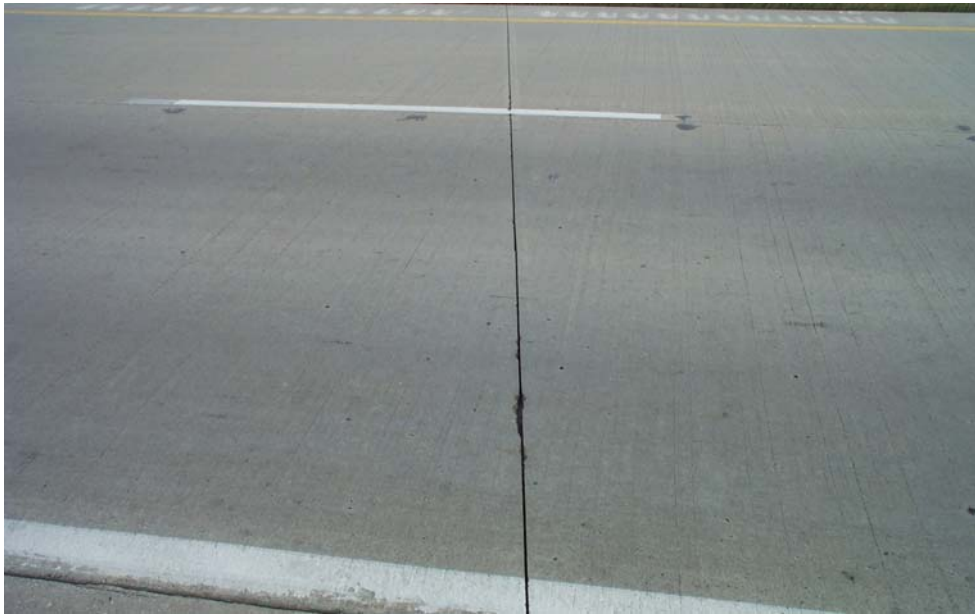
The unsealed joint section spalls tend to be more severe than the sealed joint section. Photo 13 shows a typical spalled joint in the control section. Photo 14 shows a typical spalled joint in the unsealed section and Photo 15 displays a joint with severe spalls.

Photo 14 - Typical spalled joint in the unsealed (test) section.

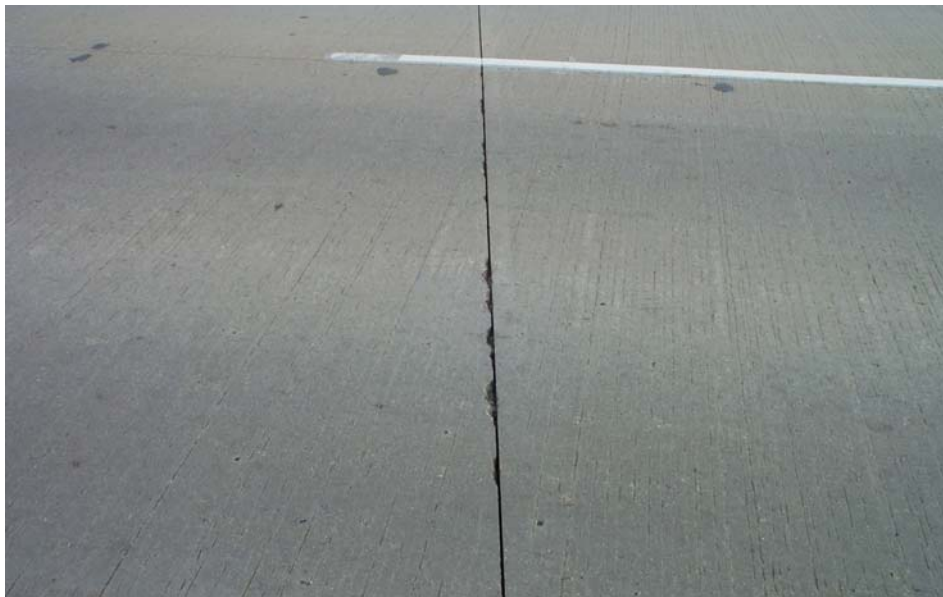
Photo 15 - Most severe spall in unsealed (test) section.

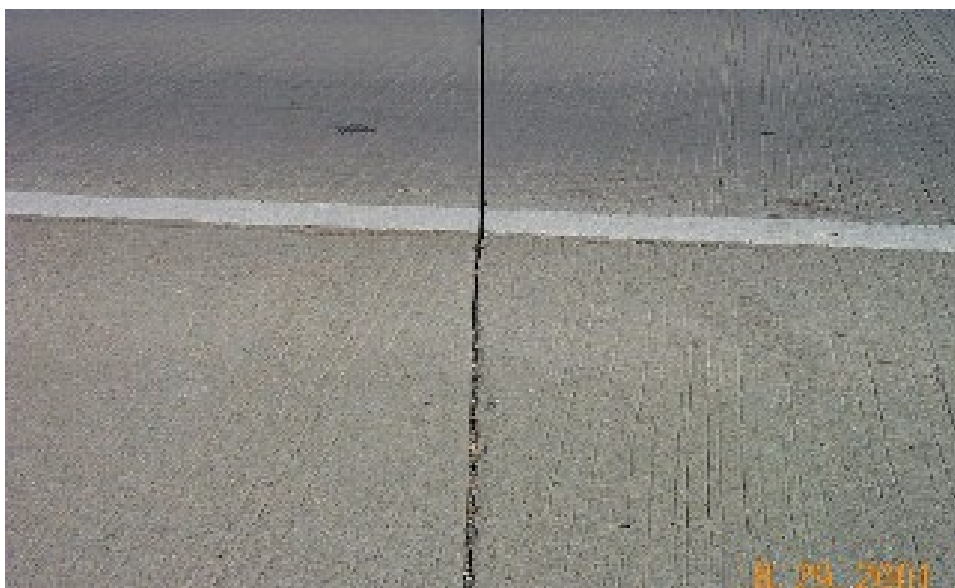
The amount of incompressible material in the unsealed joints are approximately 40-50% filled (depth) in the driving lane. The portion of the joint on the shoulder however, is full of incompressible material. The driving lanes may have remained relatively free of incompressible material due to differential air pressure caused by a vacuum created by the traffic. Photo 16 shows a comparison between the driving lane and the shoulder. This photo is from 2001 and the amount of incompressible material has not changed.

Photo 16 - Incompressible material in shoulder versus driving lane.

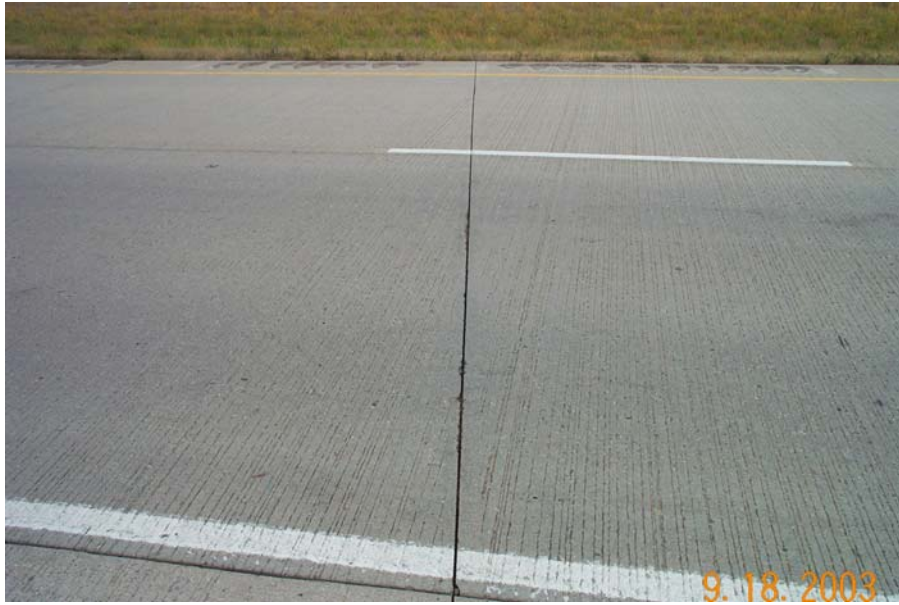
Photo 17 - Typical spalled joint in the test section.

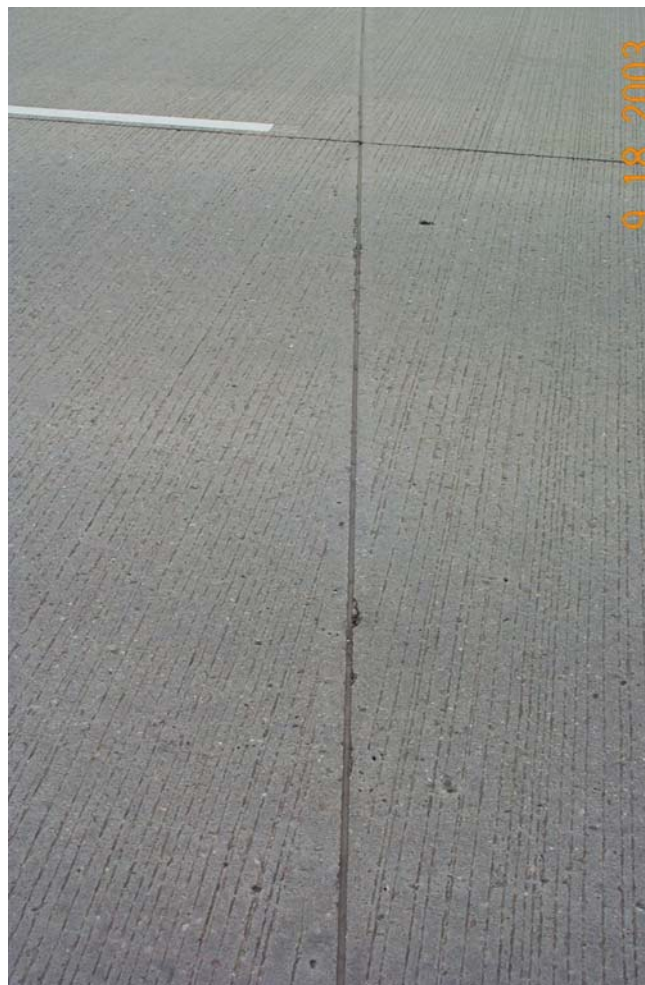
Photo 18 - Typical spalled joint in control section.

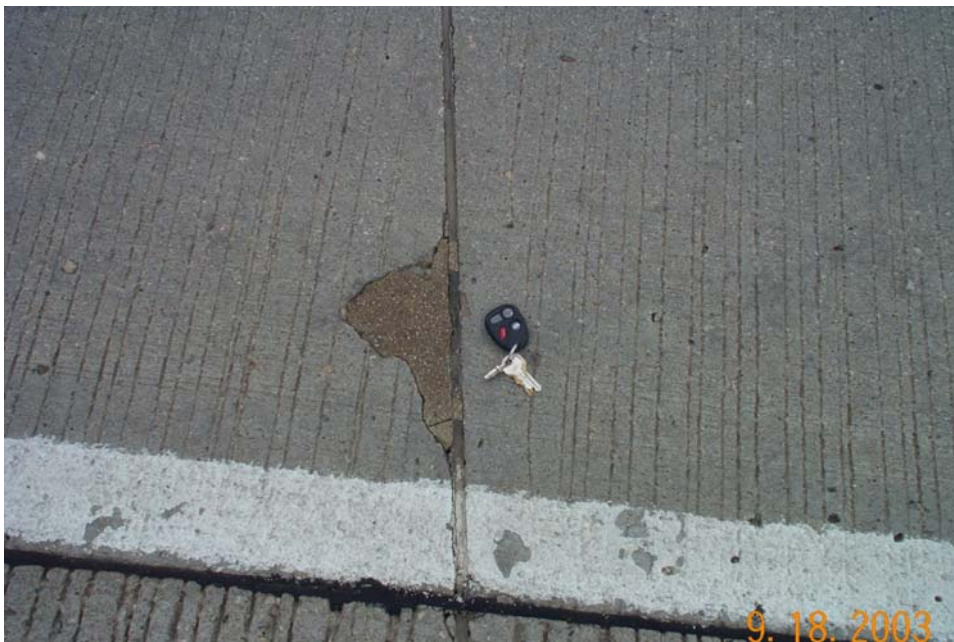
Photo 19 shows an attempt to patch a spalled area in the sealed section. There was also an area in the unsealed section that was repaired as well.

Photo 19 - Attempted spall repair in sealed control section.

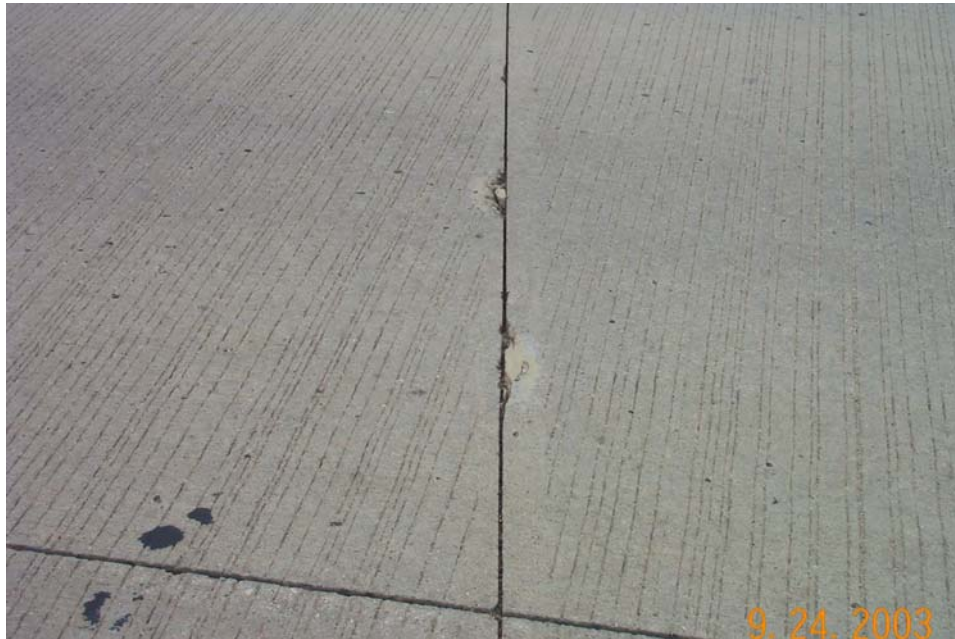
Photo 21 shows a spalled joint in the test section that was attempted to be repaired.

Photo 21 - Attempted spall repair in test section.

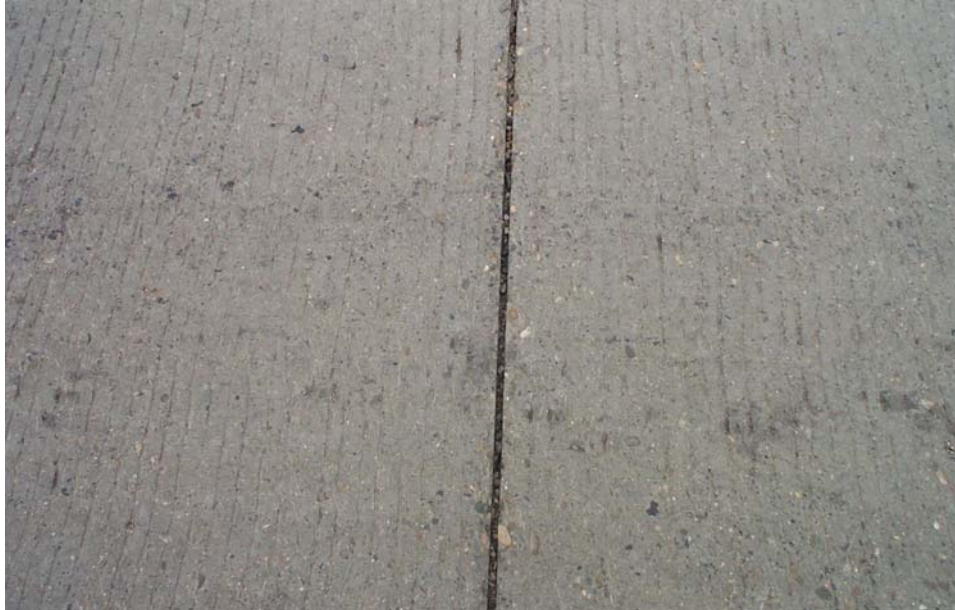
Photo 22 - Incompressible material in an unsealed joint at the shoulders.

Incompressible material has filled the unsealed joints on the shoulders completely. The joints in the driving lane are partially filled with incompressibles ranging from 3/8" to 1 1/8" below the concrete surface. The amount of incompressible material

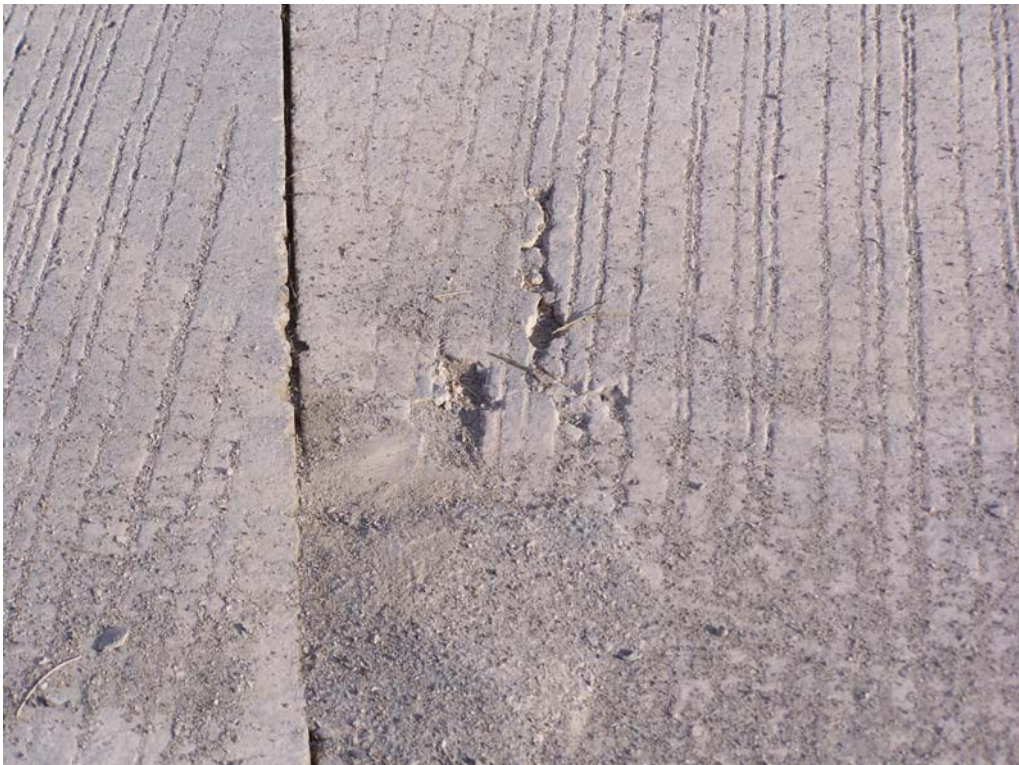
This test section experienced some distresses that the other test sites didn't experience. There is map cracking on the transverse joints in the wheel paths. There is also a longitudinal crack running down the center of the roadway for the majority of the project. These distresses can be seen in Photos 23 & 24.

Photo 23 – Photo of severe map cracking next to transverse joint in “control section”.

These sections of roadway were repaired in the fall of 2005. Materials and Research visited the test section when it was repaired. Sections of the roadway

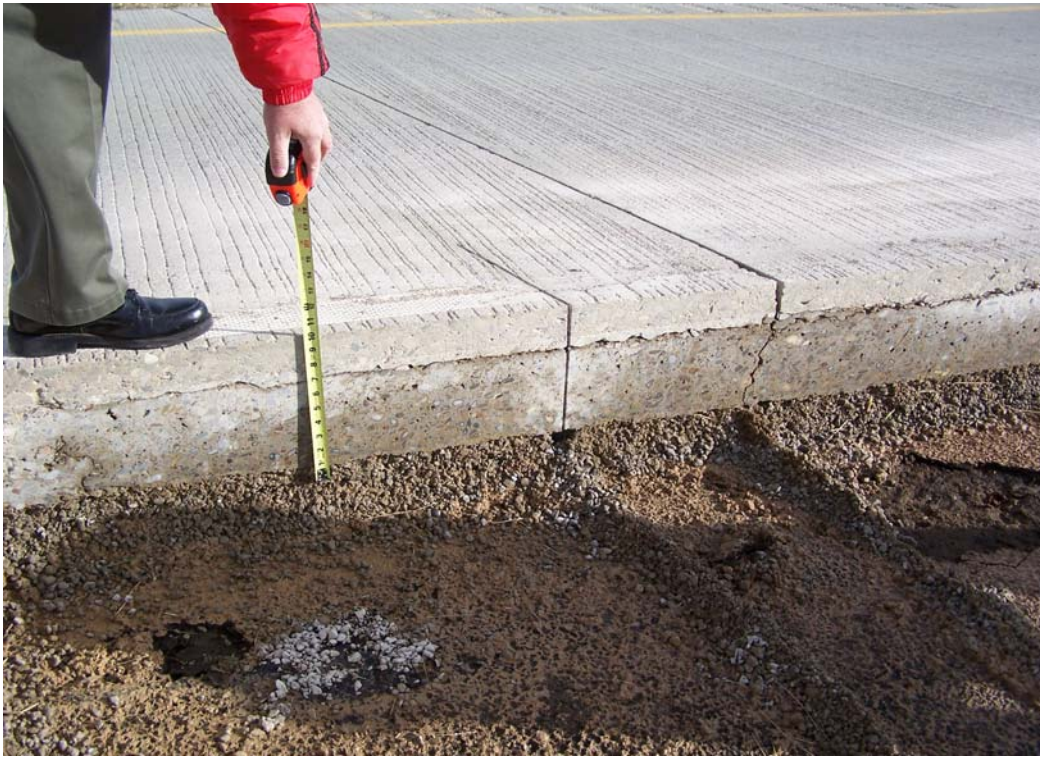
Photo 24 – Photo of longitudinal joint after concrete was removed.

slab depth could be seen. This can be seen in Photo 24 and 25. Cores were taken to be tested by American Petrographic Services, Inc. Samples from these cores were taken at different depths of the concrete. Their testing reported that the cause of the deterioration appears to be due to inconsistencies in the entrained air void system throughout the concrete. They reported that in general they observed lower entrained air content volumes in the upper portions of the concrete. Note the delaminated condition of the pavement section, as depicted in photo 24 and 25. See Appendix A to review report from American Petrographic Services, Inc.

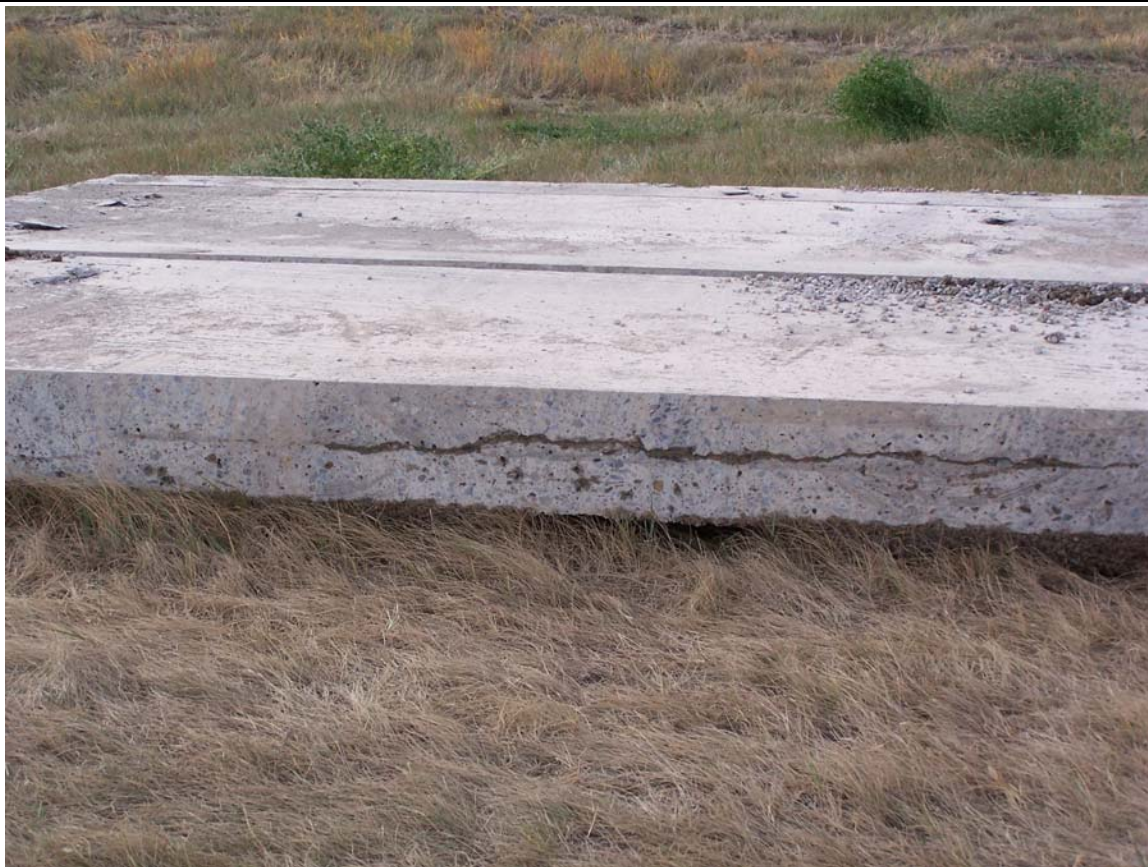
Photo 25 – Photo of crack running transversely in the center of a pavement section removed from roadway.

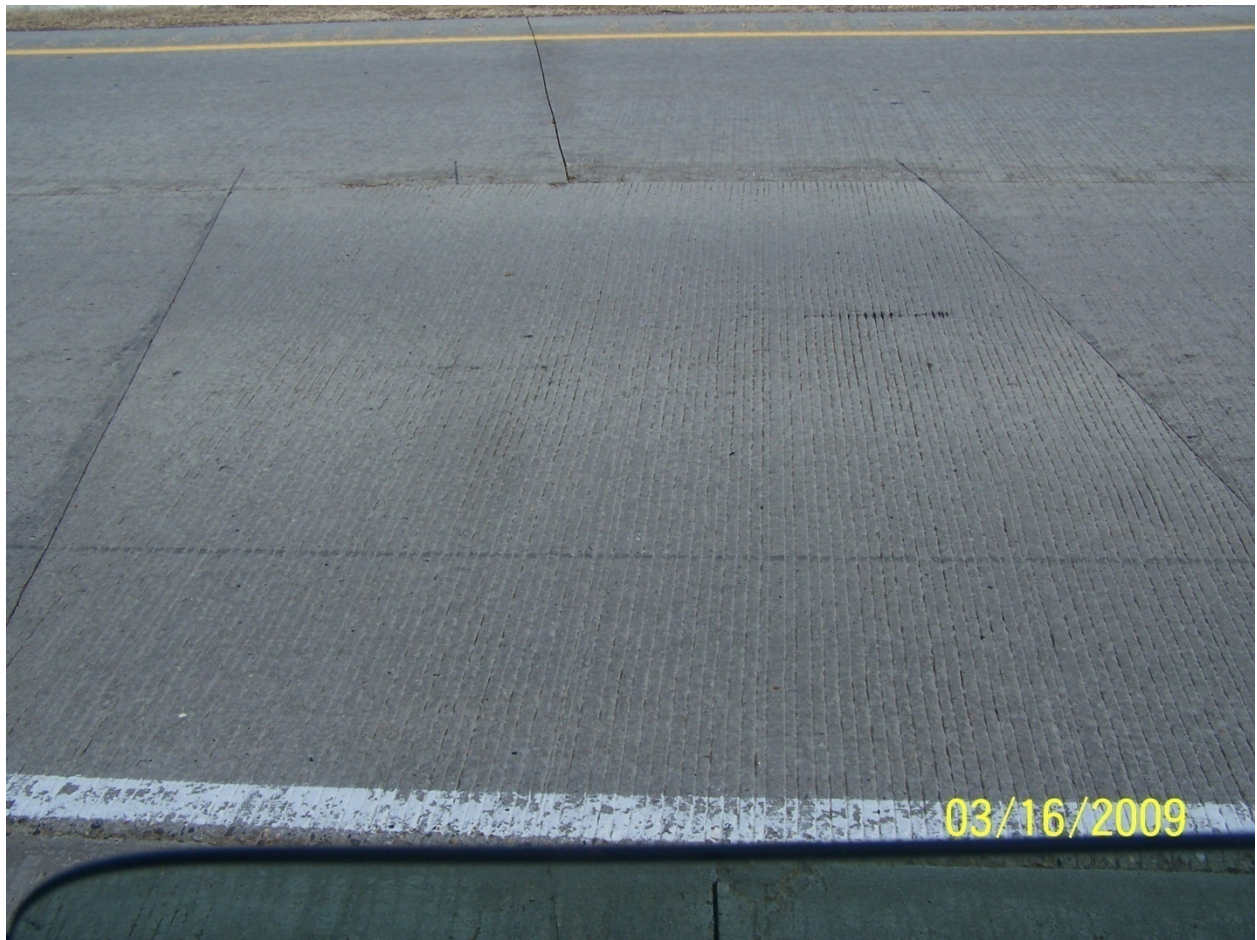
Photo 26 – Photo of repaired joint.

This site was not evaluated for transverse joint spalling or longitudinal joints spalling after the pavement was repaired in 2005, once the original joints are now gone. Table 8 displays the spall results from 2005. A photo of a repaired joint can be seen in Photo 26.

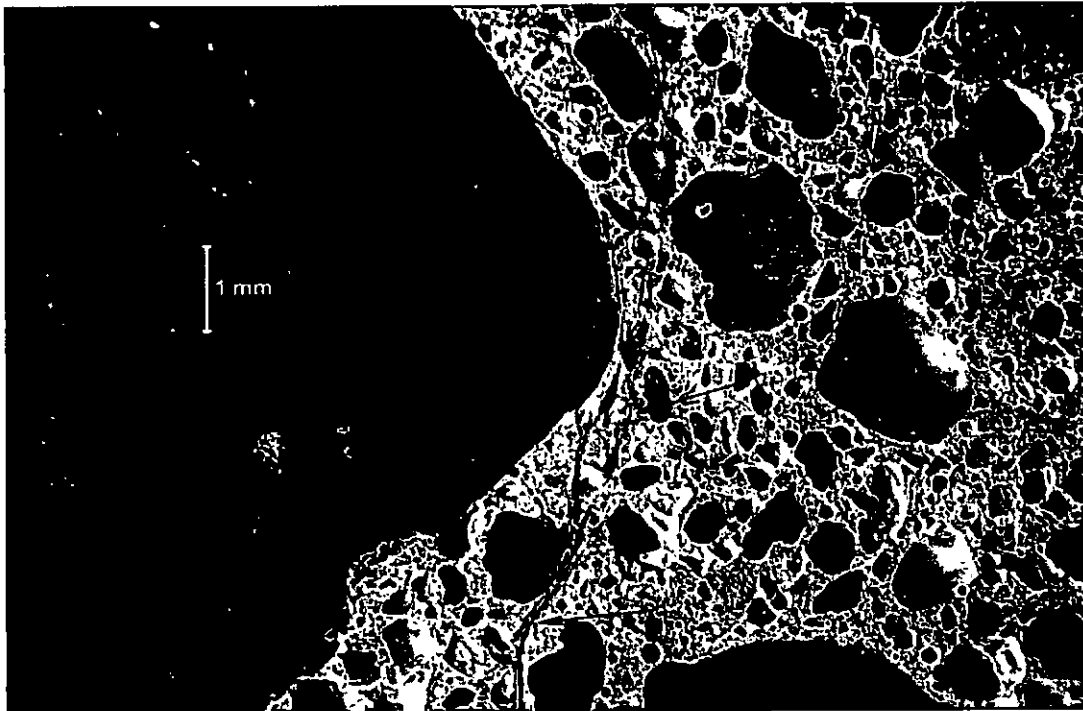
9. **Secondary deposits:** Clear to white alkali silica-gel was observed partially filling the subvertical microcrack between approximately 76 mm (3") and 92 mm (3-5/8") depth from the top surface.

SAMPLE ID: 1 DESCRIPTION: Clear ASR gel partially fills a subvertical microcrack proceeding from the top surface.
