Experimental Study MR 97-04

**Evaluation of Dowel Bar Retrofit  
Using Minnesota Specified 3U18 Patch Mix**

**Final Report**

Project IM-8-029(006)000

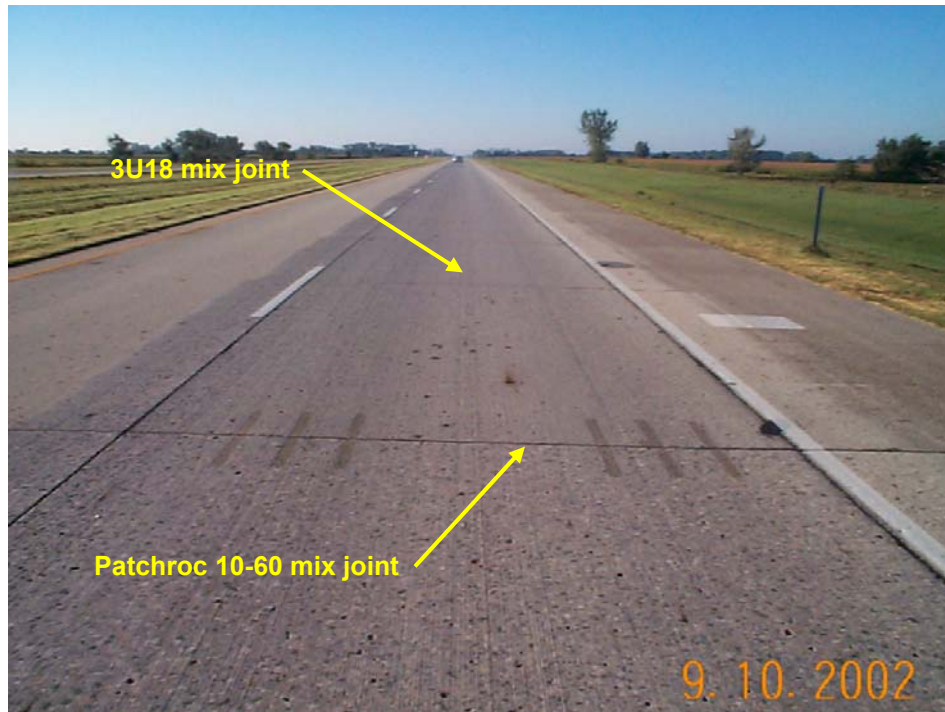
**Photo 13 - Overview of dowel bar slots, 1<sup>st</sup> joint contains Patchroc 10-60.**

Overall the 3U18 patch mix looked good with some visible cracks appearing at the surface. The cracks do not appear to be affecting the performance of the mix. Shrinkage cracks were detected within three months after placement of 3U18 patch mix in the 1995 test section that had affected the performance.

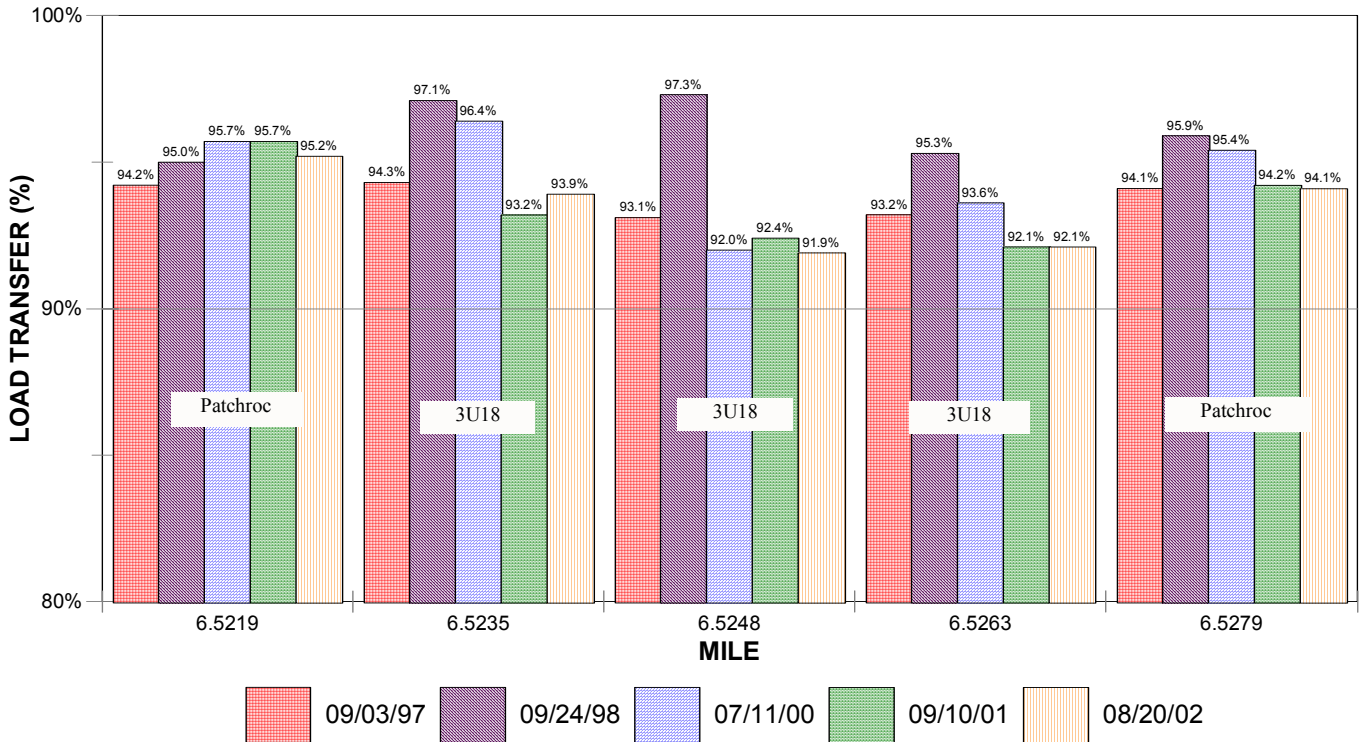
LOAD TRANSFER-South Bound

FWD analysis shows the 3U18 mix has an average load transfer efficiency of 92.6% while the Patchroc 10-60 mix has 94.7% load transfer efficiency after five years. Refer to the chart on the next page for the load transfer efficiency numbers.

The 3U18 mix has some hairline cracks between the existing concrete and the patch mix in some of the dowel bar slots. These cracks do not appear to be affecting the load transfer efficiency as dictated by an average load transfer of 92.6%. The other distress that is occurring in the 3U18 mix is minor aggregate popouts. The surrounding pavement also has popouts.

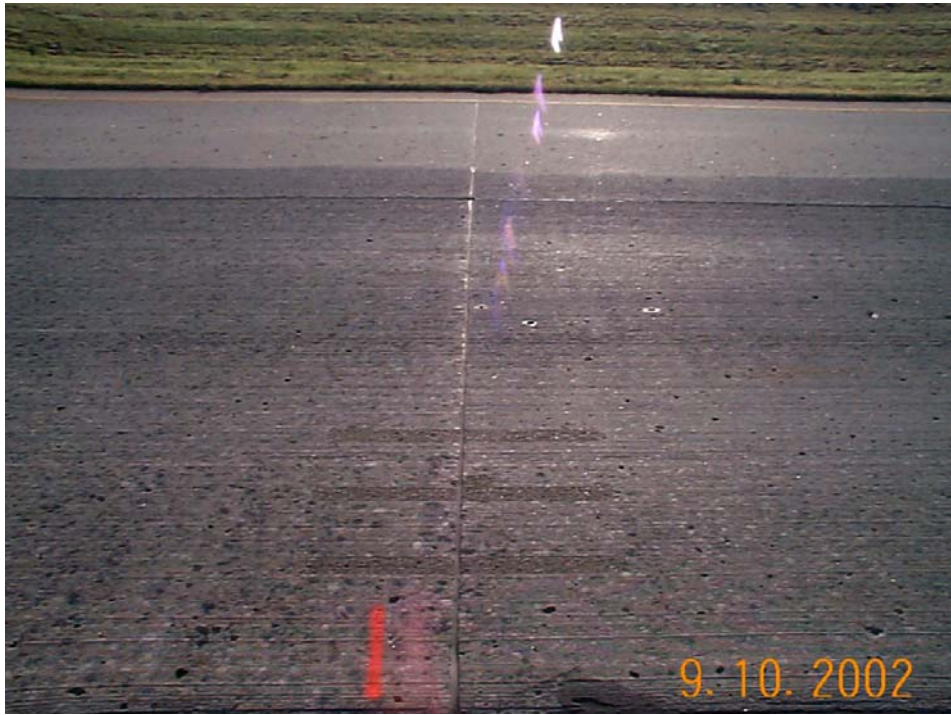
One very noticeable difference between the 3U18 mix and the Patchroc 10-60 mix is the aesthetics of the mix. Photo 13 shows one the Patchroc joints and then the 3U18 mix joints. The 3U18 mix joints are virtually undetectable. Photos 14, 15, and 16 shows the joints with the different patch mix materials.

Photo 14 - Dowel bar slots containing Patchroc 10-60.

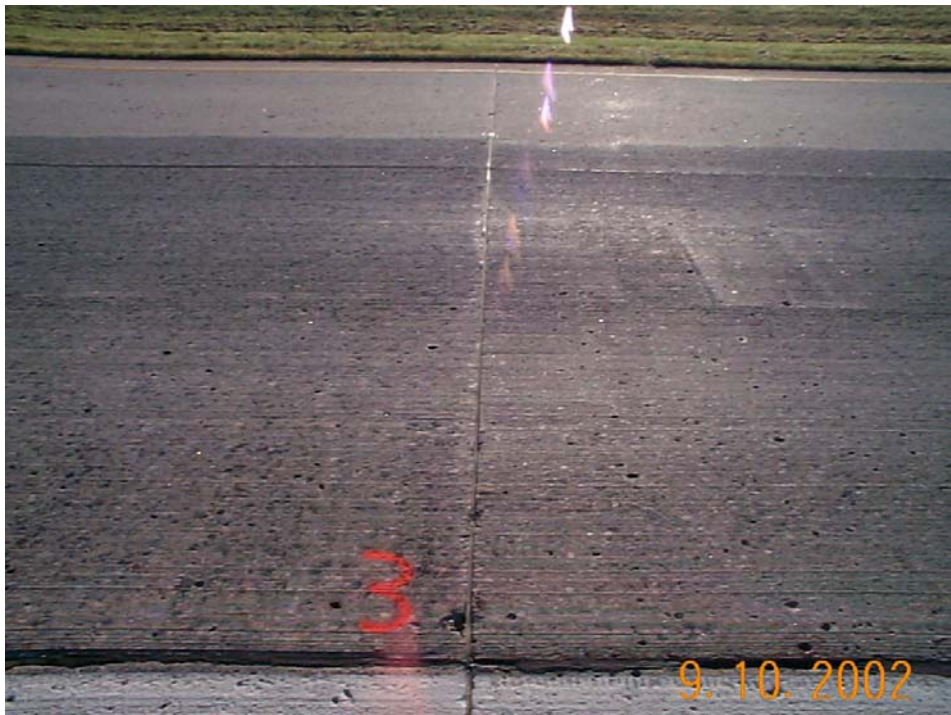
Photo 15 - Dowel bar slots containing 3U18.

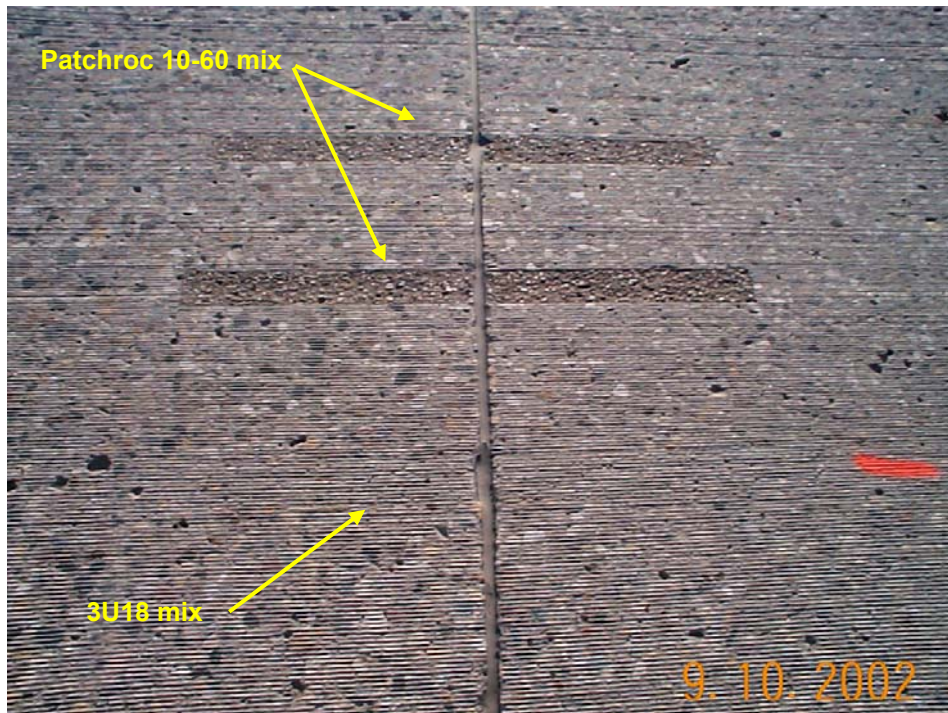
Photo 16 - Comparison of the mixes side by side.

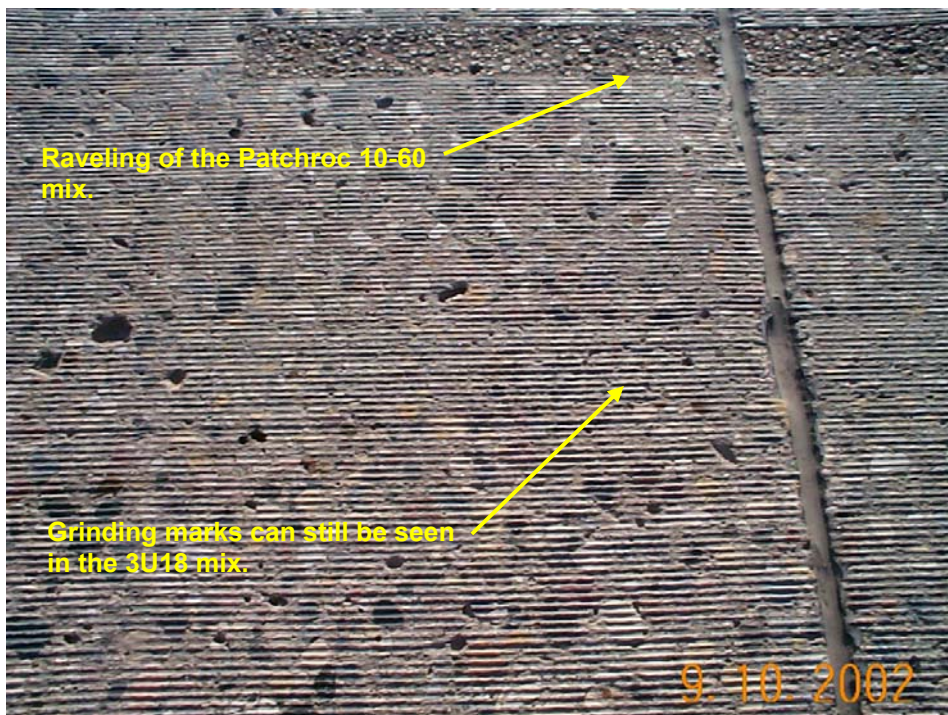
The durability of the 3U18 mix also appears to be better than the Patchroc 10-60 mix. Refer to photo 17.

Photo 17 - Durability of both mixes.

As can be seen in photo 17, the Patchroc 10-60 is raveling at the surface while the grinding marks can still be seen in the 3U18 mix.

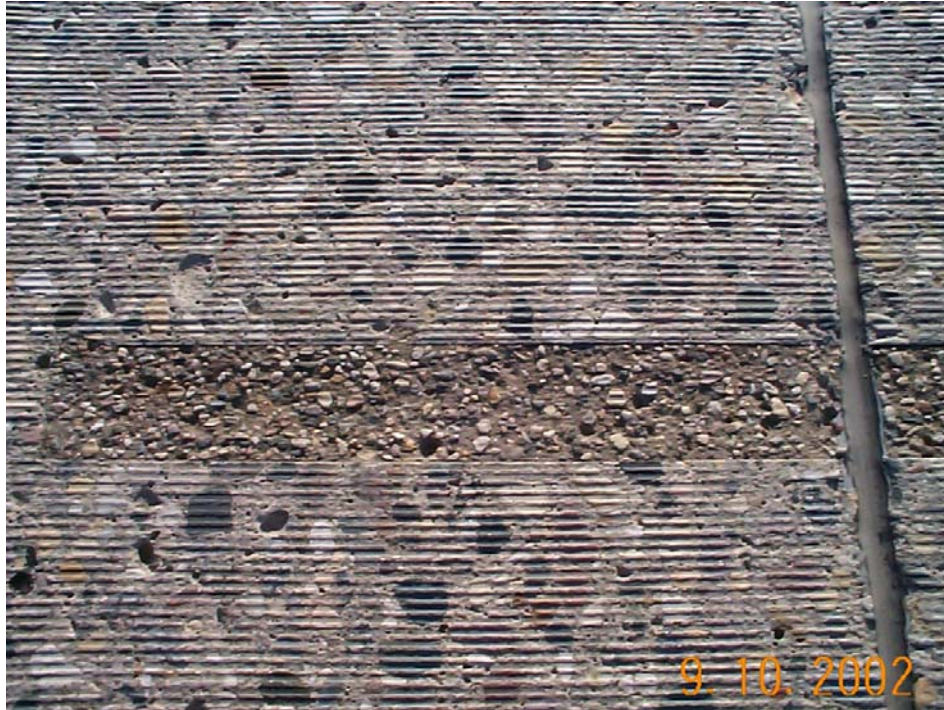
**Photo 18 - Close up view of the Patchroc 10-60 mix shown in photo 17.**
