Experimental Study MR97-06

**Crafco Experimental Sealant to Level Depressed  
Cracks and PCCP Spall Repair Material**

**First Annual Report**

March 1998

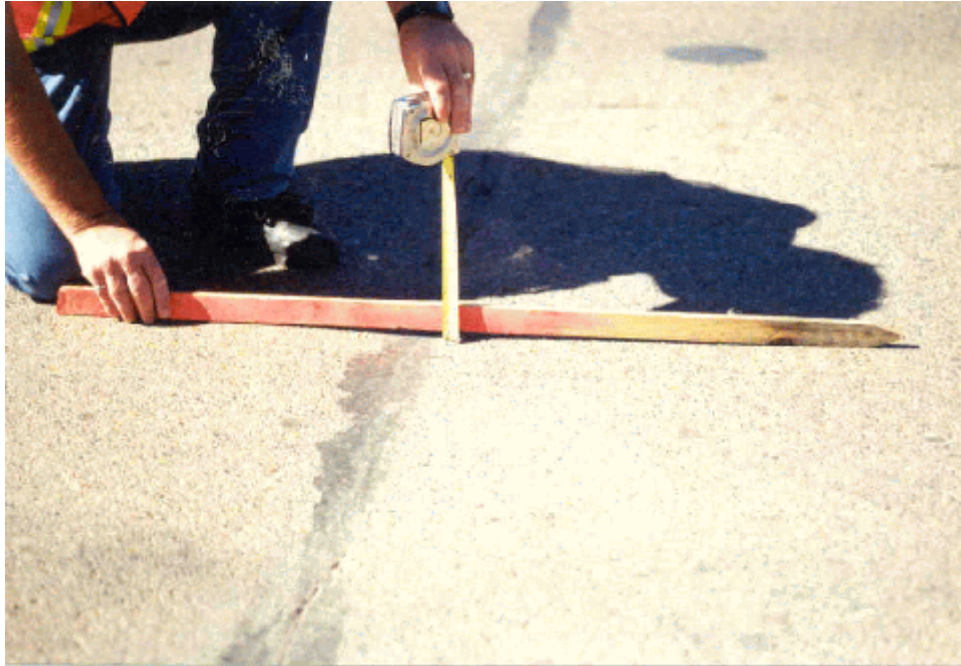
**Photo 1 -- Transverse crack depression (Approx. ½")**

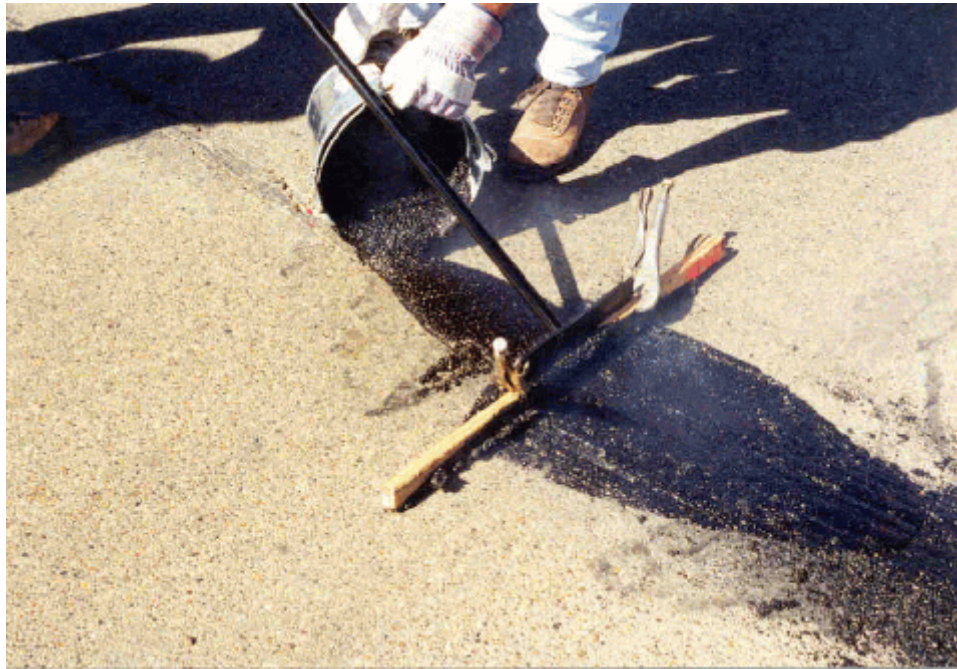
**Photo 2 -- Pouring poly-patch material and straight-edging**

Photo 2 shows the pail method of applying the poly-patch material and one type of straight edge used.

The small kettle used to melt the poly-patch material was not set up for large applications. Thus the material was retrieved from the kettle by gravity flow through a small nozzle. The nozzle had to be heated with a torch at times to keep the material flowing. A pail was used to apply the material. The short straight-edge used was extended by a broken lath clamped to the straight-edge. This worked much better, but should have been even longer. If the straight-edge is too short, the depressed crack will not be completely filled.

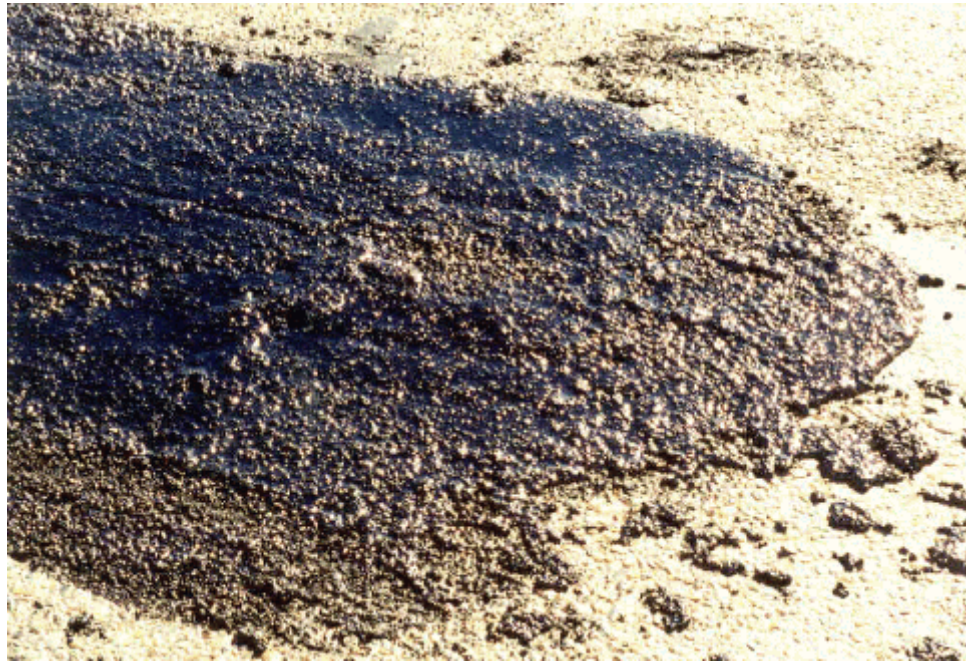
The patch material cooled quite fast from the time the pail was filled to the time it was poured and leveled. This made it difficult to level and often built up on the straight-edge. Another factor in this leveling process was the light weight aggregate in the material. The aggregate was of a size that did not feather out to a smooth finish. This can be seen in photo 3.

**Photo 3 -- Close-up of material texture**

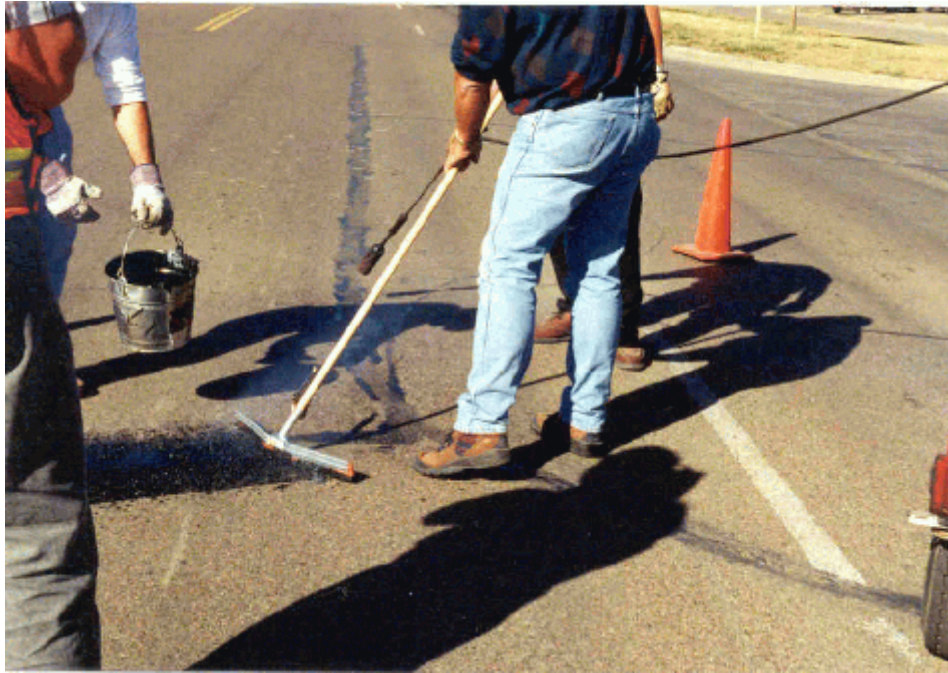
A new type of straight-edge was used. It was not very rigid and not wide enough. See photo 4.

**Photo 4 -- Preheating surface with torch and new straight-edge**

After the material was installed and hardened, a test drive over the repaired cracks improved the ride by about 50% compared to the ride before the cracks were repaired. This is well below what was expected. The main reason being the straight-edge was not wide enough. The crack depression extends out from the crack at least a foot or more in many places. This usually occurs in the wheel paths. CrafcO said that they did not ship enough product to North Dakota to go over the cracks again. They will ship more product and obtain a longer straight-edge to do the second and final leveling of the depressed cracks.

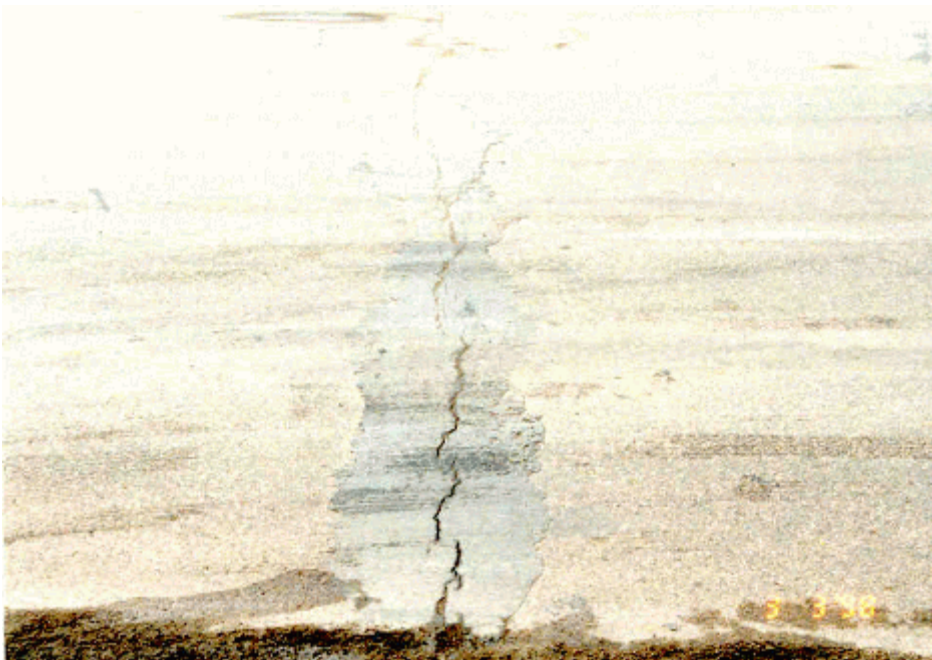
have been poor at that location. A typical leveled crack after six months of service is shown in photo 5.

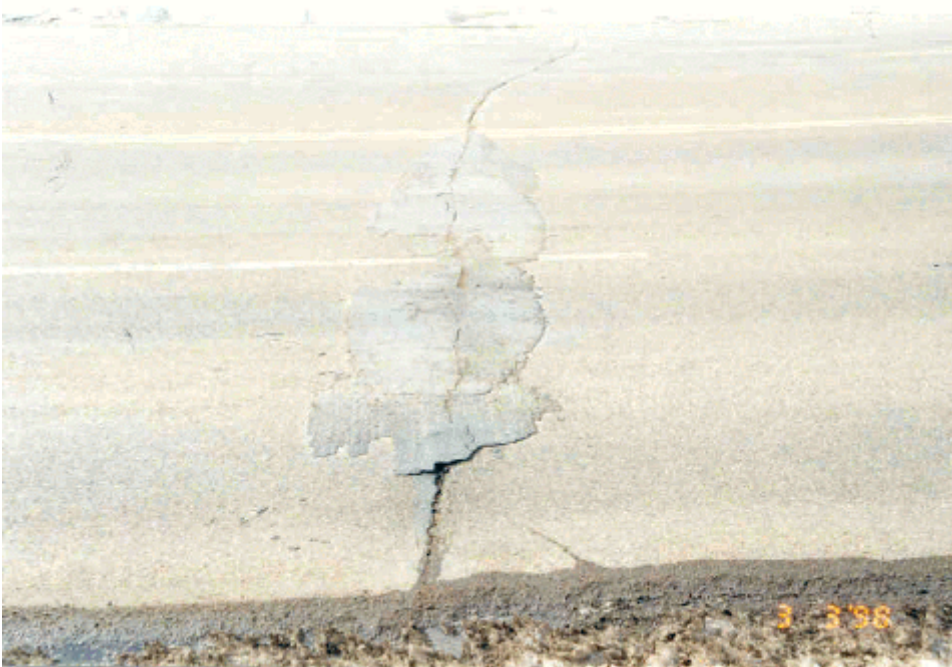
material is gone in the outer wheel path of the outside lane. Most likely the patch material was

**Photo 6 -- Poly-patch material missing---Probably by snowplows**  
rapidly, adhesion could

The experimental section was observed over the winter months and visited on March 3, 1998. The section rides as good as it did after construction, with the exception of one transverse crack where the leveling

removed by snowplows. It is also possible that poor adhesion was to blame. Using a pail to distribute the material from the kettle is a slow process and allows the material to cool. Being this material hardens

Photo 6 shows the crack where with the poly-patch material missing in the outer wheel path. The roadway has some rutting which is responsible for the snowplows removing patch material at the higher points between the wheel paths.

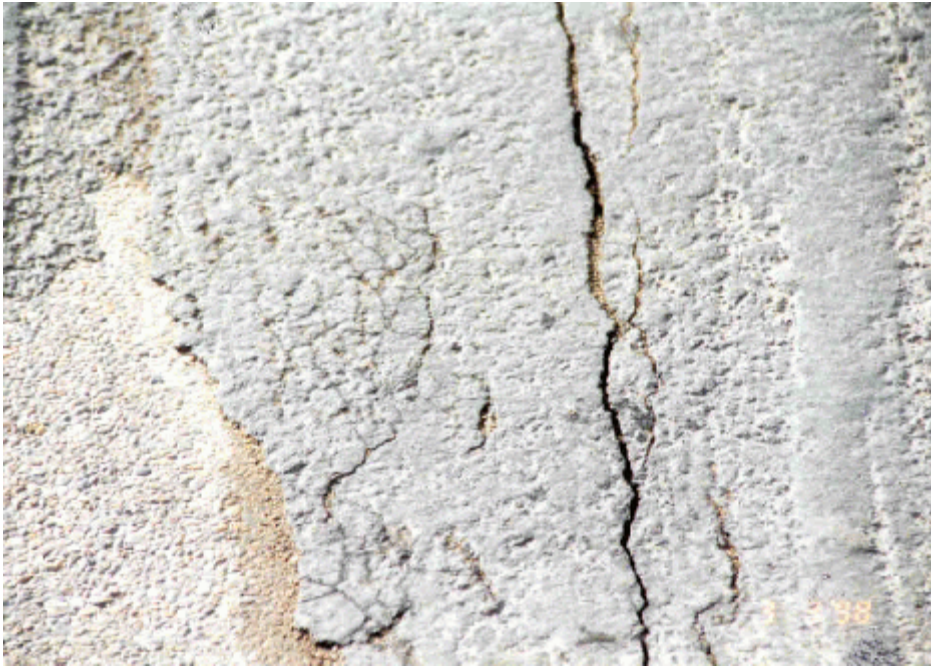
**Photo 7 -- Small cracks developing in poly-patch material**

is rough and the material seems to be performing very well to date. There is some evidence that the poly-patch material is becoming brittle and developing small cracks. See photo 7. None of the cracks leveled with poly-patch material have

stopped reflective cracking. The poly-patch material is slightly raised from the roadway due to the size of the light weight aggregate in the poly-patch. This makes it easier for the snowplows to catch the edges of the patch and chip away at it.

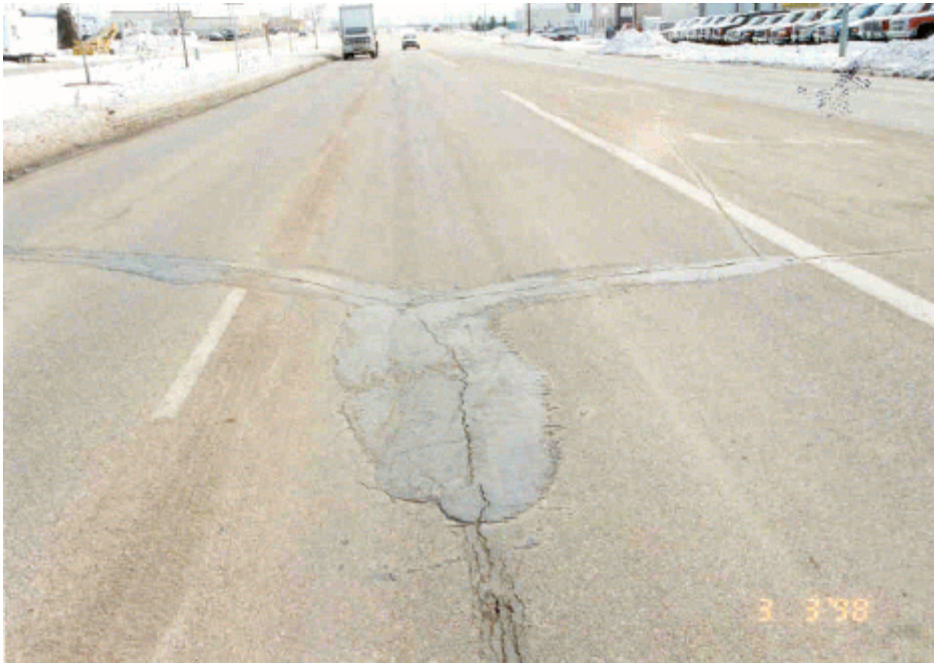
**Photo 8 -- Poly-patch material in good condition**

The last depressed transverse crack in the section that was leveled with poly-patch is in good condition. Part of it runs down a slightly rutted wheel path. The poly-patch has reflected the old crack and shows a 4" spall in the inner wheel path of the left

or inner lane. This crack is shown in photo 8.

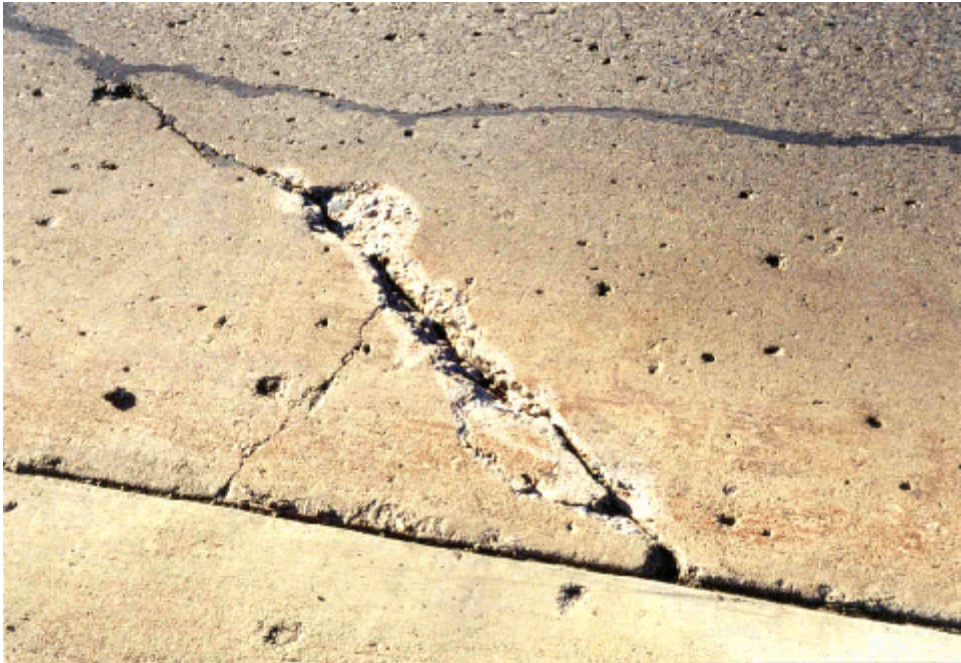
**Photo 10 --Spall area cleaned by sandblasting and high pressure air**

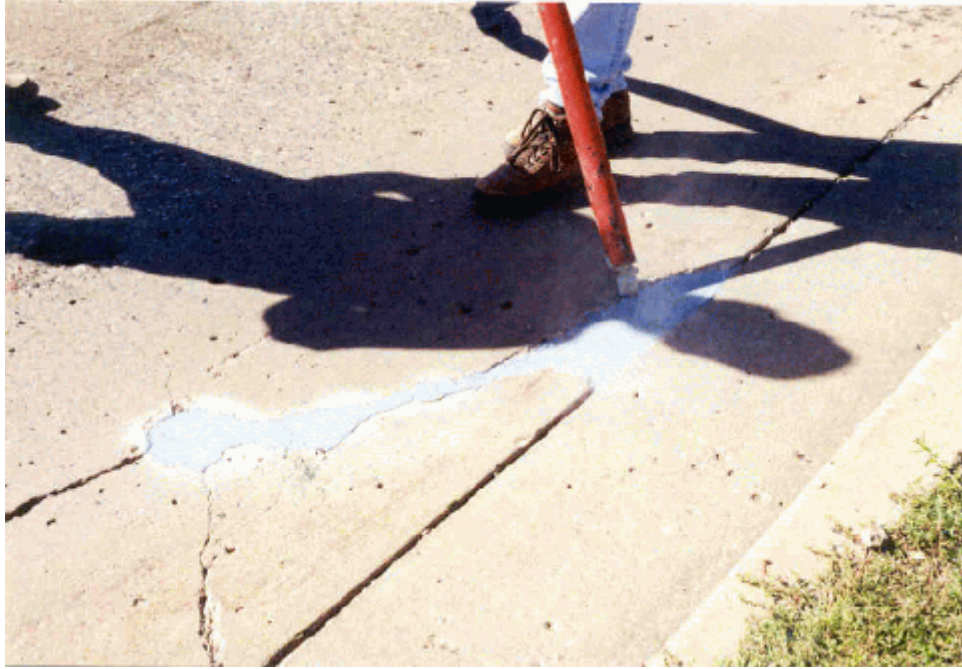
**Photo 11 -- Applying final lift of spall repair material**

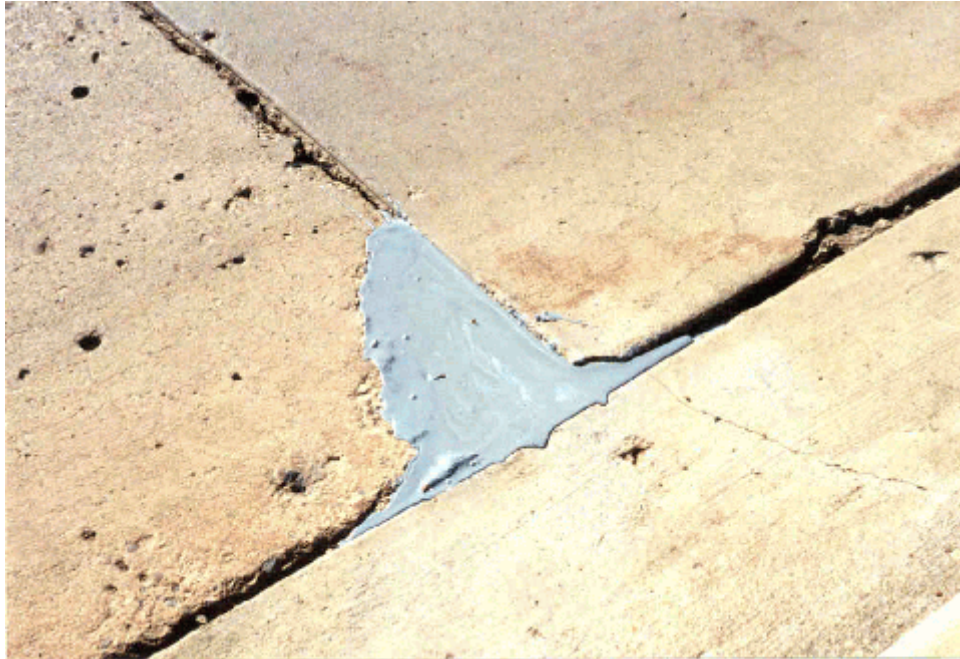
**Photo 12 -- Typical spall filled with cold weather repair material**

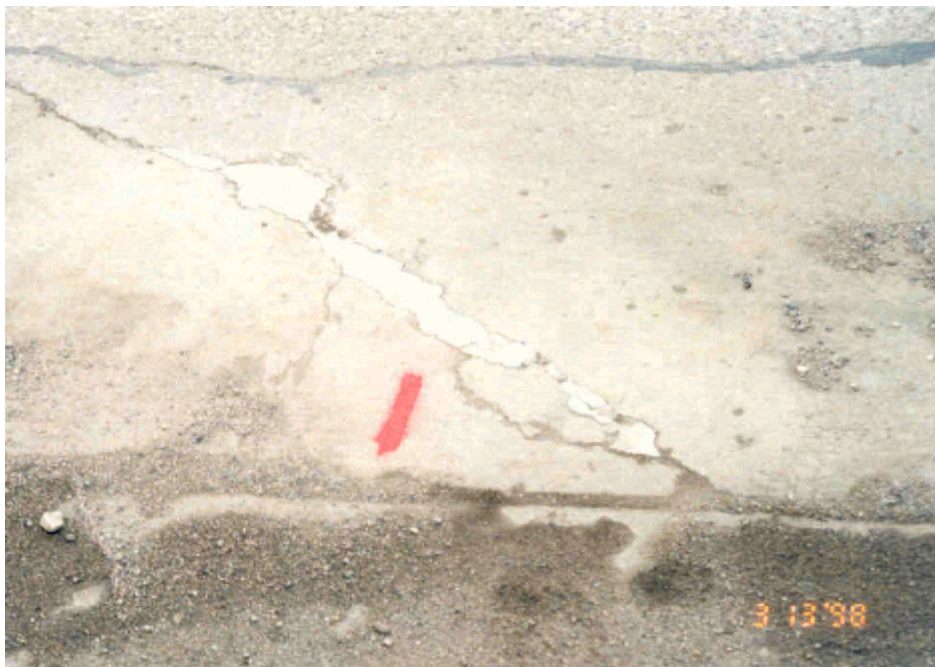
Photo 13 is an overview of the test section. Photo 14 shows the material still in place except for a few small missing pieces. This photo is the same as shown in photo 10. Photo 14 is the warm weather material.

Photo 14 -- Warm weather repair material ---good condition

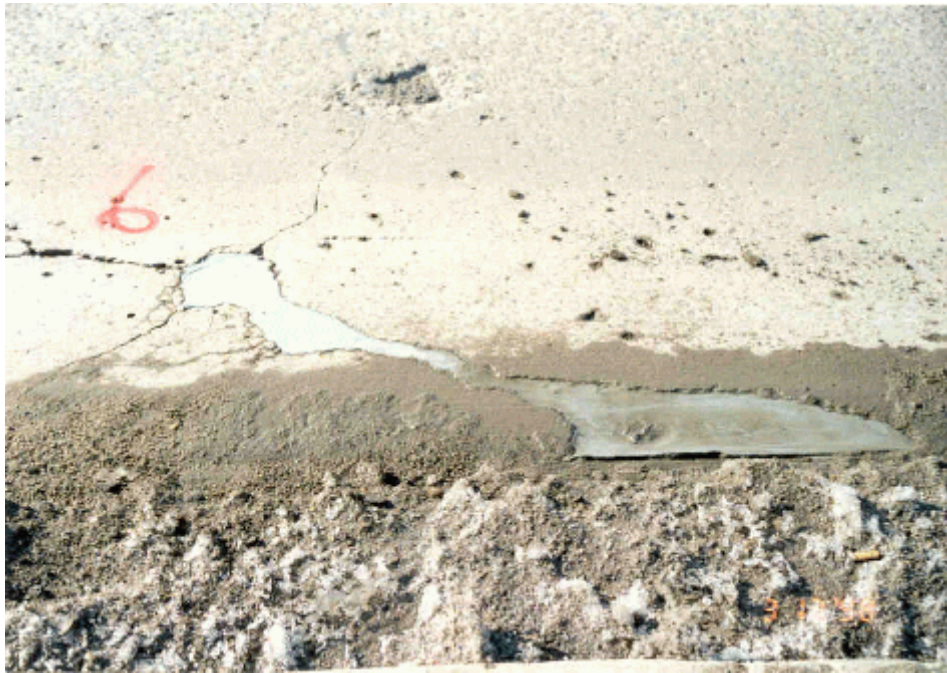
Photo 15 -- Cold weather repair material --looks good

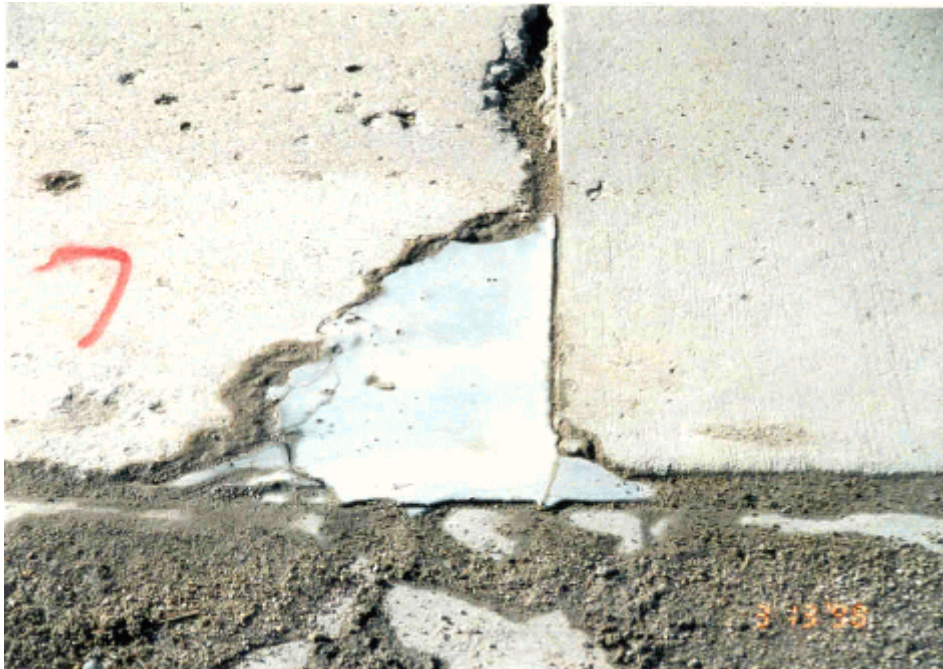
Photo 16 -- Cold weather repair material ---some cracking

For the most part , both the warm and the cold weather materials are performing satisfactorily with only a few small spalls in the material. Some hairline cracks have developed in the material of some of the repaired joint spalls. Some are considered to be reflective cracks. The cold weather material may be performing a little better than the warm weather material. Another evaluation of these test sections is planned during the summer months.
