Experimental Study MR 02-01

**Microsurfacing Performance  
Evaluation**

**Final Evaluation Report**

NH-5-085(041)041

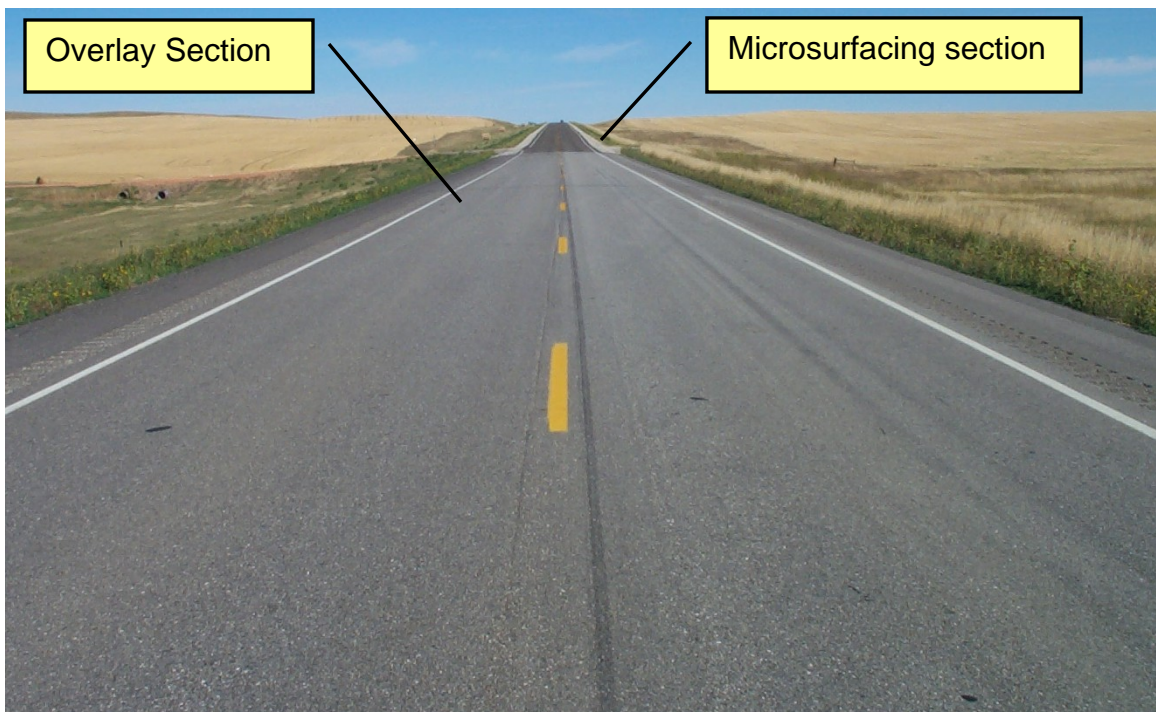
**Photo 1 – An overall photo of the overlay section.**

This first evaluation took place on September 15, 2003. The overlaid section did not have many distresses. There were some transverse cracks beginning to appear. The cracks were sealed in the spring of 2003. The ride was good. The overall condition of the asphalt was very good. An overall view can be seen in photo 1.

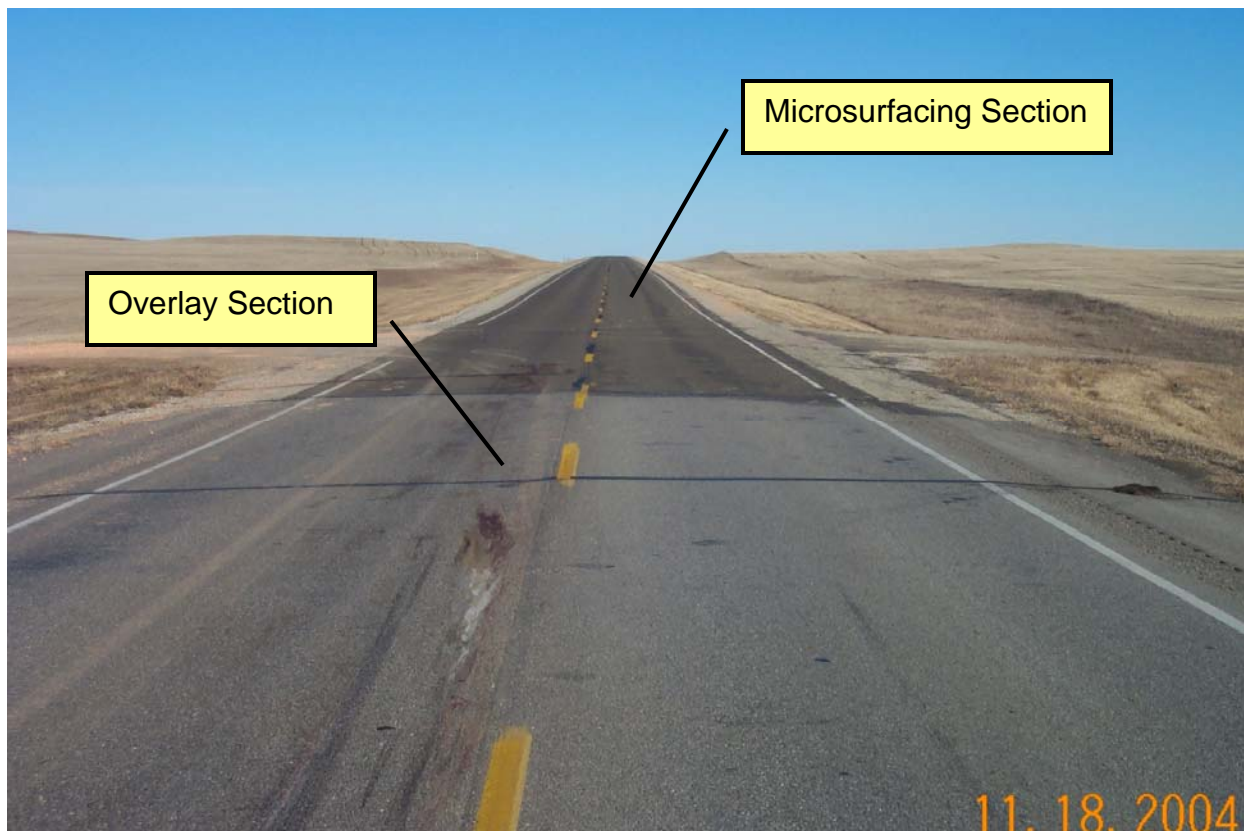
**Photo 3**

This final evaluation took place on November 18, 2004. The overlaid section did not have many distresses on it. The transverse crack spacing was approximately 75'. The ride appeared to be good and the overall condition of the asphalt was very good. An over all view can be seen in photo 3.

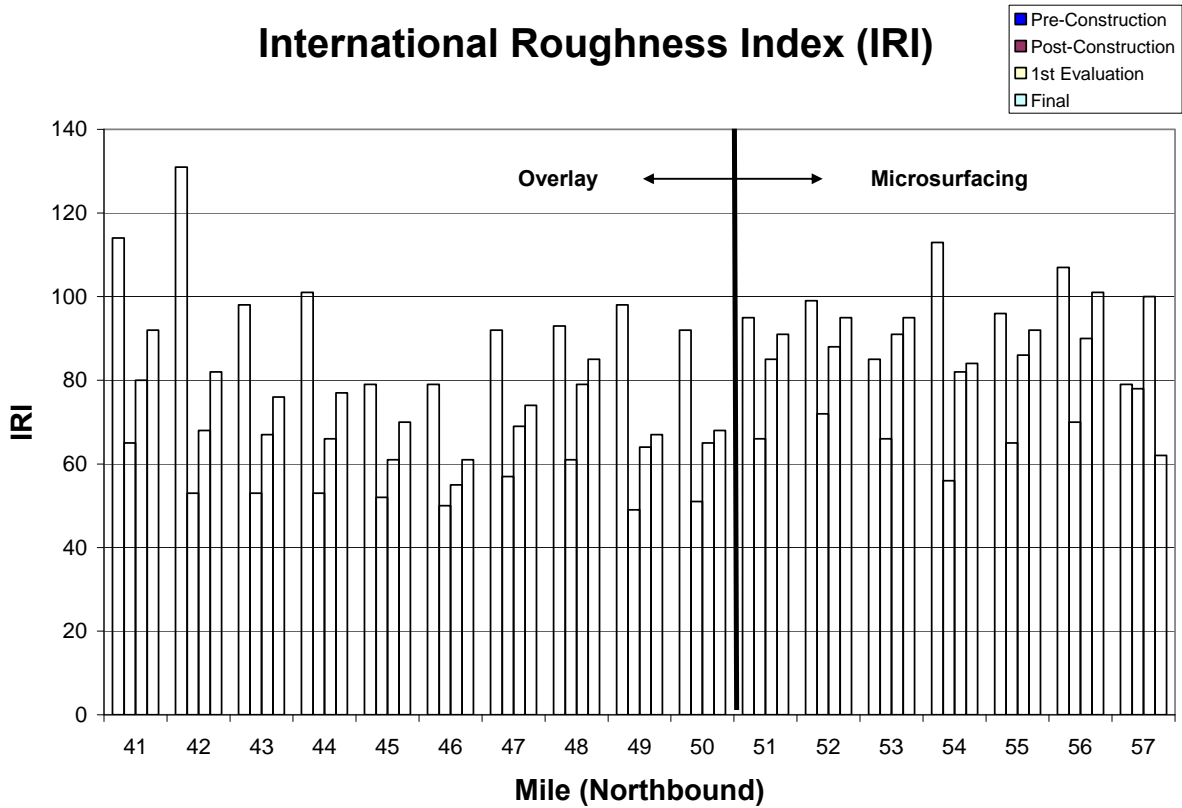
**Chart 1**

The rut depth and IRI are two very important factors for the evaluation of this project. Chart 1 through Chart 4, shows the IRI and rut depth for overlay and microsurfacing section in the northbound and southbound direction. The Overlay Road Profile Report displays the IRI broken down into the percentage good, fair, and poor. It also has the rut depth broken down in the same manner. This report can be seen in [Appendix D](#).

The IRI and the rut depth for the whole project can be seen in charts 1 through 4. The microsurfacing section did not perform well compared to the overlay section. The IRI and rut returned to similar scores prior to the rehab. In May 9, 2006 evaluation the roadway appeared to still be rutting. The HBP in between the wheel paths appeared to shoving. This was determined by using a straight edge to show that the lanes were crowned in the center of the lanes.
