Experimental Study ND 92-01

**Evaluation of Ralumac as a Rut Filler
and Its Rut Resistant Capabilities**

Final Report

Project UNH-1-810(012)002 and
U-1-981(033)042

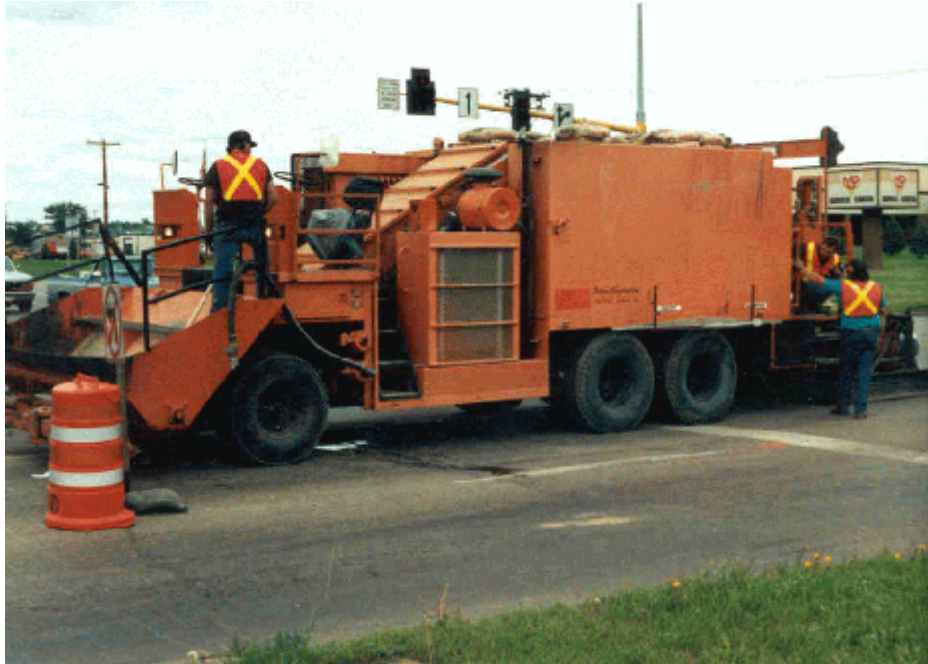
Photo 1. Micro-Surfacing Machine

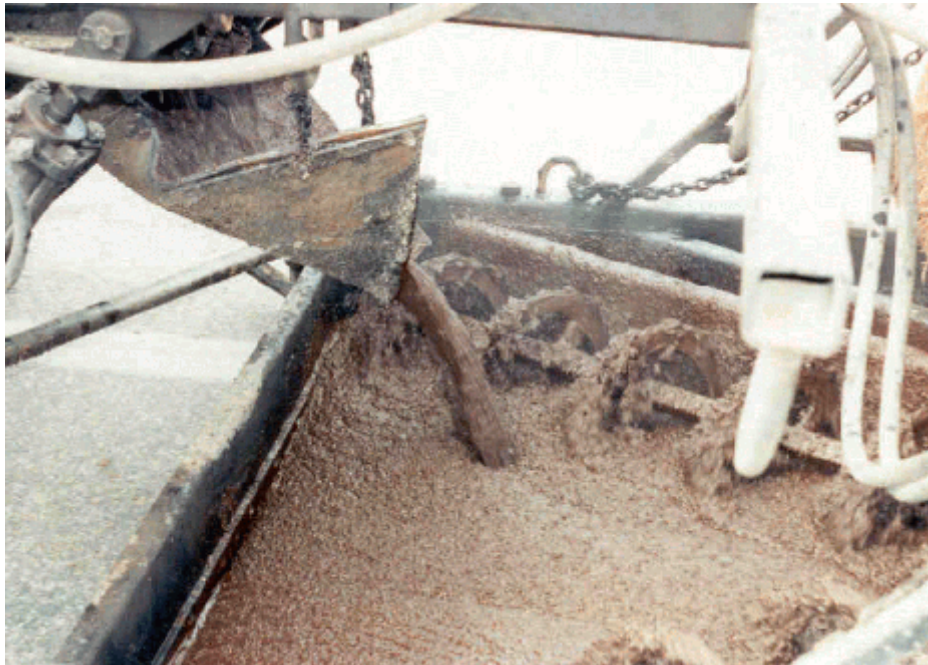
Photo 2. Continuous flow of the Ralumac slurry into the spreader box

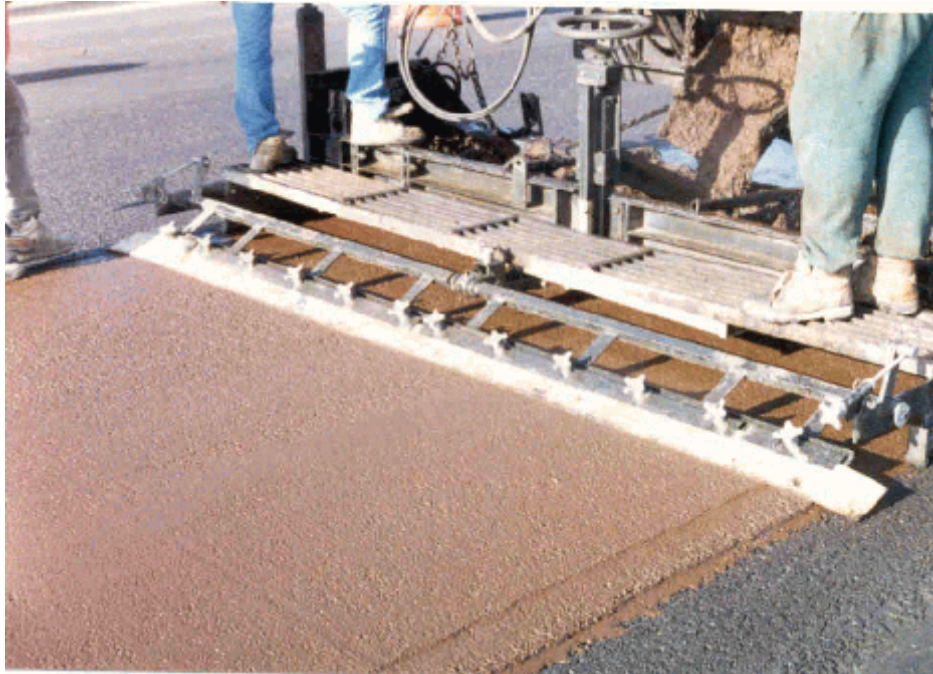
Photo 3. Ralumac slurry is brown and within a few minutes it turns black

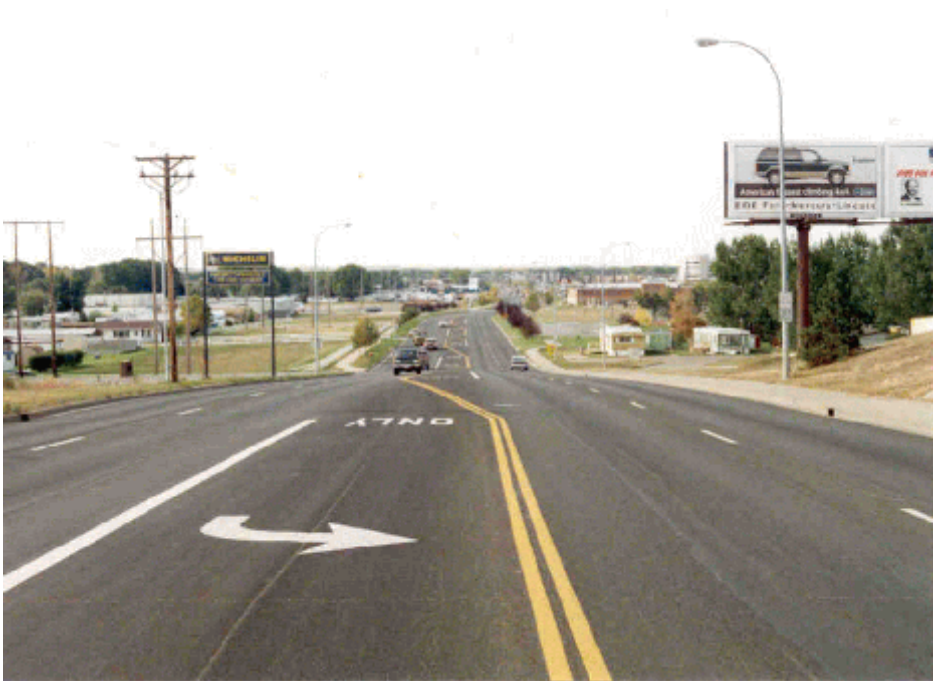
Photo 4. Finished project looking west from 18th street on Expressway

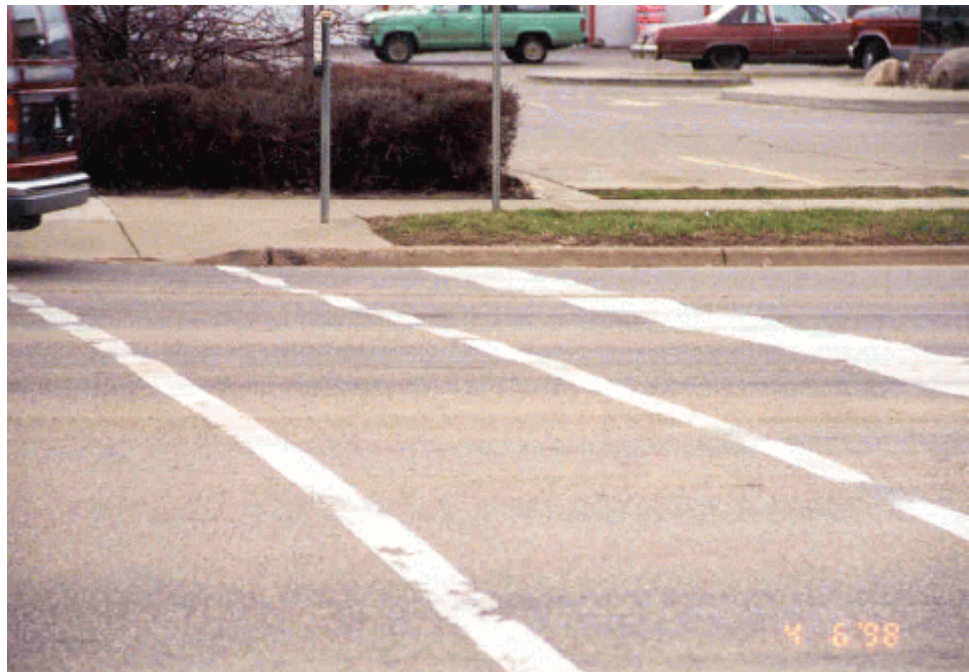
The Ralumac has prevented the severe rutting from returning, thus achieving its intended purpose. In 1994 the project received an average distress score of 88.5. This is a good rating. The ride and rutting were also in the good category. During the fourth and fifth year of service, the Ralumac still was not rutting much, except at some stop-bars as shown in photo 5.

Photo 5. Bismarck Expressway --rutting at stop-bars at 9th St.--W.B.

Stresses imposed on the pavement from vehicles stopping and accelerating are causing the rutting. The wearing surface of the Ralumac looks good. The wheelpaths have been worn and have a shiny appearance. Other than the

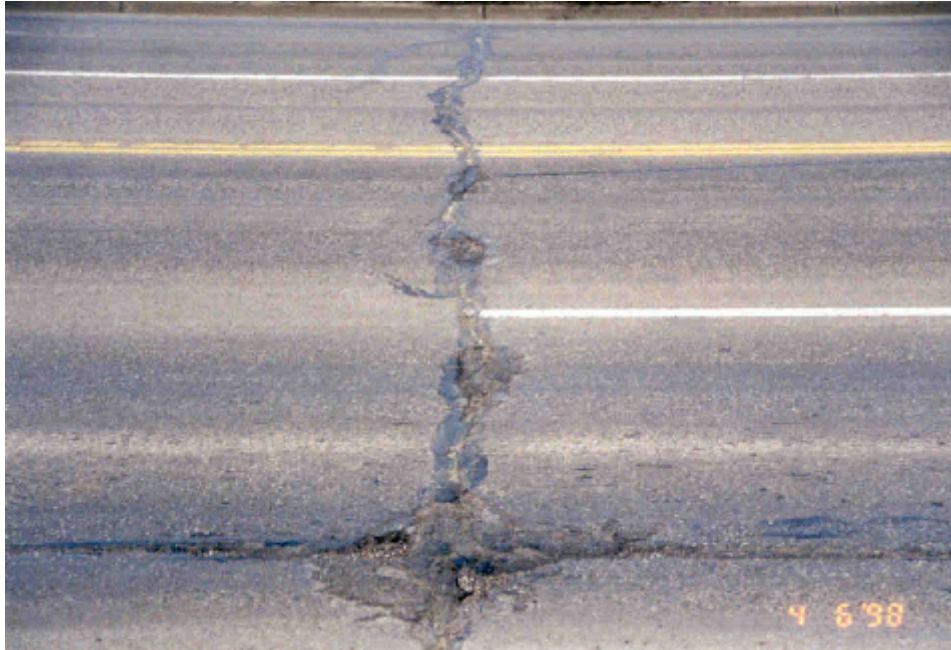
Photo 6. Typical transverse crack ---patched

transverse cracks, the ride on this project is considered to be good. Transverse cracks are open and many are spalling. Bismarck city crews have been patching the spalled areas and

small potholes. A typical transverse crack is shown in photo 6. An area were Ralumac material was lost due to spalling is shown in photo 7.

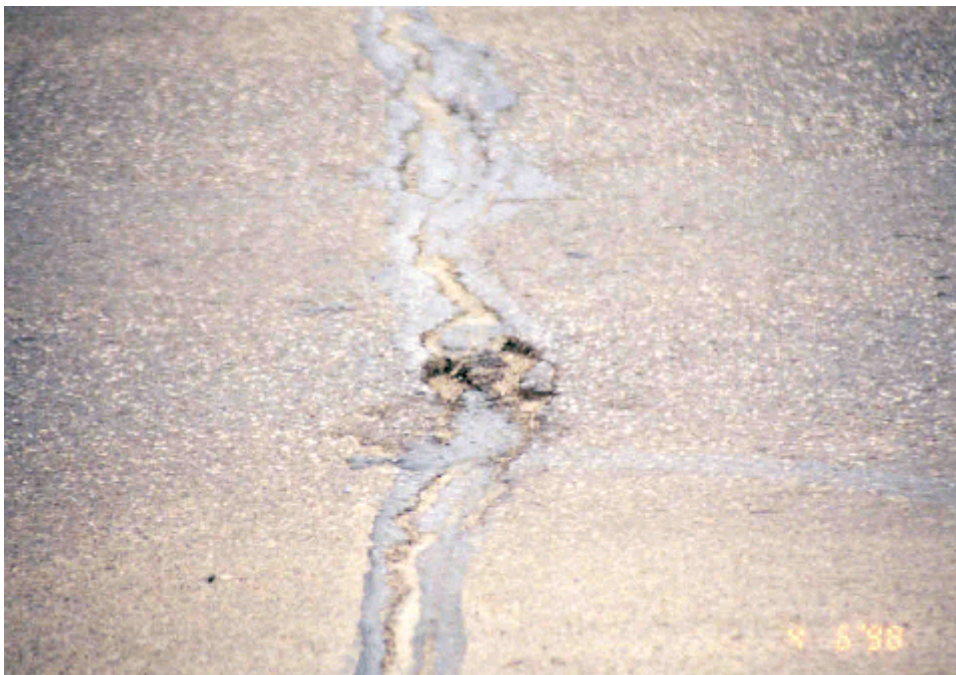
Photo 7. Spalling has resulted in the lost of Ralumac material

This spalling usually takes place in the wheelpaths where they cross a transverse crack. The Bismarck Expressway is heavily traveled. The Bismarck maintenance crews have been sealing transverse cracks and have stated the difficulty they had in sawing or routing the cracks. The crew said that when routing was performed, the edges of the crack would break off. They claim that the Ralumac is brittle and compare it to concrete. This Ralumac is hard on their cutting edges. The maintenance crew for the city of Bismarck hope that this project would be the last using Ralumac. The city Engineering Department likes the performance they have received from Ralumac.

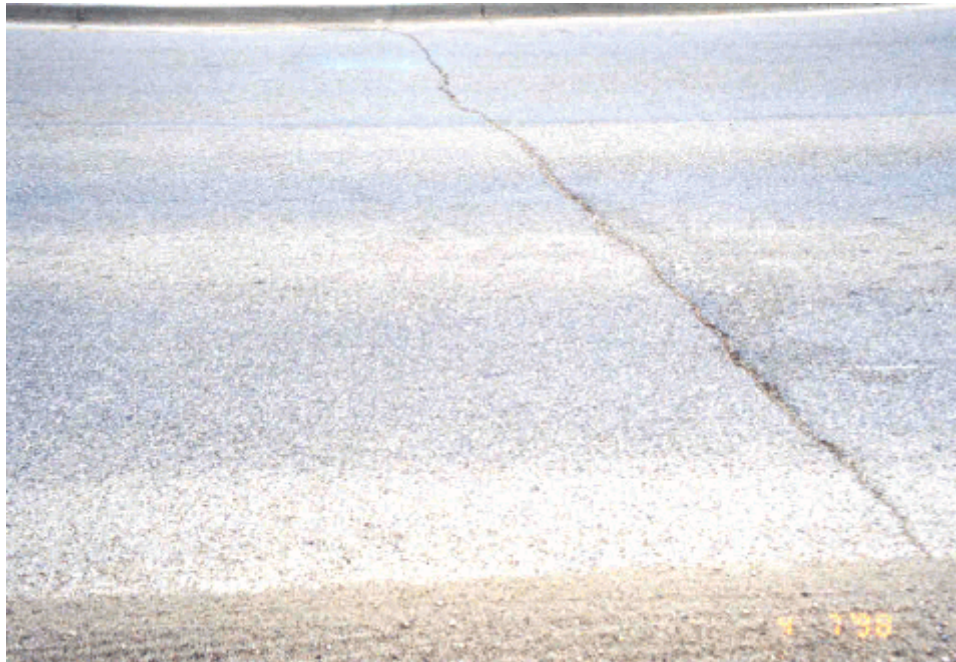
Photo 8. Present texture of Ralumac -- wheelpath and between

This photo was taken in the westbound lane at 2nd street. Notice the wear in the wheelpaths. The rougher texture is in between the wheelpaths or to the outside of the lane.

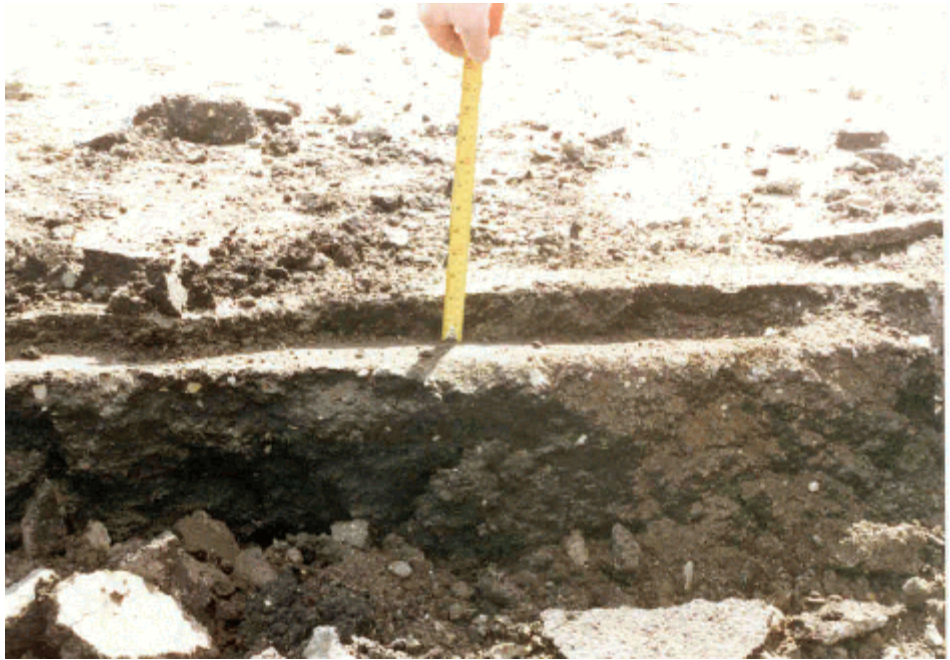
A sewer line problem developed from 19th street westward on Bismarck Expressway. This area was subcut and rebuilt in July of 1996. The repair section was topped with a Hot Bituminous Pavement. It was approximately 370 feet in length and covered both roadways from 19th street westward. Photo 9 shows the repair section. Photo 10 shows where the Ralumac meets the repair section. The repair section is performing satisfactory so far and has no cracking.

Photo 9. Subgrade repair section -- measuring Ralumac thickness

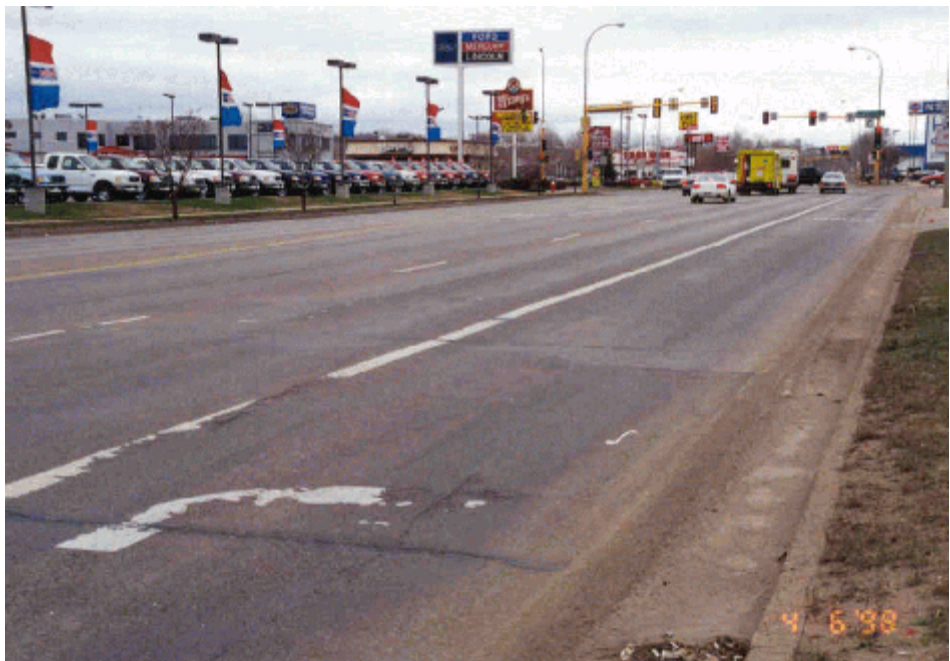
Photo 10. Line indicates where subgrade repair begins+ 370 feet

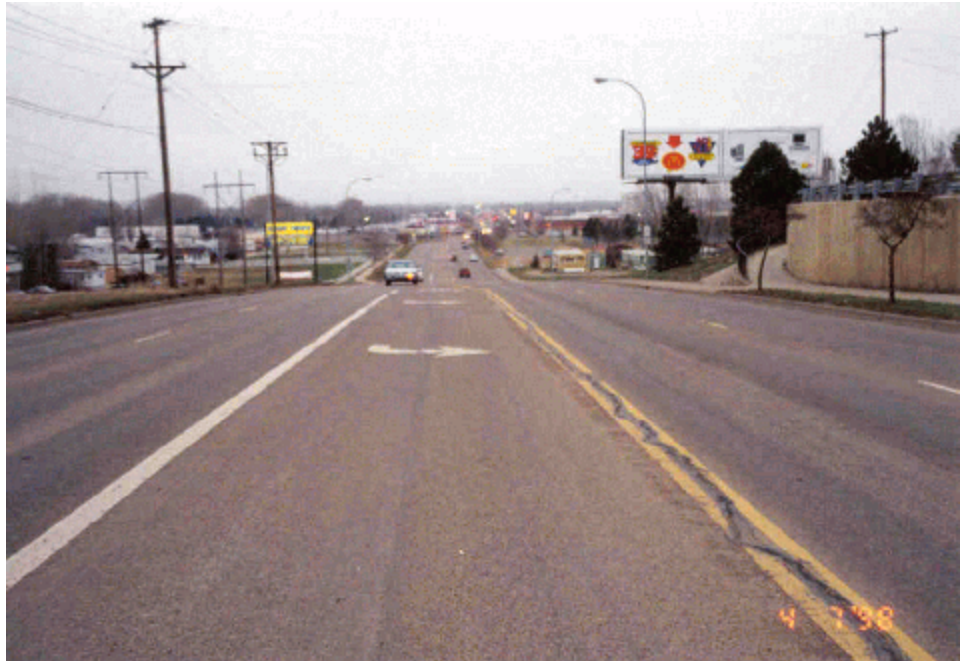
Photo 11 is a view of Bismarck Expressway looking west from near 18th street. This photo was taken on April 7, 1998. Compare it to photo 4 of this report which was taken soon after construction in 1992. To compare

Photo 11. Looking west from near 18 th street–April 7, 1998

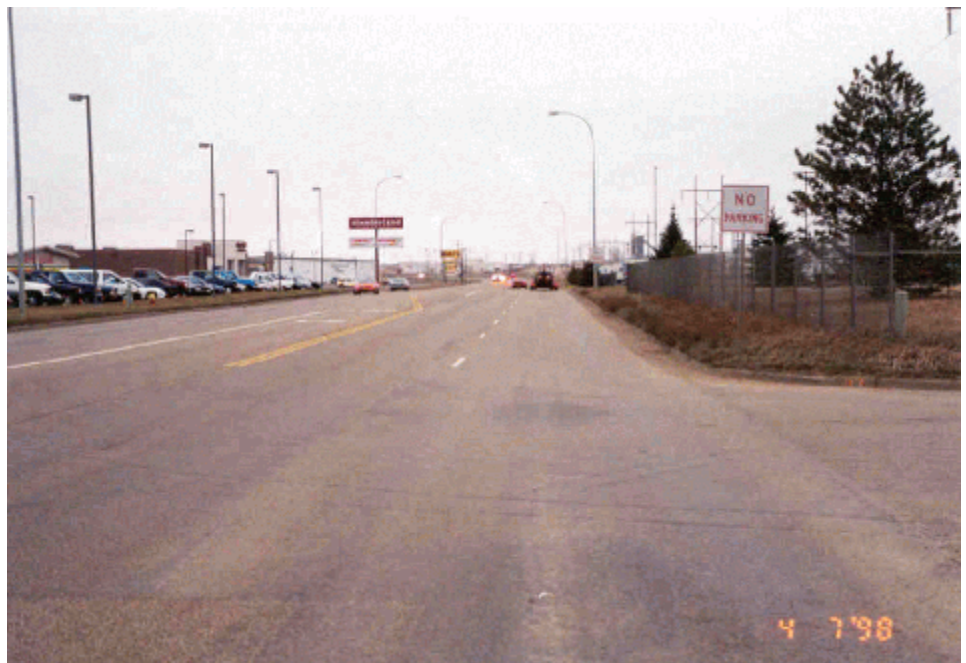
Ralumac to an asphalt pavement, a photo was taken east of airport road. Photo 12 is taken on Expressway from 22nd Street looking east. This asphalt pavement has tighter transverse cracks and no spalling compared to the

Photo 12. Asphalt east of airport road -- looking east from 22 nd street

Ralumac section. This section is on high ground and may consist of different soil types. The subgrade in the Ralumac and asphalt sections are similar and were constructed in 1985.
