**Evaluation of Stratagrid's A-100
Ability to Strengthen an Asphalt Overlay**

Final Report

Projects
ST-6-032(017)191 & NH-4-002(046)130

October 1997

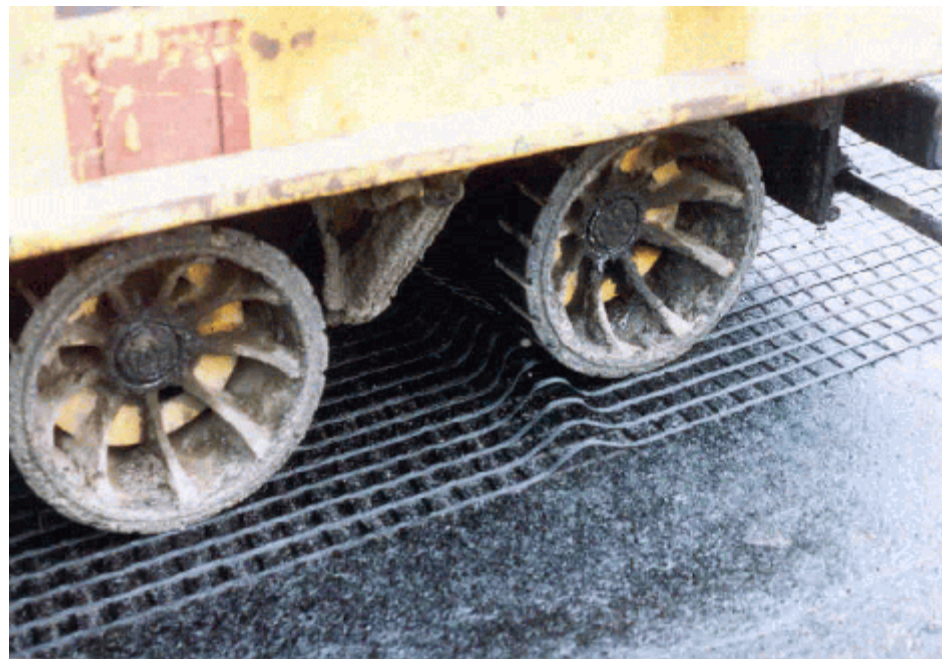
to back up from the end of the test section to the start of the test section. The trucks drivers were instructed to minimize sharp turns and sudden braking or acceleration movements while backing on the geogrid. It was important the geogrid was left lying flat and undisturbed. This was not the case when the overlay operation began. In photo 6 the geogrid is being lifted by the adhesive tack on the laydown machine wheels.

Photo 6. View of the geogrid being lifted by the laydown machine wheels.

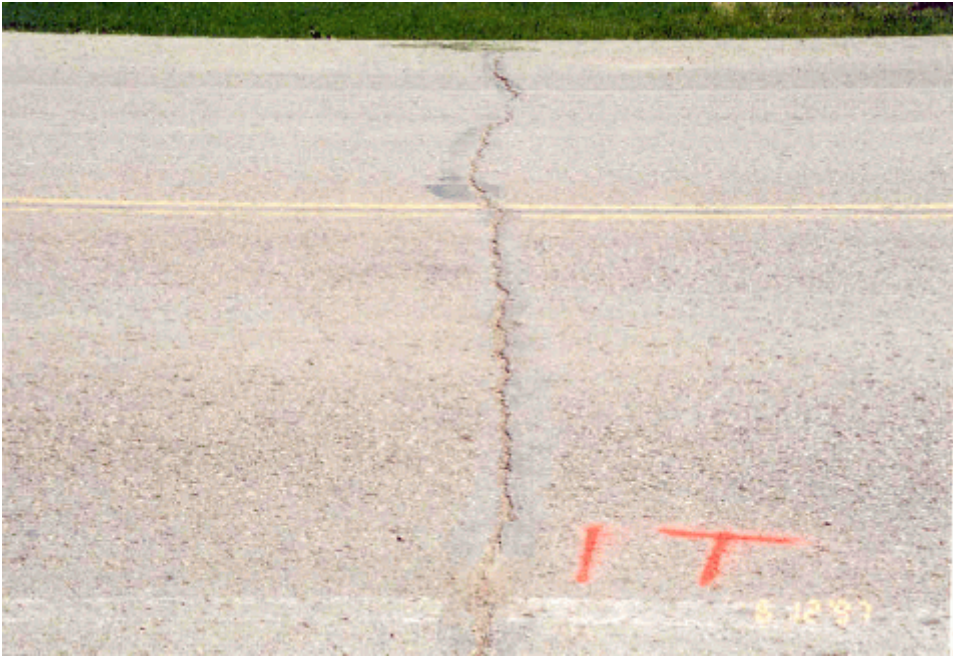
Photo 9 is a view of a typical transverse crack located in the test section.

Photo 9. View of a transverse crack in the stratagid test section

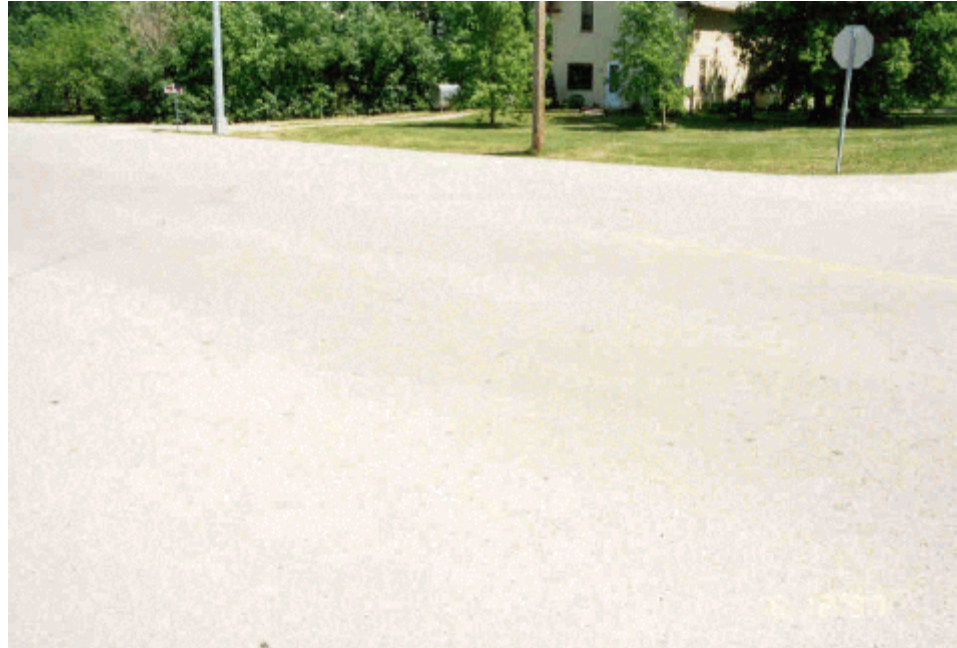
Photo 10 is an overview of an area located in the test section taken in 1997. Photo 11 is a view of the same area taken before the asphalt overlay and Stratagrid were applied. It would appear from these photos that the cracks shown in

Photo 10. Overview of an isolated area located in the test section

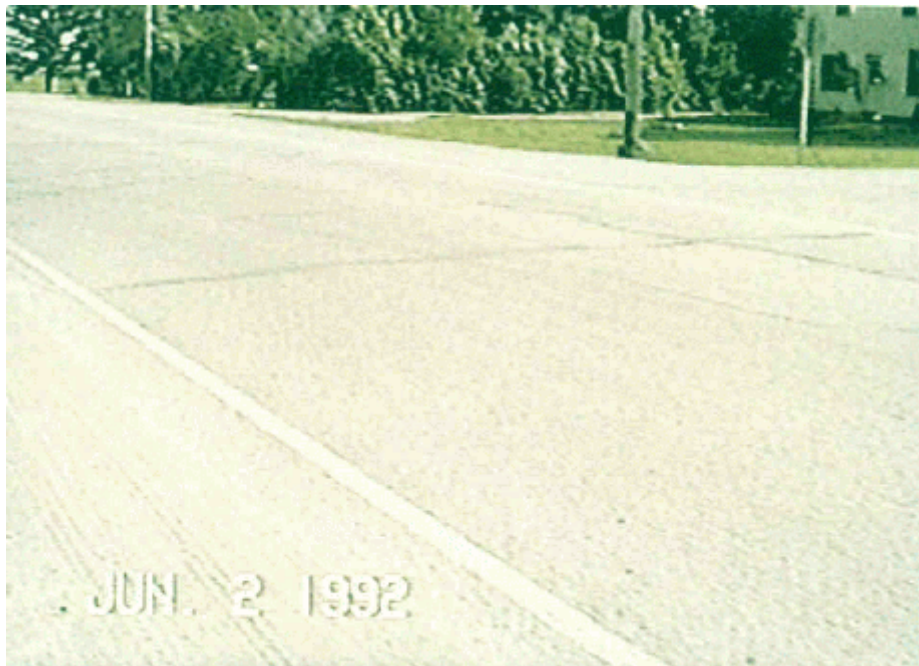
photo 11 have not all reflected through at this time. Also the test section appeared to

Photo 11. Similar view of the area shown in photo 10 taken before the asphalt overlay and stratagrid were laid down.

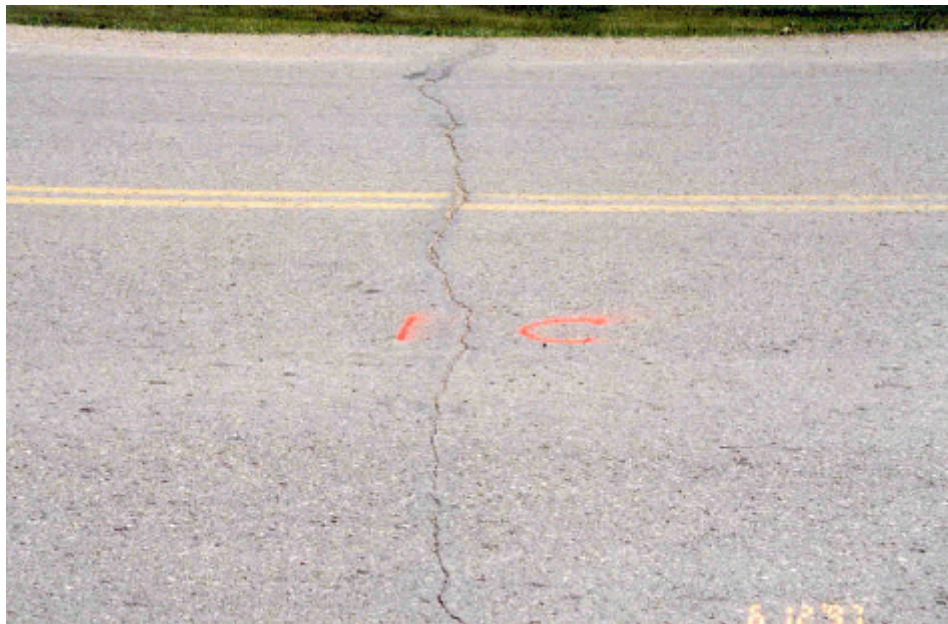
Photo 13. View of a typical transverse crack in the control section.

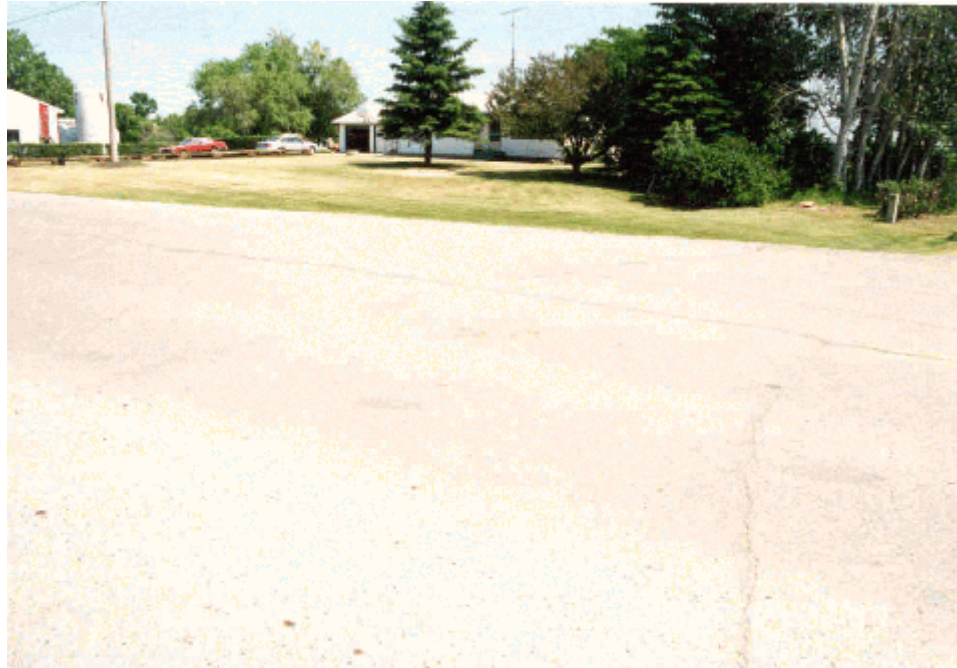
Photo 14 is an overview of an area suffering from a combination of longitudinal and transverse cracking located in the control section. Photo 15 is a view of typical longitudinal cracking. Upon viewing the preconstruction video, it would appear that most or all of the distresses in the control section had already reflected through.

Photo 14. View of an area displaying both transverse and longitudinal cracking in the control section.

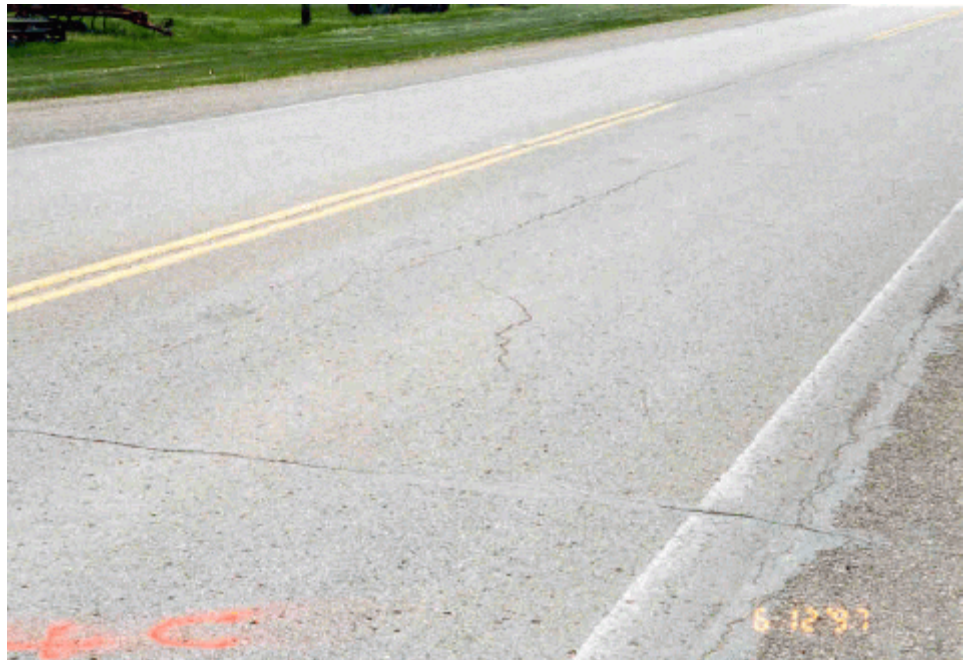
Photo 15. A view of typical longitudinal cracking occurring in the control section.

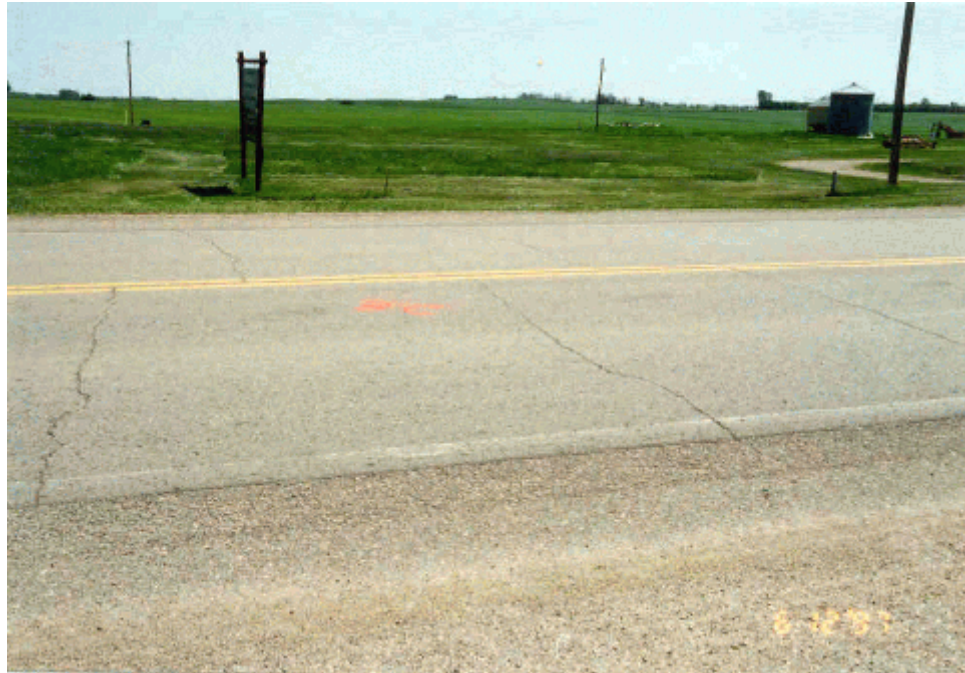
Part of the increase in transverse cracking in the control section is due to the type of cracking shown in photo 16. These cracks appear tighter and more closely spaced. They also rarely extend across the

Photo 16. View of the transverse cracking emerging in the control section. entire roadway. Upon viewing the preconstruction video, it was difficult to locate any of these distresses prior to the overlay.

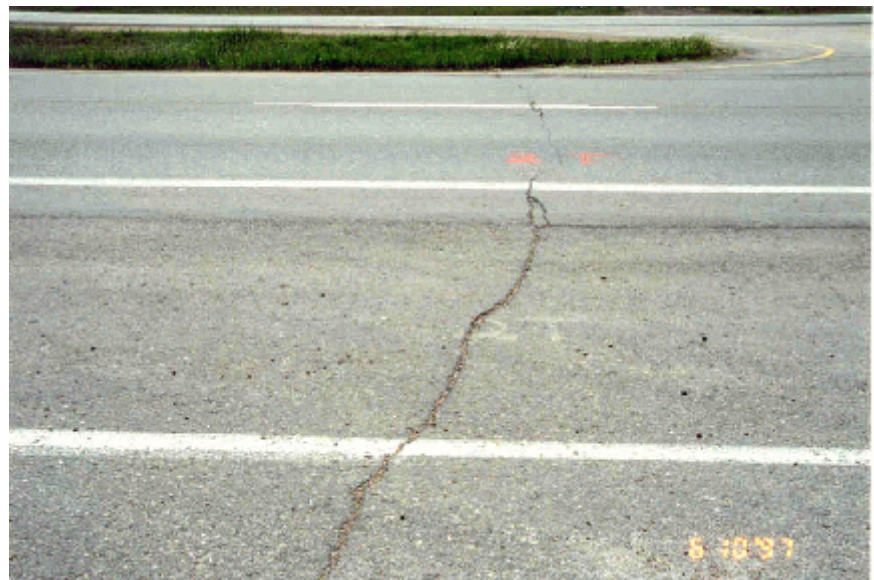
The test section registered nine full length transverse cracks and one longitudinal crack approximately 30' in length located along one of the shoulders. Photo 17 shows a view of the Stratagrid test section. Photo 18 shows a view of a typical crack in the test section.

Photo 18. A view of a typical transverse crack located in the stratagrid test section.

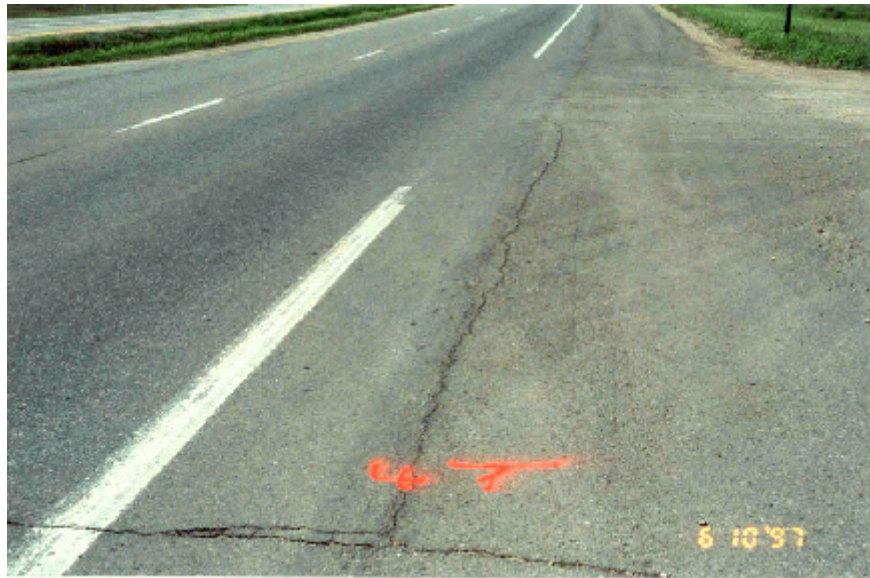
Photo 19 shows a longitudinal crack present in the shoulder (driving lane). Photo 20 shows one of several shoulder cracks present in the test section. These cracks have increased in length over the last two years but not to any significant amount. As was previously mentioned the

Photo 19. A view of a longitudinal crack located in the shoulder of the test section

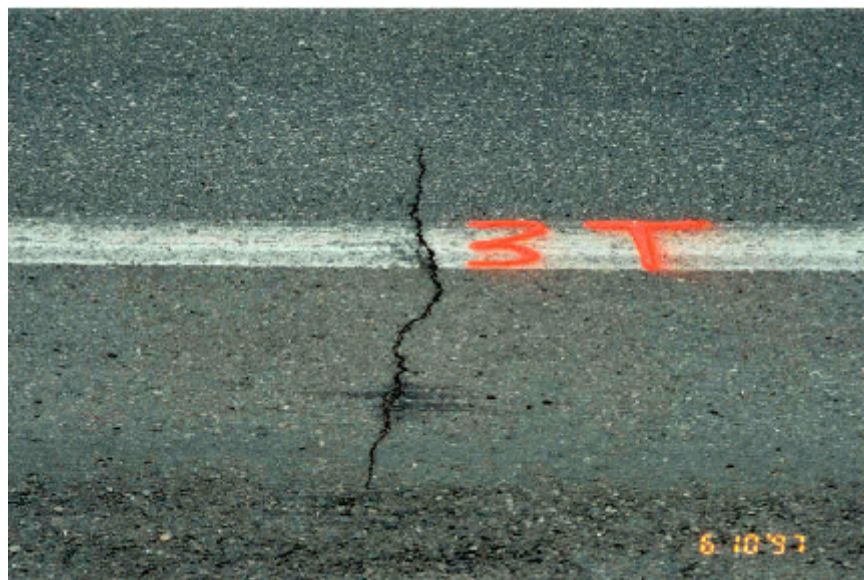
Photo 20. A view of a typical shoulder crack that is extending into the mainline.

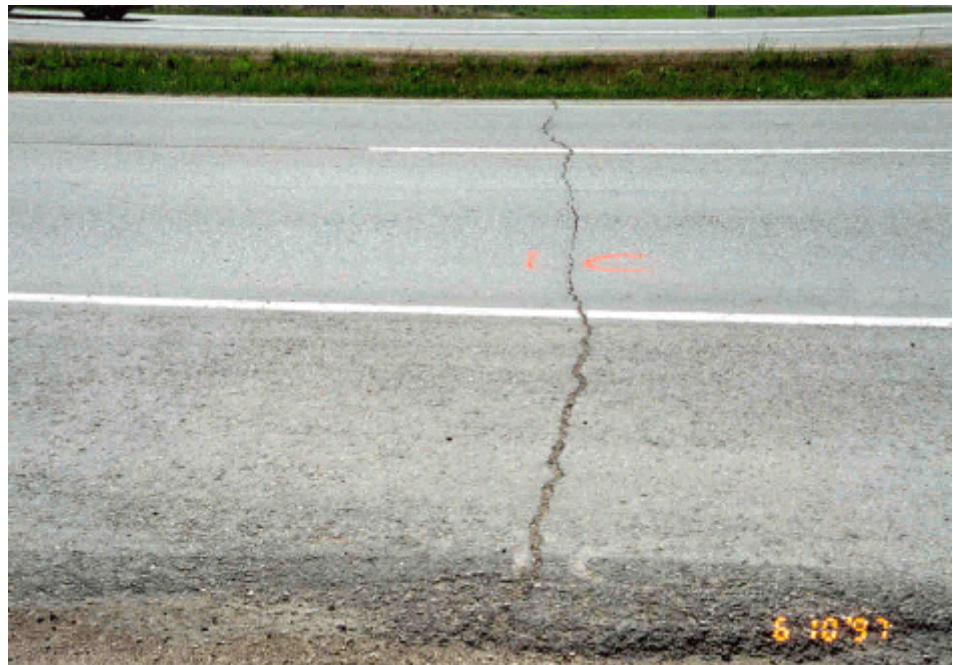
Photo 21 shows an overview of the east control section. The east control section registered 12 full transverse cracks and a 30' longitudinal crack in the shoulder. Photo 22 shows a typical crack located in the east control section.

Photo 22. A view of a typical crack in the east control section.

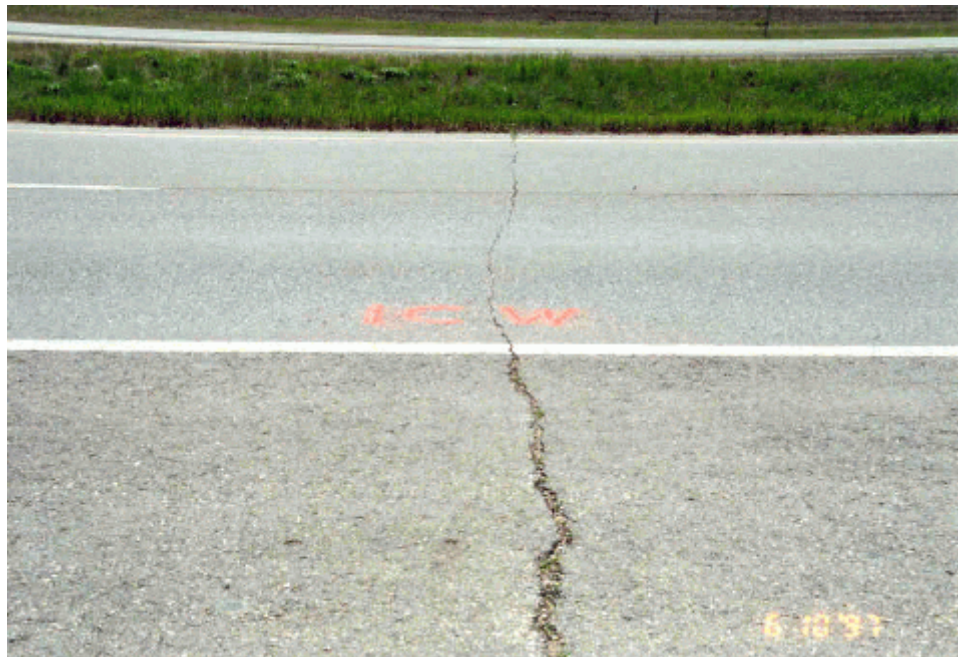
Photo 23 shows an overview of the west control section. The west control section registered eight full transverse cracks and a 30' longitudinal crack in the passing lane. Photo 24 shows a typical crack located in the west control section.

Photo 24. A view of a typical crack in the west control section.
