Experimental Study ND 94-01

**Evaluation of Saw and Seal
over the Overlaid Existing
Concrete Joints**

Final Report

Project NH-3-002(040)212

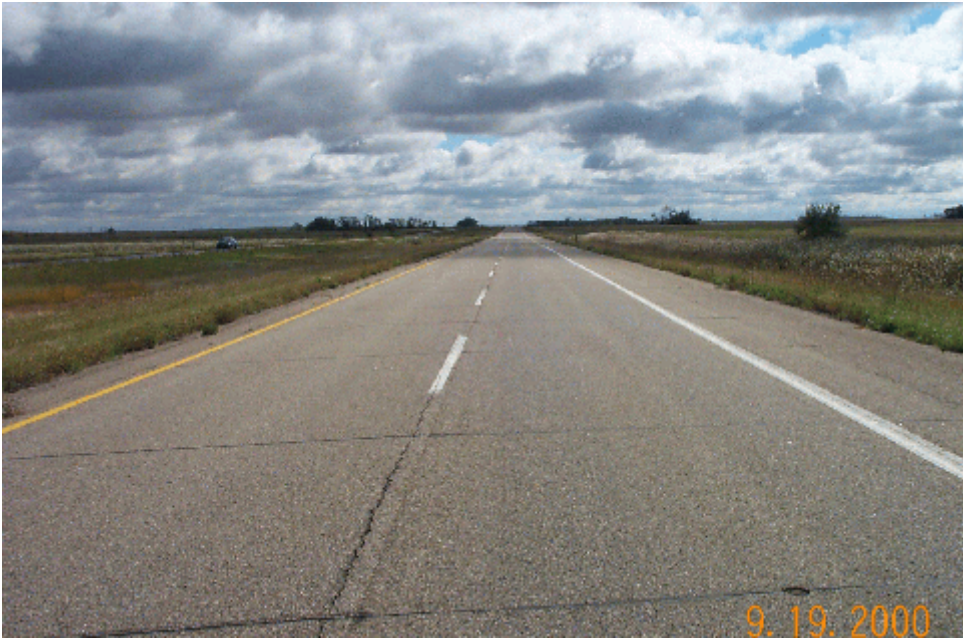
Photo 1
Overview of the Saw and Seal Section just east of Knox

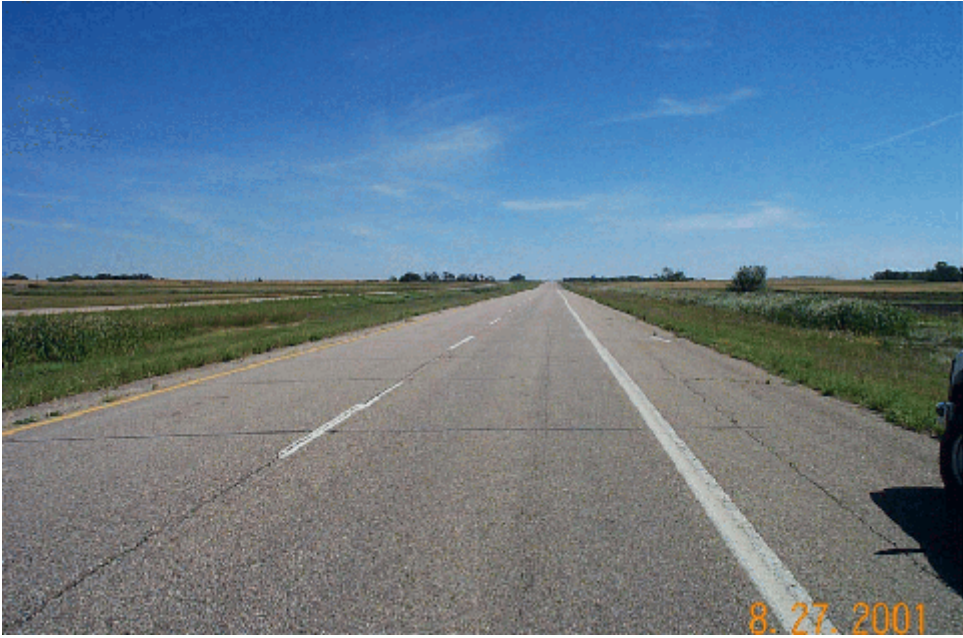
Photo 1A
Overview of the Saw and Seal Section just east of Knox

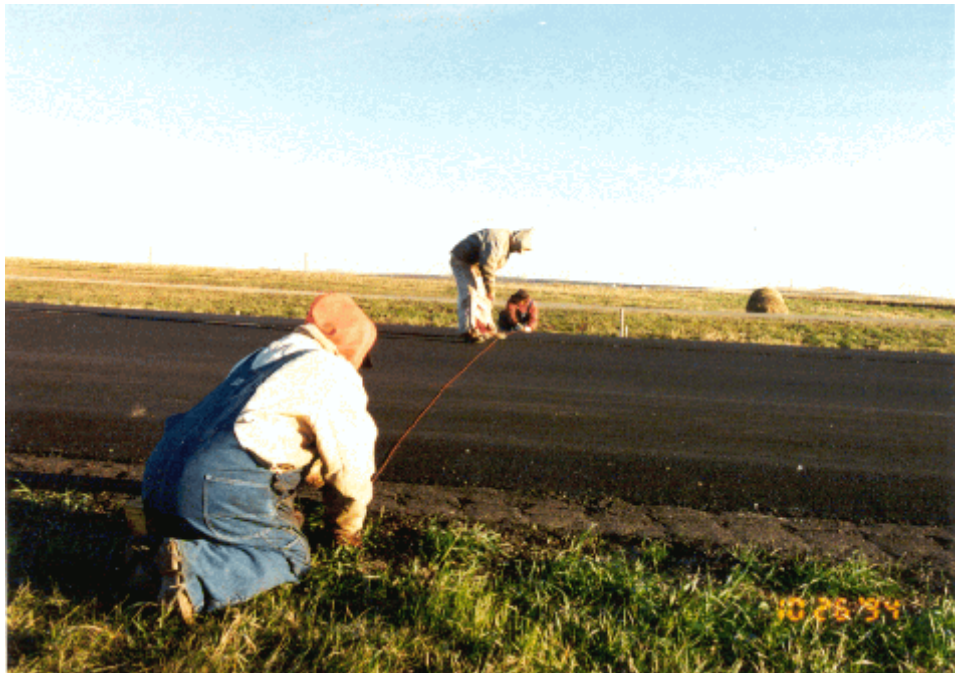
Photo 2.

A view of the Process by which the joints were reestablished in the overlying asphalt layer

The joint locations were reestablished by a chalk line run between the reference points as shown in photo 2.

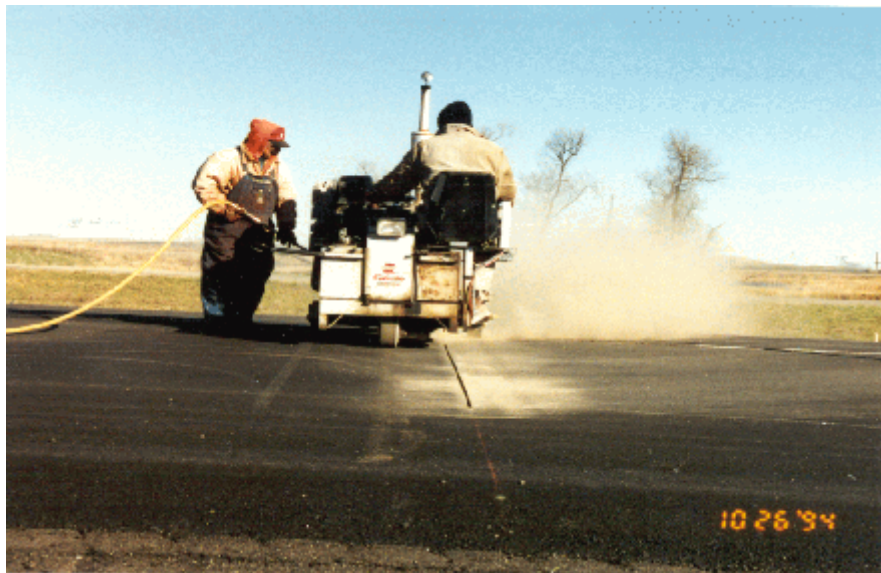
Photo 3
A view of the saw cutting operation

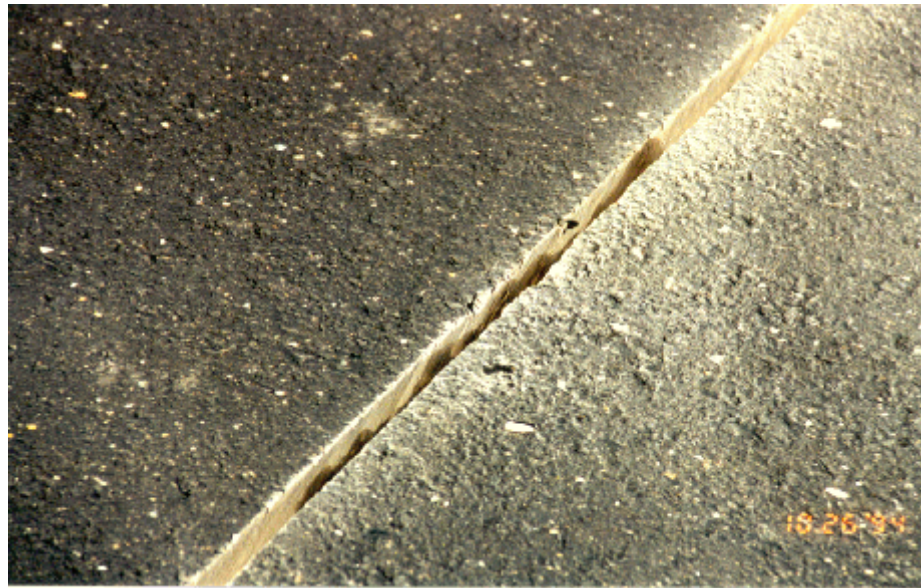
Photo 4

order to achieve a clean joint. Many of the sawcuts had places that were wet or moist as shown in photo 4. No explanation was given for the presence of the moisture. The contractor believed the moist joints would present a problem for the sandblasting operation. This prompted the contractor to apply the HCA step prior to the sandblasting. Photo 5 shows a view of this.

A view of a vessel that had moisture present along the walls

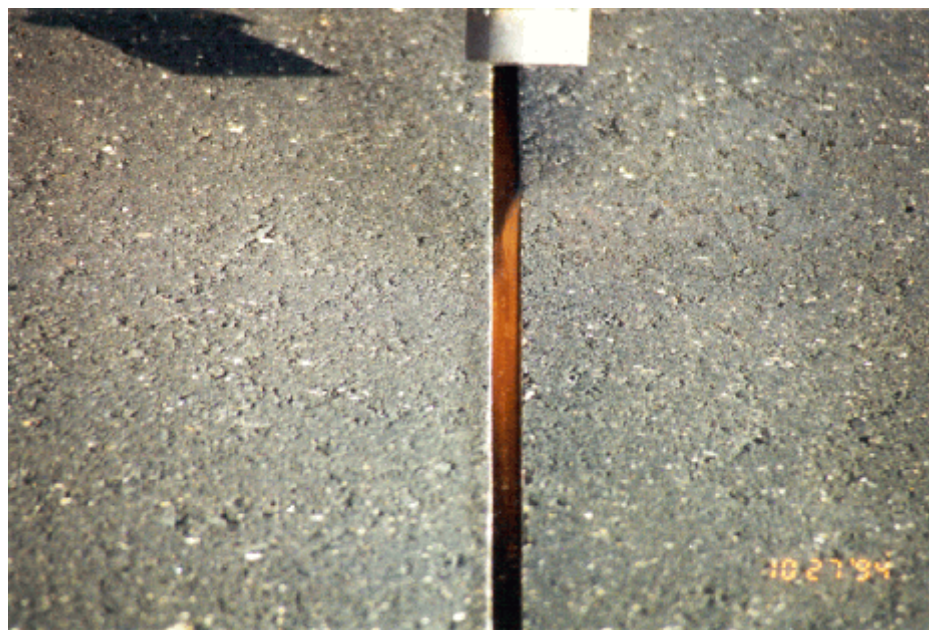
Photo 5

A view of the heat lance operation .

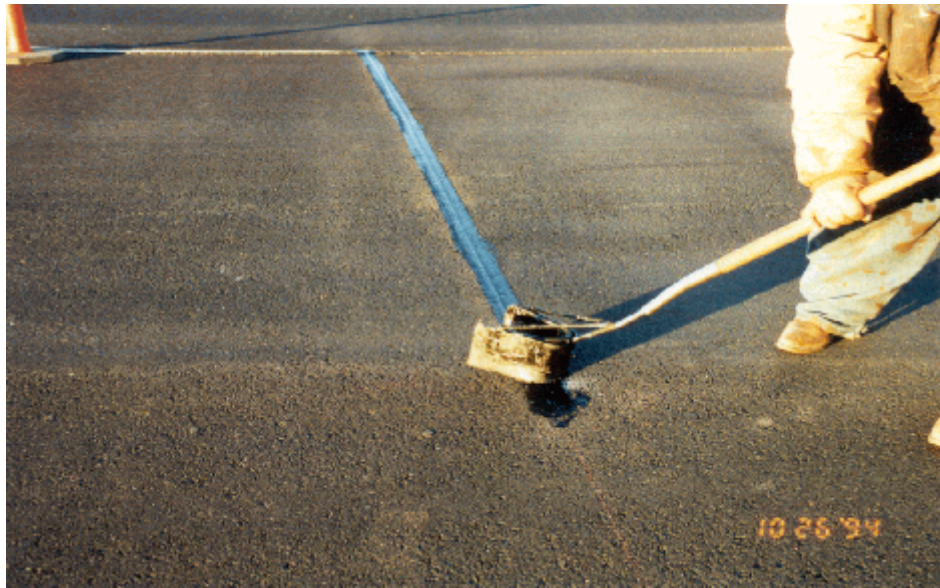
Photo 6
A view of the squeegee operation .

and fill the sawcuts. The sealant was heated to 355EF to 360EF before crack filling began. The filling of the transverse joints was started on the low side moving to the high side filling from the bottom up. All the vessels were slightly overfilled from the bottom up and followed with a soft rubber U-shaped squeegee to form a "wipe zone" of approximately three inches wide along the vessel and flush with the pavement surface. The joints were squeegeed in both directions. This procedure is shown in photo 6. The sealant quickly cools and contracts after it is squeegeed.

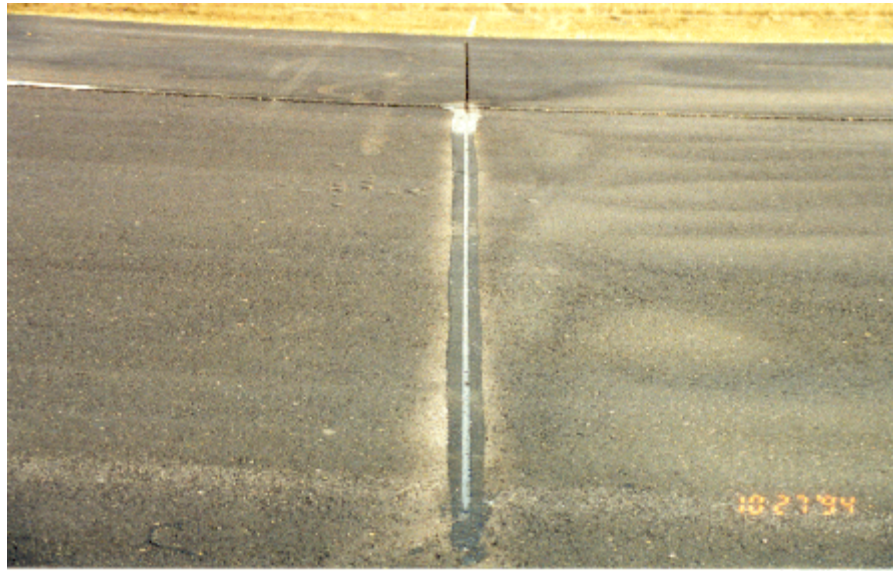
Photo 7 shows a joint that has been filled and squeegeed.

Photo 7
A view of a typical joint that has been filled with sealnt and squeegeed.

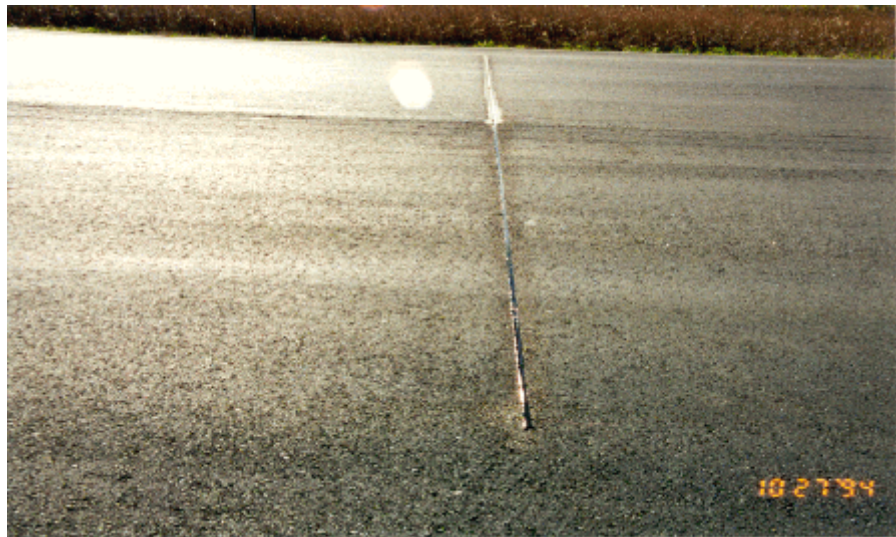
Photo 8 shows a joint that has been filled and not squeegeed. Only one of the joints were non-squeegeed. Extra time is required to fill a vessel that will not be squeegeed since care has to be taken to ensure the sealant is being applied at just the right height.

Photo 8
A view of a vessel that was sealed but not squeegeed.

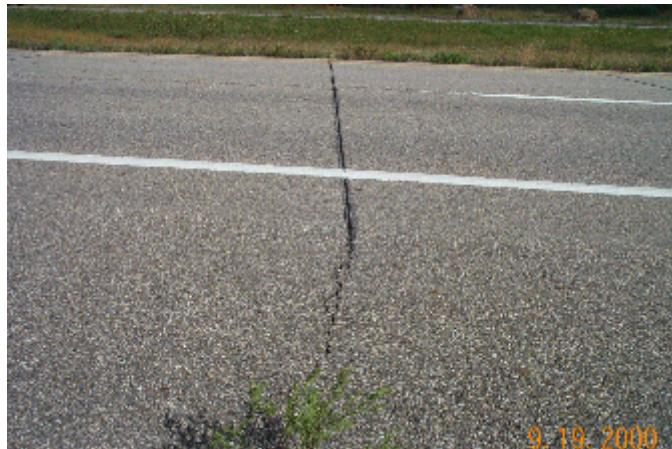
On September 19, 2000 Materials and Research conducted another evaluation of the Saw and Seal Experimental Section. Photo 9 shows a view of a typical sawed and sealed joint. At this location the crack has reflected through the shoulder. The entire test section appears to be in good condition with only a few spalls in the driving lane where the wheelpaths intersect the joint.

Photo 9
Typical saw and seal crack

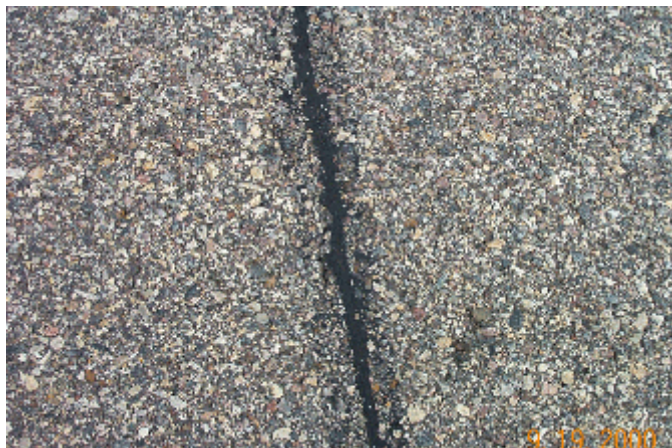
Photo 10
Spalling in wheelpath

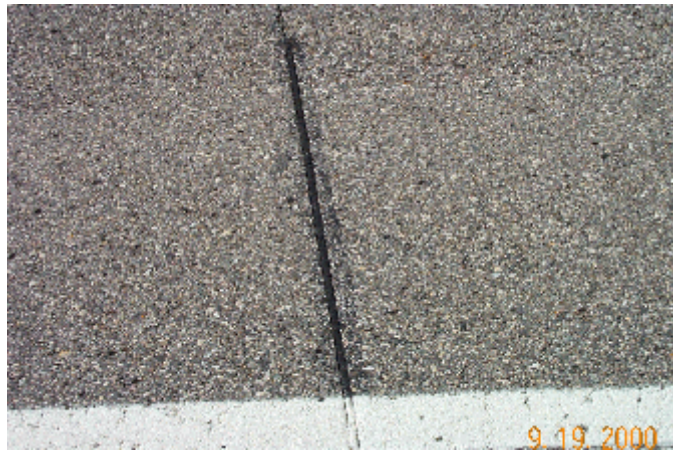
Of the 54 sawed and sealed joints in this test section, 20 have established cracking in the shoulders. Another 12 joints are experiencing emerging or established cracking about two feet into the shoulders adjacent to them. This amounts to 59% of the total joints that are experiencing reflective cracking in the shoulders. There is no other cracking that can be seen on this test section. The section produces a good ride. One joint in the passing lane only was constructed without using a squeegee. This joint is performing very well. The sealant has not lost adhesion as was expected. This method however may not be feasible as controlling the level of the sealant during filling is slow and hard to achieve. Photo 11 shows this non squeegeed joint.

Photo 11
Non squeegeed joint

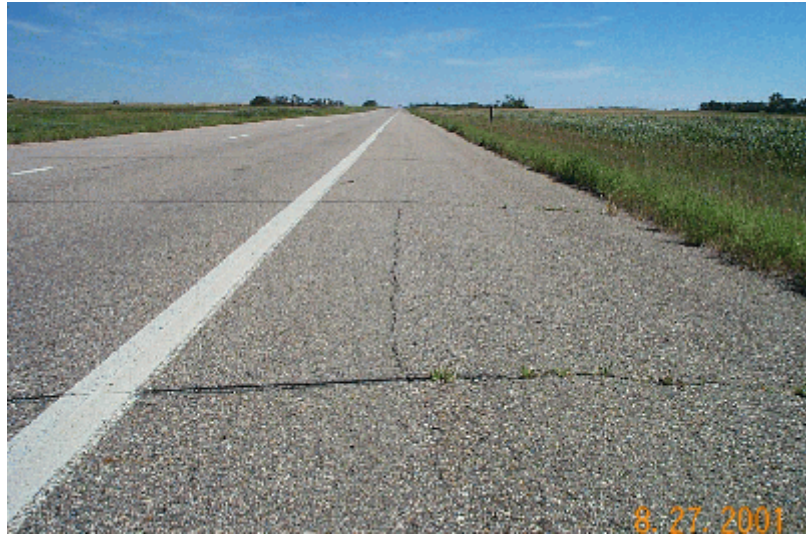
A final evaluation of the project was conducted on 8-26-01. The section is performing about the same as in 2000 with one exception. Two longitudinal cracks developed in the shoulder between joints. One such crack is shown in photo 12.

Photo 12
Longitudinal shoulder crack
