Experimental Study ND 94-07

**Scoping Edge Drains with
an Optical Camera**

Final Report

Project IM-8-094(005)331

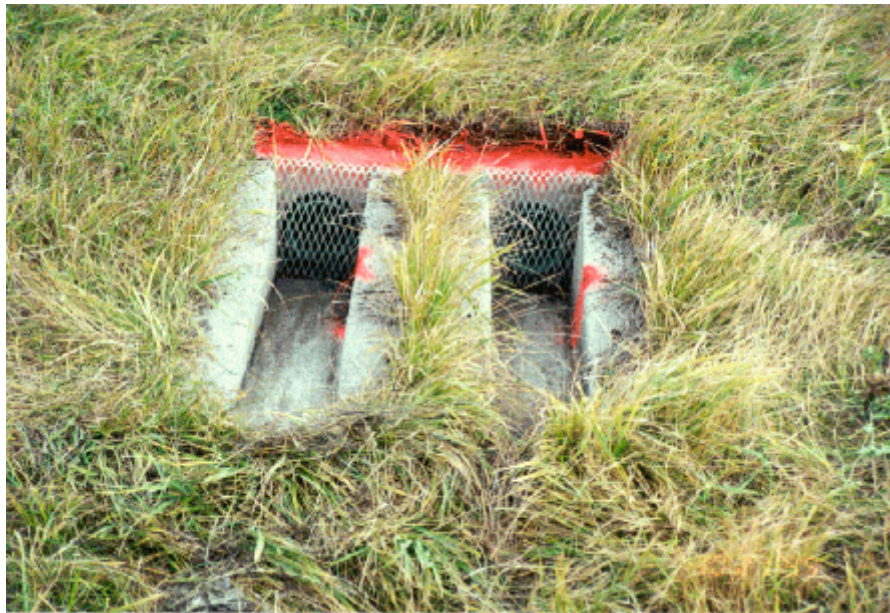
Photo 2: Typical Headwall-Painted for Ease of Location and Identification of Damage

After evaluation, the back edge of each headwall was painted for identification purpose. Any physical damage, (cracks, chips, etc.) was spot painted. Damage to any rodent screen was repaired. Note the location of chips in the headwall as indicated by the spot painting on Photo 2. Observations indicated that the condition of 3 of the 38 (7.9%) edge drain systems improved, 16 of the 38 (42.1%) had no change, and 19 of the 38 saw a degradation in their condition since last year's evaluation. The degraded conditions included; 19 of the 38 (50.0%) edge drain headwalls contained grass clippings, 7 of the 38 (15.8%) had damaged rodent screens, and 4 of the 38 (10.5%) had evidence of rodent nests at various locations within the drain pipes.

Mowers appear to be causing damage to the rodent screens. This raises the potential for intrusion of rodents into the edge drain systems. Rodent nests could introduce restrictions within the system and lead to collection of sediment. Damage is limited to the bending of the screens and is easily repaired utilizing hand tools.

The condition of the headwall area is critical to the performance of the edge drain systems. The headwall should be kept clear of grass clippings and other debris. Damaged rodent screens should be repaired to prevent rodents from entering the edge drain system.

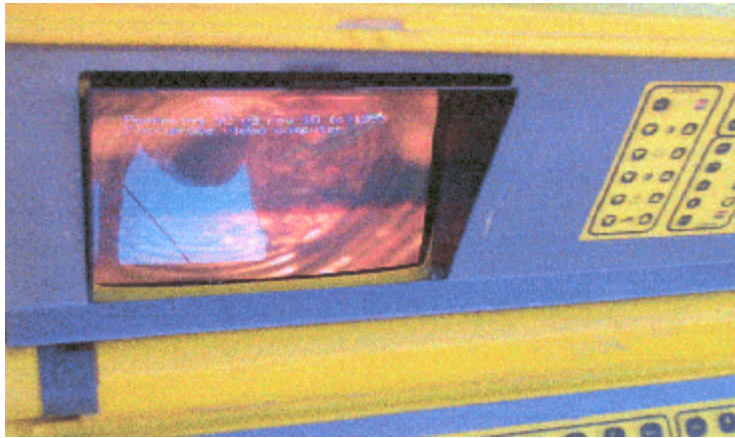
The Pearpoint optical camera system worked very well in observing the internal edge drain system. Performing regular maintenance is all that is needed to ensure optimum performance. Photo 3 shows what is observed on the optical camera monitor. If you look past the reflection on the screen, aggregate can be seen in the drain pipe.

Photo 3: Aggregate blockage in drain pipe.
