Experimental Study ND 96-01

**Evaluation of "Wasser" Single Component  
Moisture Cured Polyurethane Paint  
for Bridge Maintenance Overcoating**

**Final Report**

Project IM-1-094(017)156

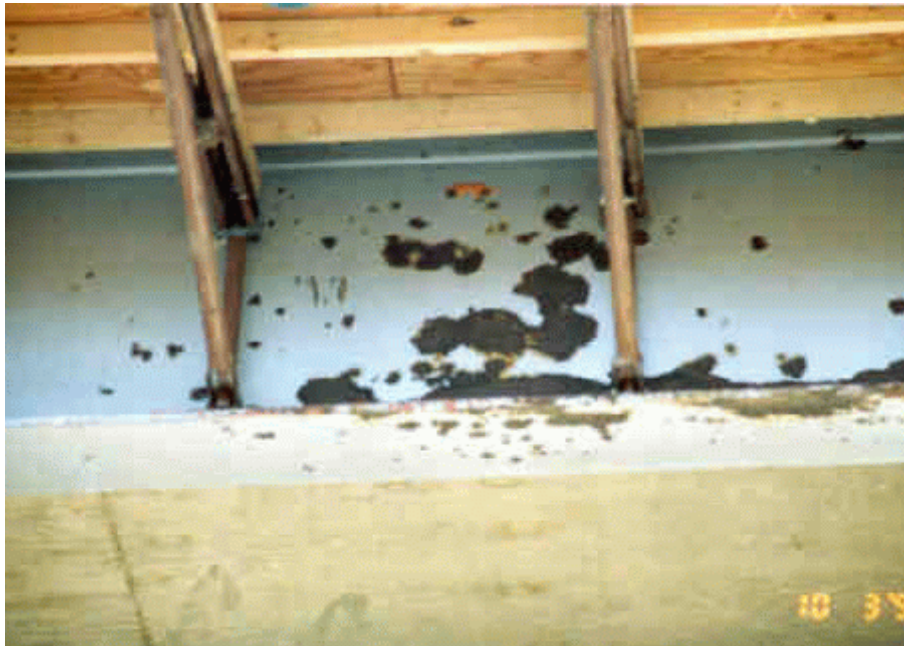
very well. Photo 6 exhibits one of the exterior beams after it has been washed with the high pressure washer. This is an area that requires spot grinding with a power hand grinder. This operation is depicted in photo 7.

Photo 6: View of exterior beam after high pressure wash.

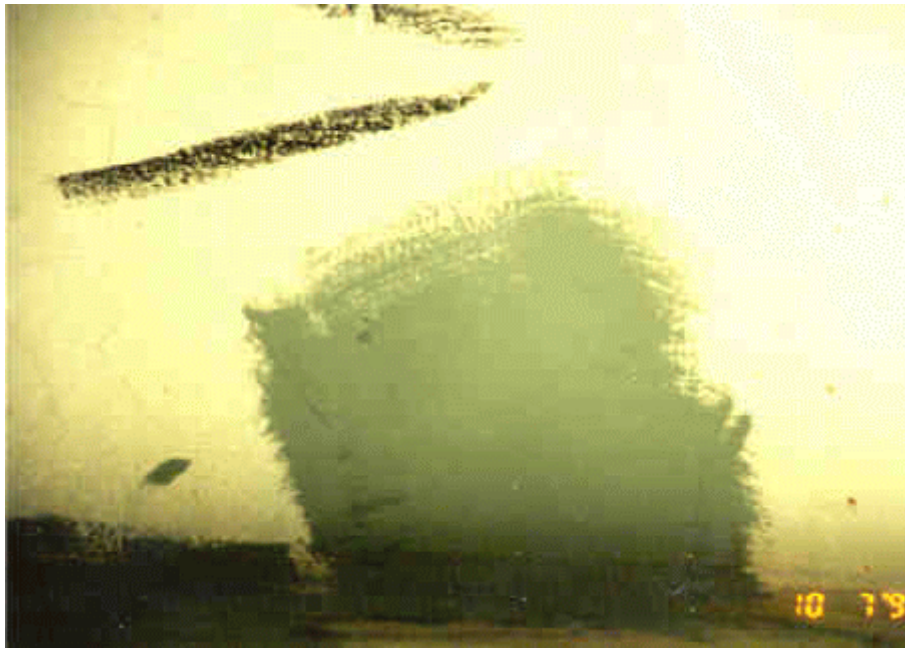
**Photo 8: View of spot primed area.**

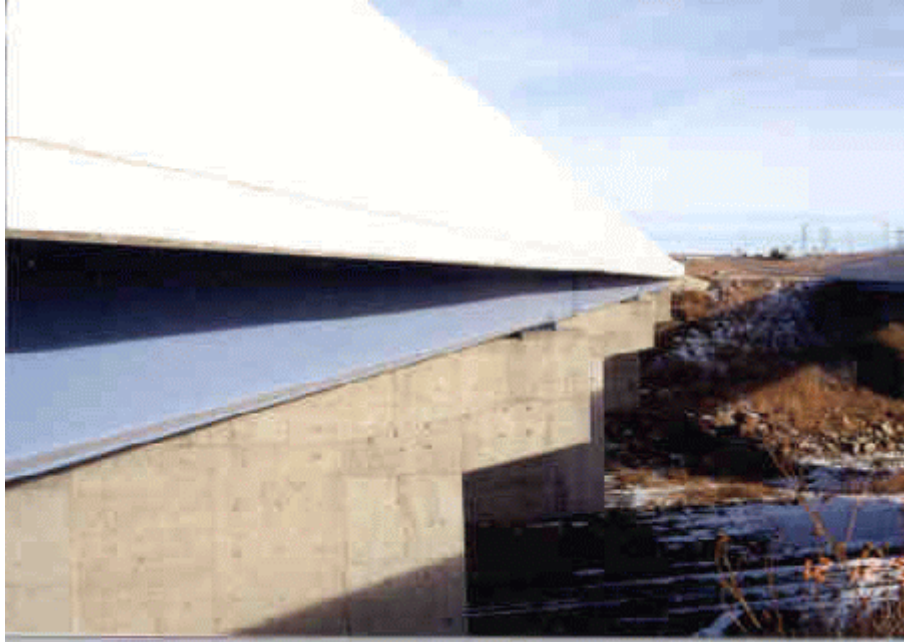
The evaluation team conducted the first year evaluation on December 17, 1997. There were no paint failures reported on either bridge. Some damaged areas were noted near the west end of the westbound structure. These appear to have been caused by other construction activities. Photo 13 is of the westbound structure and photo 14 is of the eastbound structure.

**Photo 13: View of south side of westbound structure.**

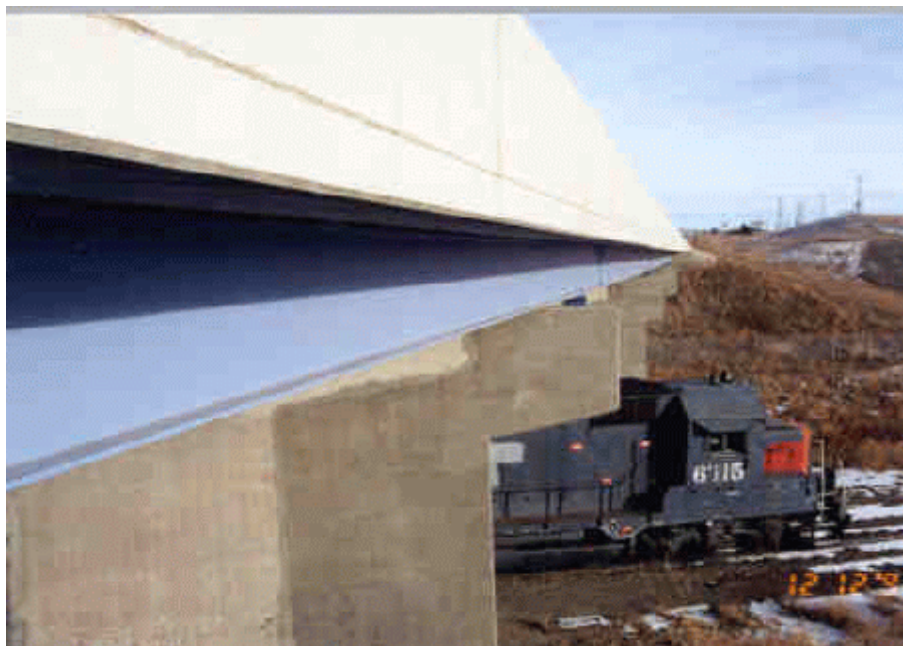
**Photo 14: View of south side of eastbound structure.**

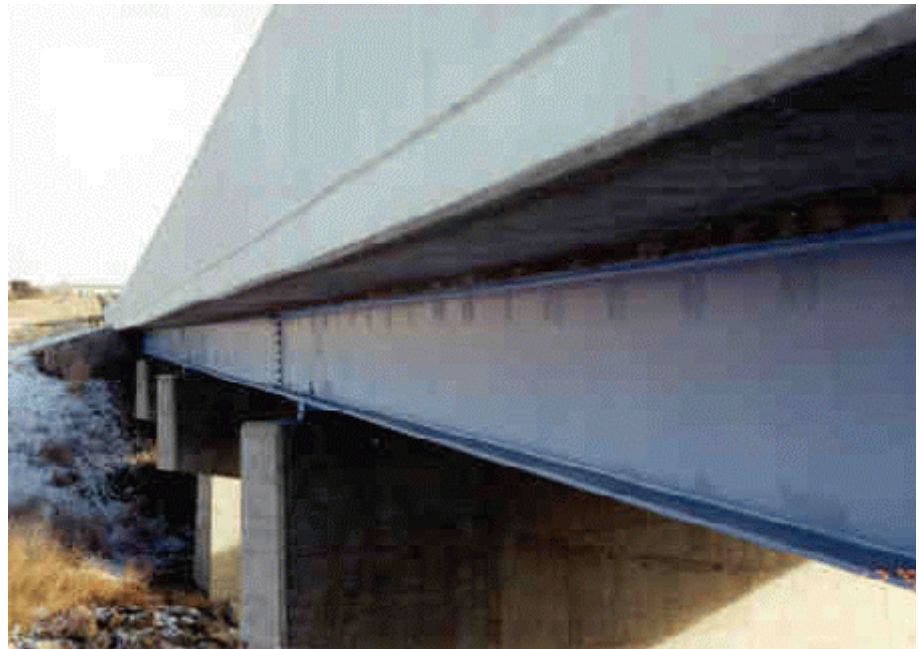
The only discrepancy noted on the westbound structure was the paint color on the touch up areas on the north beam of the westbound structure did not match very well. This condition is shown in photo 15. These areas were caused by the scaffolding hanging

**Photo 15: View of north beam on westbound structure.**

from the structure for the deck work damaging the new beam which had been shop painted. All members of the team agreed that due to the location of the beam, this was quite acceptable. The entire evaluation team stated that both paint systems looked "exceptional".

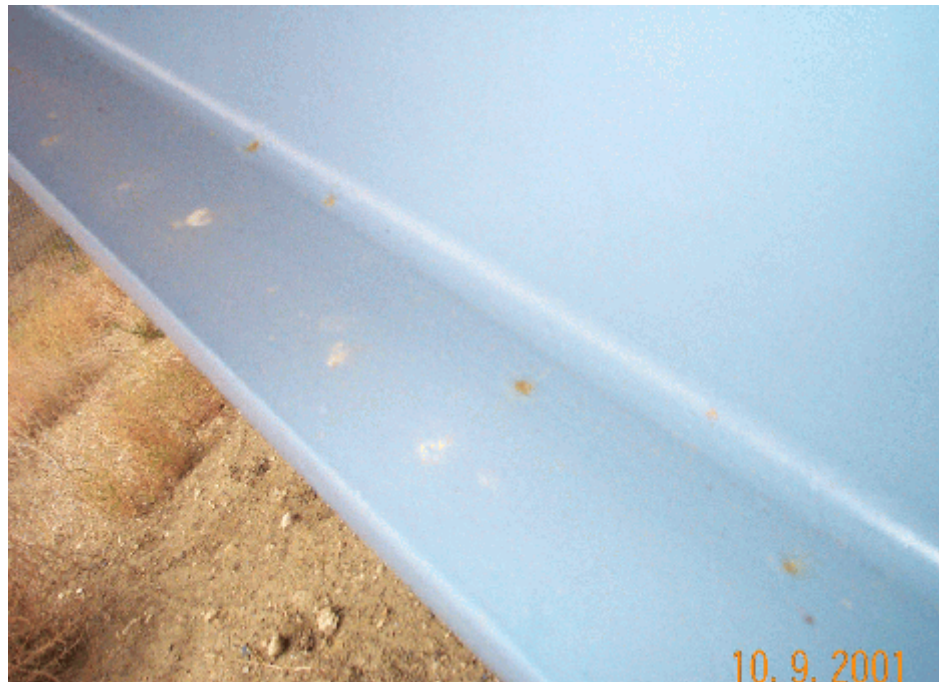
The second evaluation was on October 9, 2001. Some spot rusting were noted near the east end of the westbound structure (south beam). Photo 16 shows where the rust is starting to appear on the flange. This is only apparent on a four foot section of

**Photo 16: Spot rusting on south beam on westbound structure.**

the flange.

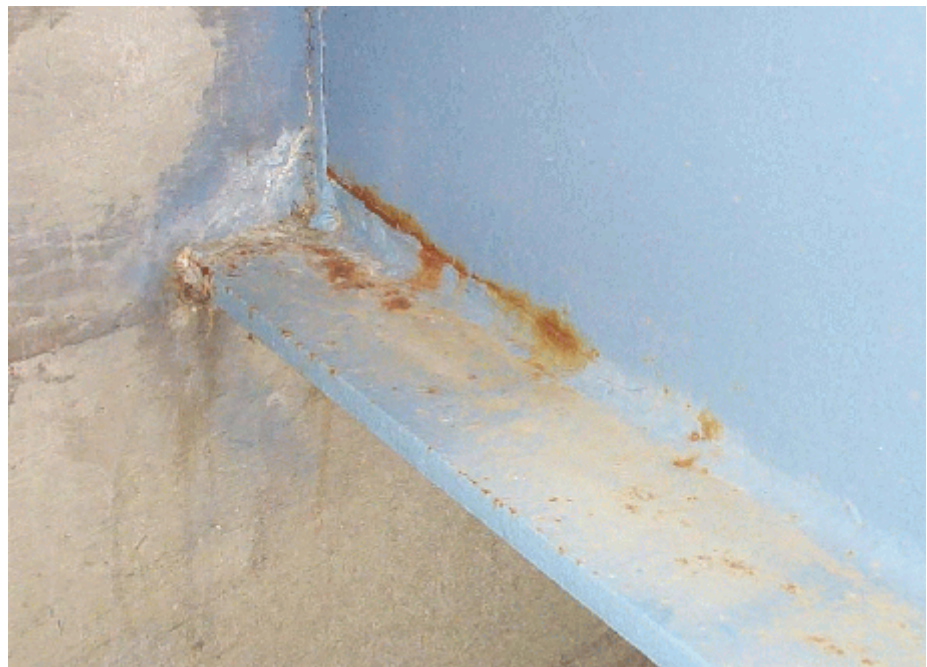
A damaged section on the west end of on the westbound structure was also noted (south beam). Photo 17 shows the damaged area. It appeared as if the paint had cracked along the top of the flange area which allowed moisture to enter.

**Photo 17: Damaged south beam on westbound structure.**

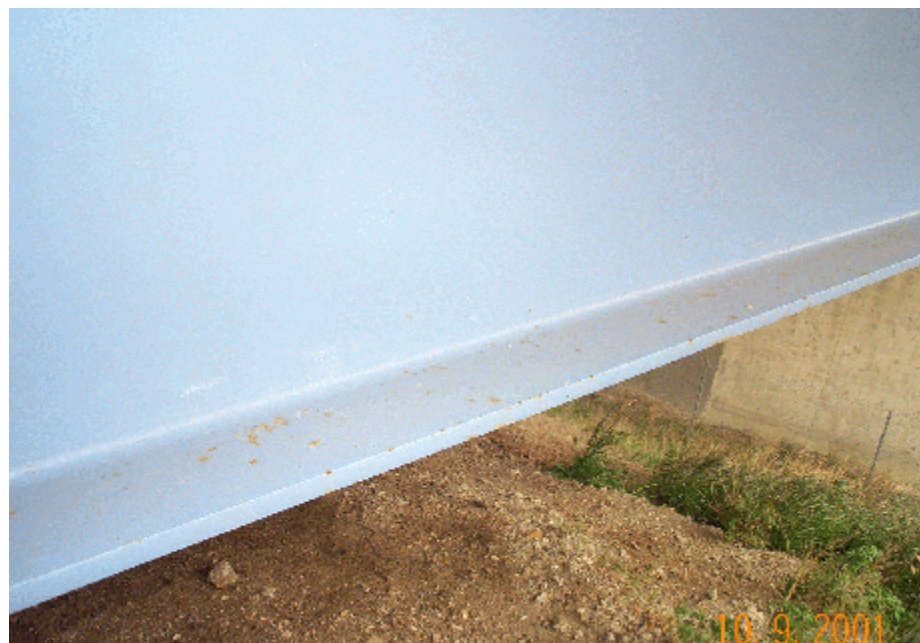
The control structure which is the eastbound Haycreek separation structure also had some damaged areas. As shown in Photo 18,

staining which is associated with rust has covered much of the flange area. About half of the flanges were effected.

**Photo 18: Staining associated with rusting on eastbound structure.**

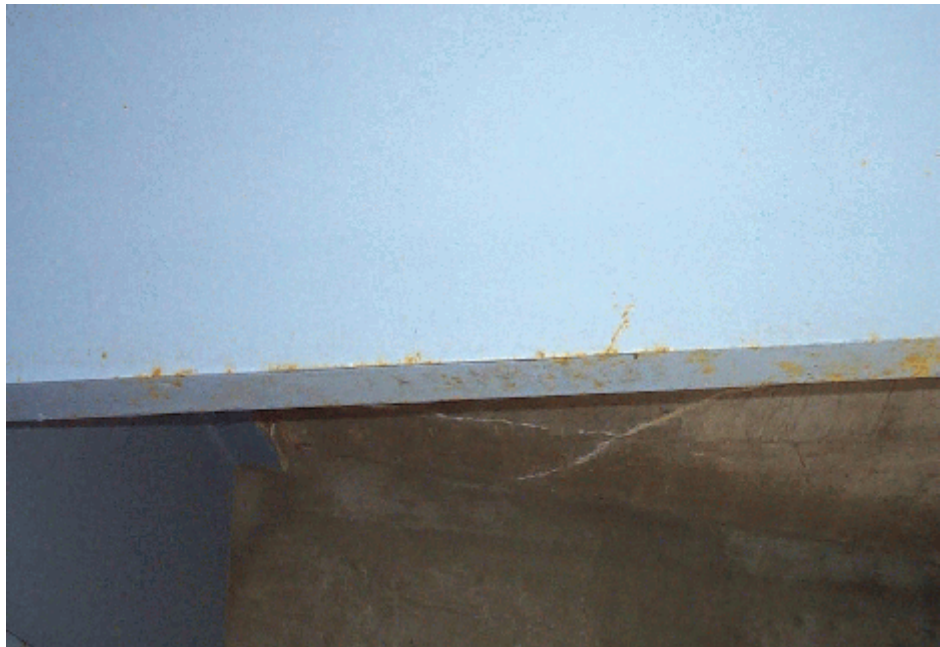
Staining also occurred under the beams. Many beams again were effected. Photo 19 shows a typical beam.

**Photo 19: Staining underneath the beam on eastbound structure.**

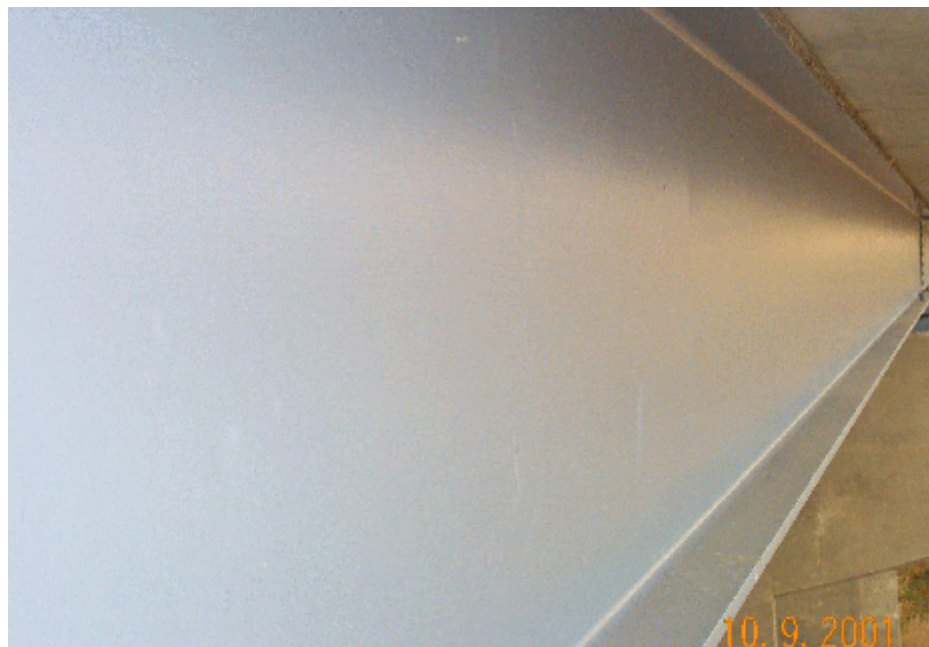
The paint system on the south beam of the eastbound structure appeared to be in good condition. No visible signs of staining or rust was apparent. Photo 20 shows the south beam of the control structure.

**Photo 20: View of south beam on eastbound structure.**
