Experimental Study ND 98-01

**Evaluation of Portland Cement Concrete  
as a Rehabilitation Option for  
Overlaying an Existing Asphalt Roadway**

**Final Evaluation Report**

Project NH-2-052(012)244

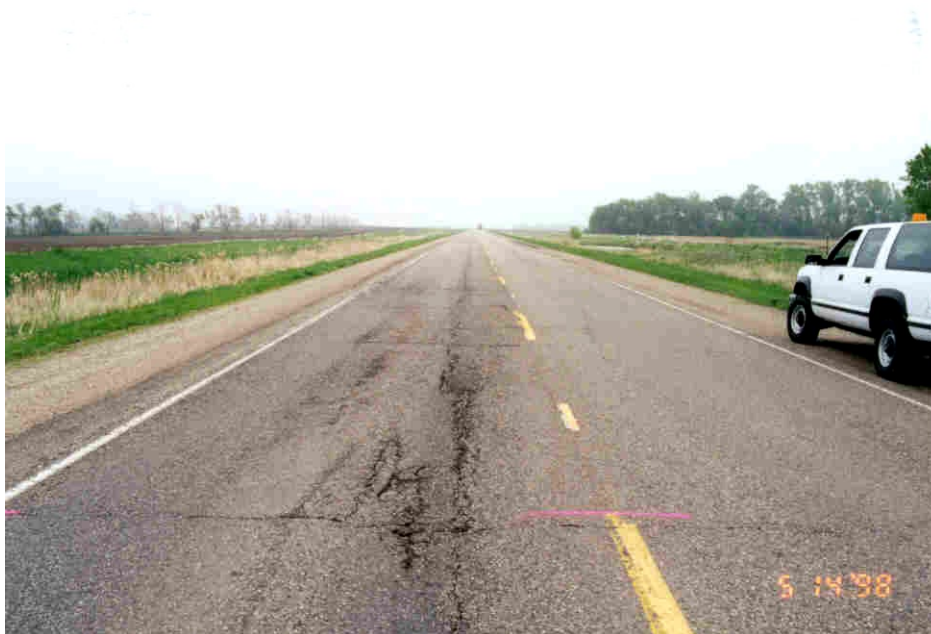
The roadway in question was experiencing distresses such as longitudinal and transverse cracking, rutting (1/8" to 3/8") and shoving pavement, and depressed transverse cracks. This segment of roadway was listed as poor for the ride and the international roughness index. Photo 1 depicts a segment of US 52 with a severely depressed longitudinal crack. One of the rehabilitation options for this roadway was to mill the existing asphalt and overlay with new HBP. However, this option was not considered since the existing cracks would eventually reflect through the new pavement.

**Photo 1 - Overview of distressed areas on a segment of US 52.**

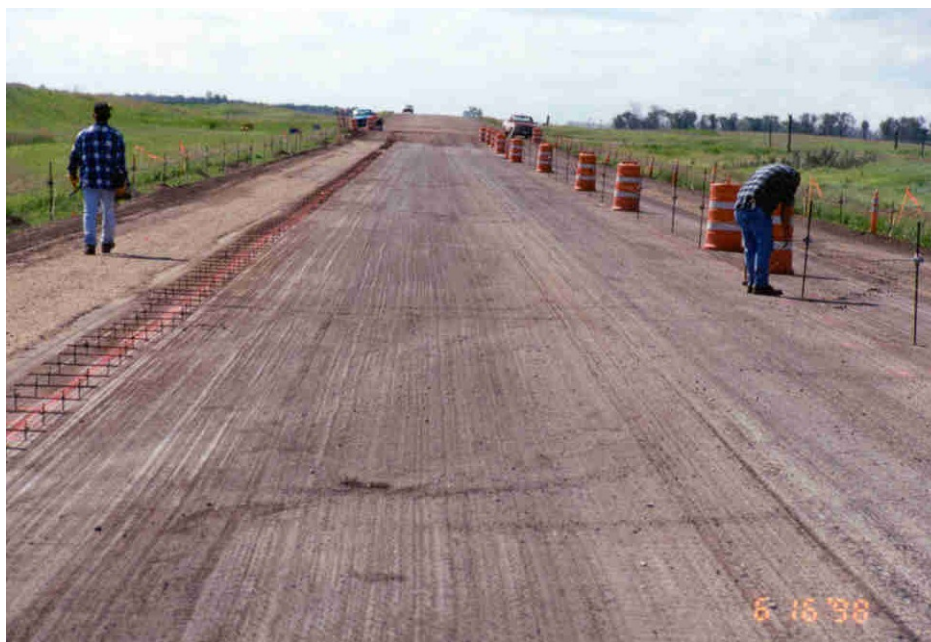
Photo 2 depicts the surface after the milling was concluded. Upon further examination there appeared to be some loose particles and dust still present on the surface. On the left side of Photo 2 tie bars are visible which are located between the impending shoulder and mainline.

**Photo 2 - HBP surface after milling was concluded.**

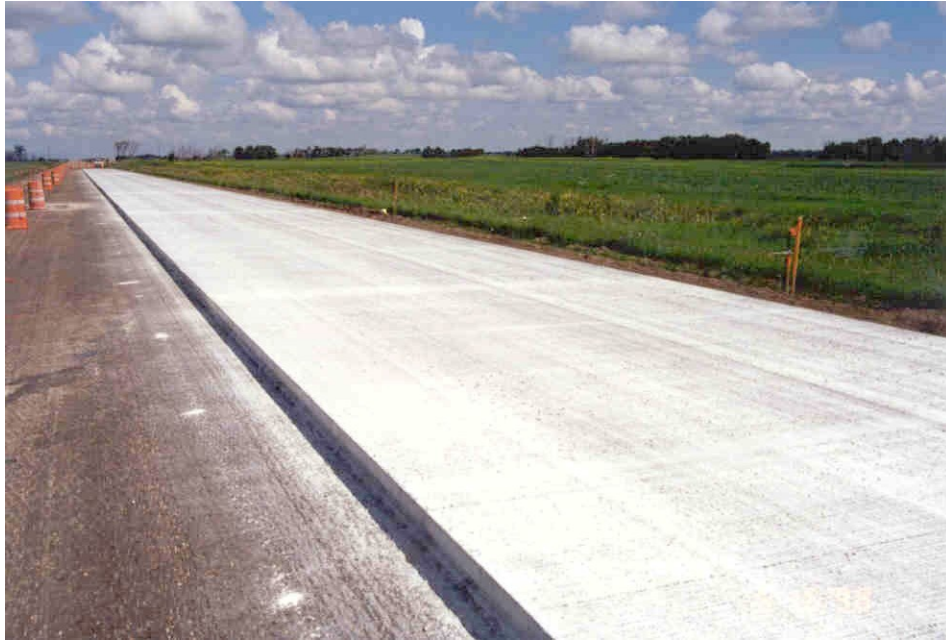
Photo 3 depicts an overview of the finished slab in the northbound lane of section 1 (5" PCC). The contractor commented that during the construction of the 5" PCC slab he had to lower the tie bars. This was necessary since the paver was hitting the top ends of the bars leaving them sticking out of the slab after the paver passed over them.

**Photo 3 - Overview of finished slab in the northbound lane of section 1 (5" PCC).**

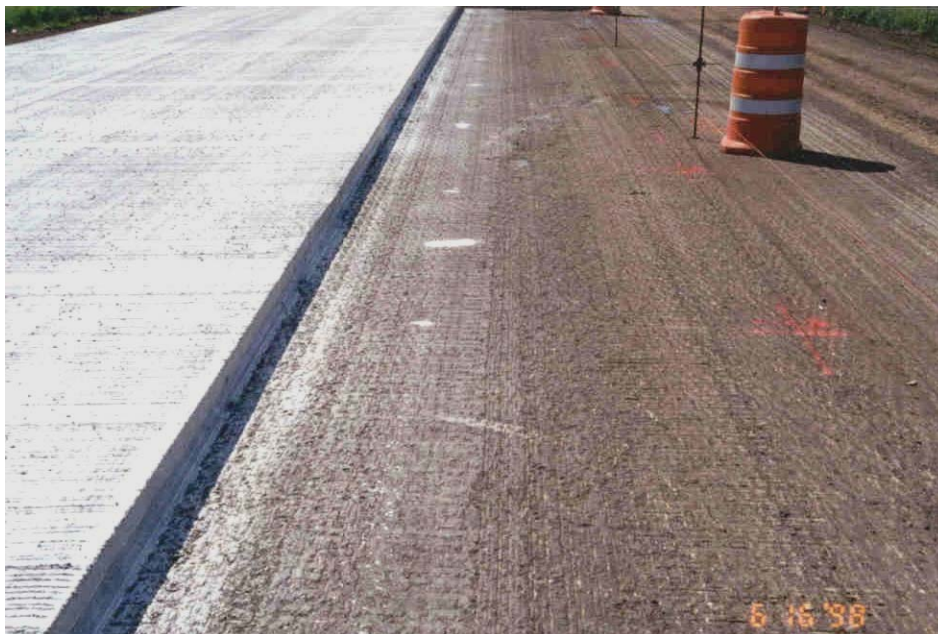
Photo 4 depicts excess curing compound that was sprayed where the southbound lane would be constructed.

**Photo 4 - View of excess curing compound sprayed where the southbound lane would be constructed.**

The NDDOT personnel were concerned the over-sprayed curing compound would hamper the bonding effect between the PCC and the existing asphalt. The contractor agreed to remove the compound from the surface prior to placing the slab. The contractor finished all three test sections in the northbound lane by mid to late afternoon. Although precise times were not kept, the placing of the 6" slab required a little more time than the 5" slab because of the increase in the volume of PCC. The contractor commented that the job would have progressed at a faster rate if the ready mix trucks could have kept up to the paver.

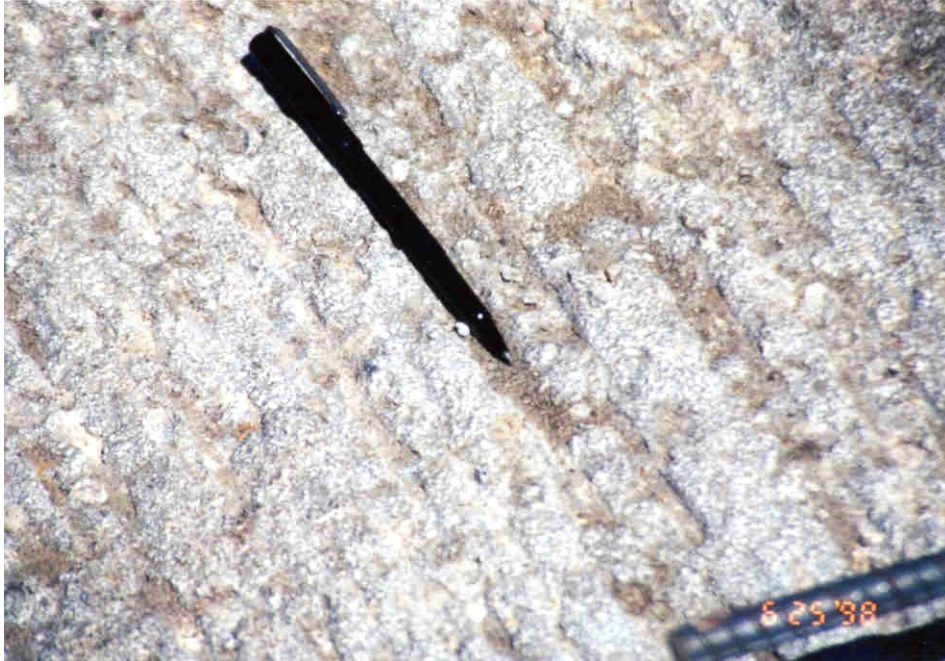
Photo 6 shows a close-up view of small particles and dust that remained on the milled surface that were not blown off prior to paving.

**Photo 6 - Small particles found on the HBP prior to paving.**

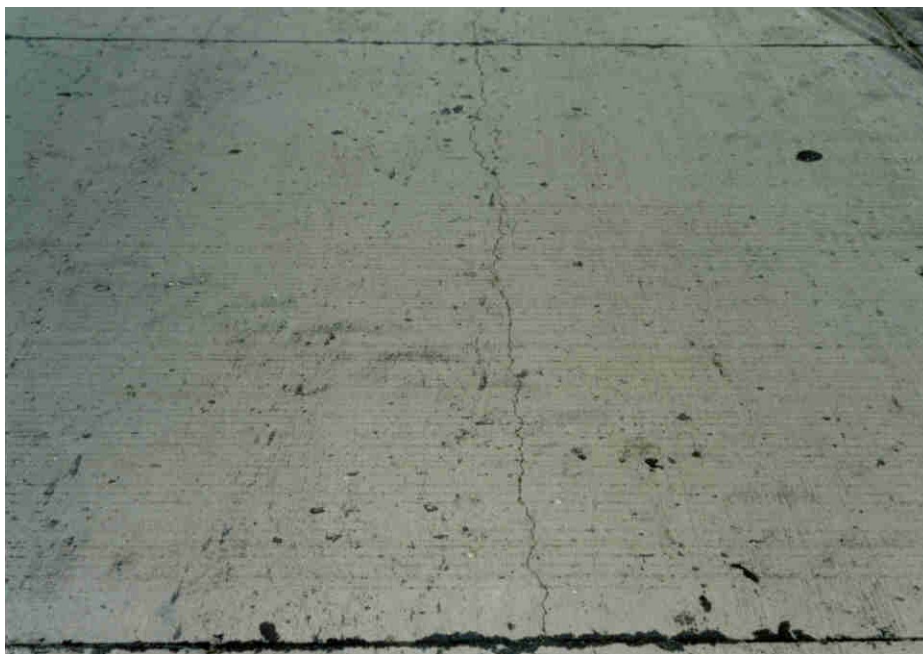
Photo 7 depicts an overall view of test section 1. A representative of the Materials and Research Division visited the site a few weeks after construction. The test sections were free of distresses except for a longitudinal crack located in the northbound lane near the beginning of test section 1. Photo 8 depicts a view of this distress which spans approximately 40'.

**Photo 8 - Longitudinal crack in test section 1 after construction.**

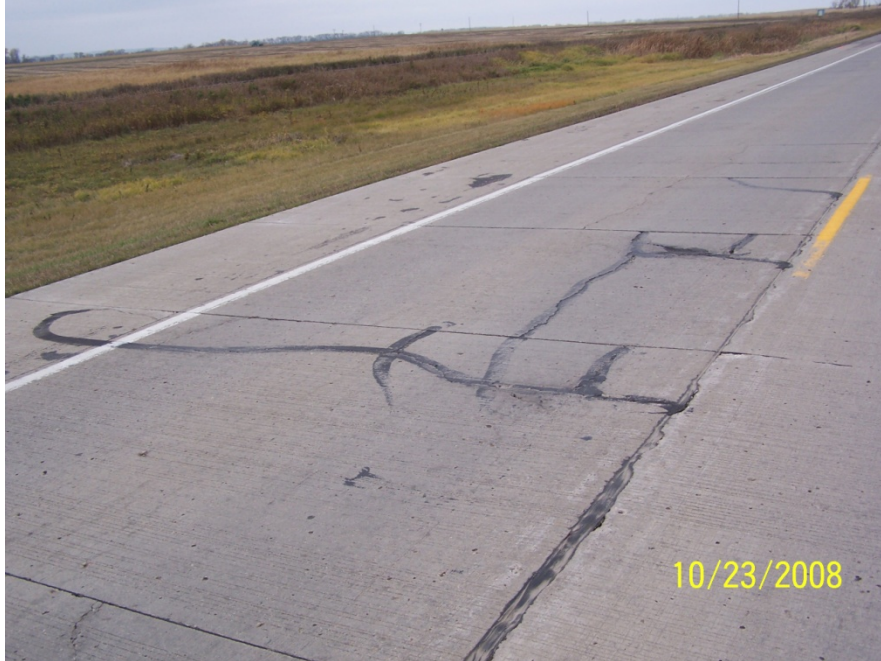
During a post construction evaluation of the white topping test section, it was discovered that some cracks had begun to form. In the summer of 1999 the Valley City district performed some preventive maintenance on the longitudinal cracks. This process consisted of using a router to saw ½" of PCC adjacent to the cracks, and filling the void with the polymer sealant CRAFCO 231. The Valley City District has since resealed the longitudinal cracks with an asphalt binder.

The review team located approximately 220 feet of low to medium severity longitudinal cracking in this section. Ten corner breaks were noted, one with low severity spalling. There were also 4 transverse cracks noted. Some of the transverse cracks were located on the same panels that had longitudinal cracks. This gave the concrete a 'block cracking' appearance indicating a failure of the underlying asphalt and/or subgrade. This distressed area is shown in Photo 9. Most of the transverse joints had light spalling. The joint sealant was losing contact with portions of the PCC panels due to spalling. The longitudinal joints also had low and medium severity spalling. The areas of medium spalling have been repaired with an asphalt material. Photo 10 shows the condition of a typical longitudinal and transverse joints as well as areas of spalling and spalling repair.

**Photo 9 - Longitudinal and Transverse cracks in test section 1**

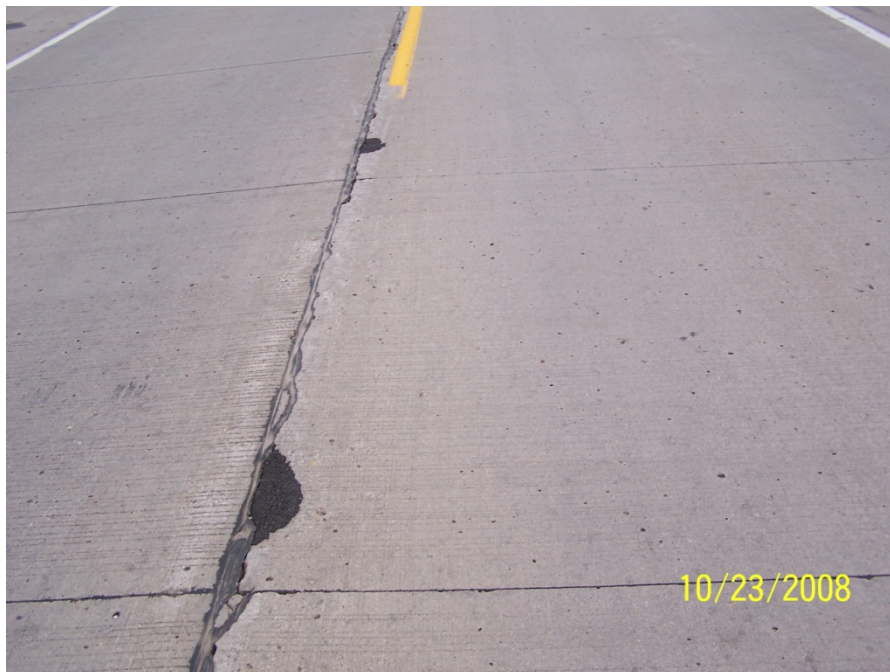
**Photo 10 – Typical longitudinal and transverse joints.**

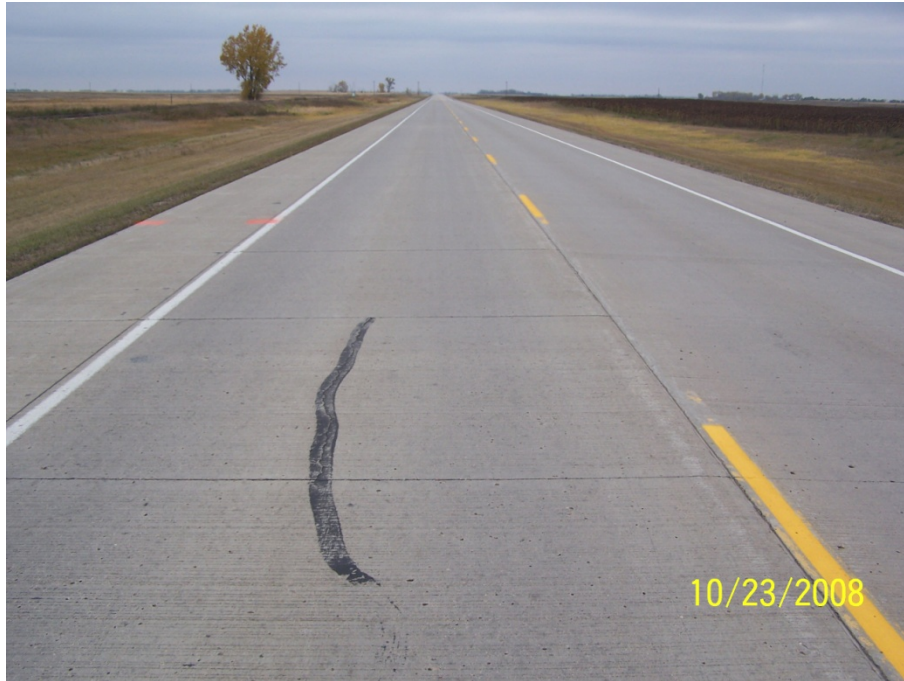
Test Section 2 is composed of 6" PCC with 11.5' joint spacing on 11" of HBP. The overall pavement condition is performing well. Photo 12 below shows an overview of test section 2.

**Photo 12 – Overview of Section 2, 6" PCC overlay**

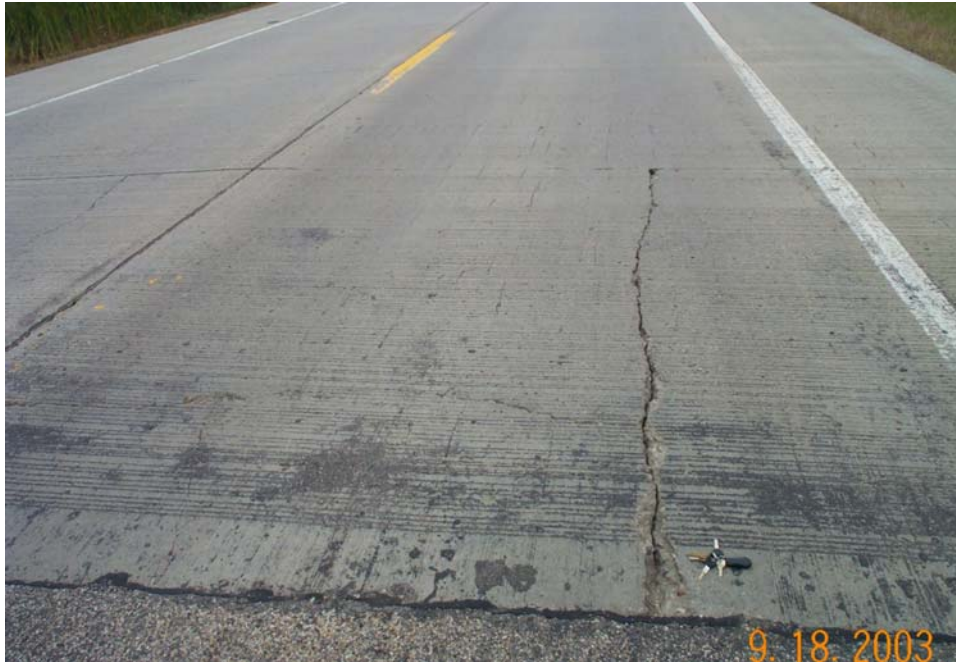
The review team located approximately 140 feet of low severity longitudinal cracking that occurred in Section 3. This section had some low severity spalling occurring at transverse joints and also the centerline longitudinal joint. There were also four corner breaks in this section which still appeared to be very tight. There was an area of 'block cracking' located at the transition of test section 3 and the control section. Photos 14, and 15 show a progression of the distresses at this transition from 2003 to 2008.

**Photo 14 - Longitudinal crack in test section 3 looking north on 9/18/03.**

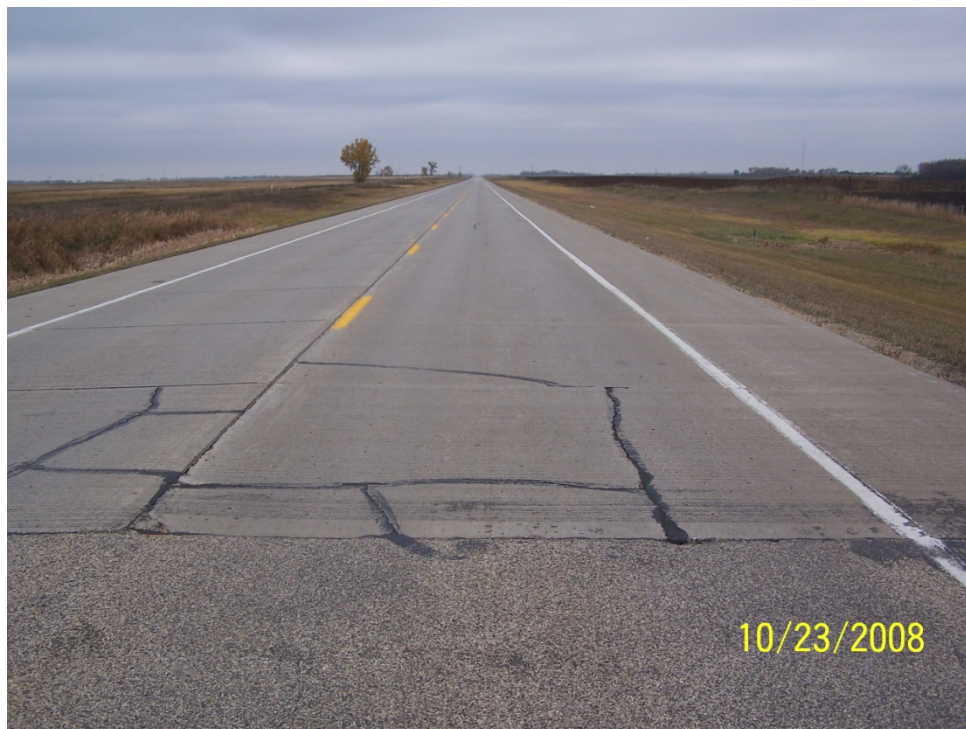
**Photo 15 – Block crack in test section 3 looking North on 10/23/08**

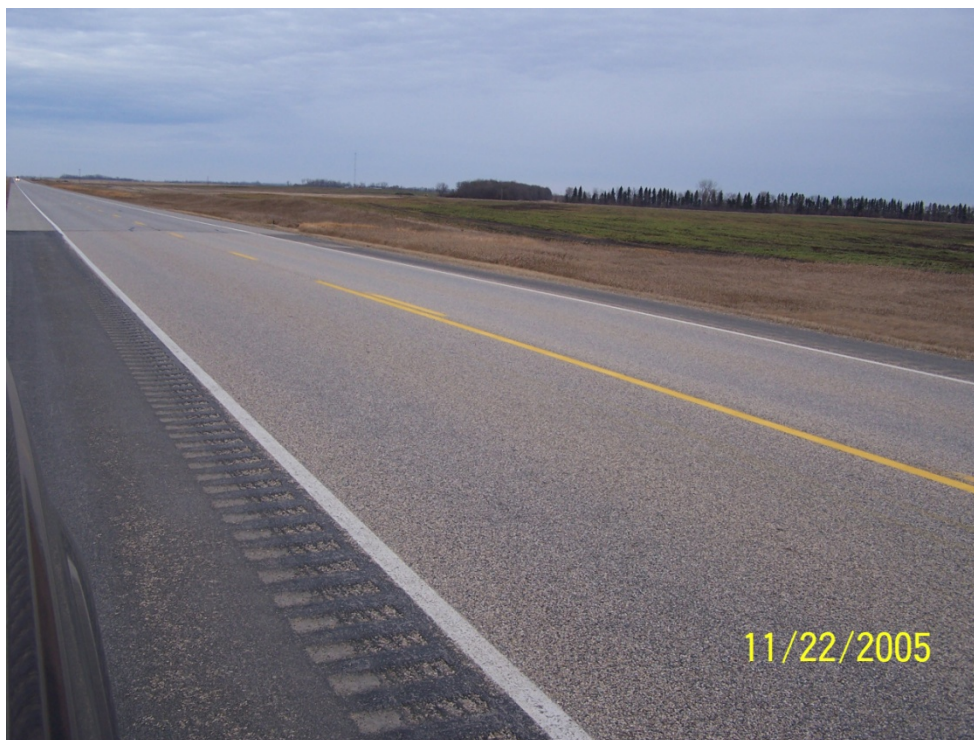
The review team also inspected the asphalt control section located directly south of the whitetopping test site. The section appeared to be in good condition. Photo 16 shows the general condition of the control section. Some bleeding had occurred in the north bound lane.

**Photo 16 - Overview of Control Section looking North**

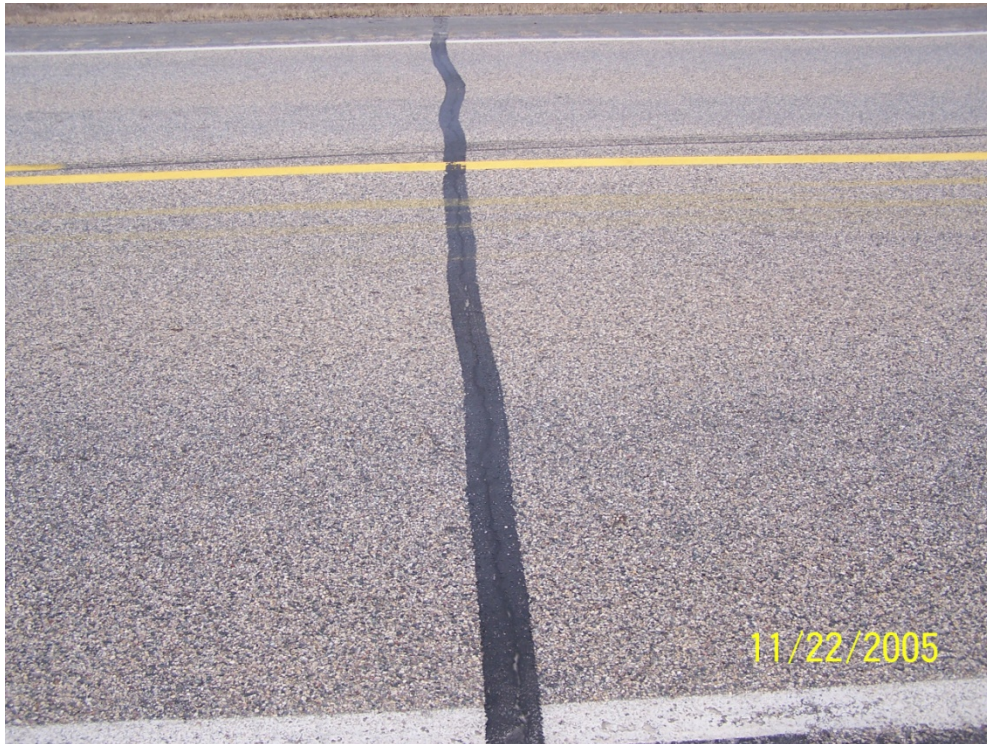
Four transverse cracks were identified within the control section. Minor rutting has occurred, ranging from 1/16" to 1/8". Also, a 40 foot longitudinal crack had formed along centerline near the field approach.

**Photo 17 - Transverse Crack in Asphalt Control Section**
