Experimental Study ND 98-02

**Snow Management by the  
Use of Snow Fence Systems**

**Final Evaluation**

May 2006

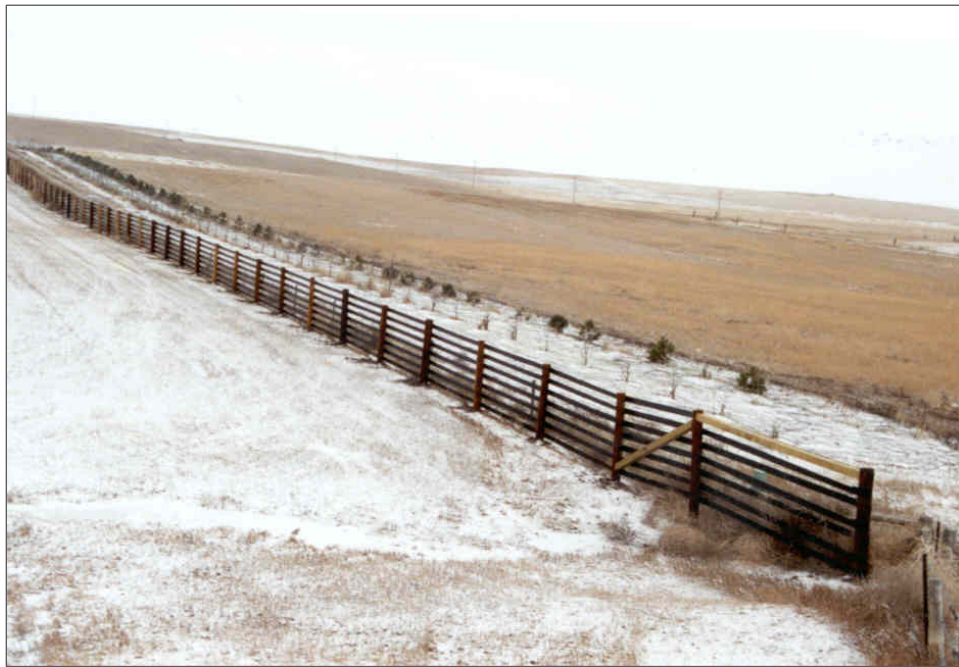
The North Dakota Department of Transportation (NDDOT) had installed demonstration structural snow fence systems at four sites located on the interstate system. These four sites were problem areas due to poor visibility and snow accumulation on the roadway. One of the sites had an existing living snow fence, consisting of a young shelterbelt of Ash and Pine trees. Photo 1 shows a six feet tall structural snow fence with the living snow fence in February 1998.

**Photo 1 - Structural snow fence and living snow fence in February 1998.**

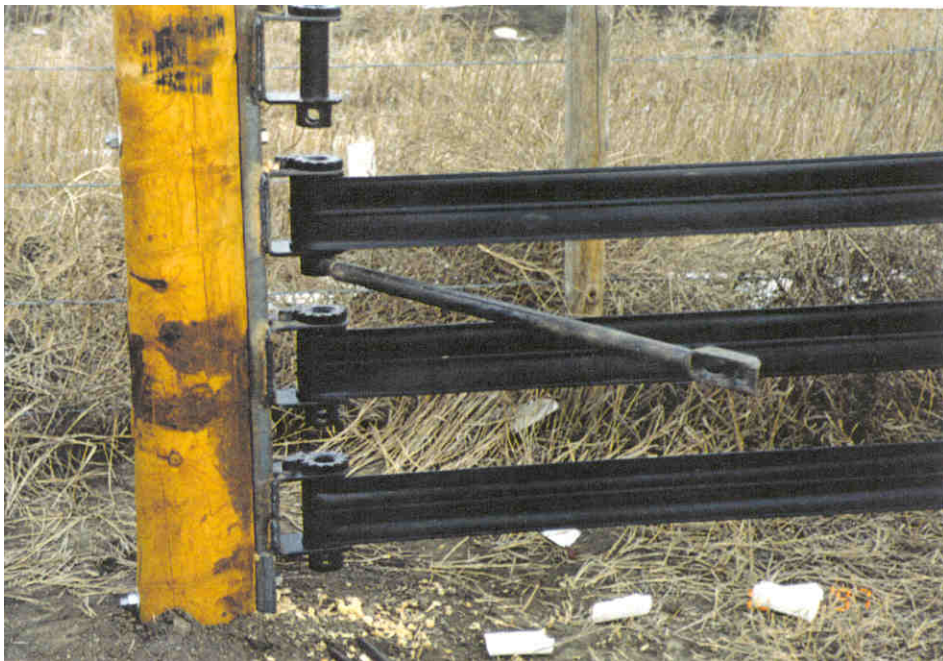
The structural snow fences were constructed with a post and rail design. The rail is a composite polymer strap in which three 10.5-gauge wires are embedded. This product, marketed as Centaur HTP fencing, is five inches wide and comes in lengths up to 660 feet. Because 40% to 50% fence porosity is considered ideal, the straps are spaced five inches apart. The straps are mounted to the posts by brackets that allow the straps to freely slide along the length of the strap and the straps are tensioned with a ratchet system permanently attached to a post on one end of the fence. Photo 2 shows the polymer straps being tensioned with the ratchet system during construction.

**Photo 2 - Polymer straps are tensioned with a ratchet system.**

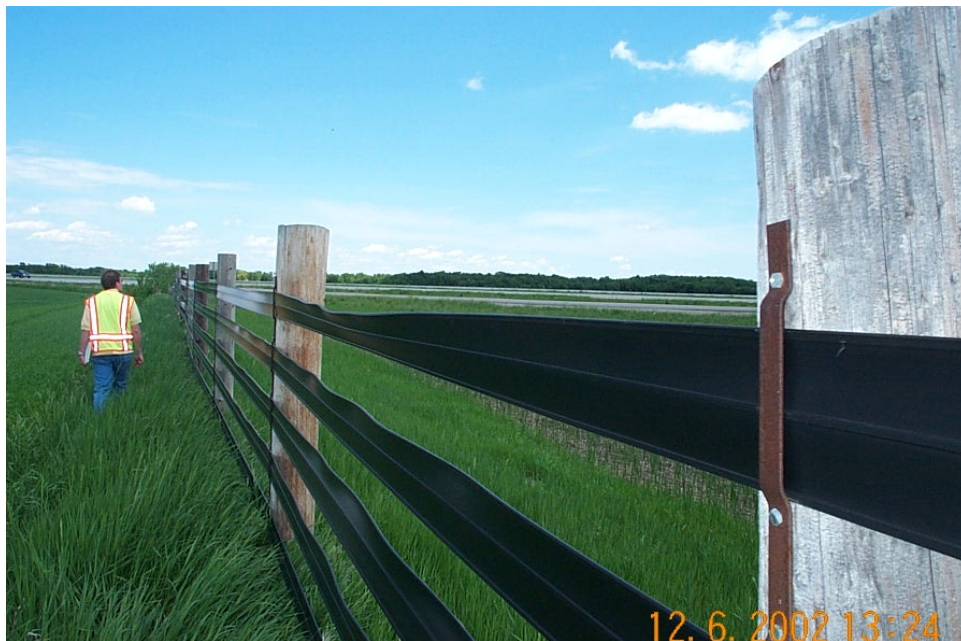
Sites 2, 3, and 4 were inspected on June 12, 2002 and site 1 was inspected on August 12, 2002. The overall condition of the snow fences was good. The ratchet hardware showed signs of corrosion but appeared to be operable. The polymer strap material showed no signs of deterioration but on most of the snow fences the polymer straps needed to be adjusted by tensioning the straps. Photo 3 shows a fence with polymer straps that need tensioning.

**Photo 3 - Loose polymer straps.**

Installation of the snow fence systems went well. The structural snow fences were in good condition but do require maintenance to keep the polymer straps tensioned and to reattach the loose brackets. The living snow fence is thriving and has grown significantly.

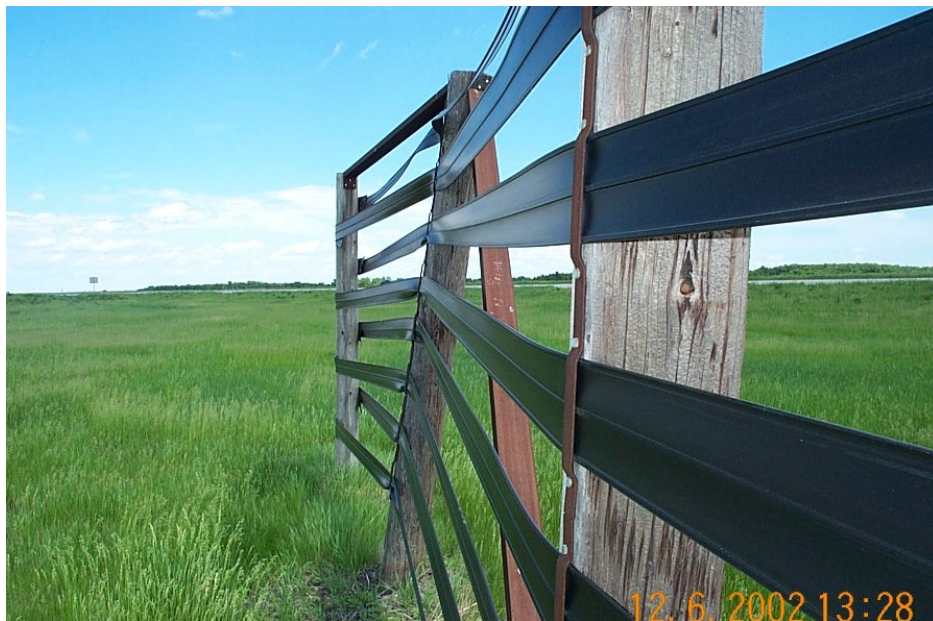
At site 4, a fence post had tilted and had caused some of the polymer straps to become loose and other straps to bind. Photo 5 shows the tilted post. This post was near the north end of an eight-foot fence that is located between Interstate 29 and the southbound exit ramp. This end of the fence is in an area that appeared to collect water and the ground at the base of the fence post was wet and quite soft.

**Photo 5 - A tilted fence post at Site 4.**

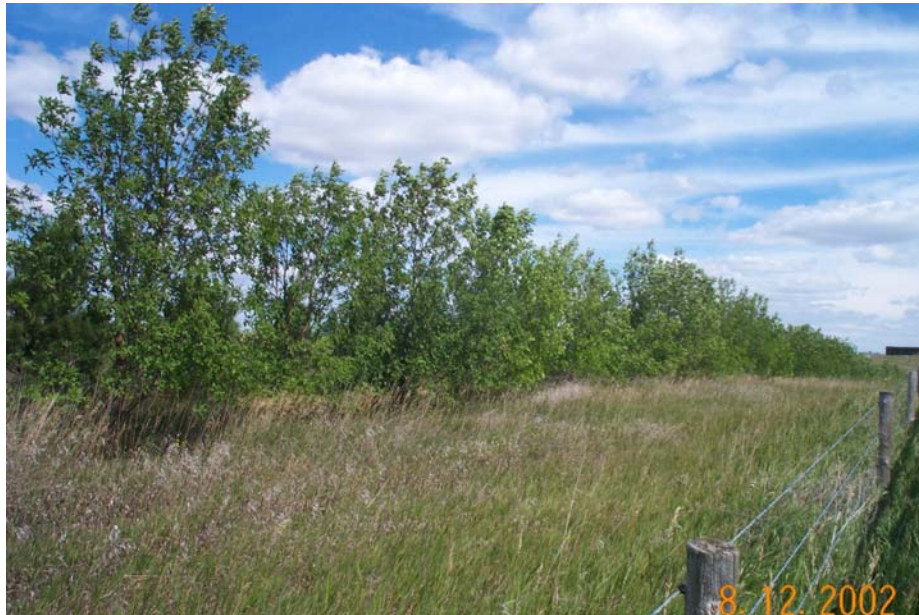
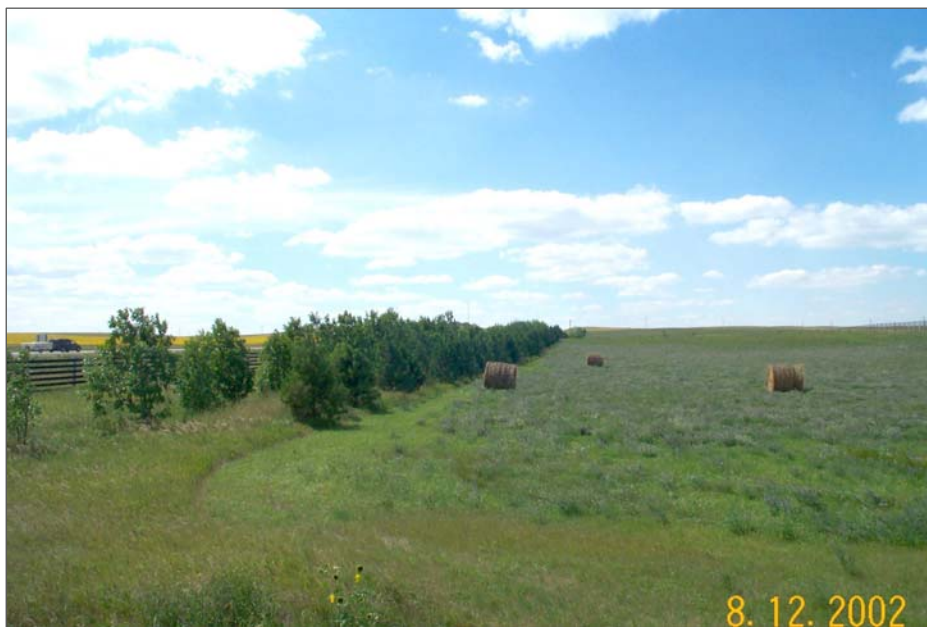
The living snow fences at site 1 appeared to be thriving and no trees appeared to have died. The Green Ash trees are approximately 12'-16' tall and the Pine trees are approximately 8'-10' tall. The condition of the living snow fence is shown in photos 6 and 7. The height of the living snow fence in 1998 is shown in photo 1.

**Photo 6 - A view of the living snow fence in 2002.**

**Photo 7 - Another view of the living snow fence in 2002.**

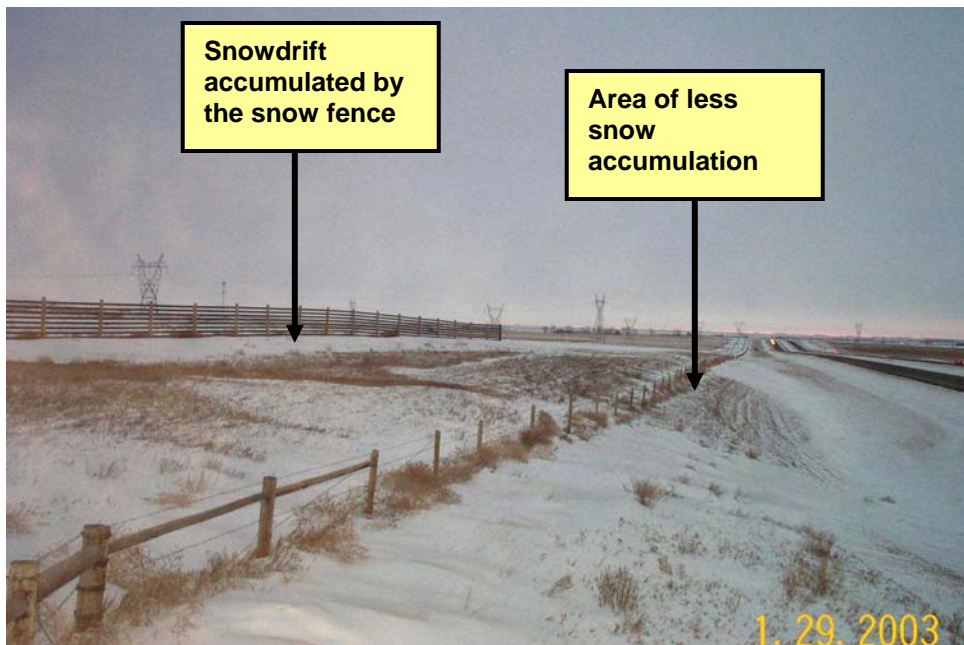
All of the snow fences had collected a drift on the downwind side of the fence and most snow fences had also collected a drift upwind of the fence. Downwind of some snow fences there was an obvious area where less snow had accumulated on the ground than in the surrounding area. Photo 8 shows a snow fence with an area of less snow accumulation at site 2.

**Photo 8 - A snow fence at site 2 in January 2003.**

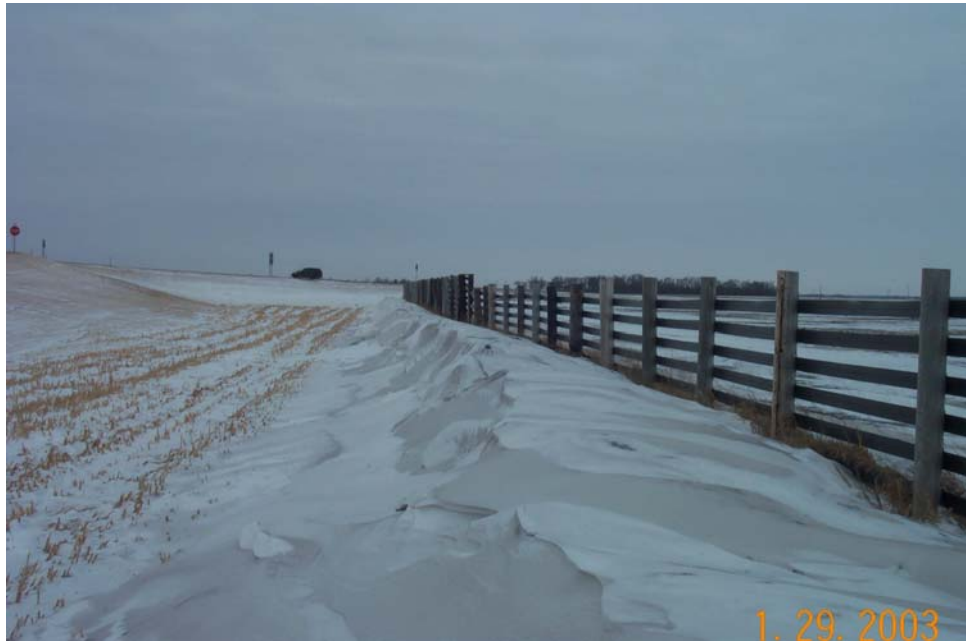
Snow fences at higher locations than surrounding areas appeared to collect more snow than fences in low areas. Photo 9 shows a large drift along a snow fence in a high location on the west side of site 3. Photo 10 shows the relatively small amount of snow collected by a snow fence in a low location at site 3.

**Photo 9 - A large drift accumulated by a snow fence at a relatively high location at site 3.**

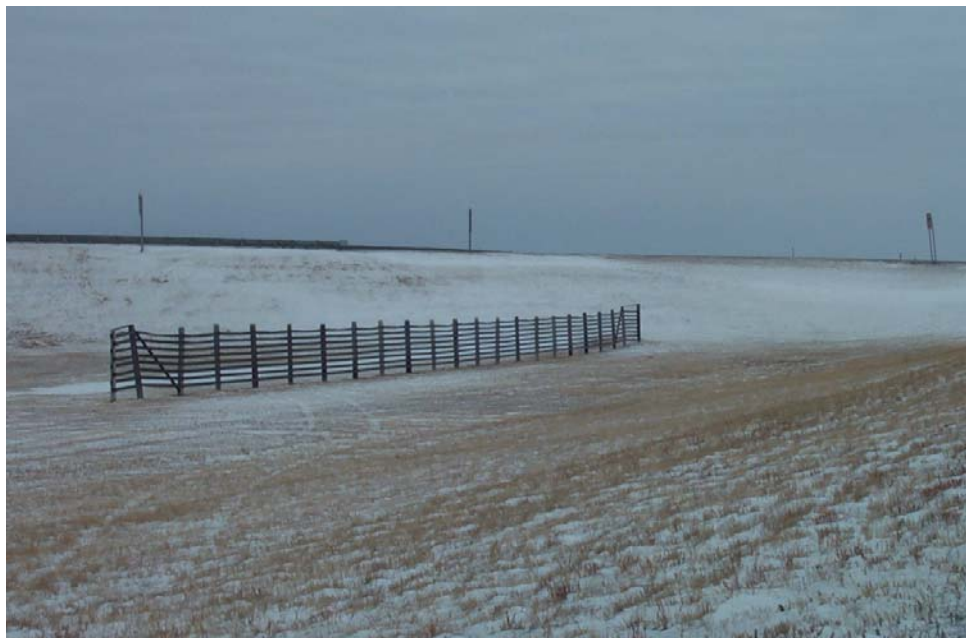
**Photo 10 - A snow fence in at a low elevation at site 3 with relatively little snow accumulation.**

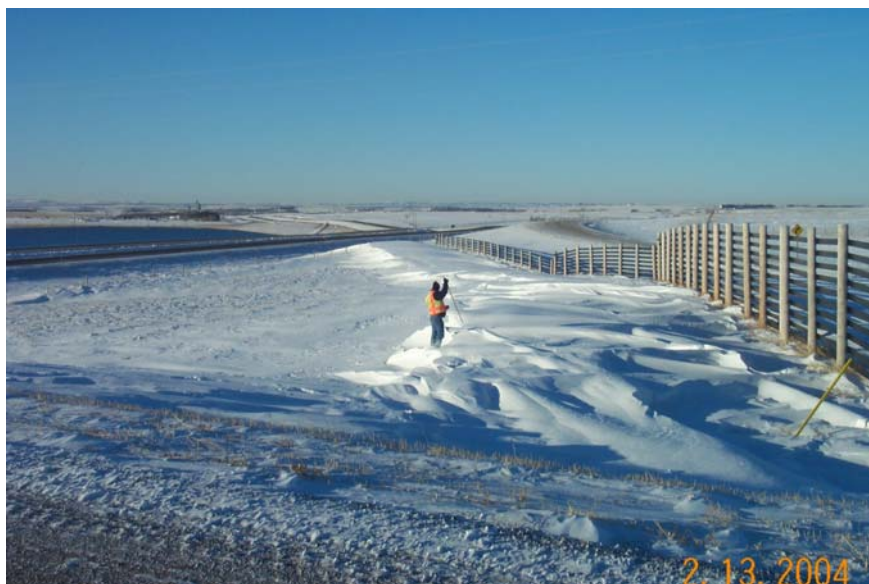
Sites 1 and 2 were evaluated on February 13, 2004 for their ability to collect snow in drifts. There had been recent snow fall and there was 6-10" of snow on the ground. The roadway had already been plowed so that there was no snow on the pavement. It appeared that the snow fences were functioning according to design. Typically, the downwind side of the snow fences had drifts 1 1/2 ft to 3 ft deep. From the shape of the drifts it appeared that the prevailing winds are from approximately the same direction as used for the design of the snow fences. Photo 11 shows a snow fence at Site 2 and the drift it created. Photo 11 was taken facing southwest.

**Photo 11 – Snow drift created by a fence at Site 2.**

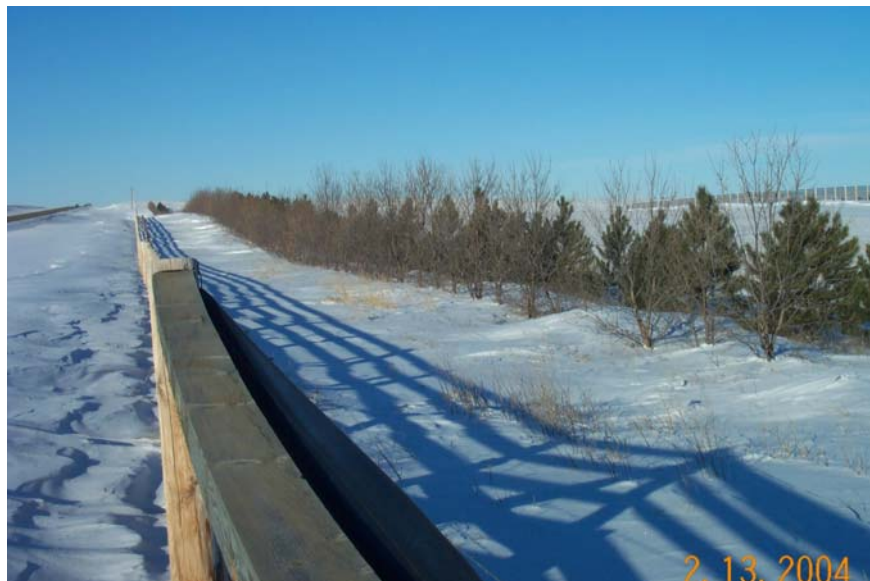
The living snow fence at Site 1 had collected snow also. The snow was mostly collected within the two rows of trees and did not appear to develop a downwind drift like the structural snow fences. This may be because the snow collected between the two rows of trees was collected by the Pine trees and the Ash trees collected little snow. The snow was approximately 1' to 2' deep within the two rows of trees. The structural snow fence that ran along the living snow fence collected drifts the same size as other snow fences and the amount of snow it collected wasn't obviously affected by its proximity to the living snow fence. Photo 12 shows the snow collected within the living snow fence.

**Photo 12 – Snow collected within the living snow fence.**

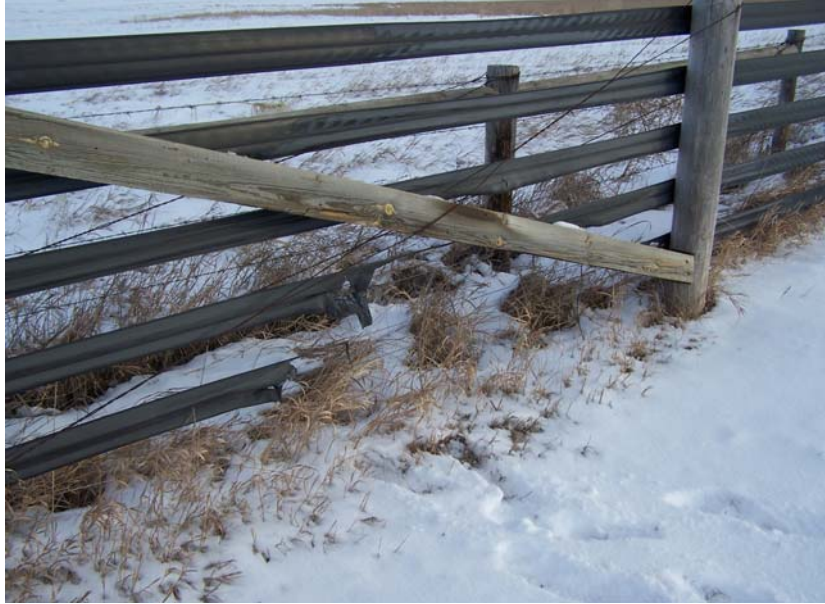
At Site 1, the easternmost 4' fence had sustained some damage from a grass fire in the ditch. The two lowest polymeric straps had been burned through but the internal wires remained intact and continuity of the straps wasn't compromised. The damaged area of the fence is shown in Photo 13.

**Photo 13 – Damage to polymer straps caused by a grass fire. Note that the internal steel wires remained intact.**

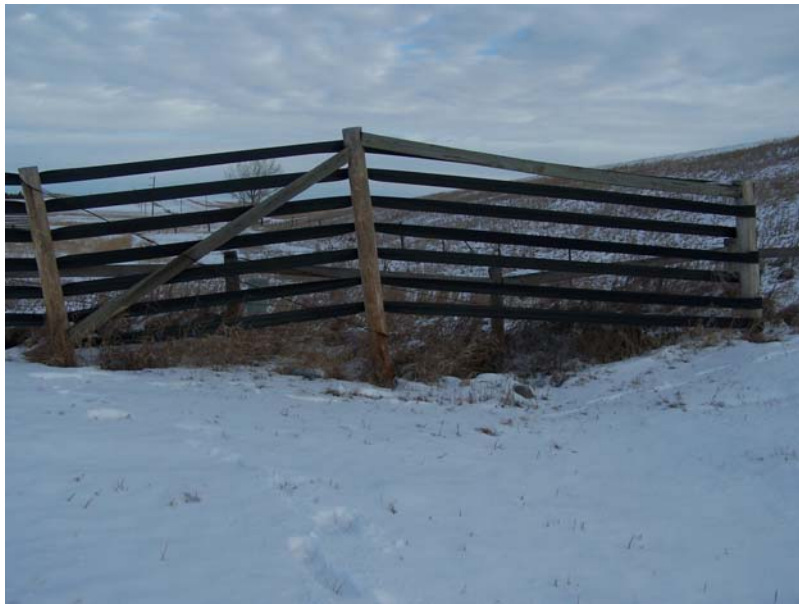
The 6' fence on the west side of Site 1 had several posts tilting and one post being pulled out. This was in an area on the fence's east end that often has wet soil. The posts are shown in Photo 14.

**Photo 14 – A fence with tilted posts in wet soil at Site 1.**

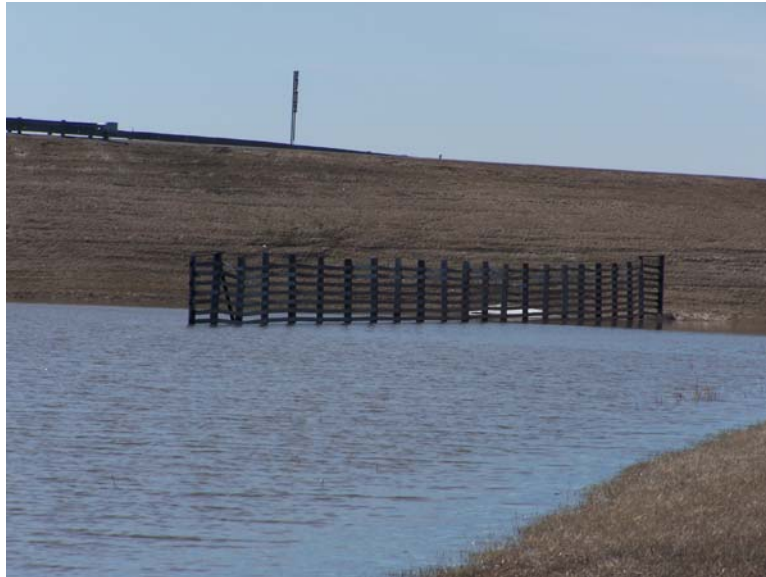
In the spring of 2006, Site 4 was observed to be partially flooded. This was during a period of widespread spring flooding in the Red River Valley. The fences didn't appear to be affected by the flooding. Photo 15 shows Site 4 during flooding in 2006.

**Photo 15 – Fence at Site 4 during spring flooding in 2006.**
