Experimental Study ND 2002-01

Base Reinforcement Using Geogrid

Fifth Evaluation Report

NH-4-052(044)058

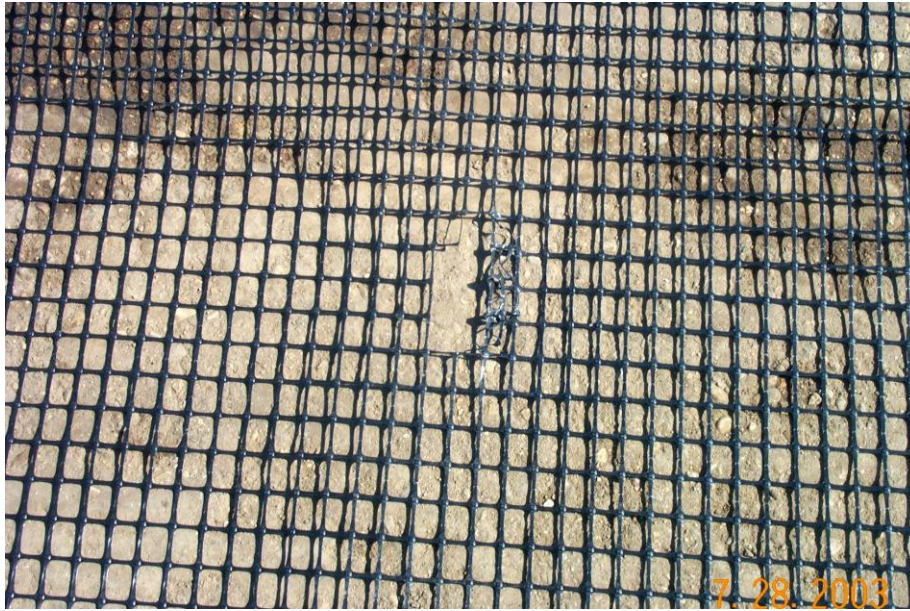
Photo 6 - Damaged areas like this can be repaired by overlaying with a 3'x3' patch.

The geogrid installation was completed with minimal problems. Patches had to be placed in a few areas due to geogrid tears. Waves in the geogrid occurred if aggregate dumping or spreading of the aggregate was placed too fast. Overall the geogrid installation went very well.

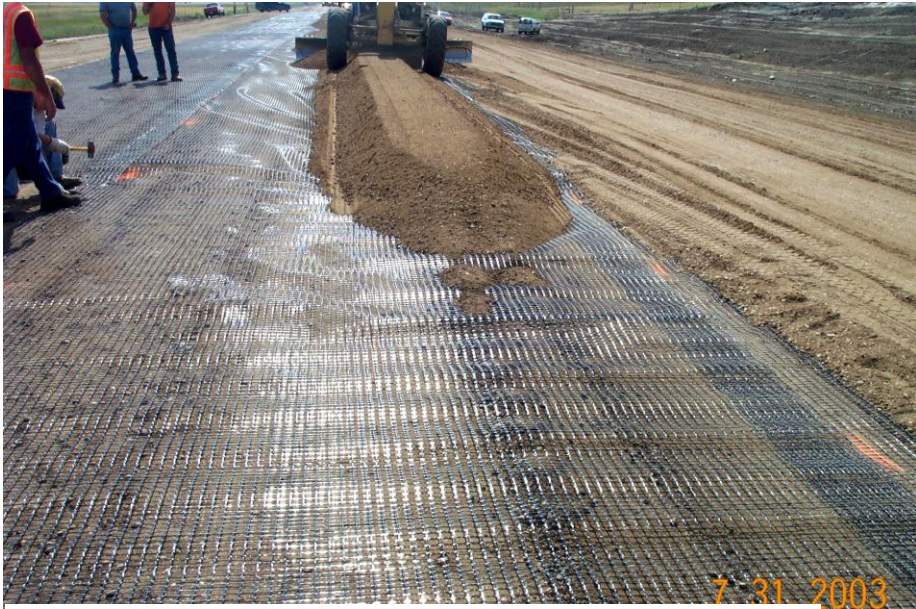
Photo 10 – Some waves in the geogrid – nailing overlap area.

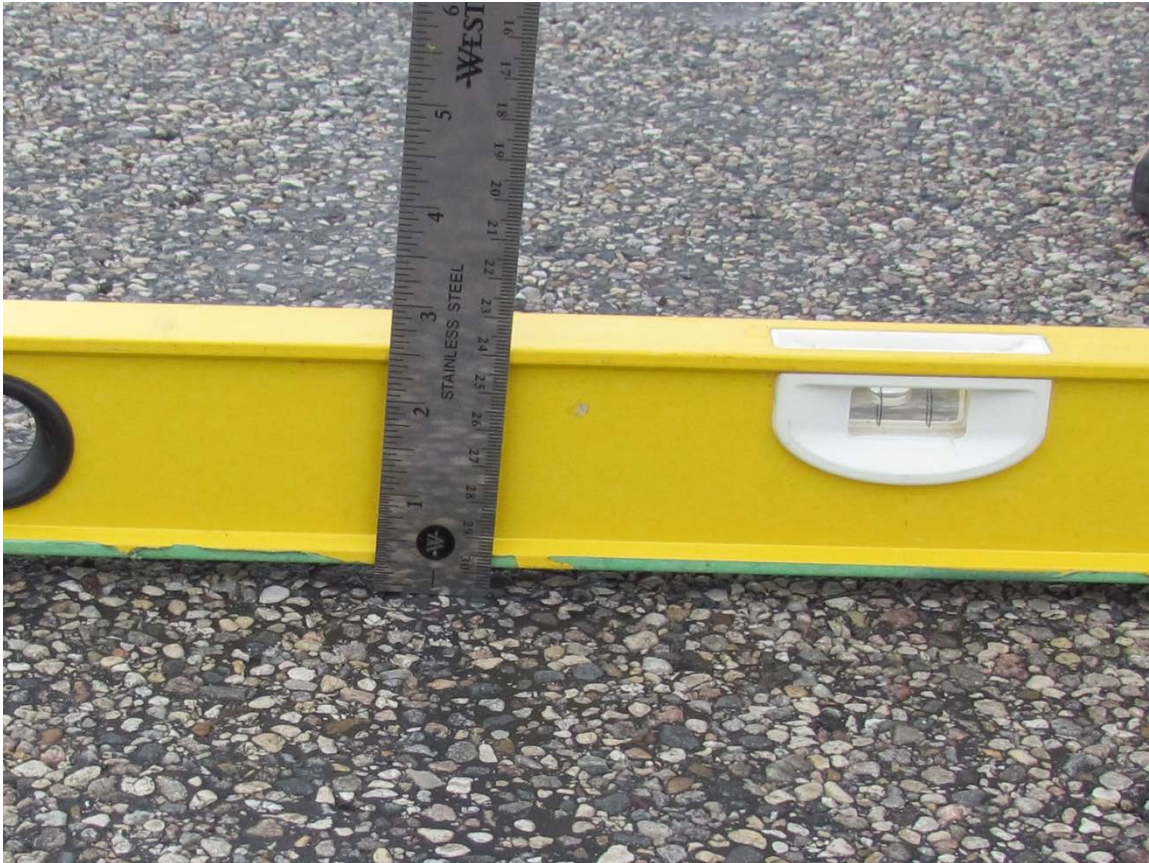
There were two transverse cracks in the control section, one that is sealed and one that is unsealed, and there was one transverse shoulder crack which extends to the driving lane. It was also observed that rutting was occurring throughout this section in both wheel paths which was a change from no rutting from the fourth evaluation. The rutting was between 1/8" to 1/4", and can be seen the photo below.

Photo 4, Rutting in Section 1

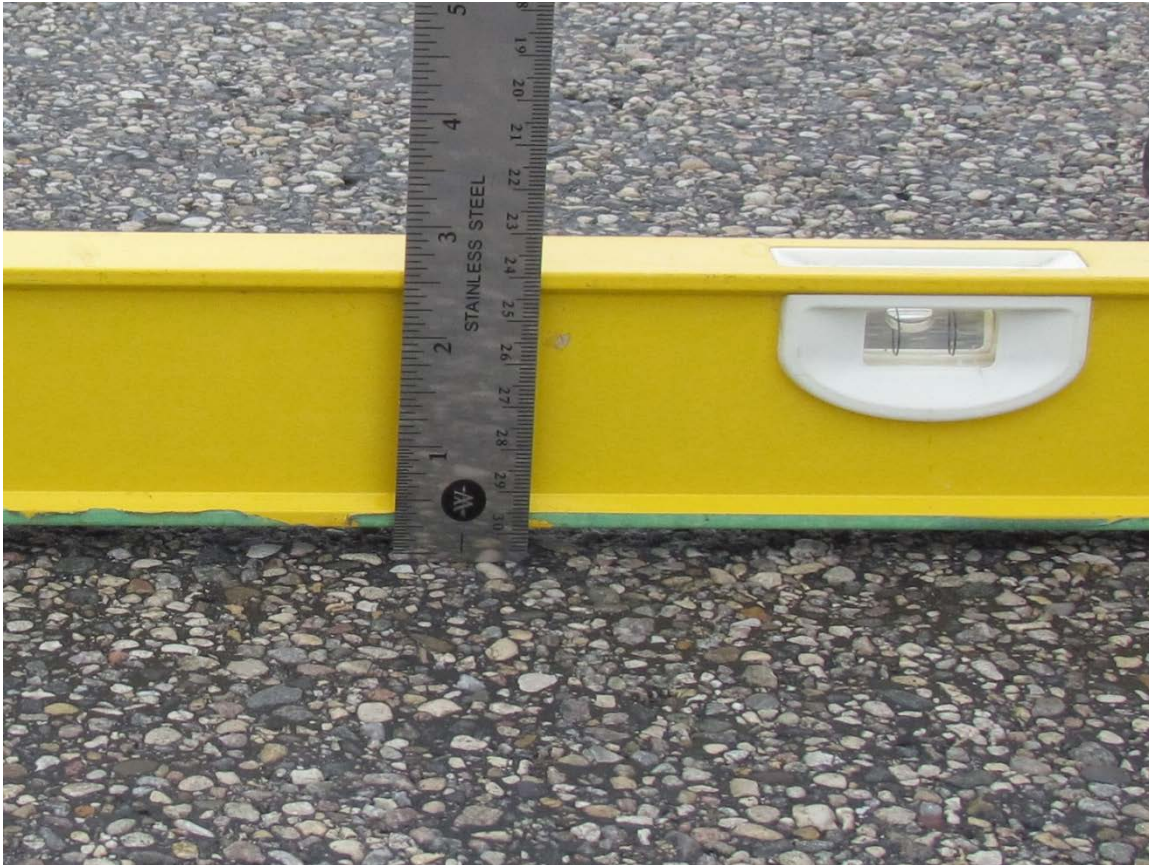
There was one transverse crack found in Section 2 which was a change from the fourth evaluation. It was observed that rutting was occurring throughout this section in both wheel paths which was a change from no rutting from the fourth evaluation. The rutting was between 1/8" to 1/4", and can be seen in the photo below.

Photo 5, Rutting in Section 2

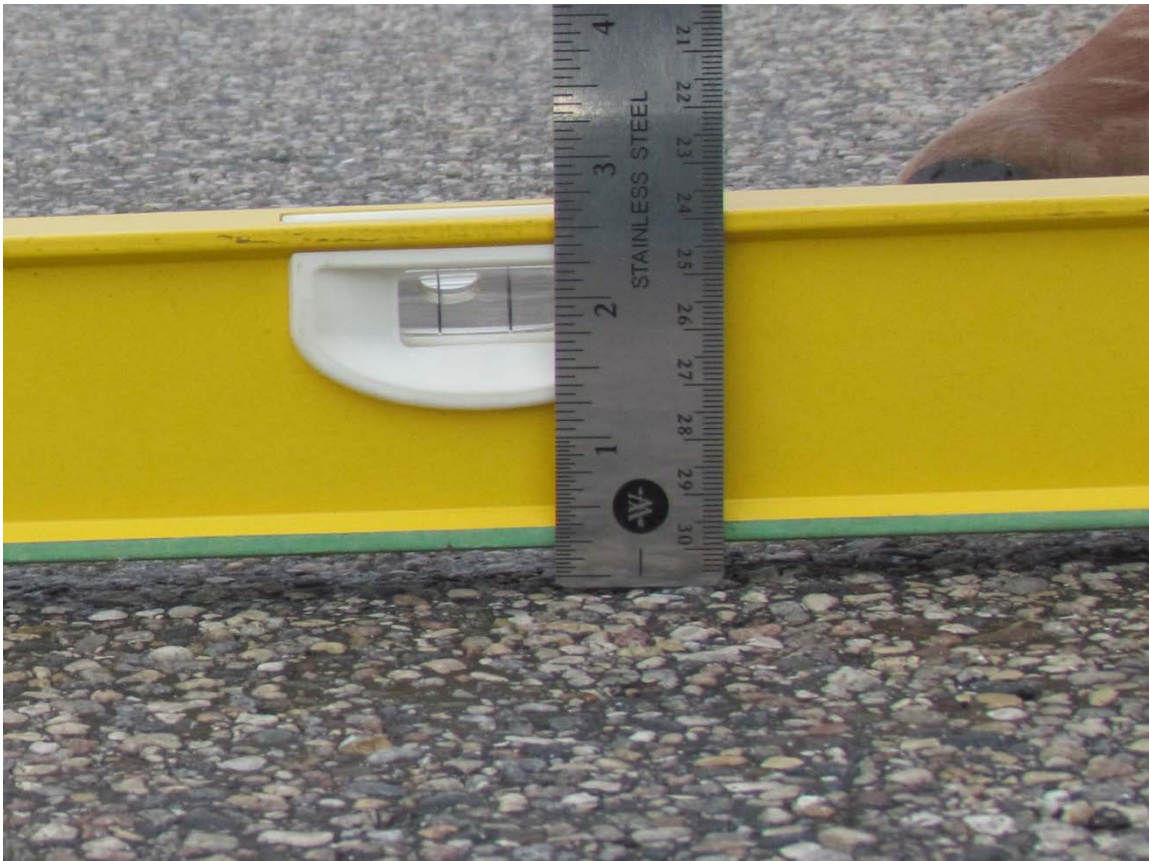
There were one 6' longitudinal crack in the outside wheel path, one transverse shoulder crack, and four transverse cracks approximately 2ft apart found in Section 3 which was a change from the fourth evaluation. Rutting was found from the visual inspection in Section 3. The rutting found was between 1/8" and 1/2", which was similar from the fourth evaluation. The rutting is shown in the photo below:

Photo 6, Rutting in Section 3
