Experimental Study ND 2002-02

Performance of HBP vs. PCC Pavement

Final Evaluation

Project NH-8-013(030)380

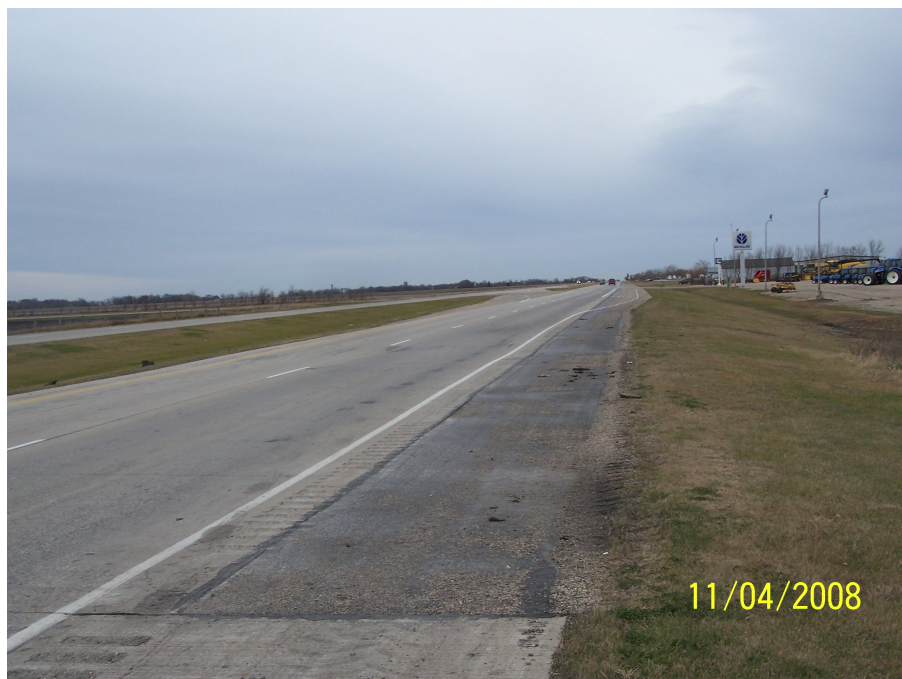
Segment 2 did not show any distresses on the PCC. The asphalt shoulders were starting to show some distress near an implement dealership. Other than the shoulder showing some distress Segment 2 had no other visible distresses.

Photo 1 – Asphalt shoulder near implement dealership at transition between Segments 2 and 3.

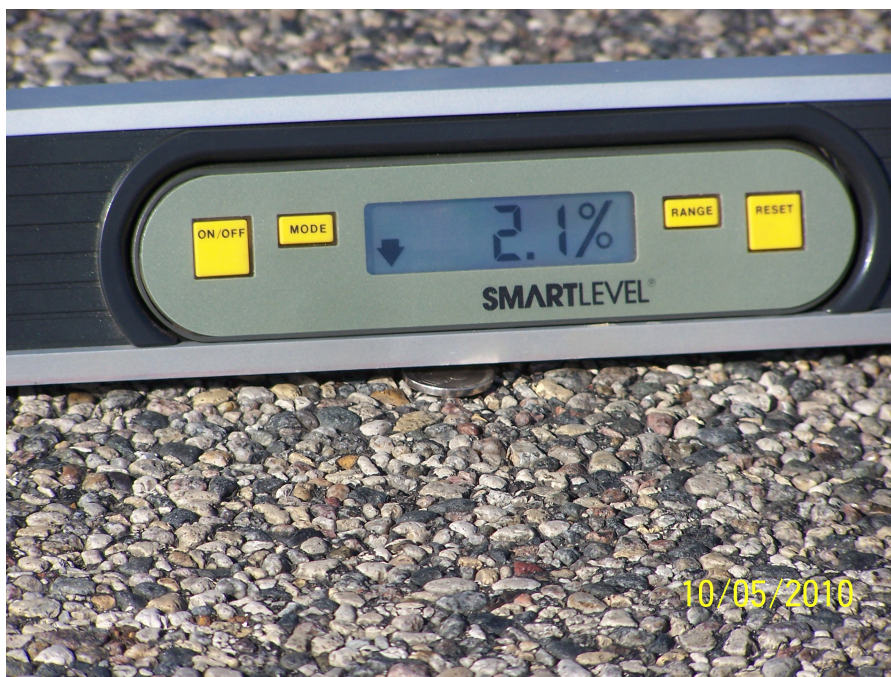
The fourth evaluation was conducted October 5, 2010. Segment 1 had noticeable wear in the chip seal which was installed in 2005. A majority of the wear in the chip seal is occurring in the wheel path. Materials and Research physically measured rutting using a seven foot metal straight edge. Rutting in the wheel path measured 1/16th to 1/8th of an inch and was checked every half mile throughout Segment 1. There were also 12 transverse cracks in Segment 1.

Photo 1: Rutting in a wheel path in the driving lane of Segment 1.

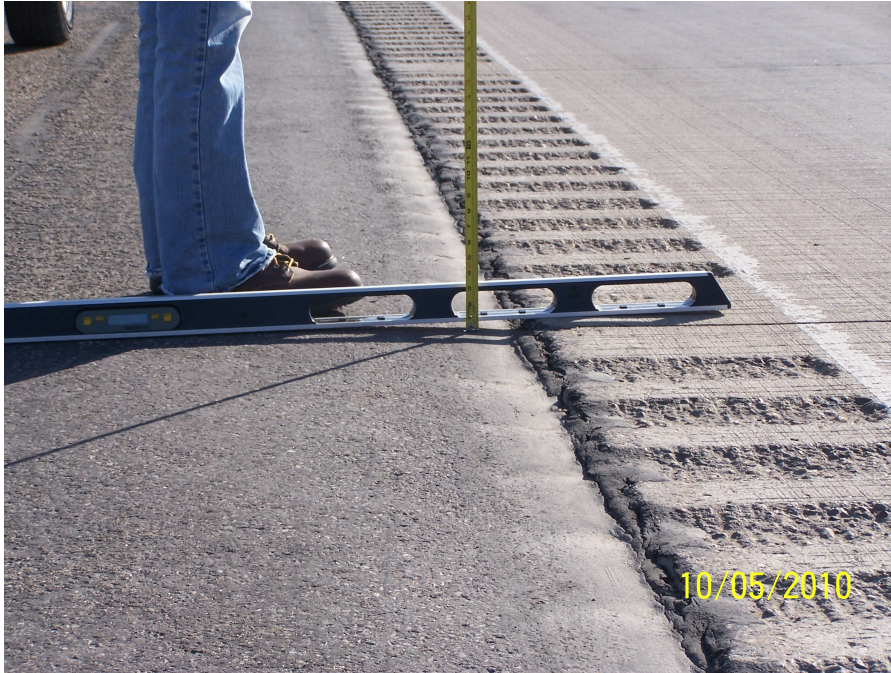
Segment 2 has a noticeable dip in the shoulders on each side of the box culvert located in this segment. It has two new transverse cracks near the transition from Segment 3 to Segment 2. The asphalt shoulders have settled approximately 1/2 inch throughout the section. A longitudinal crack is located 800' east of the Wild Rice Bridge in Segment 2.

Photo 2 – Settling of the asphalt shoulders in Segment 2.

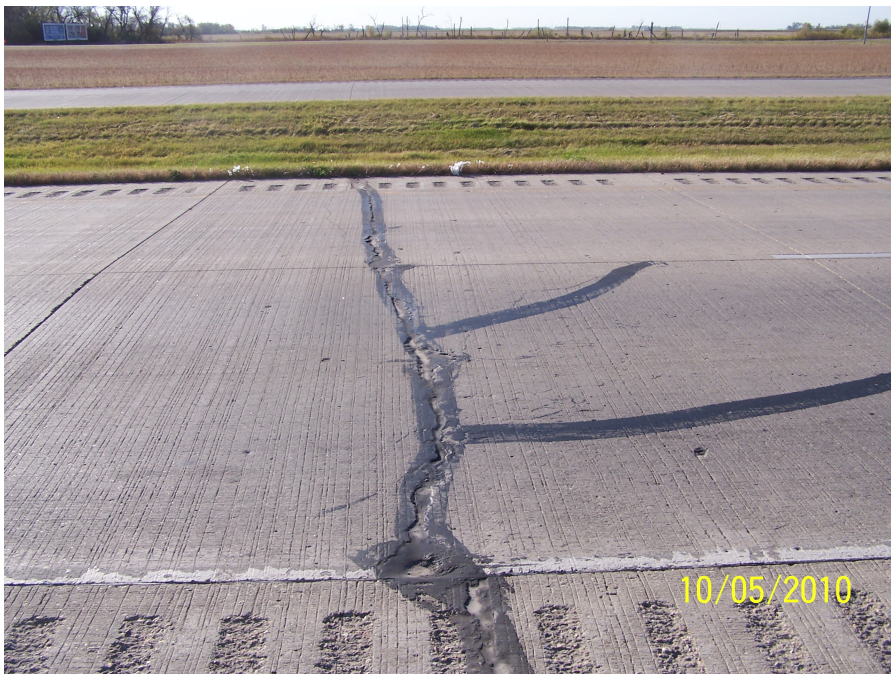
Segment 3 has one new transverse crack at station 20550+45 which was sealed. 4 small corner breaks and 3 edge line breaks have developed.

Photo 3: Distress located in Segment 3.

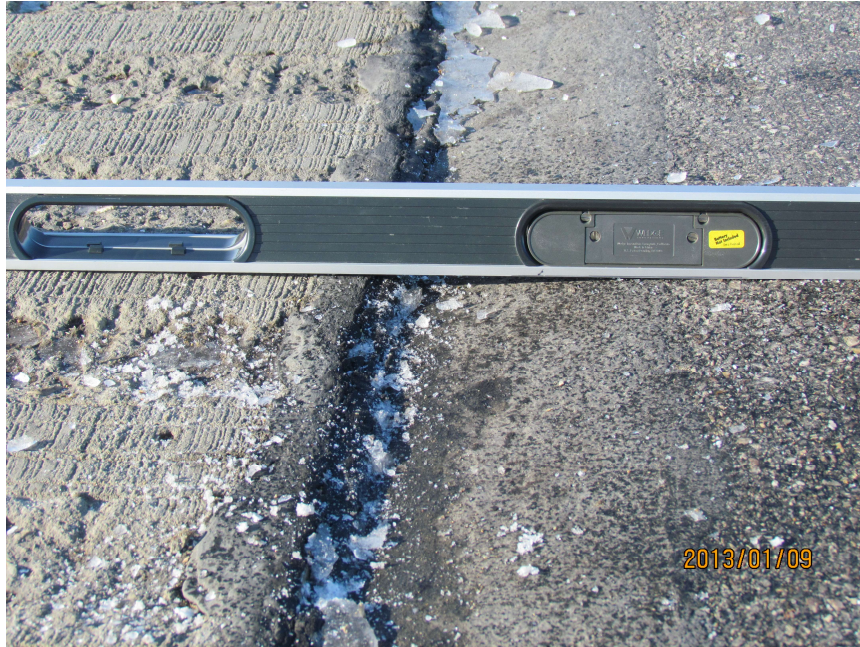
Segment 2 has a noticeable dip in the shoulders on each side of the box culvert located in this segment as in the 2010 evaluation. It has two transverse cracks near the transition from Segment 3 to Segment 2 as in 2010. The asphalt shoulders have settled approximately 1/2 inch throughout the section. One new longitudinal crack was observed about 900' east of the Wild Rice Bridge, along with the longitudinal crack observed in the 2010 evaluation. There was also one new transverse crack located near the east

Photo 2 – Settling of the asphalt shoulders in Segment 2

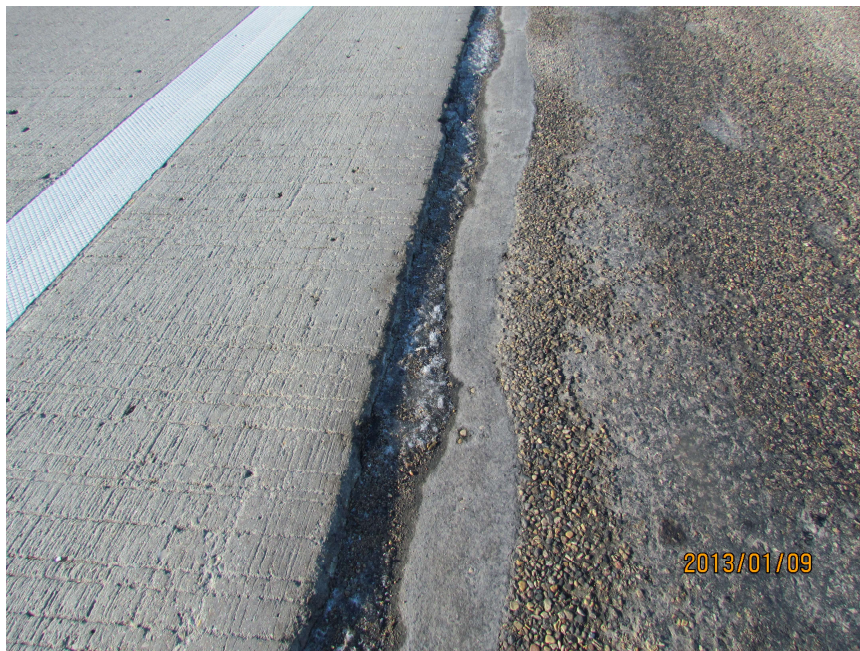
end of the Wild Rice Bridge in Segment 2. There was a HBP turning lane approximately at RP 386.6 that had settled about 3/4th of an inch below the PCC roadway, see photos 2 and 3.

Photo 3 – Settling of the asphalt turning lane in Segment 2

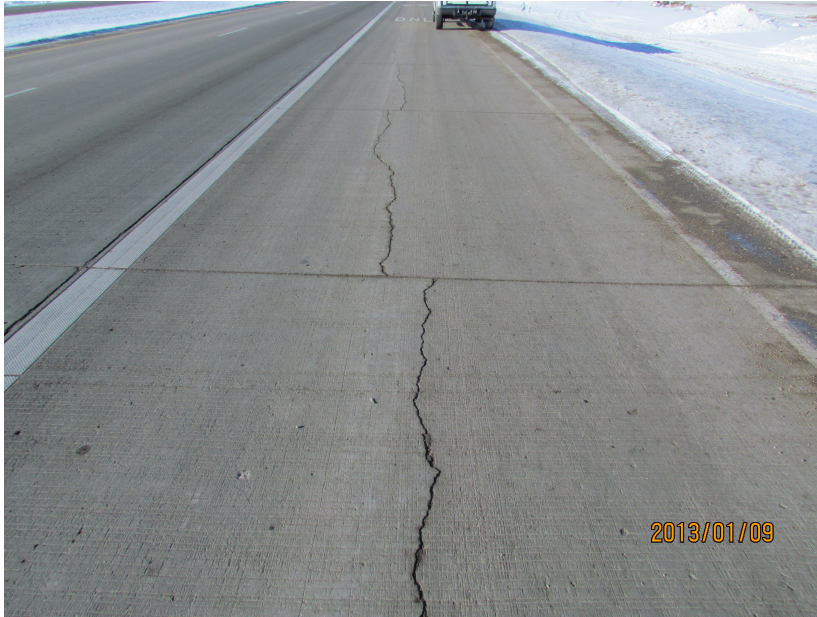
Segment 3 had the one sealed transverse crack as observed in 2010. There were also 5 edge line breaks and 5 small corner breaks observed throughout the section. At a turning lane located approximately at RP 388.4 it was observed that there is a new unsealed longitudinal crack spanning approximately 300' over the 330' turn lane.

Photo 4 – Longitudinal crack in turning lane in Segment 3.

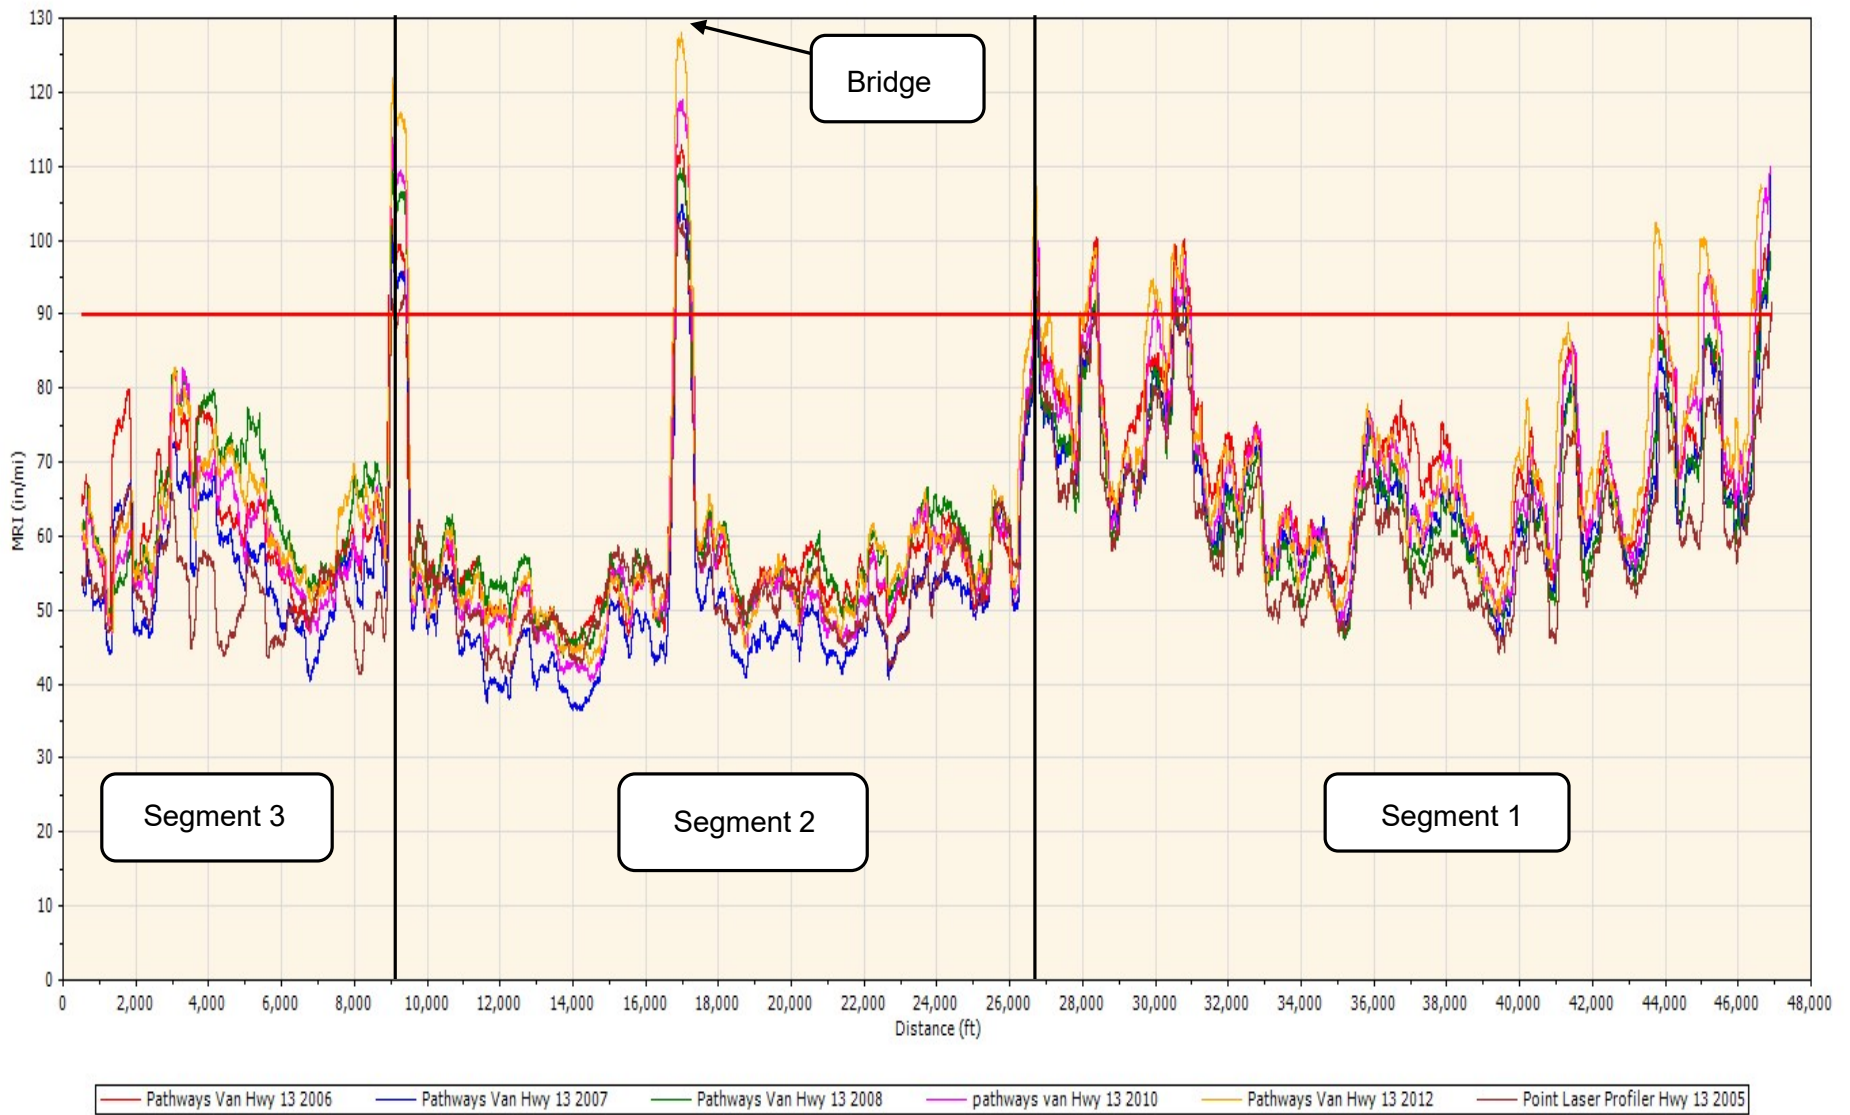
Chart 2, Graph of Profile Data

The ride in all three sections was good except for several dips at culverts. Most notable was the box culvert at RP 387.783 at the beginning of Segment 3. The roughness at this location can be seen in the IRI graph in Appendix B Chart 2. A summary of the pavement condition can be found in Table 4 in the summary.

The “Pathways Van” data shows that there has been loss of ride quality from initial construction. The HBP Segment 1 has the highest IRI followed by the concrete in Segment 3 and the best ride quality is the concrete in Segment 2. The decrease in the IRI could be attributed to deviation from the previous path in the driving lane while profiling or conditions of the roadway varied from year to year. There has been little change in the IRI in the concrete Segments 2 and 3 since 2008 but the IRI in the asphalt section in Segment 1 continues to increase.
