Experimental Study ND 07-01

High Density Polyethylene Pipe

Final Evaluation

Project AC-HPP-NH-5-012(031)054

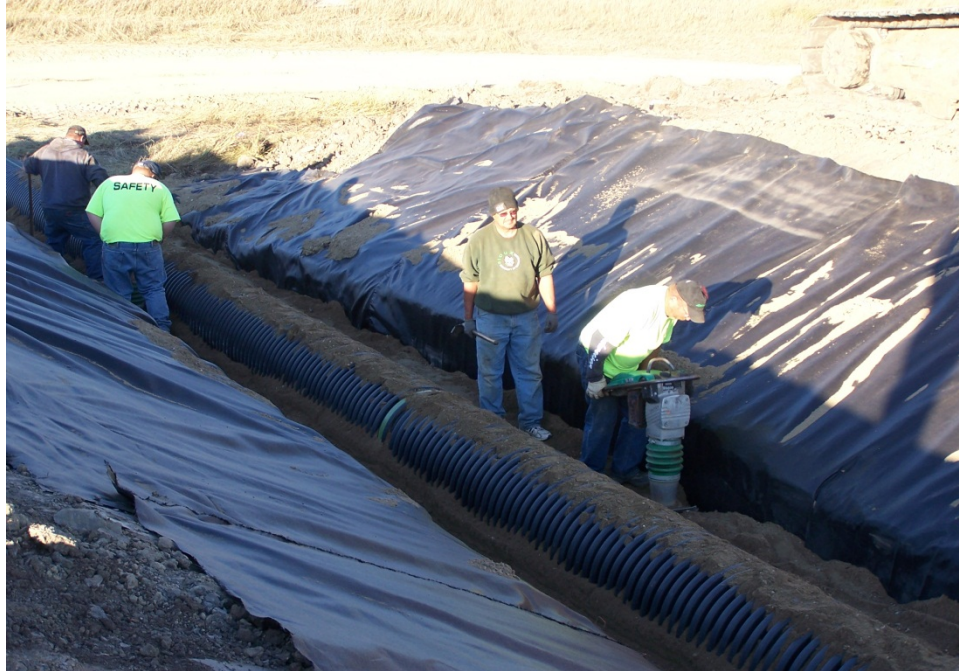
Photo 1: Centerline HDPE pipe being installed

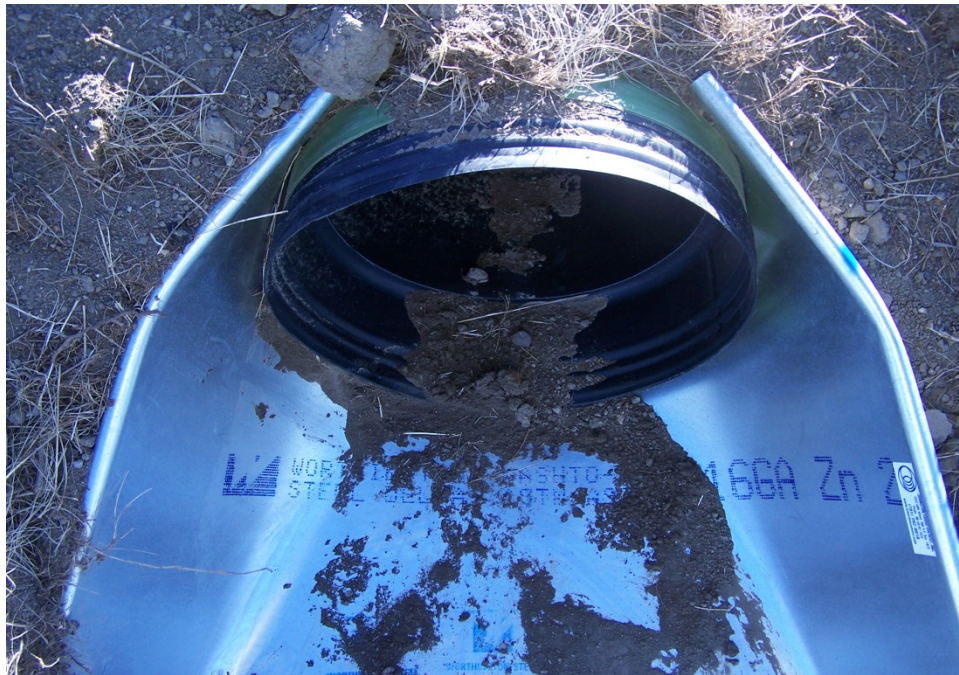
Photo 2: Metal End Section of HDPE pipe.

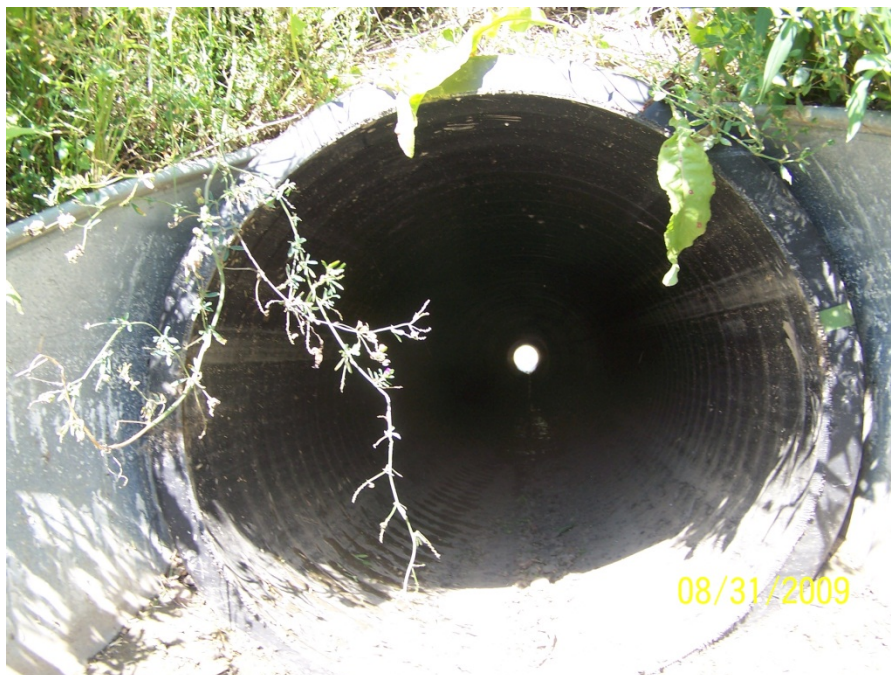
Photo 3:End Section of Pipe
