Experimental Study ND 07-02

Bridge Deck and Roadway Surface Treatments

Second Evaluation Report

December 2013

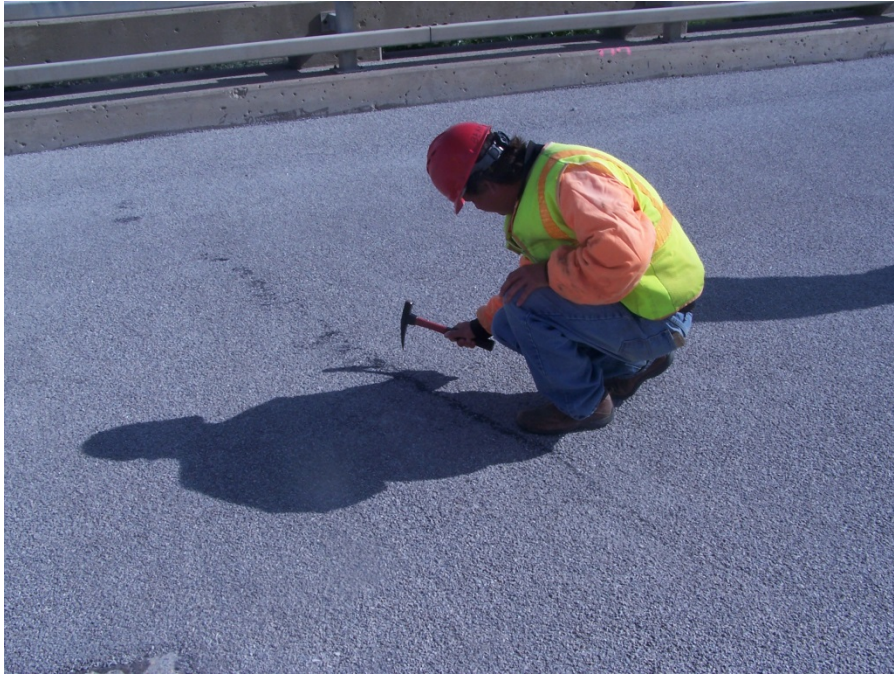
of the course was fully cured. The project engineer decided to continue construction and call this area of the overlay a blemish. He inspected the area the next day and decided that no remedial action would need to be taken. Aggregate did not adhere to some spots of this batch, see photo 14.

Photo 14: Project Engineer Inspecting Hand Mixed Portion

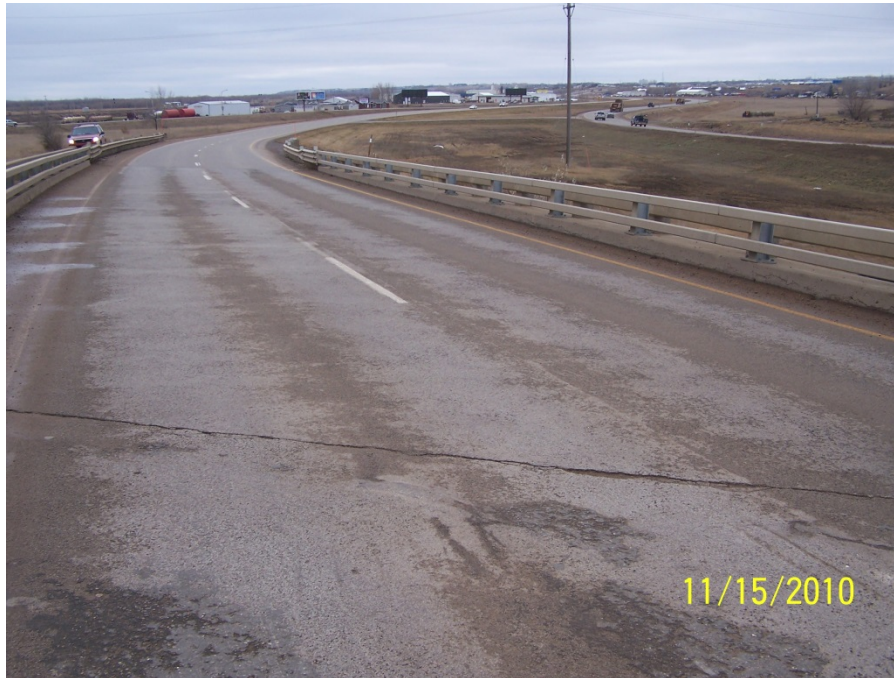
Photo 20: SafeLane™ Facing West

SafeLane™ was installed on the ND 2 Sand Creek Structure in the Williston District and was last visually inspected on November 15, 2010. All of the epoxy and most of the aggregates remain in place on the concrete portion of the installation. On the asphalt portion there is rutting. Because of the rutting, some of the road profile is higher and at these locations most of the material has been removed, which is most likely from snow plow activity. In the wheel paths, the angularity of the aggregate has reduced since installation. Vehicle traffic has polished the aggregate and reduced the surface friction.

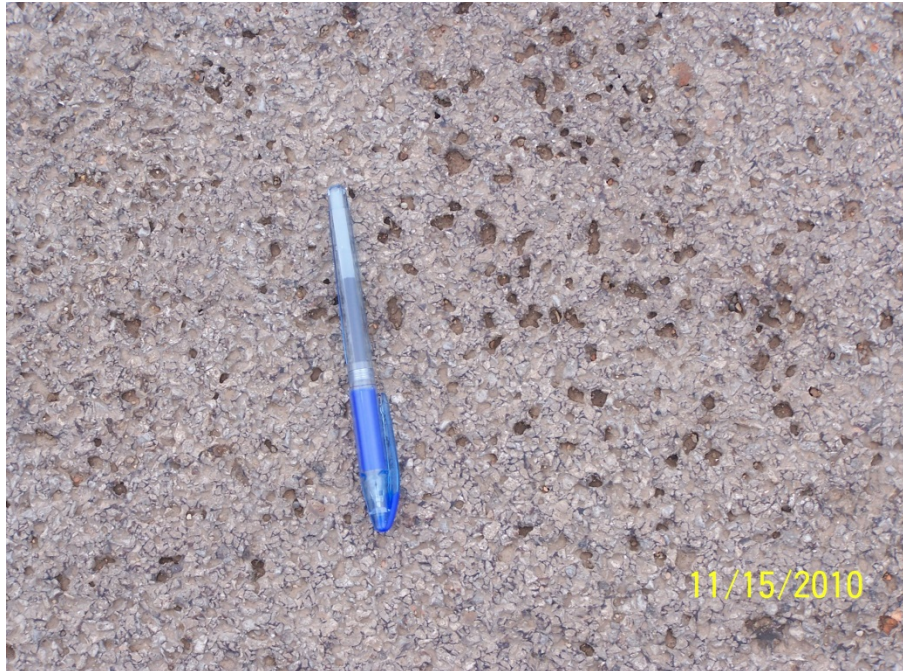
Photo 21: Small Pockets Were Evident in the Aggregate

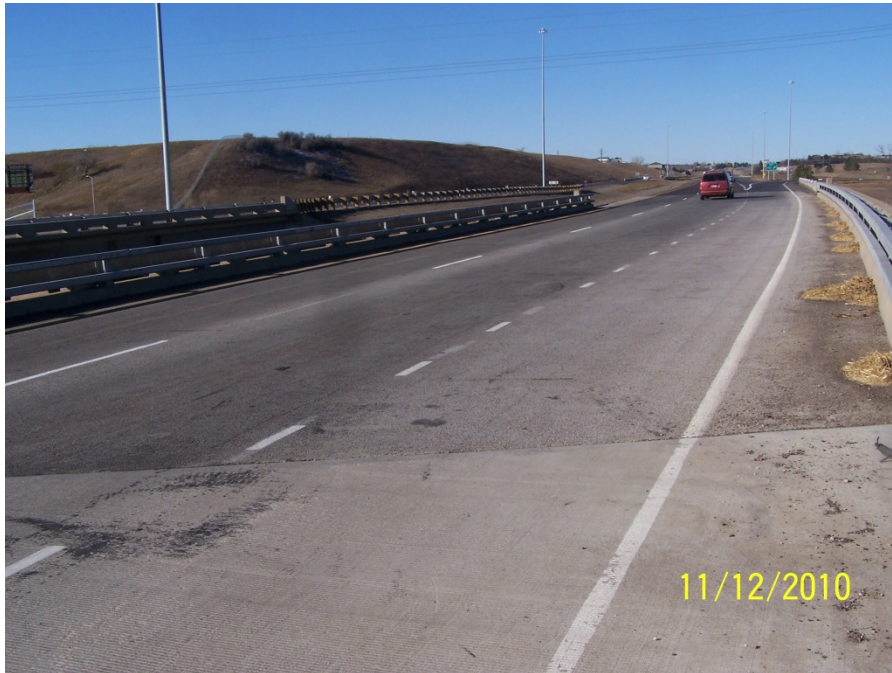
Photo 22: BNRR and Missouri Road SafeLane™ Looking West

The SafeLane™ on the I-94 Structure was visually inspected on November 12, 2010. All of the epoxy and most of the aggregate from the epoxy overlay remains in place. In the wheel paths, the angularity of the aggregate has reduced since installation. Vehicle traffic has polished the aggregate and reduced the surface friction.

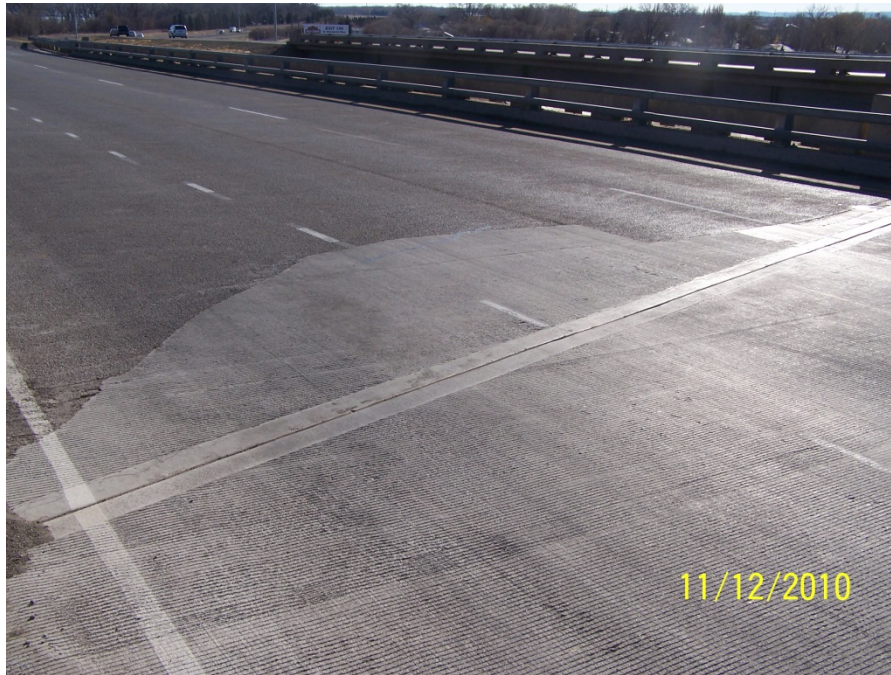
During the 2010 construction season the approach and exit slabs were replaced along with some concrete repair on the west end of the structure. A portion of the SafeLane™ was removed on the approach slab as well as a portion on the west end of the structure. These repairs were tied into the replacement of the adjacent eastbound structure.

Photo 23: Obliteration Occurred on Part of Installation on the West End

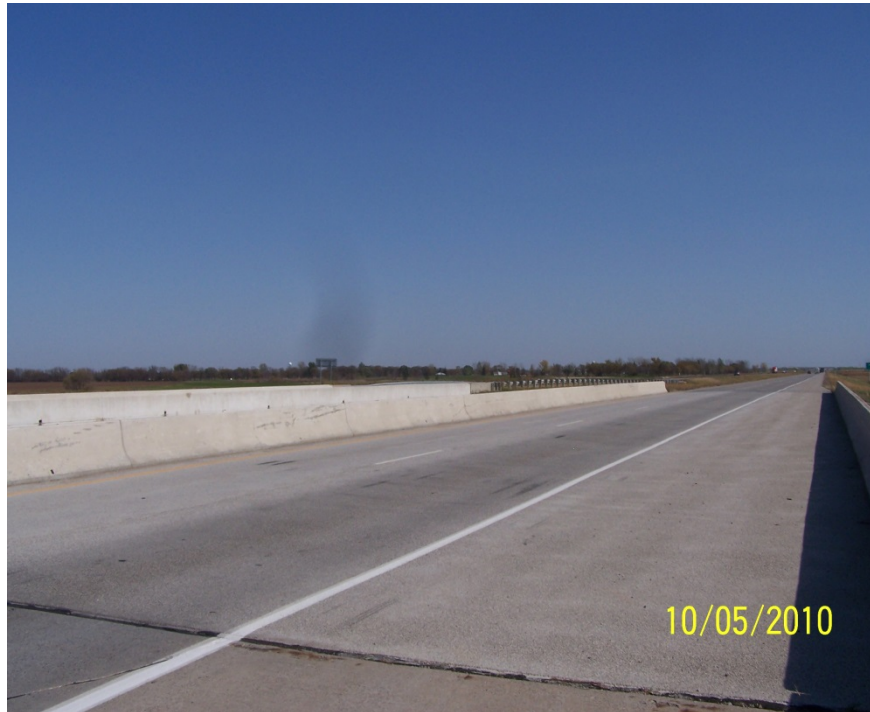
Photo 24: FLEXOGRID™ Installation Looking East

Materials and Research visited the I-94 Maple River Structure with FLEXOGRID™ on November 5, 2010. This FLEXOGRID™ system appears to be performing well after one year. The epoxy and aggregate is still intact. The skid resistance may have gone down some but does not appear to be significantly changed.

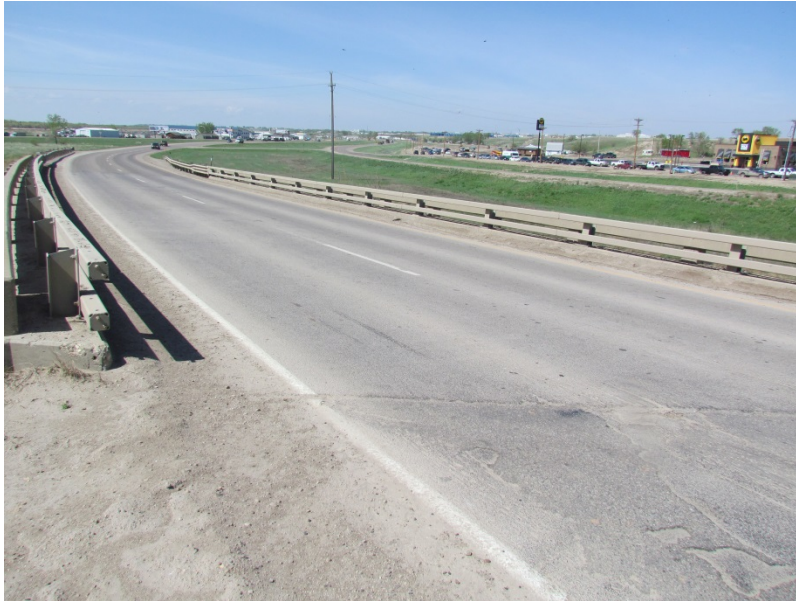
Photo 26: SafeLane™ Facing West

The SafeLane™ product on the ND 2 Sand Creek Structure in the Williston District was evaluated in the fall of 2012 and spring of 2013. This was completed to find if the winter activities of snow plows caused damage to the product. It was observed that the friction qualities of the product continued to deteriorate over the winter, most likely from snow plow activity. Most of the epoxy and aggregate seems to be intact on the concrete bridge deck but the asphalt portion is rutting and in poor condition with a lot of the product gone most likely scraped off from snow removal. Some of the asphalt portion is shown below:

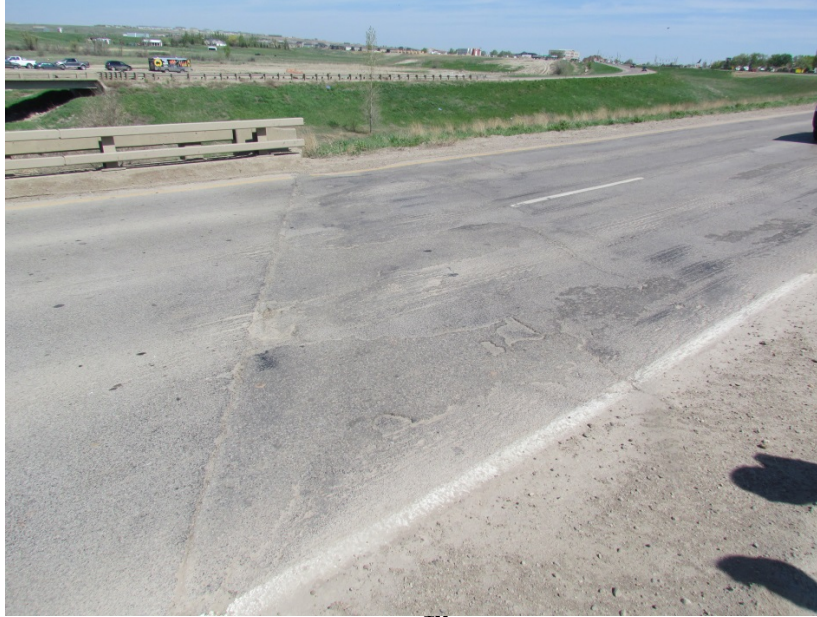
Photo 27: SafeLane™ Asphalt Portion

The aggregate continues to lose its angularity, and is smooth in the wheel paths. Vehicles continue to polish the aggregate on both the asphalt and concrete portions and this greatly reduces the surface friction of the product. There also seems to be some damage to the material from a mill machine or plow, as if something went onto the bridge a little bit and scarred the material. This damage is shown in the next photo:

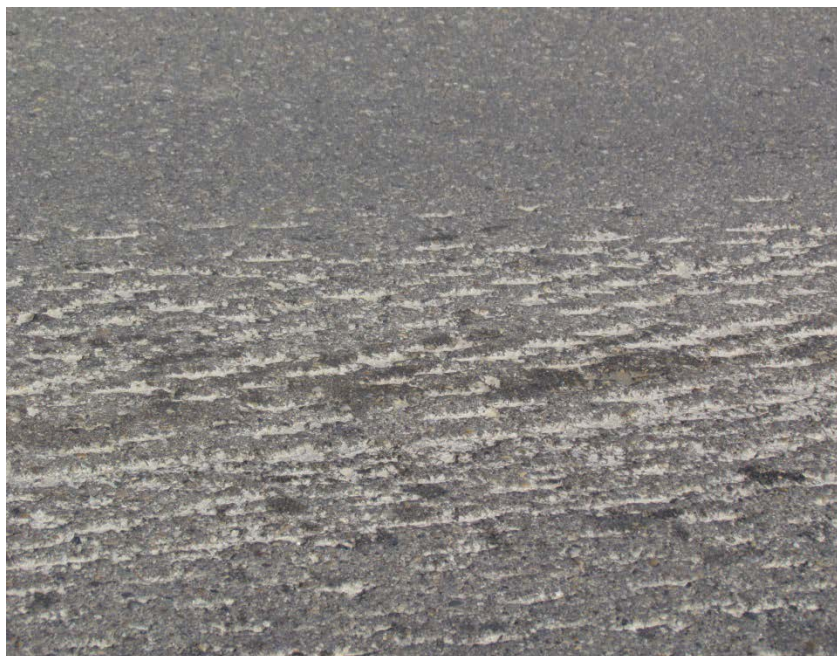
Photo 28: SafeLane™ Bridge Damage

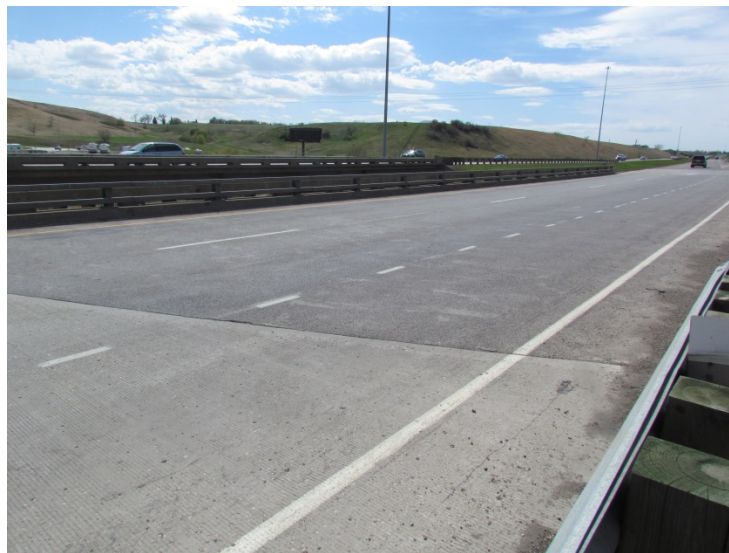
Photo 29: BNRR and Missouri Road SafeLane™ Looking West

The SafeLane™ on the I-94 Structure was visually inspected in the fall of 2012 and spring of 2013. This was completed to find if the winter activities of snow plows caused damage to the product. In the wheel paths, the angularity of the aggregate has continued to deteriorate since installation. Vehicle traffic continues to polish the aggregate and reduce the surface friction. The decrease in the angularity of the aggregate is most likely from snow plow activities.

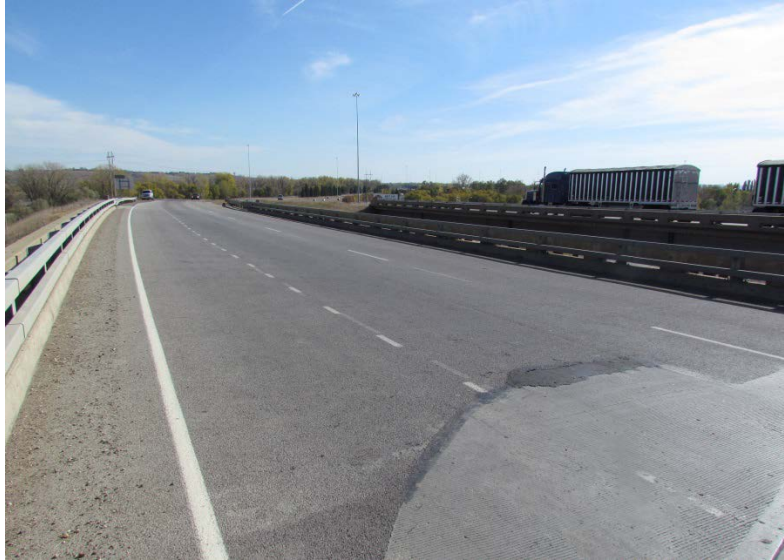
The portion of the SafeLane™ that was removed on the approach slab as well as a portion on the west end of the structure in 2010 continues to deteriorate and expand. This is shown in the photo below.

Photo 29: Obliteration Occurring on Part of Installation on the West End of Bridge

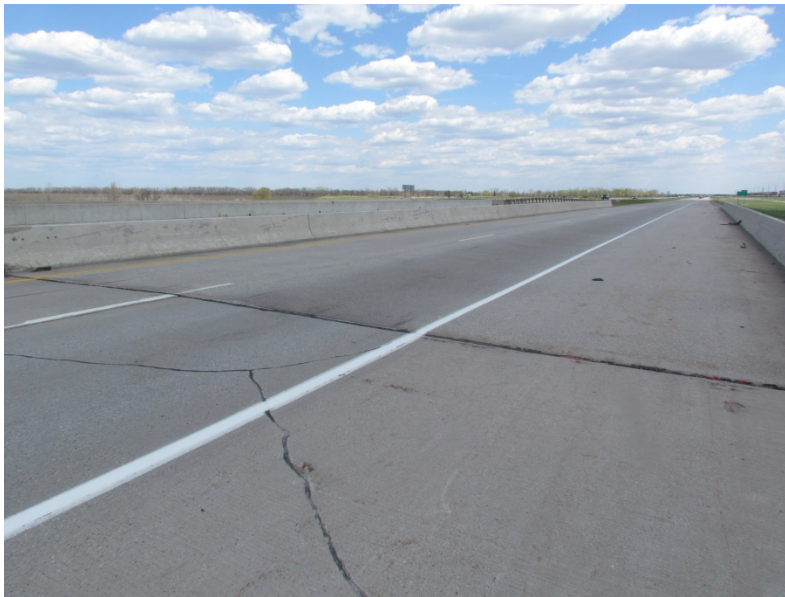
Photo 30: FLEXOGRID™ Installation Looking East

Besides for the small area that is coming off at the beginning of the bridge, the FLEXOGRID™ system appears to be performing well after four years. The epoxy and aggregate is still intact on the main part of the bridge, and most of the angularity of the aggregate is still present. The surface friction has diminished since the first evaluation but does not appear to be completely depleted.

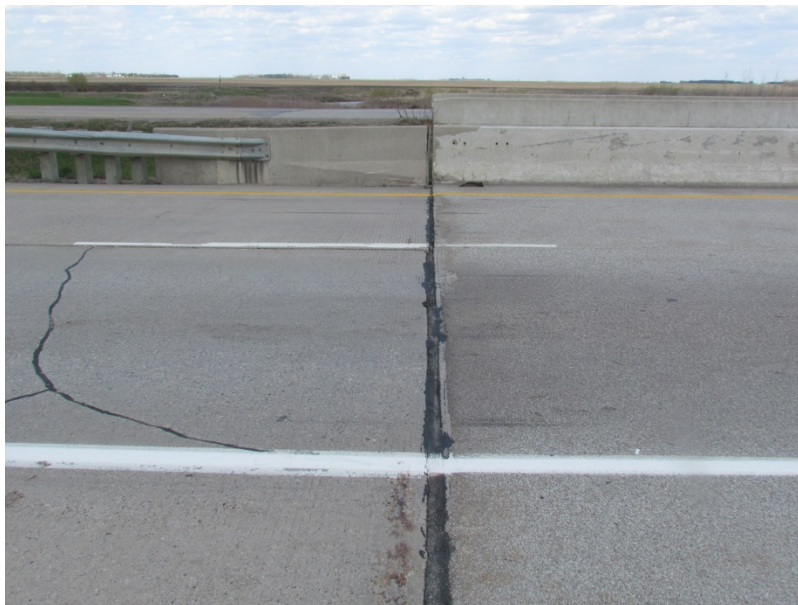
Materials and Research visited the I-94 Maple River Structure with FLEXOGRID™ in the fall of 2012 and spring of 2013. The product showed no difference between the fall and spring. Some of the material is coming off right at the beginning of the bridge, as shown below:

Photo 30: Beginning of the Bridge

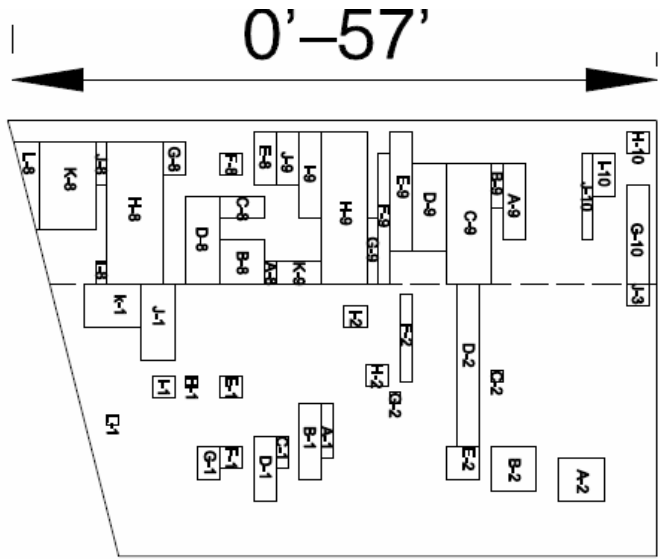
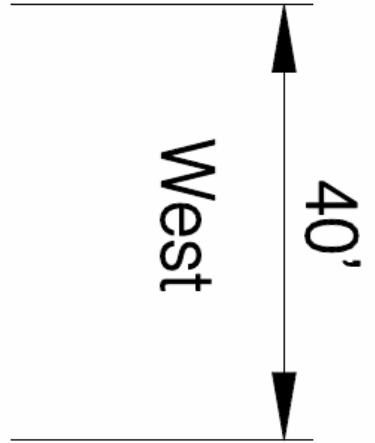
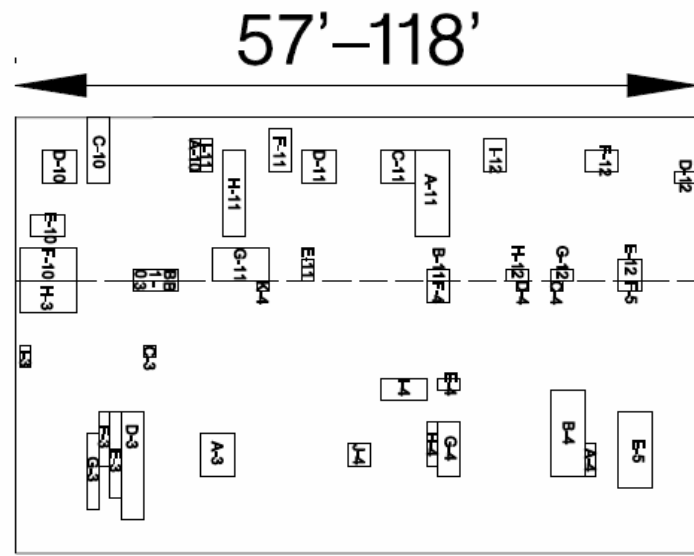
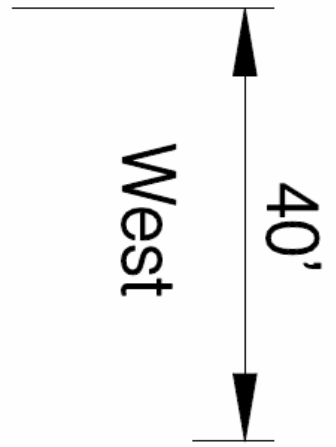
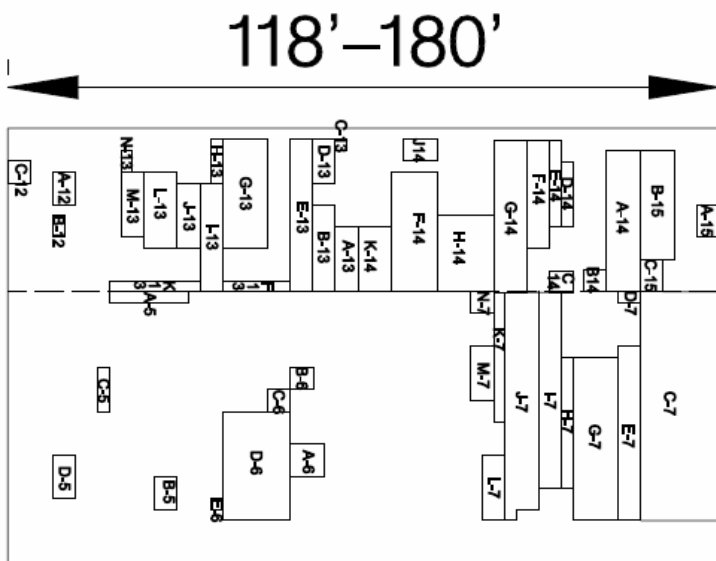
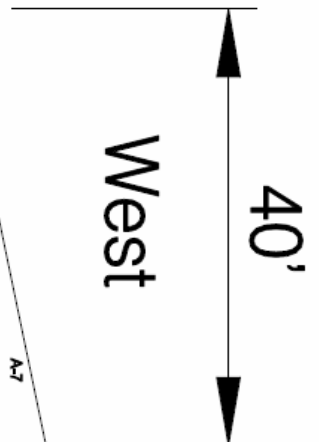
Sand Creek Structure chain drag results

C-4	1	F-8	4	C-12	4		
D-4	1	G-8	6	D-12	2		
E-4	2	H-8	65	E-12	4		
F-4	4	I-8	2	F-12	6		
G-4	10	J-8	4	G-12	2		
H-4	4	K-8	40	H-12	2

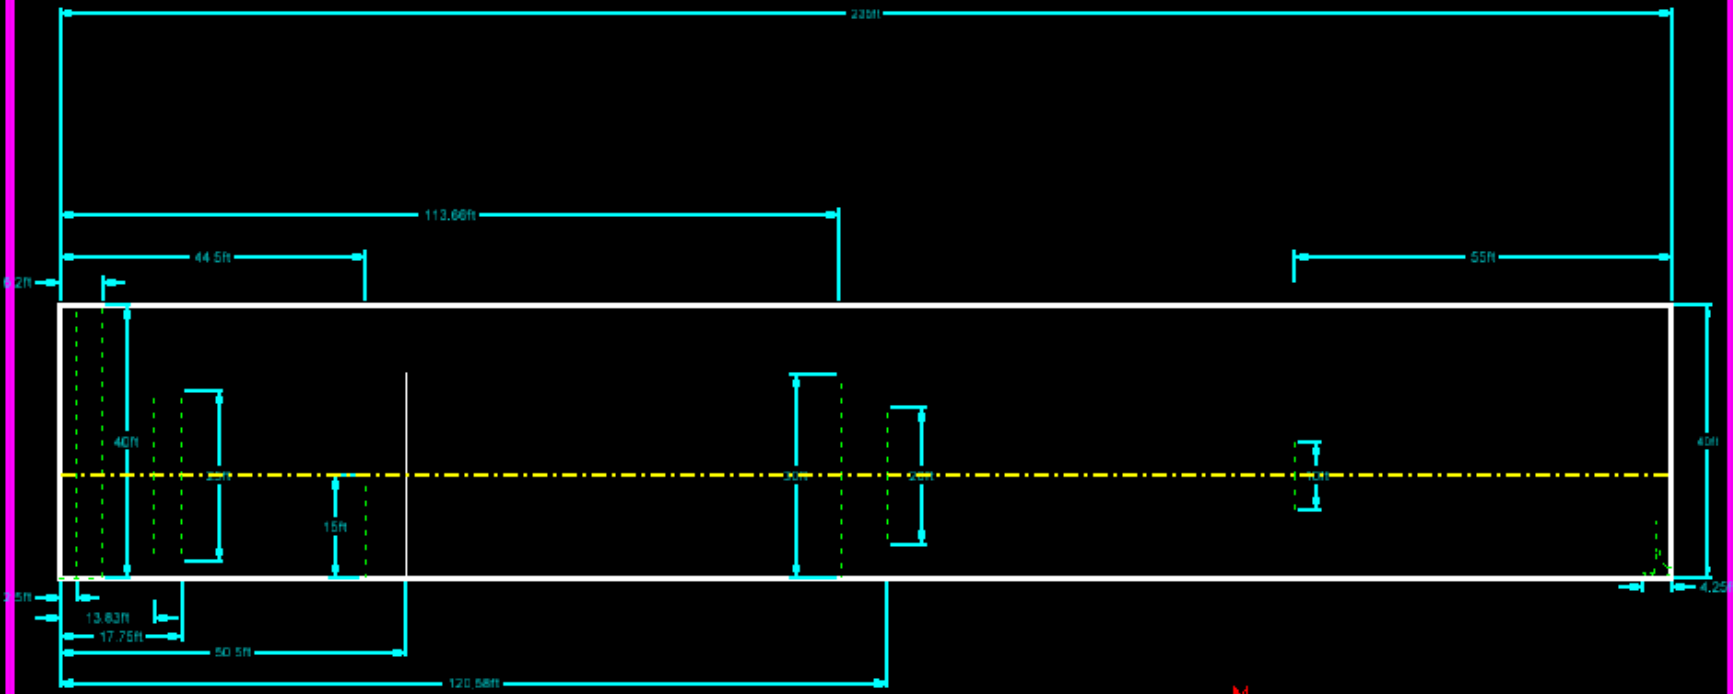
- Cracks in bridge
- Bridge Deck Boundary
- - - - - Centerline of driving lanes

* All locations and crack widths are approximate and crack survey was conducted in the passing lane only
