Experimental Study ND 2013-01

**Evaluation of Grooved, Rumbled
Pavement Markings**

Final Evaluation

HES-HRR-1-999(021)

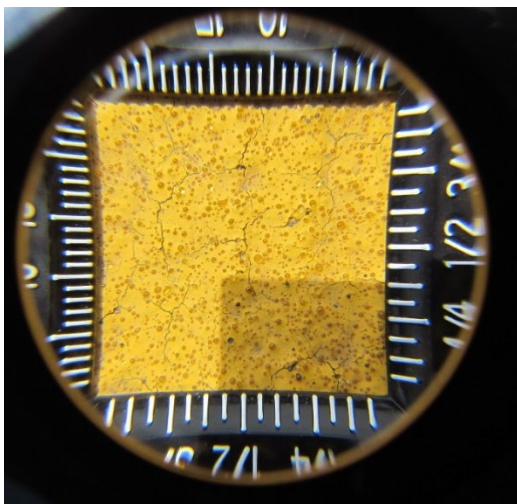
Segment 1 is a water based control section. This segment was constructed according to all NDDOT standards with the exception of a 200mil+ groove. The paint is 16 mils thick and has 6lbs/ gallon of AASHTO M 247 Type I Glass Beads. After 2 years in service the water based marking was still present. Some of the marking lost adhesion to open rock faces. In all locations the marking was fractured (see Photo 1), likely from thermal stresses on the coating. However, most of the glass beads were still present.

Photo 1 – Cracks in Water based marking

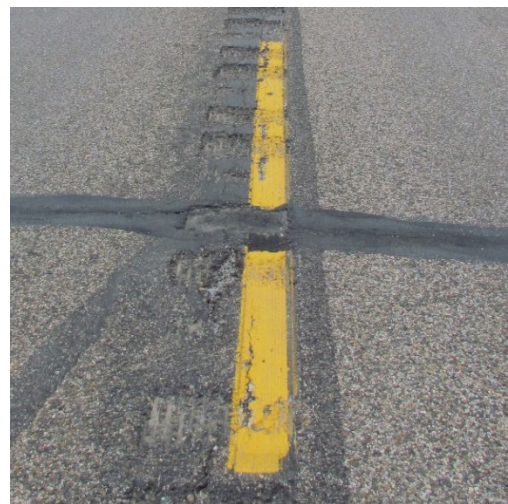
Photo 2 – General Condition of Segment 1

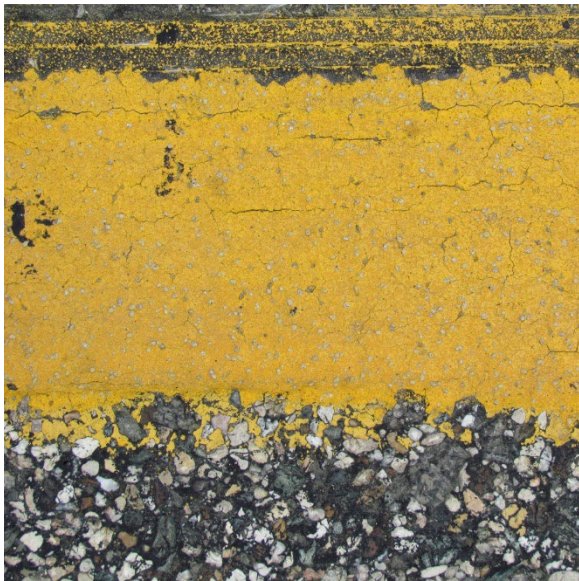
Segment 2 is water-based marking with 3M All Weather Elements. This paint is 25 mils thick with a double drop of reflective media (20 lbs per gallon of AASHTO M 247 Type 1 and 2.12 lbs per gallon of 3M All Weather Elements). The marking and reflective media are both still present. Similar cracking in the paint to the control section was observed, but no loss of adhesion to the open rock faces.

Photo 3 – Cracks in Water-based Marking

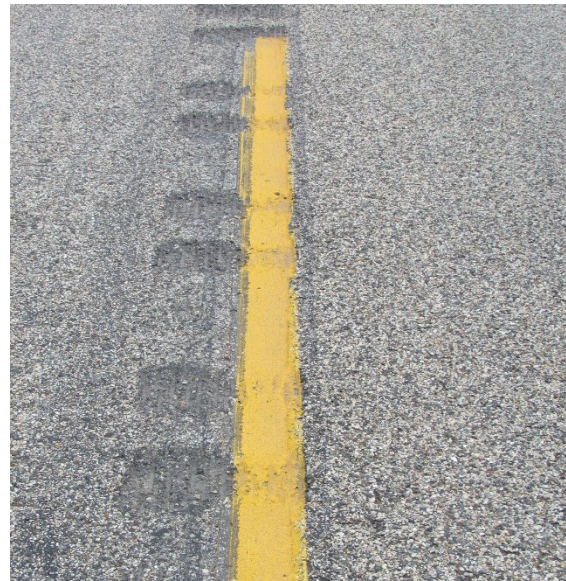
Photo 4 – General Condition of Segment 2

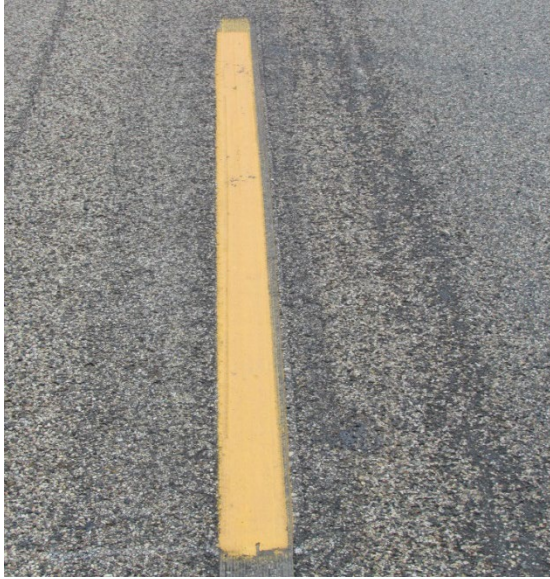
Photo 5 – Segment 3 – Epoxy Marking Intact

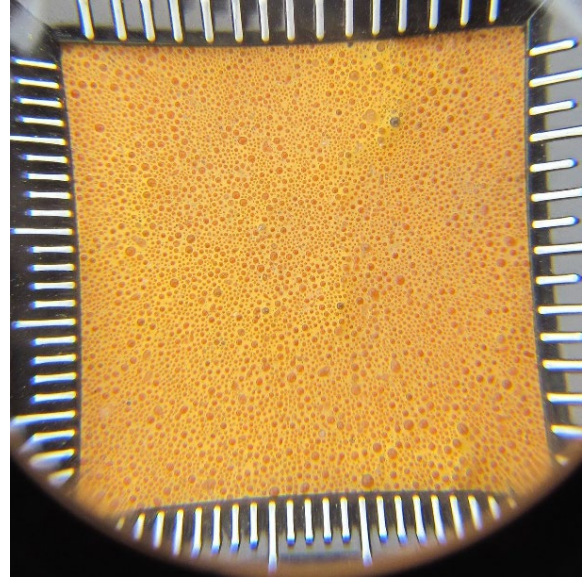
**Photo 6 – Segment 3 Epoxy Marking Intact
(Magnified)**

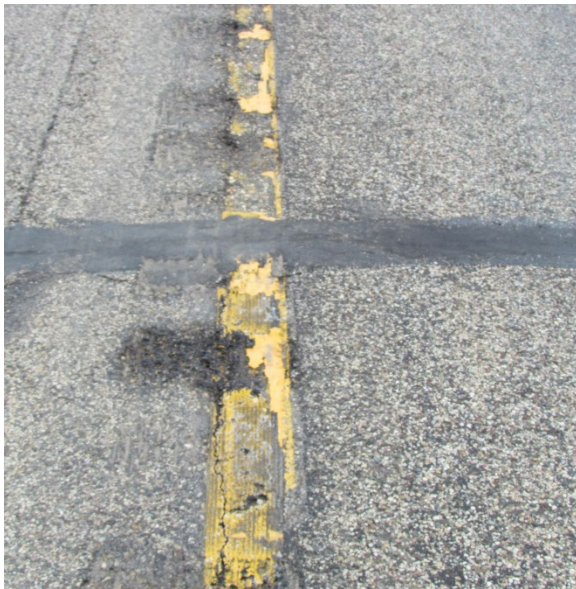
Photo 7 – Segment 3 Delamination

The reason for the delamination is the construction sequence trapped an uncured fog seal between two layers of temporary water based paint. After the old pavement marking was removed, an application of temporary paint was applied, as the centerline of the road cannot be left unstriped overnight without other means of traffic control. The temporary paint was in place until the rumble stripes were cut. Next, the rumble strips

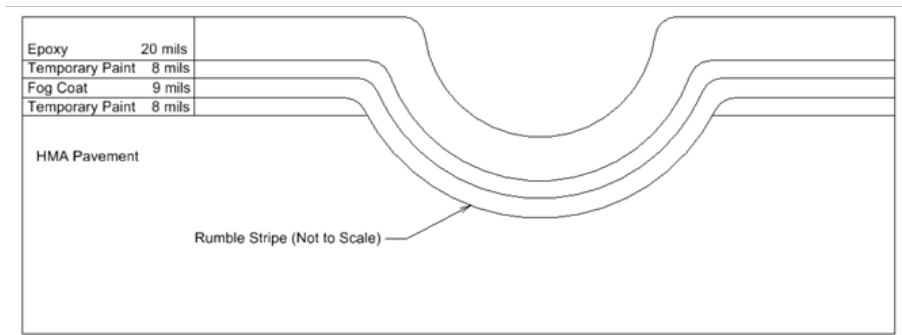
are cut (also removing some of the original temporary marking). Then the rumble strips are covered with a fog seal. The fog seal is covered with a temporary stripe the same day, again because the centerline cannot be left unstriped. Finally, the permanent stripe is placed. A cross section of this marking is shown in figure 2:

Figure 2 – Longitudinal Cross section of pavement marking system.

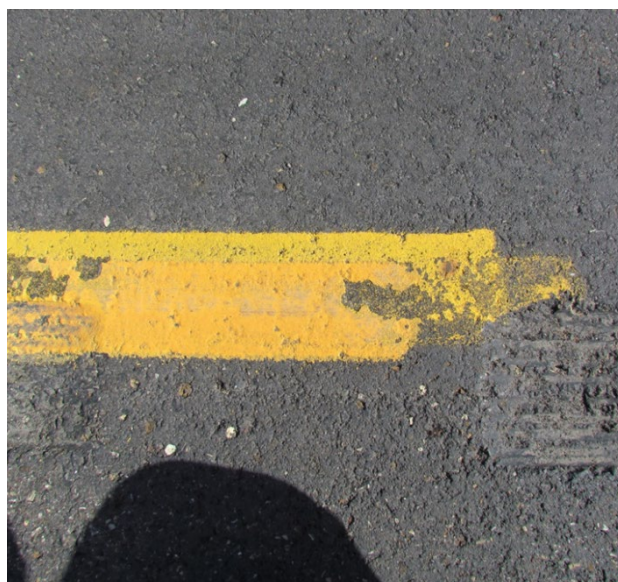
Further examination of the delamination of this pavement marking system showed that when the upper pavement marking layers were removed, fog seal remained both on the pavement and on the back of the delaminated material. This indicates that the break is occurring within the fog coat. When this pavement marking system is impacted by the snowplow, it will break within the weakest layer of the system. If we look again at the cross section, what’s currently visible is the first layer of temporary paint, under the remaining fog seal.

Photo 10 – Delaminated areas appear to show HMA Underneath.

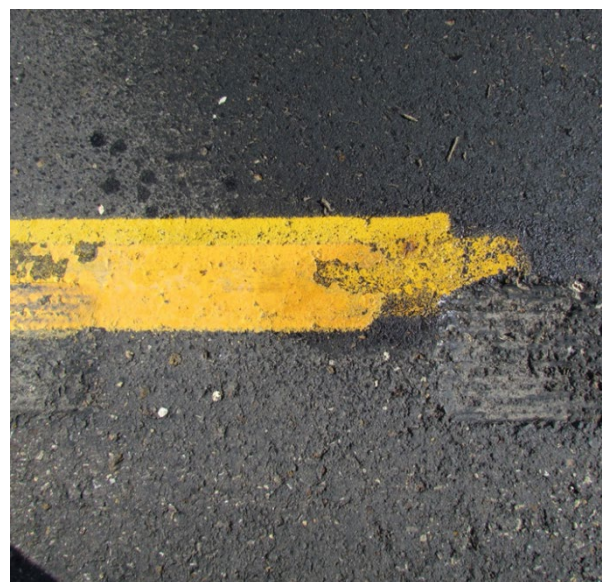
Photo 11 – After cleaning, temporary paint visible underneath, indicating that the black material is fog seal.

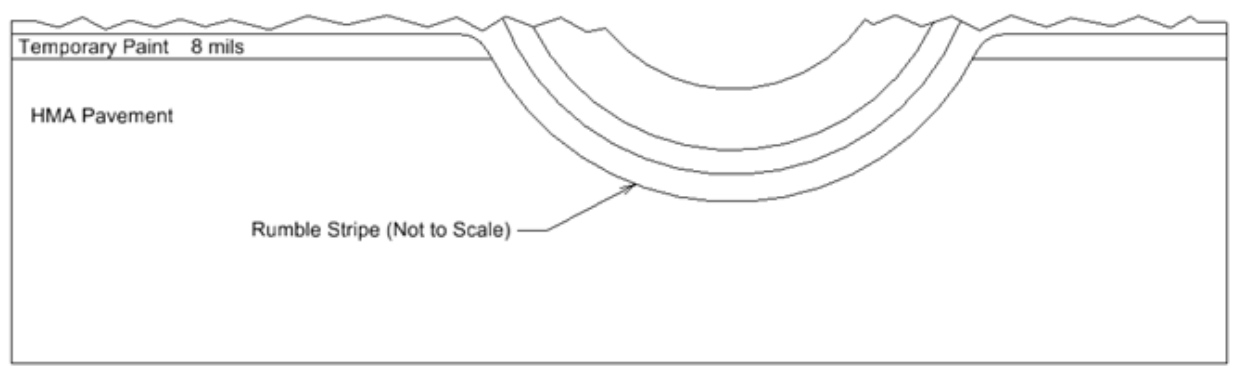
Figure 3 – Longitudinal Cross section of pavement marking system after delamination.

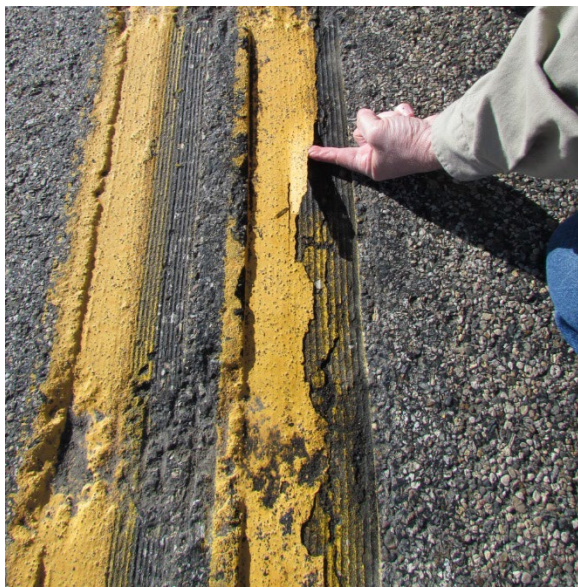
Segment 4 is an epoxy pavement marking with 3M Elements. This segment had the same delamination issues as segment 3, see Photos 8 and 9.

Photo 8 – Segment 4 – Delamination

The early failures of segment 3 and 4 are the same mechanism, and have nothing to do with the use of 3M elements.

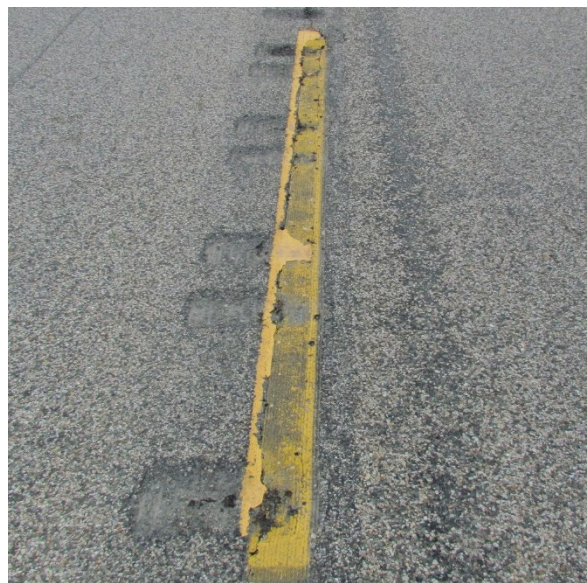
Photo 6 – Segment 4 Delamination

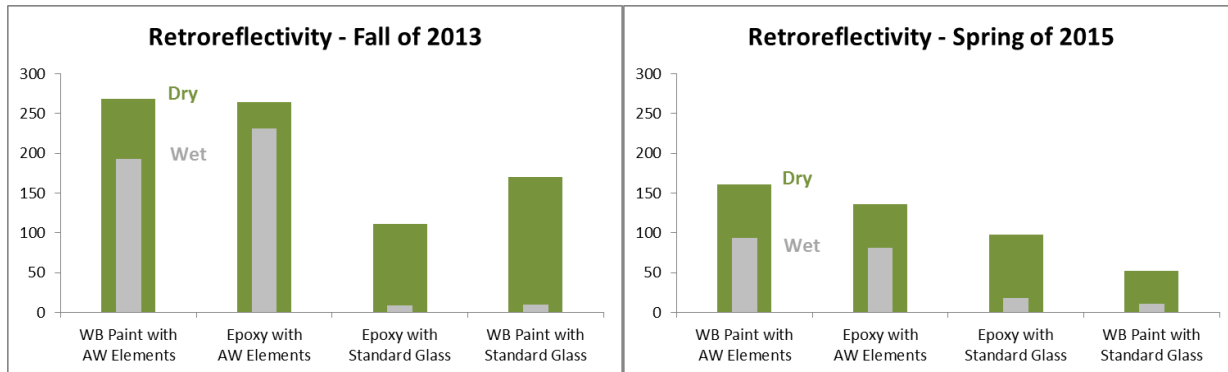
The retroreflectivity data shows that the water based paint and epoxy with AW elements has outperformed the water based paint and epoxy with standard glass. However, all segments were heavily impacted by a significant loss of pavement marking material due to the afore mentioned fog seal issue.
