Experimental Study ND 2013-03

Spraywall Pipe Liner
Evaluation

SOIA-5-094(084)023

March, 2016

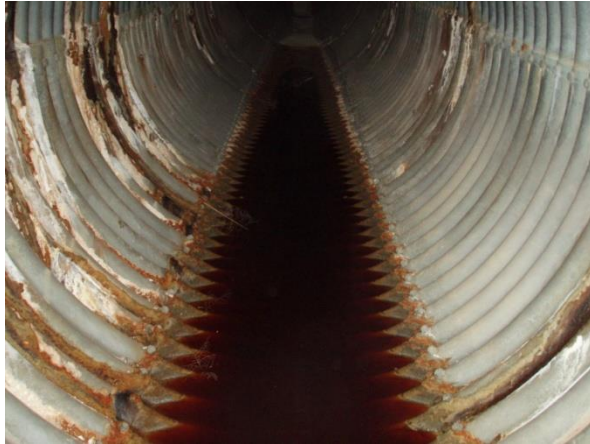
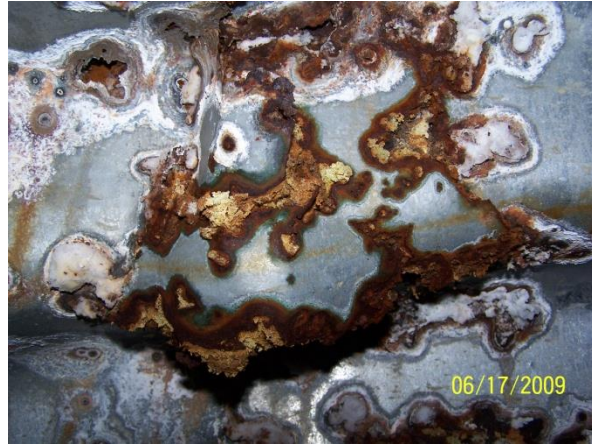
perforations. An additional 10' of liner was added to evaluate the performance of Spraywall on the transition of different gages of steel. The photos below display the deterioration of the pipe.

Photo - Deterioration of 90" Structural Steel pipe

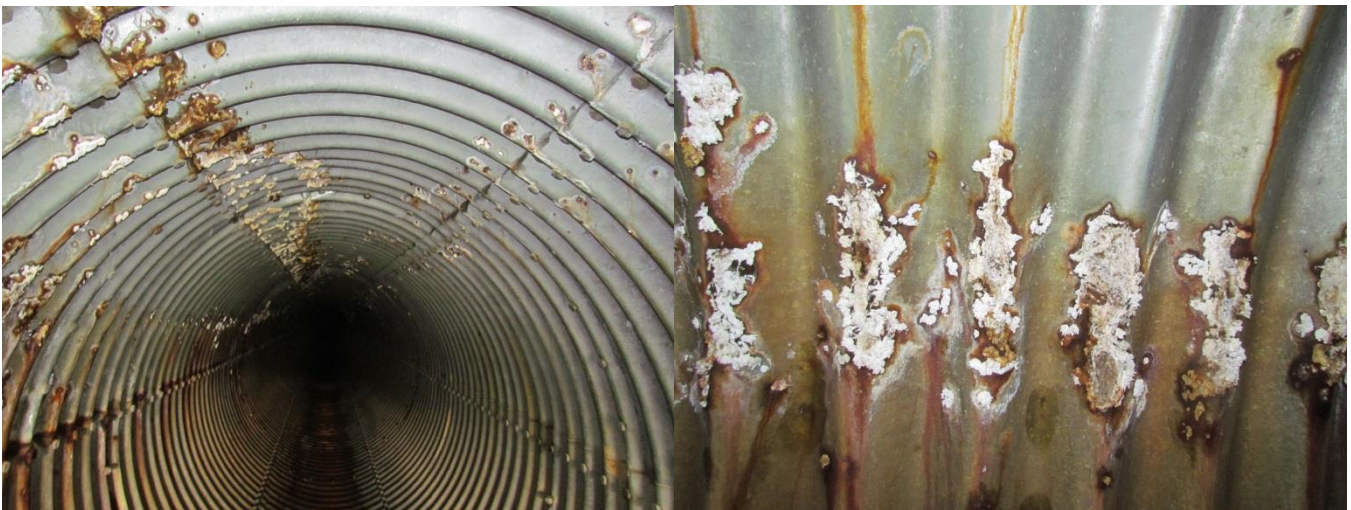
Photo 1 – Deterioration and corrosion of steel pipe.

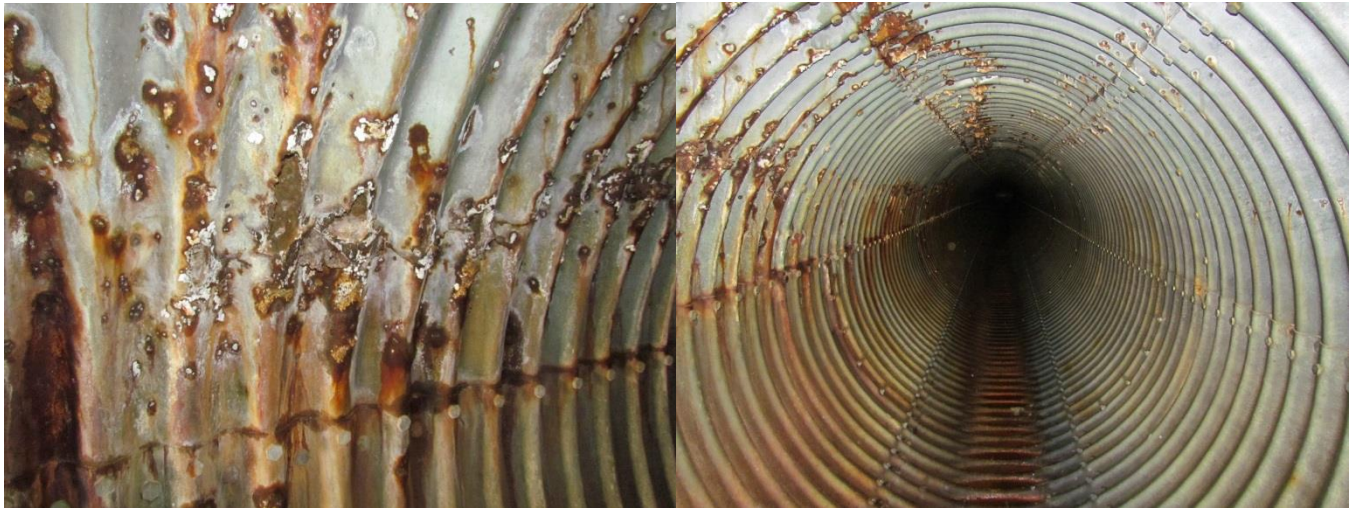
Photo 2 – Deterioration and corrosion of steel pipe In the project a rain event passed through area. When Subsurface arrived at the project location three to four inches of water still remained in the bottom of the pipe. The water was pumped through the pipe downstream to the end of the pipe. The remaining water in the bottom of the pipe corrugations were vacuumed to leave the pipe dry.

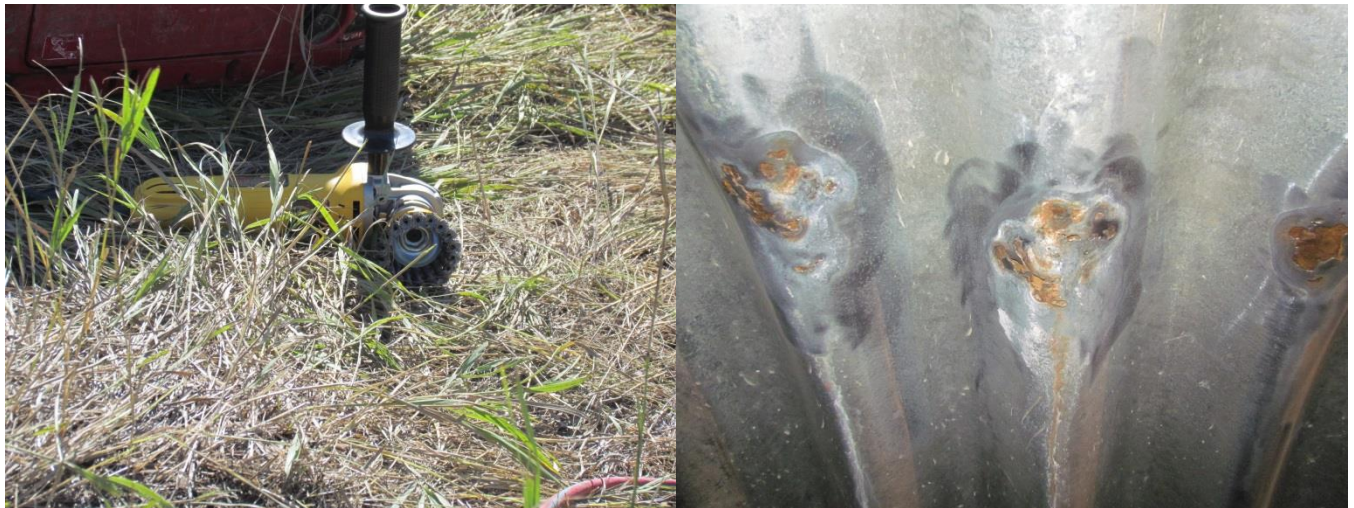
Photo 3 – Grinder and deteriorated location after corrosion has been removed.

Next the Subsurface crew began to remove the pipe corrosion and sealing up the deteriorated holes caused from corrosion. The corroded locations within the pipe were removed using a grinder attached with a cup wire brush as seen in Photo 3.

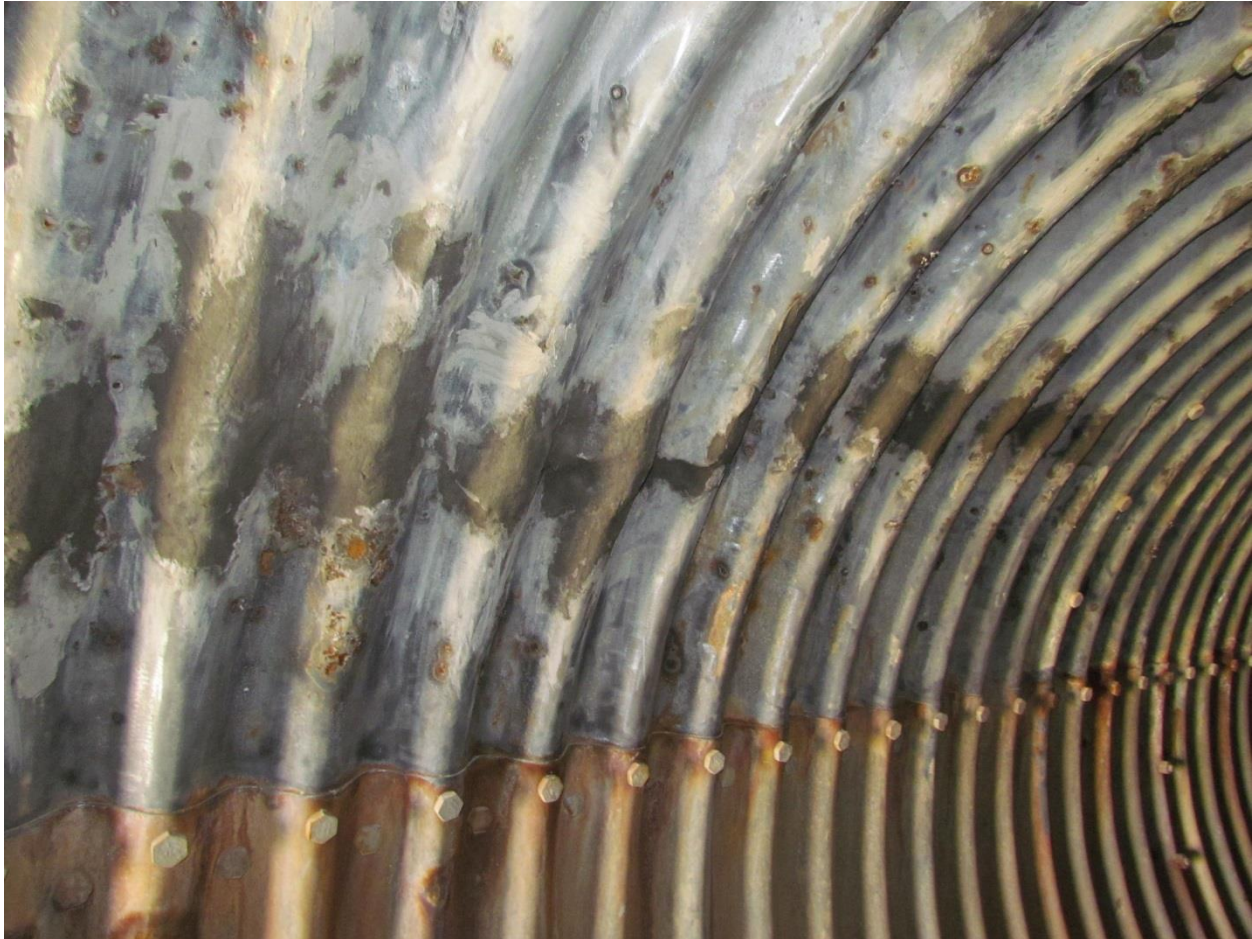
Photo 4 – Deteriorated holes filled with mortar.

After the corrosion was removed the locations with holes in the steel were filled with Speed Crete Blue Line, a rapid setting cement based mortar produced by The

Euclid Chemical Company. The mortar is to provide a clean dry substrate for the Spraywall. Example of this can be seen in Photo 4. The larger locations where the corrosion created a hole are filled with the mortar. The smaller locations where the

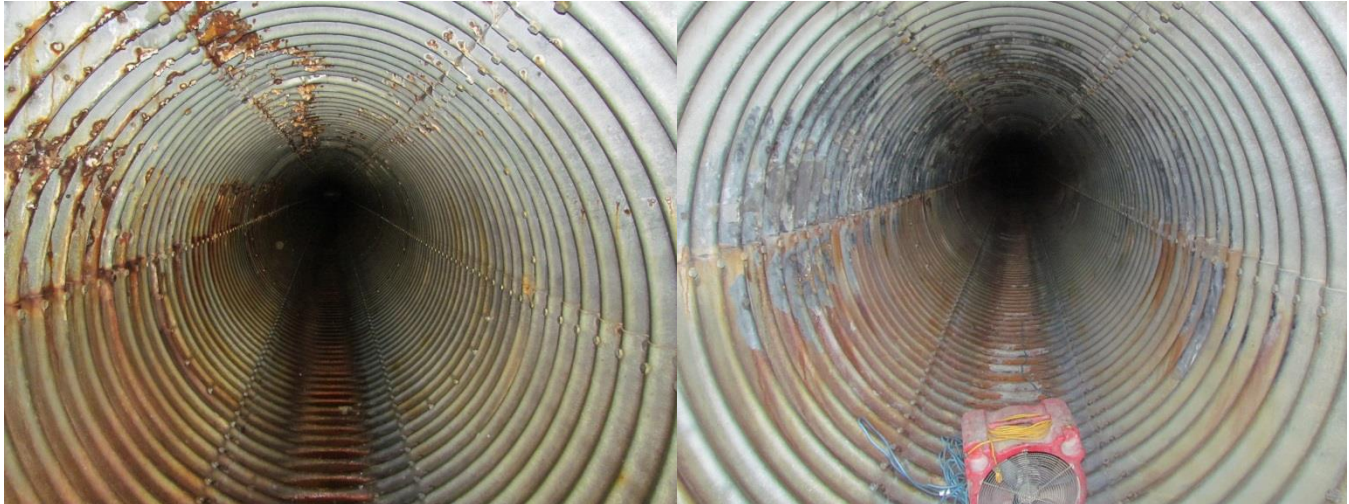
Photo 5 – Before and after pipe preparation

After the deteriorated locations were removed and the holes were filled with mortar the pipe was pressure washed to remove any debris. Heated air was then pumped into the pipe to warm and dry the pipe overnight prior to the installation of the Spraywall. The pipe was heated to approximately 75 degrees Fahrenheit. Photo 5 displays the pipe before and after the pipe preparation was completed.

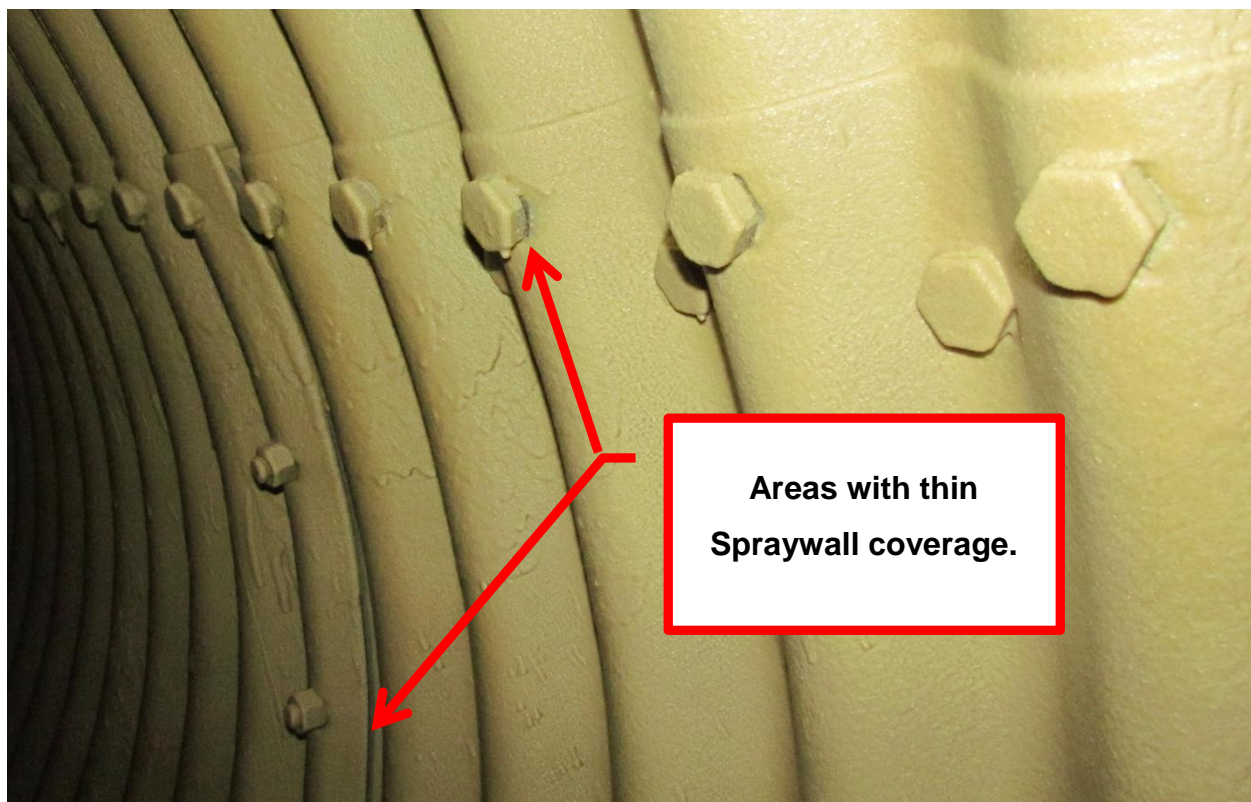
The coverage around the bolts and seams appeared very thin where there was a sharp angle on the substrate. Examples of these areas of concern can be seen in Photo 12.

Photo 12 – Examples of locations with thin Spraywall coverage.

The locations that appeared to have thin coverage of Spraywall were fixed using the SR 6100. In some of these locations a depth check was performed and the thickness of the Spraywall meet the design thickness of 500 mills in the majority of locations tested. The depth checks measurements can be seen in Appendix A.

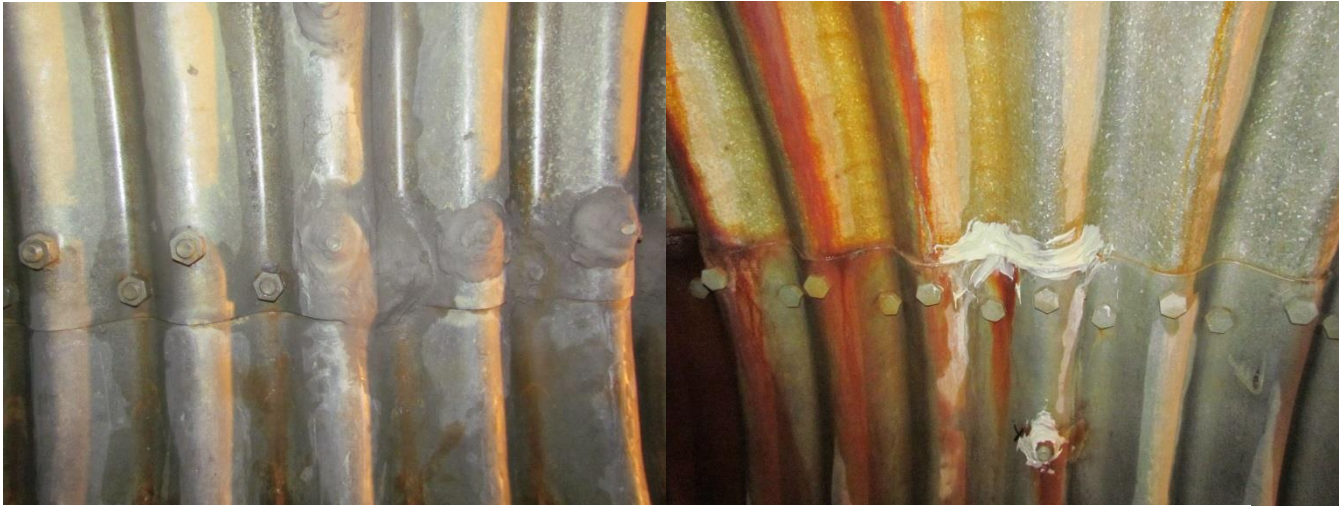
The contractor's original concern is that they were using too much Spraywall material around the bolts and plate seams. The contractor used the quick set mortar and SR 6100, an epoxy from Sprayroq, in attempt to smooth out the sharp angles of the bolts and plate seams.

Photo 13 – Quick set mortar and SR 6100 smoothing out sharp angles.

This method of smoothing out the sharp angles may remedy the sharp angles but it is very time consuming to complete the task. This method was abandoned and the Spraywall representative was approached for guidance on this problem. The Spraywall representative contacted other Sprayroq Certified Partners and it was determined that the contractor needed to adjust the technique used to spray the sharp angles. The contractor improved on the Spraywall application around the sharp angles after help was received by the Spraywall representatives.

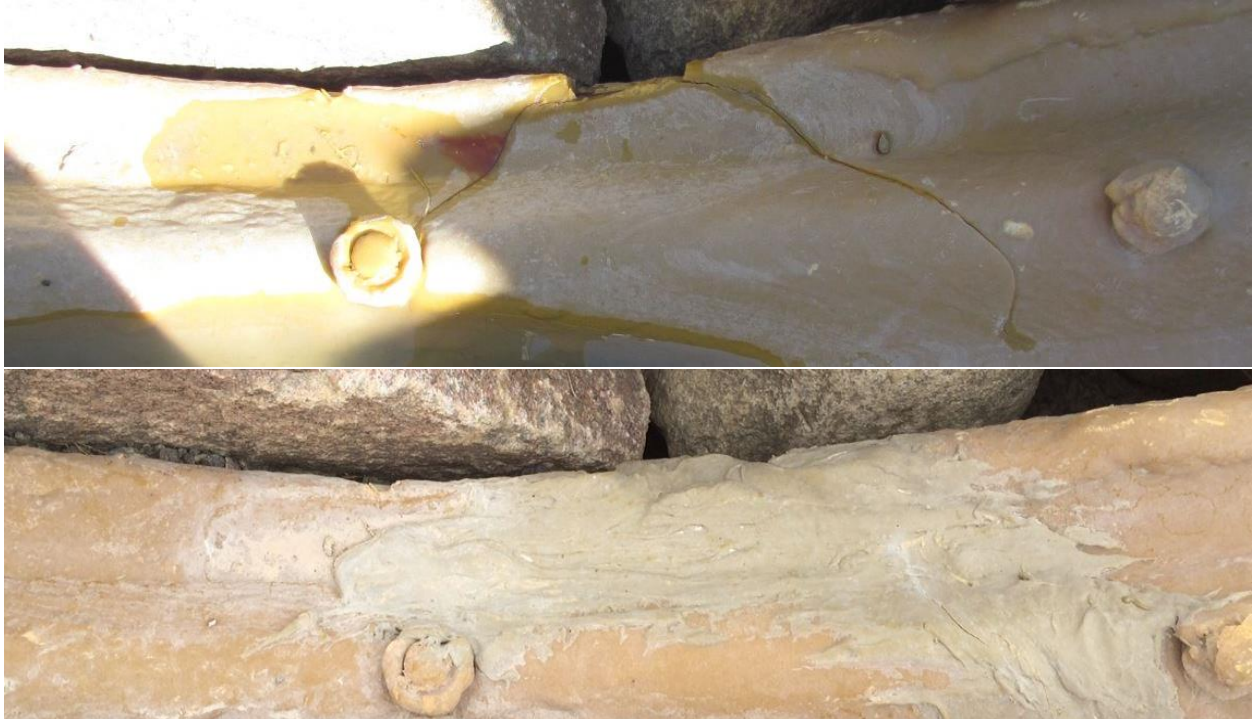
The crack on the bottom edge of the end section (refer to Photo 14) appears to have been created by installation of the adjacent rip rap. There is a chip on the edge of the liner and two cracks propagating at an approximate 45 degree angle from the chip.

Photo 14 – A crack on the bottom edge of the end section. It appears the installation of riprap caused the damage.

The Spraywall liner was inspected on July 24, 2014, May 26, 2015 and August 28, 2015. From these evaluations five cracks were found in the liner. Four of the cracks are found on the edge of the end section of the pipe. The other crack is on the floor 50' in from the end of the edge section. Four of the cracks were repaired by Subsurface prior to the May 26, 2015 evaluation. The repairs were made using Sprayroq epoxy SR 6100 product.

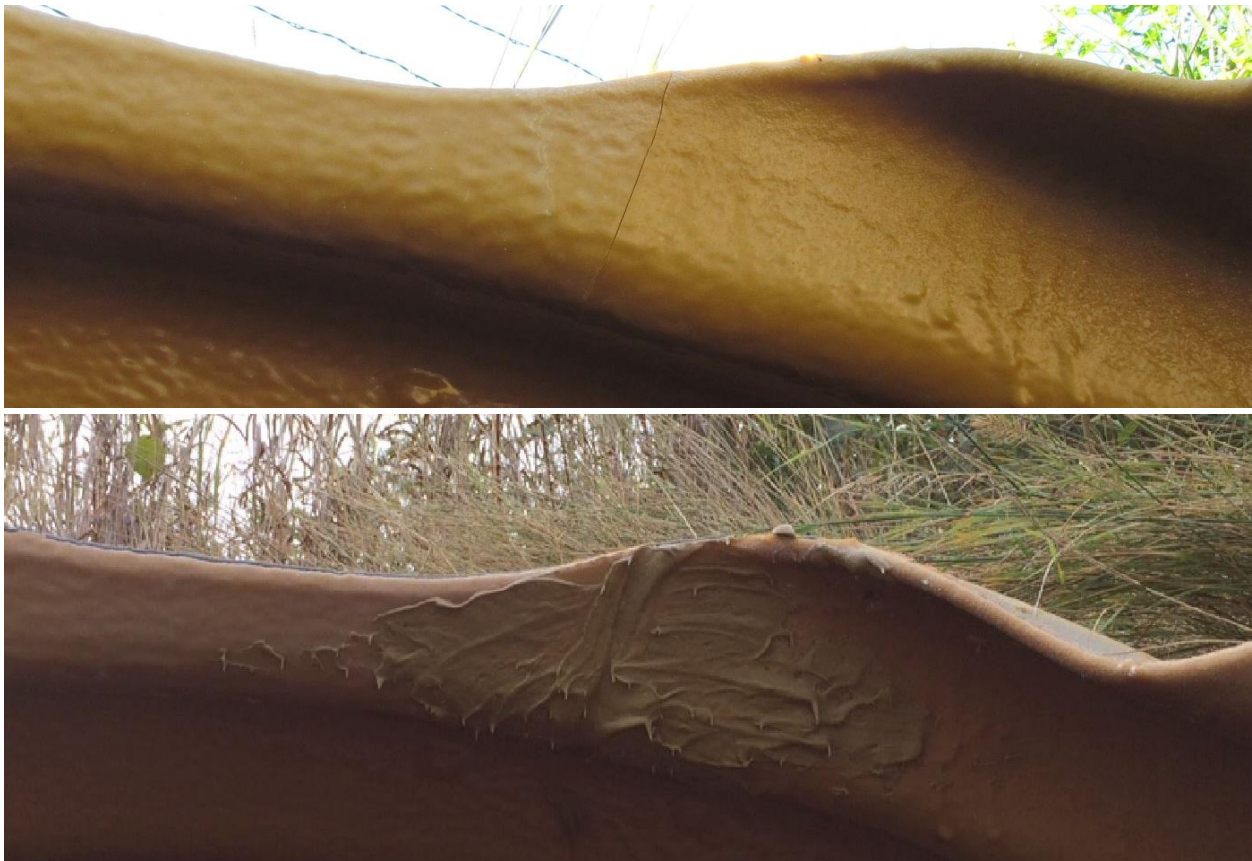
Photo 15 – A crack at the top edge of the end section before and after the repair.

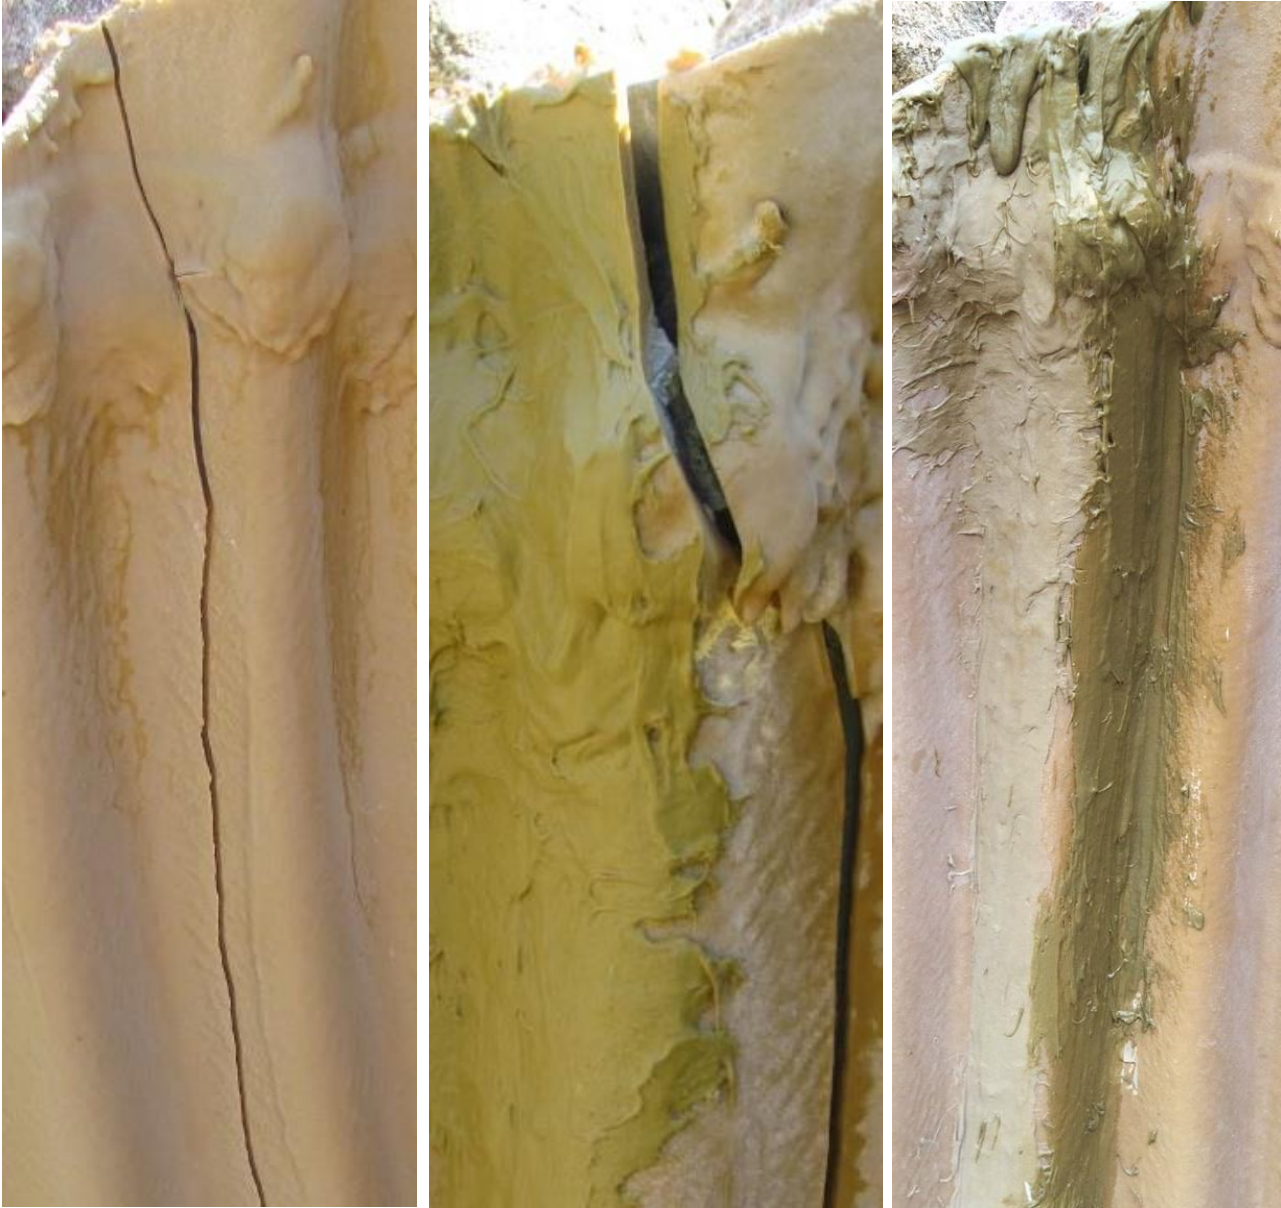
The crack on the side of the end section was the most severe crack (refer to Photo 16). The crack was repaired prior to May 26, 2015 and another crack appeared parallel next to the original crack. Subsurface then repaired the new crack prior to the August 28, 2015 evaluation. Along the edge of the end section where these cracks developed there is delamination between the end section and the Spraywall liner (refer to Photo 17). The gap between the end section and Spraywall liner were filled with Sprayroq epoxy SR 6100.

Photo 16 - A crack at the side edge of the end section before and after the repair. After the repair was complete, another crack formed parallel next the repaired crack. The new crack was repaired Subsurface.

The Spraywall liner has very little defects at this time. Most of the cracks occur on the edge of the liner on the end section of the pipe. The crack along the side of the pipe end section is the most severe crack. After that crack was repaired another crack developed parallel next to the original crack.

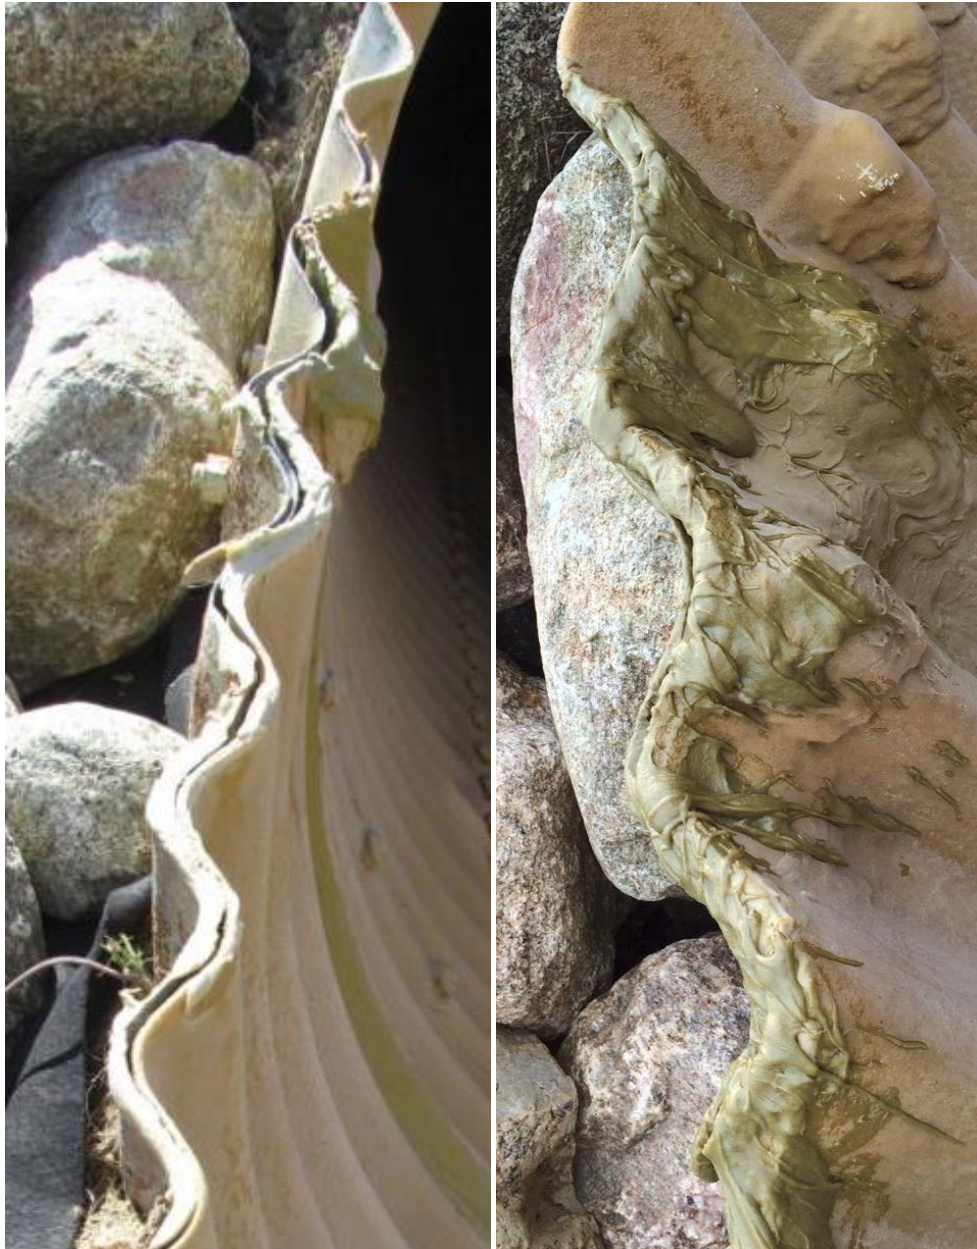
Photo 17 – Delamination between edge of end section and Spraywall liner.

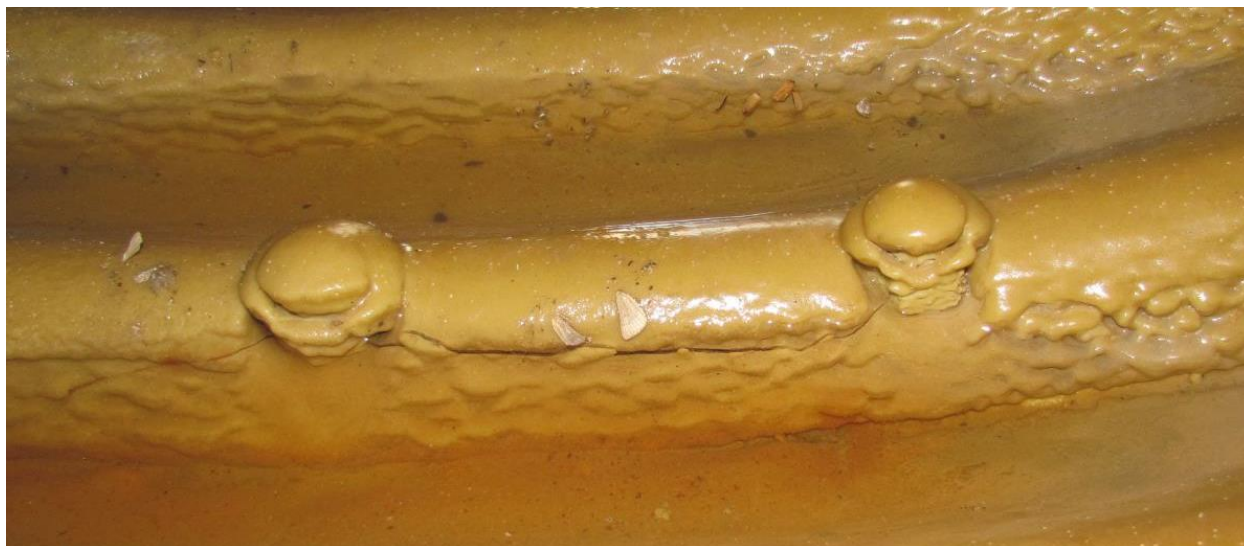
There was only one crack that was not on the outside edge Spraywall liner. This crack is on the floor of the pipe, 50' in from the end of the pipe. The crack is on a joint for the structural plate pipe (refer to Photo 18).

Photo 18 – Crack on the bottom of pipe 50' in from end of pipe.
