Experimental Study ND 95-03

Dowel Bar Retrofit for Load Transfer

Final Report

Projects IM-6-029(022)186 & IM-8-029(003)022

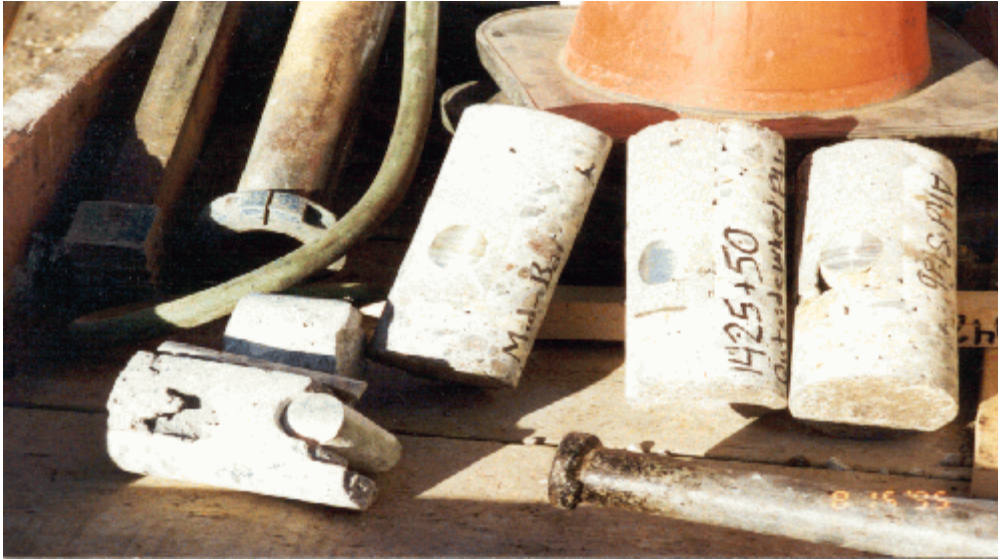
Several cores were taken shortly after the test sections were constructed. It was determined from the cores taken that insufficient vibrating of the mix had caused voids under the dowel bars.

Photo 1 provides a view of these voids which were evident in the sections where the Patchroc 10-60 mix was used.

Photo 1. View of several cores taken by the Grand Forks District

It was determined that the contractor would redo any areas with less than 50% load transfer. The contractor ended up replacing 120 dowels or about 2% of the total dowels. All of the replacement dowels were located on stations that used Patchroc 10-60.

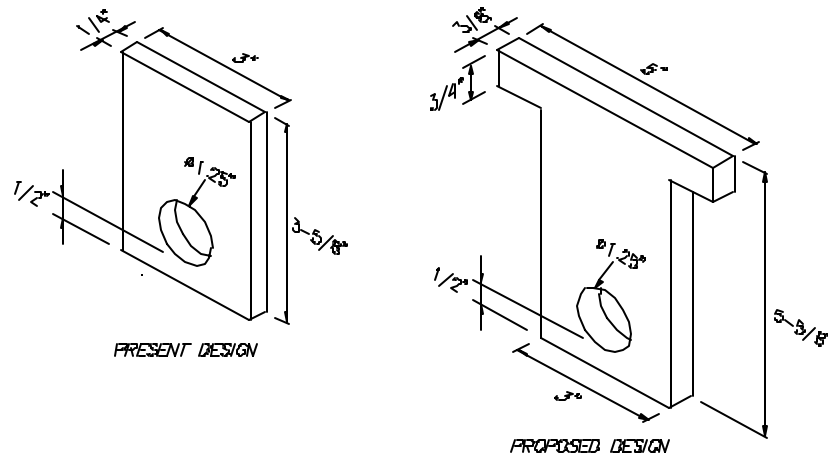
The core board design used in the Grand Forks project did not perform well. While placing the patch mix, the core board was failing to stay vertically stable. It was recommended that the core board be redesigned to include extensions on the upper portion of the core board. The extensions on the upper portion of the core board would extend into and parallel to the existing joint. This would insure the core board would run parallel in the joint and would not tilt when the sawed slot is filled with Patchroc 10-60 mix.

The Fargo District recommend that the Department of Transportation redesign the foam core boards to a T shape for future projects. They recommended a change in the thickness of the board to 3/8" thick, run the core board to the top of the slab, and have the contractor remove excess sealant where the extensions will set in the joint. Figure 1 shows the proposed change.

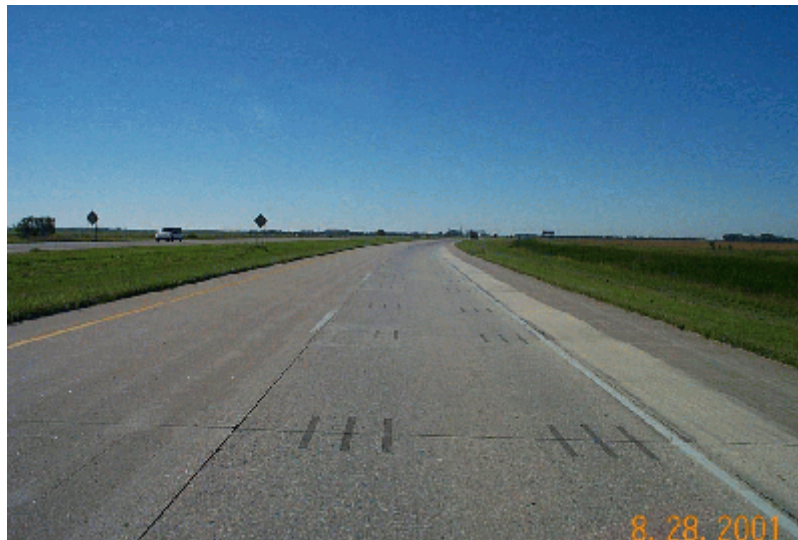
Photo 2 depicts an overall view of the dowel bar retrofit test section. This photo indicates a segment of the test section where Patchroc 10-60 had been installed as the patch mix.

Photo 2. An overall view of the dowel bar retrofit section.

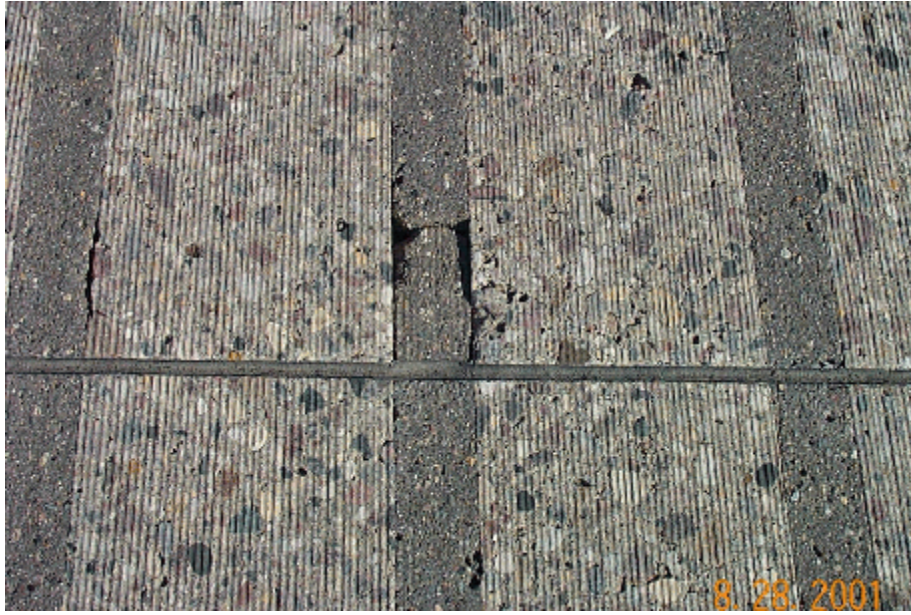
One kind of distress that was prevalent is shown in photo 3. There were several dowel bar slots experiencing this type of distress. In many cases the mix located between the adjacent joint and the transverse crack is loose. It is believed this type of distress is the result of poor consolidation of the mix around the dowel bar.

Photo 3. Typical distress detected during 2001 evaluation (A portion of the test sections containing Patchroc 10-60 patching material)

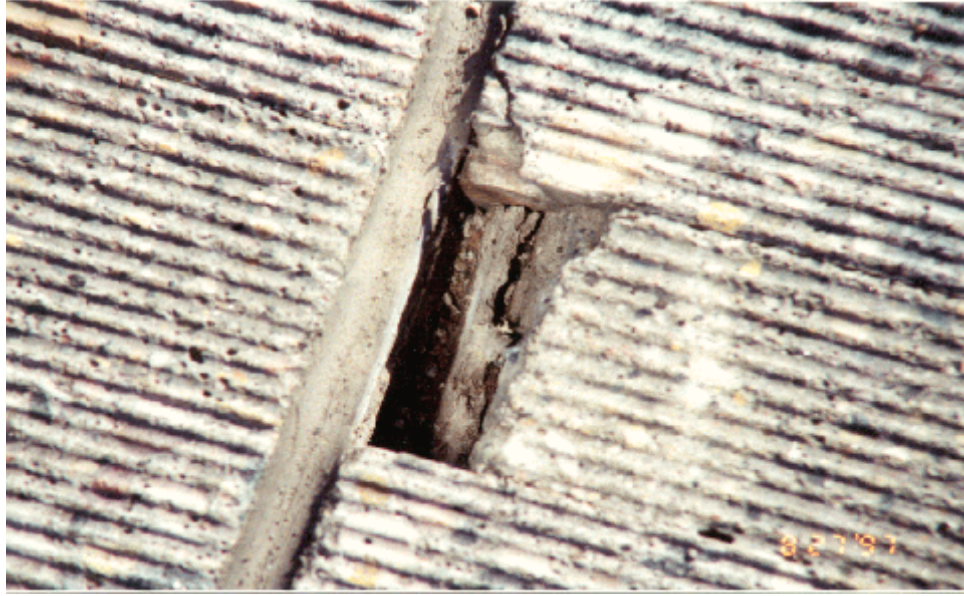
Distress related to core board failures as shown in photo 4 is also detected on one side of the joint and extends outward approximately 1" to 2". It is believed that as the patch mix was being placed the weight of mix would bend the core board over. The original core board design is shown back in Figure 1. Once the core board was forced to yield one way or the other, the patch mix would then be free to cover the core board. This condition left the core board sitting on a slant or in some cases horizontal with upwards to 2" of mix being placed on top the foam core board. When traffic was allowed to pass over the roadway, the corresponding loads may have forced the mix to shear at these areas since there was no support underneath the mix.

Photo 4. A view of a typical distress caused by a core board failure

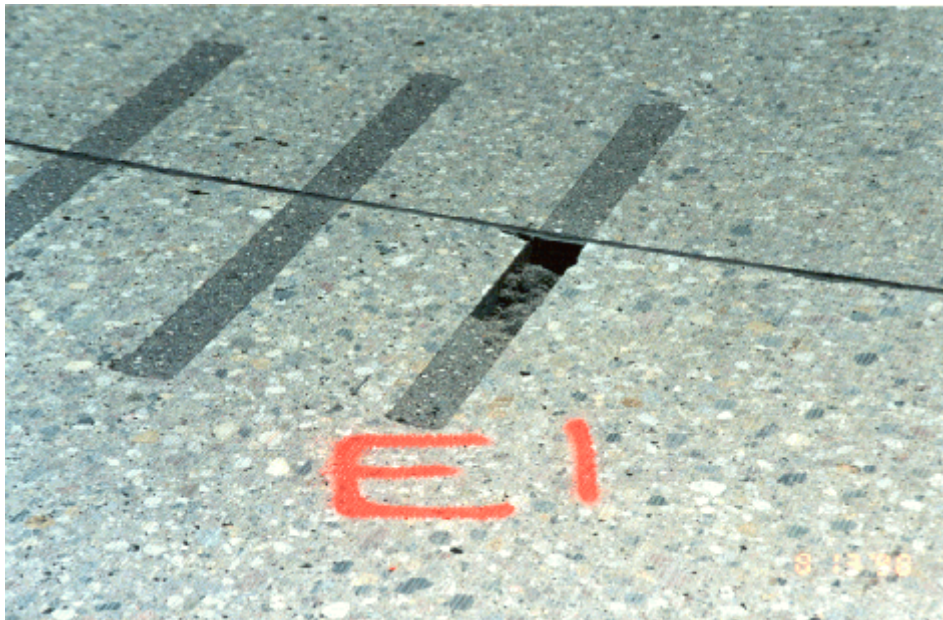
Another type of distress observed in the test section containing the Patchroc 10-60 relate to the performance of the mix. Photos 5 and 6 depict views of typical dowel bar slots in the Patchroc 10-60 section that is experiencing deterioration of the mix. Photo 5 depicts the most common failure, deterioration near the panel joint. Photo 6 provides a view of a failure some distance from the panel joint.

Photo5. Patchroc 10-60 mix deterioration near panel joint

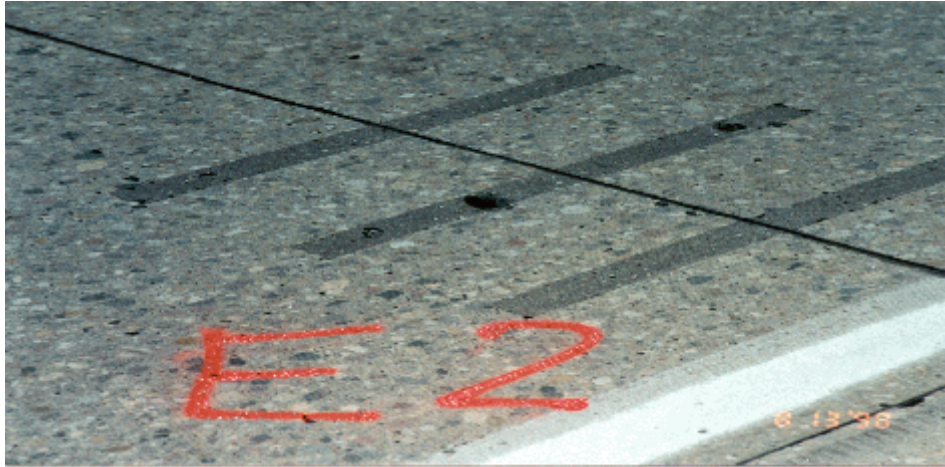
Photo 6. Patchroc 10-60 section experiencing mix deterioration

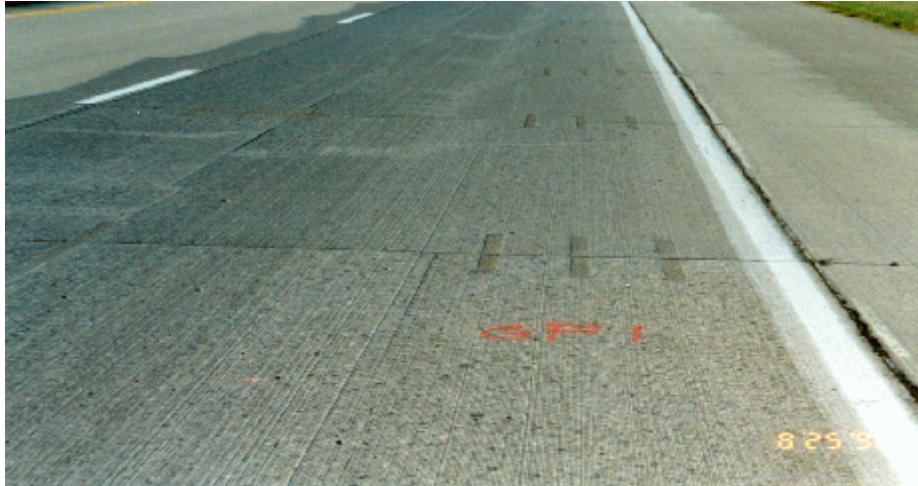
Photo 7 shows an overview of several sets of dowel bars slots located in the outside wheelpath of the Patchroc 10-60 section which are affected by deterioration of the mix. Notice in photo 7 that the traffic has worn down the material in the slots. They are now recessed relative to the surrounding pavement surface. This can also be seen by a slight shadow shown on the left edge of each slots in photo 7. Also notice that the inside lane does not appear to be as severe.

Photo 7. Dowel bars slots located in the outside wheel path of the Patchroc 10-60 section

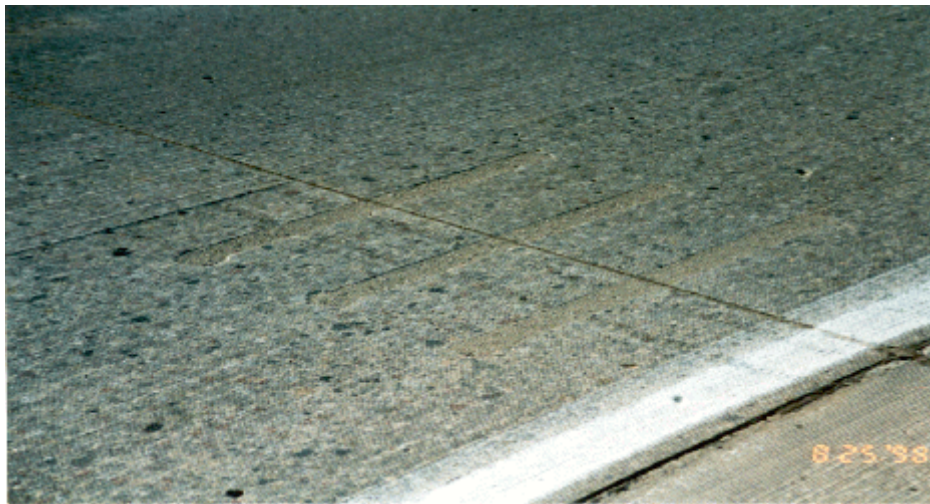
Photo 8 is a close-up view of some of the dowel bars slots affected by the mix problem

Photo 8. Close-up view of photo 7 dowel bars slots affected by mix problem

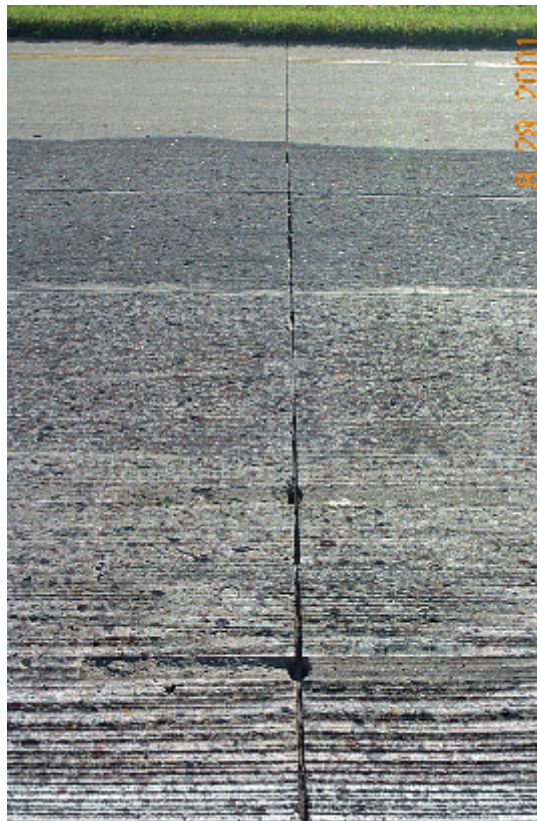
Another type of distress that is present in the Patchroc 10-60 test section is shown in photo 9. Notice the distresses present on near both sides of the joint and also the severe raveling of the mix. The distress (Patchroc material missing) located at the joint is believed to be a bonding issue. The special provision calls for caulk to be placed in the bottom of the slot and the sides along the joint so patch material does not enter the joint. If care is not taken, some

Photo 9. Note the severe raveling and the debonding along the joint.

of the caulk will end up on the sides of the slots and create a bonding problem. The severe raveling of the mix is a durability problem within the mix itself. A similar type of distress has been detected in the Fargo District.

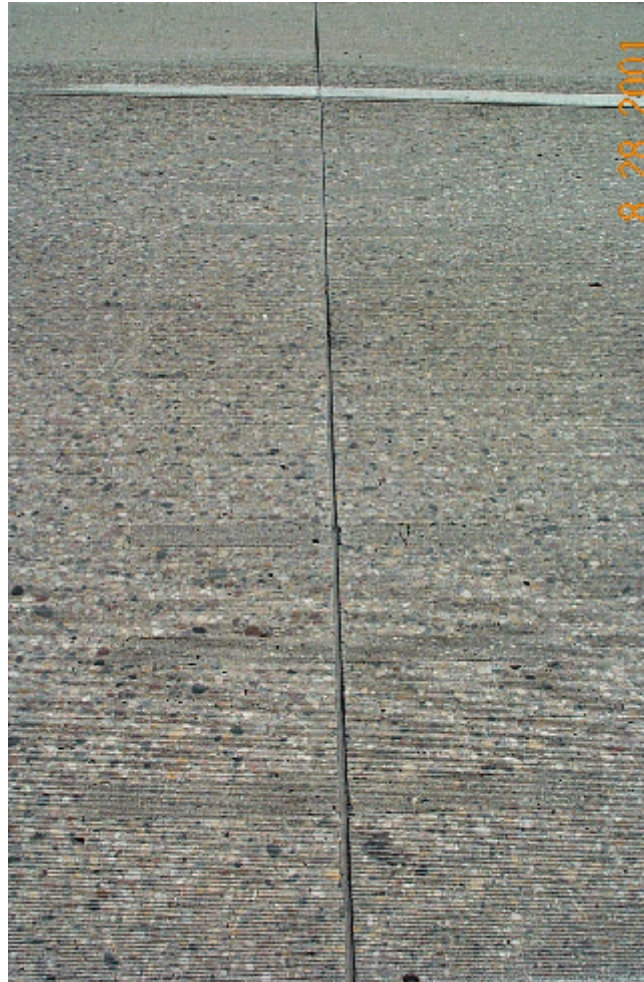
The south half of the test section contains the Minnesota specified mix 3U18 as the dowelbar retrofit patch material. Photo 10 shows a typical retrofitted joint where this mix was used.

Photo 10. Typical retrofitted joint where 3U18 mix was used. Note the shrinkage crack in the 3rd joint.

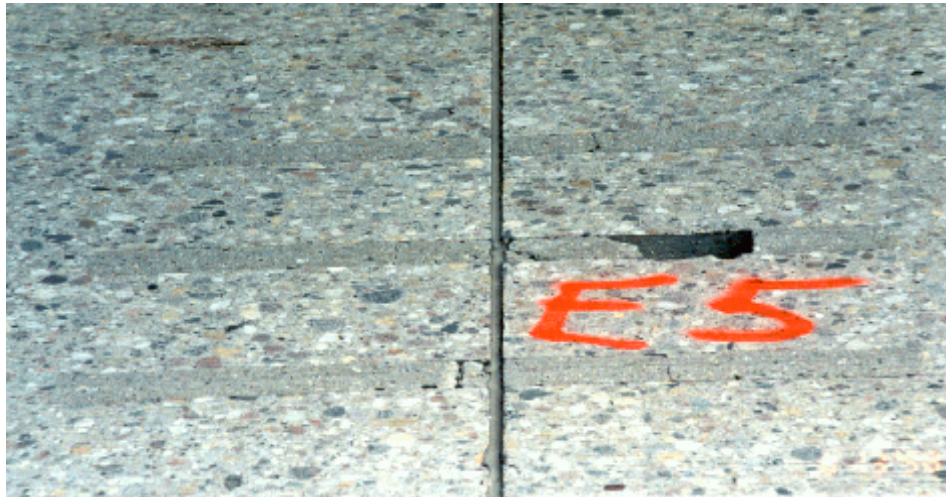
Photo 11 shows dowel bar slots affected by several types of distresses including the shrinkage cracks. Notice how the transverse cracks do not follow any distinctive pattern as to how far away from the joint they exist. Photo 11 also illustrates a view of a large piece of patch mix that is missing from the slot. The dowel bar is exposed and has to some extent rusted. At a glance it appears that the mix may have been improperly vibrated and the consolidation did not occur around the dowel bar causing the concrete to break out.

Photo 11. Dowel bar slots filled with 3U18 patch mix affected by several types of distresses including the shrinkage cracks.

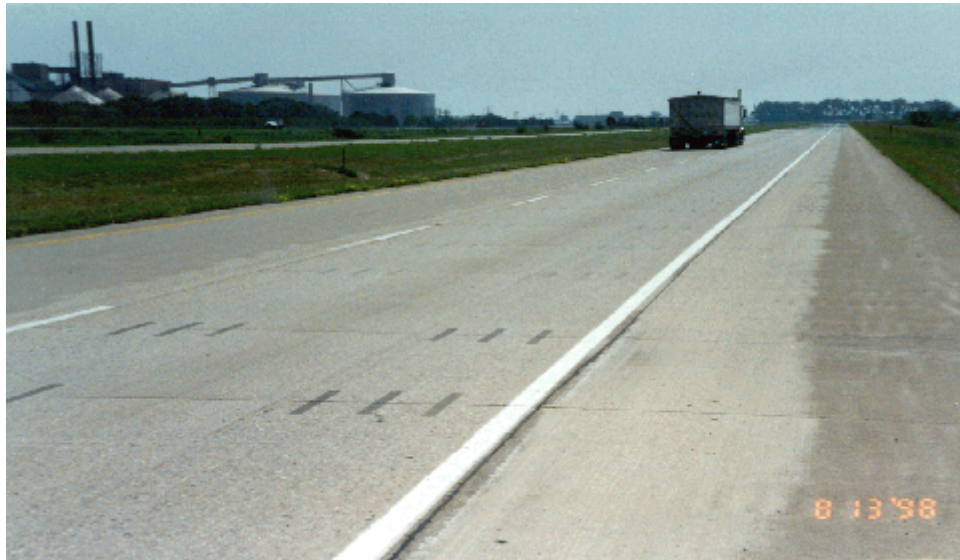
Mix problems whether construction related or within the mix itself is prevalent in both mixes. However, the 3U18 mix is not experiencing the eroding or raveling of the mix as seen the Patchroc 10-60 sections. It appears the 3U18 material is performing better than the Patchroc 10-60 material from a standpoint of durability. Photo 12 shows a view of the border between the two different patch mixes. In the foreground is the slots containing the Patchroc 10-60 material and the later the 3U18 material. At a glance it would appear, from an aesthetic standpoint, that the color of 3U18 material blends into the existing PCC much better than its counterpart.

Photo 12. View of both dowel bar patch materials. Patchroc 10-60 material in foreground, followed by the 3U18 material

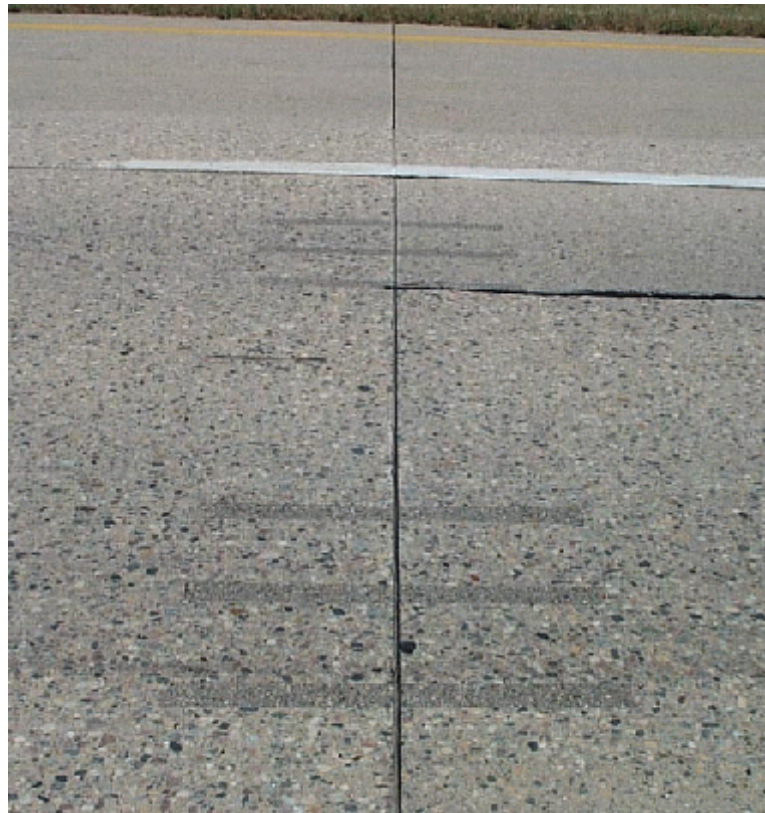
Photo 13. Typical dowel bar retrofitted joint that appears to be performing well. The longitudinal crack has not caused distress to the dowel bar patch mix.

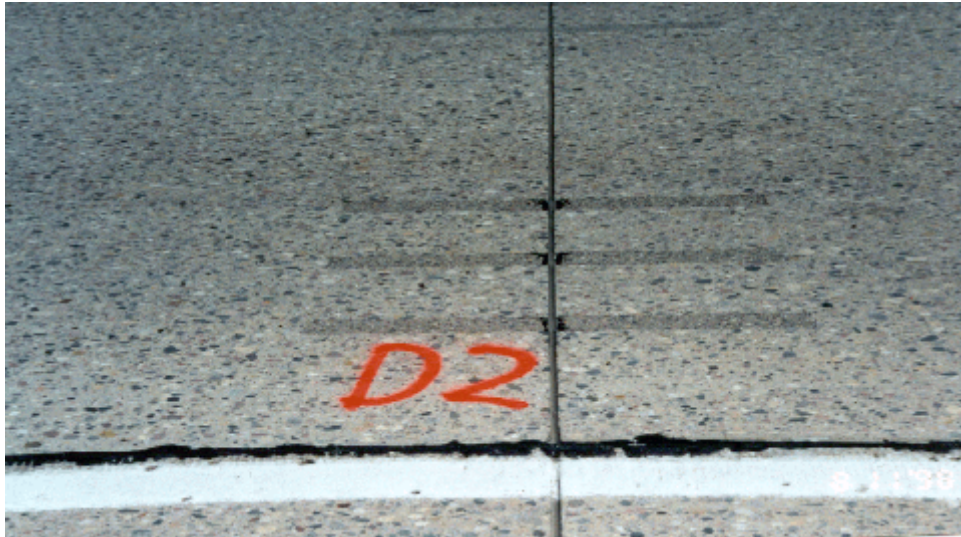
Photo 14 shows a view of several distresses that are believed to be the result of excess silicone caulk on the slot walls prevented bonding between the existing concrete and the patching material.

The bond failure is causing high stresses in a small area near the joint resulting in spalling. The types of distresses shown in photo 14 are sometimes confused with distresses that are related to core board failures (usually affecting only one side of the joint).

Photo 14. View of several distresses that are believed to be the result of excess silicone caulk on the slot walls prevented bonding between the existing concrete and the patching material.

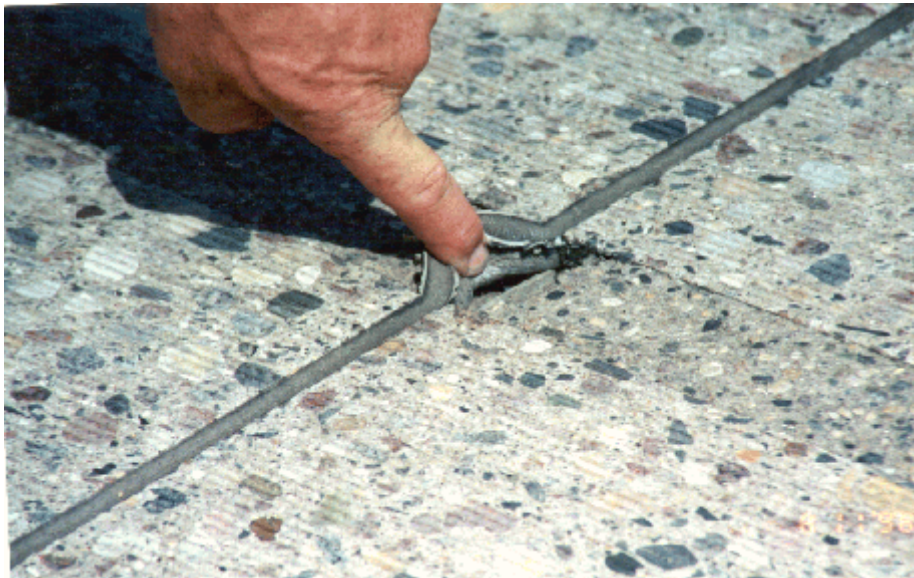
Photo 15 shows the core board in an upright manner.

Photo 15. A close-up view of one of the dowel bar slots in photo 14.

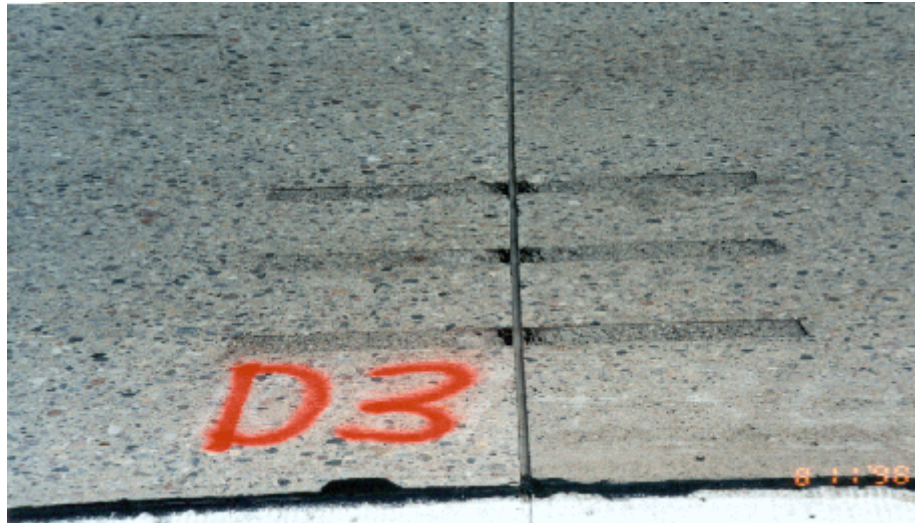
Photo 16 indicates an area that is experiencing mix problems in the dowel bar slots. Also in photo 16, traffic has wore down the material in the slots to a point where it is no longer the same elevation as the existing concrete.

Photo 16. An area that is experiencing mix problems in the dowel bar slots.

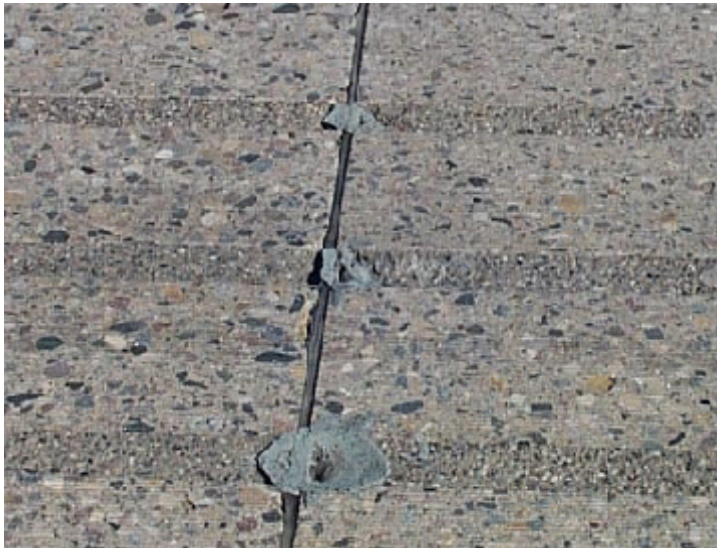
Photo 17 shows a view of dowel bar slots where an effort has been made to repair the mix that has eroded away from the slot. It is not determined at this point if this type of repair will be successful in keeping the distresses from worsening.

Photo 17. Dowel bar slot that was filled with a sealer in an attempt to seal out water and prevent further distresses from occurring.
