Experimental Study ND 98-05

**Sawing and Sealing Joints in Bituminous  
Pavement to Control Cracking**

**Final Evaluation**

Project NH-7-085(028)126

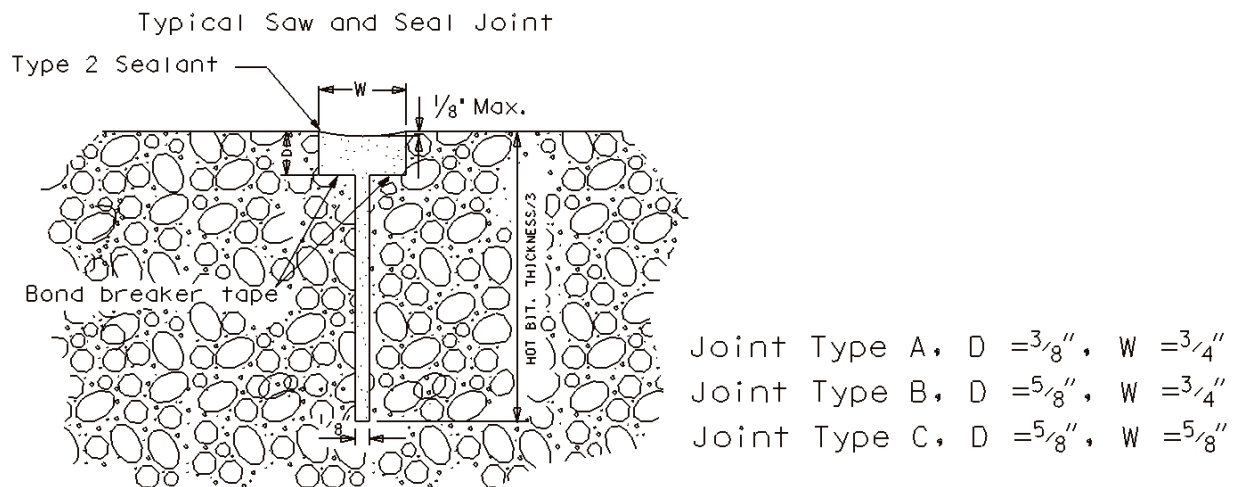
**Figure 2 – Typical Saw and Seal Joint**

The beginning of the project has three sections of 30', 40', and 80' joint spacing with Type A joints. The 30' section has a length of one mile. The 40' and 80' sections each have a length of one half of a mile. The control section follows the three sections at the beginning of the project. The control section is approximately 9 miles long. Following the control section is a 40' section with Type B joints and a 80' section with Type C joints. Each section has a length of one half of a mile that proceeds to the end of the project. Figure 2 depicts the typical section of a sawed and sealed joint.

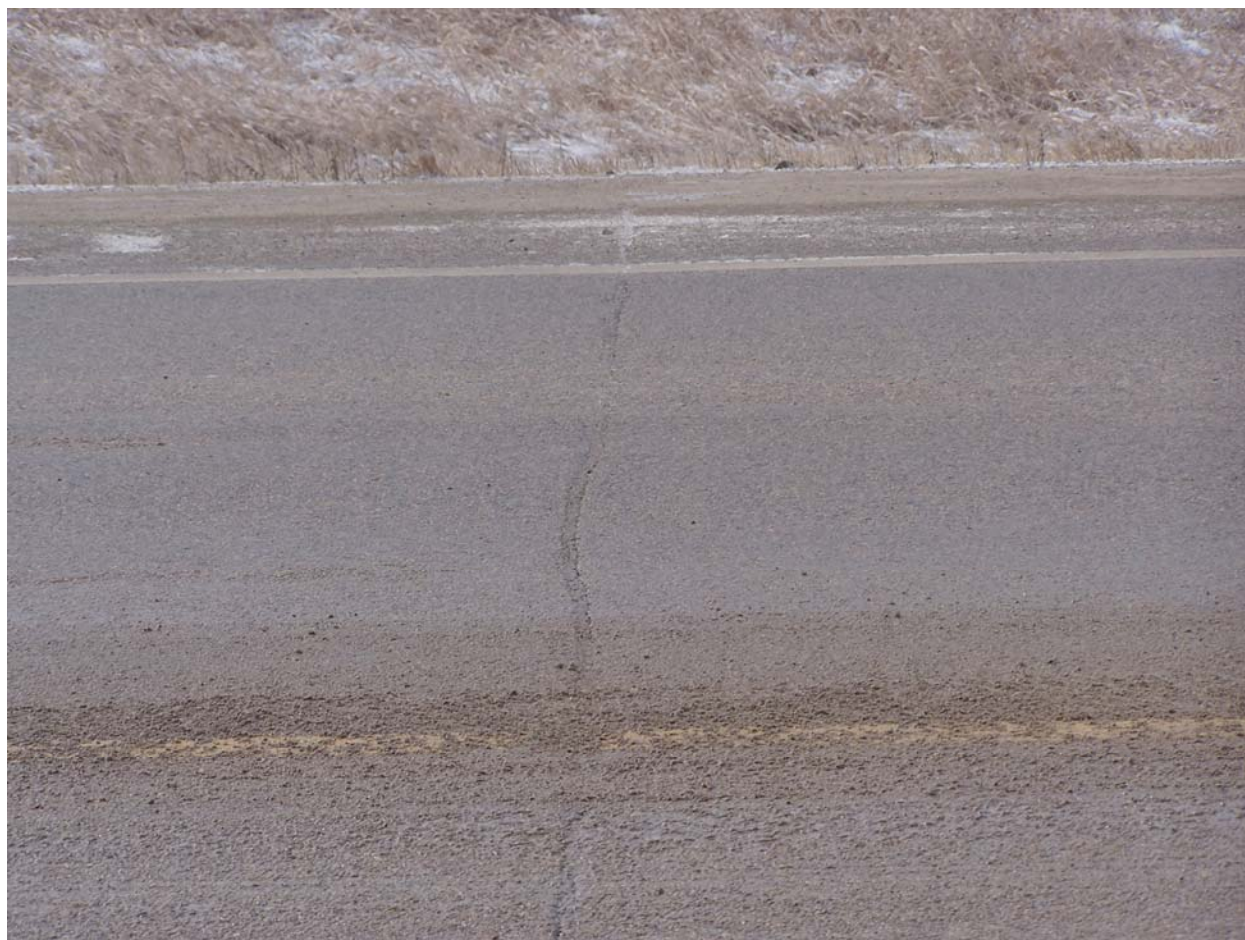
Visible rutting has begun to occur in this section. This section is located on a large hill. The crack control and reservoirs do not appear to have been affected by this rutting. The joints do appear to have shoved in the wheel paths. Photo 1 displays the joints shoving in the wheel paths.

**Photo 1 – Roadway shoving in wheel paths.**

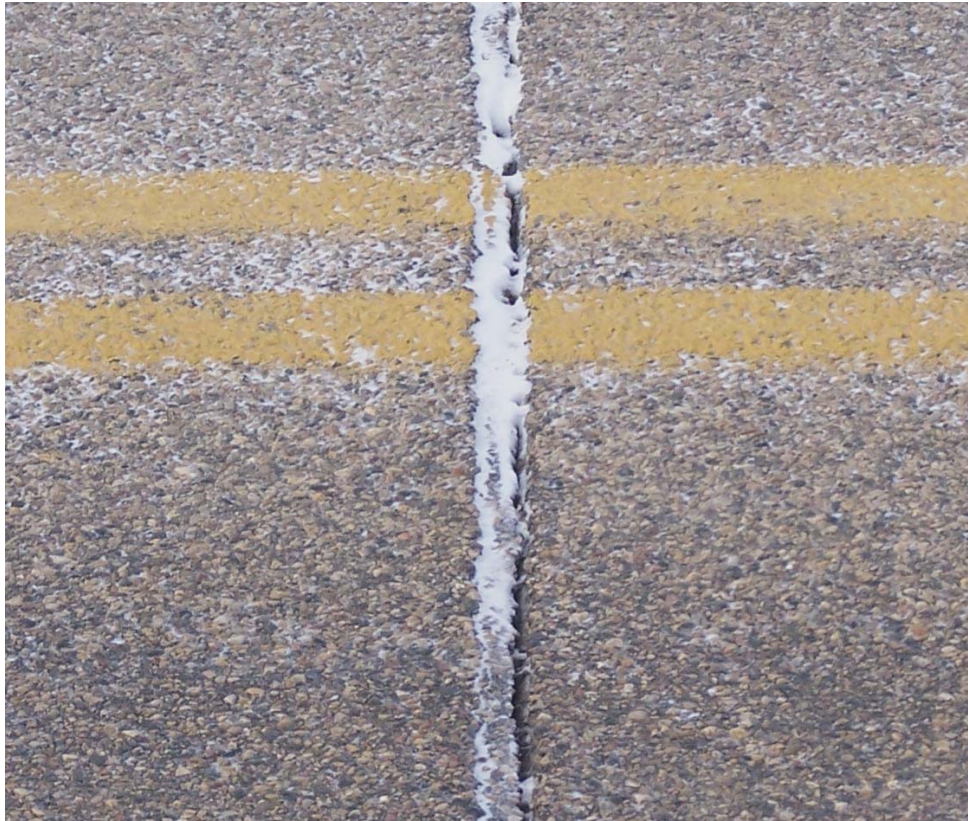
This section has 40' joint spacing and Type A reservoirs in the joints. This section has not developed any transverse cracks in between the joints since the roadway was constructed. The success of the joint spacing can be seen in Table 7. The sealants in this section appear to be separating from one of the sidewalls of the joint. There has been a large increase in sealant failures since the previous evaluation. The increase in failures can be seen below in Table 8. A photo of a joint with the sealant separating can be seen in Photo 2.

**Photo 2 – Joint with sealant separating from sidewall due to adhesion failure.**

The joint sealants are beginning to perform worse in all of the sections according to the last evaluation. The joint sealant does not adhere to the side wall in all the joints. When the joints open in the winter, a gap between the joint sealant and sidewall is exposed. With the joint being open, snow and incompressibles may enter the joint. This may cause damage to the pavement along the joint. When the pavement temperature increases, the joint will close and prevent moisture and incompressibles from entering the joints.

1. The distance between joints to control random cracking. All three different lengths of joint spacing appeared to work well for controlling random cracking. The 80' joint spacing increased the stress in the joint sealant more than the other joint spacing lengths. This may result in a failure in the reservoir type.
2. The reservoir type will determine the effectiveness of the sealant adhesion. The deeper reservoirs type B and C performed better than reservoir type A. The recommended reservoir is a type B reservoir. Also, the joints may need to be resealed after 7 to 10 years.

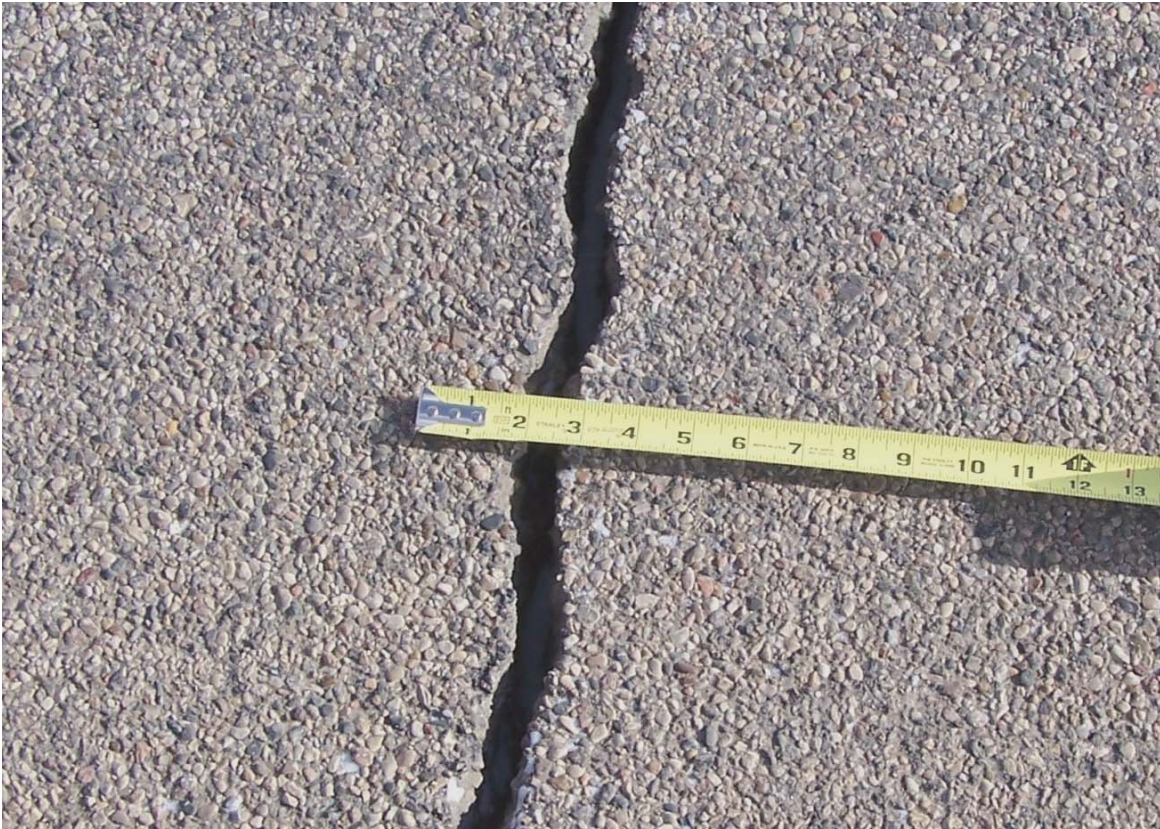
points 131 through 139. A breakdown of the cracks per mile can be seen in Table 19. Photo 3 displays a transverse crack in the control section. This photo was taken in February when the roadway was frozen, causing the crack to expand. This portion of the roadway was chip sealed in 2002. The random transverse cracks have not been sealed.

**Photo 3 – An expanded random transverse crack.**
