# GRANT MARSH BRIDGE REHABILITATION

North Dakota Department of Transportation

Brian Raschke, PE  
NDDOT Bridge Design  
April 23, 2025

Curtis Schroeder, PhD, PE  
Associate Principal  
Wiss, Janney, Elstner Associates

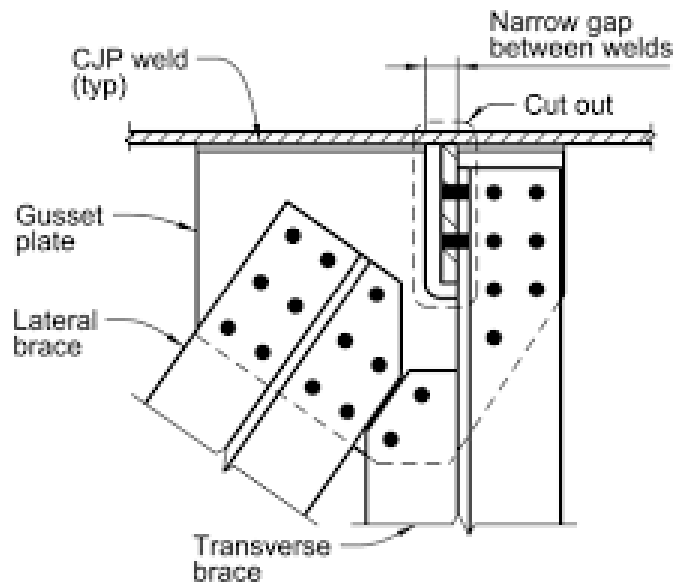
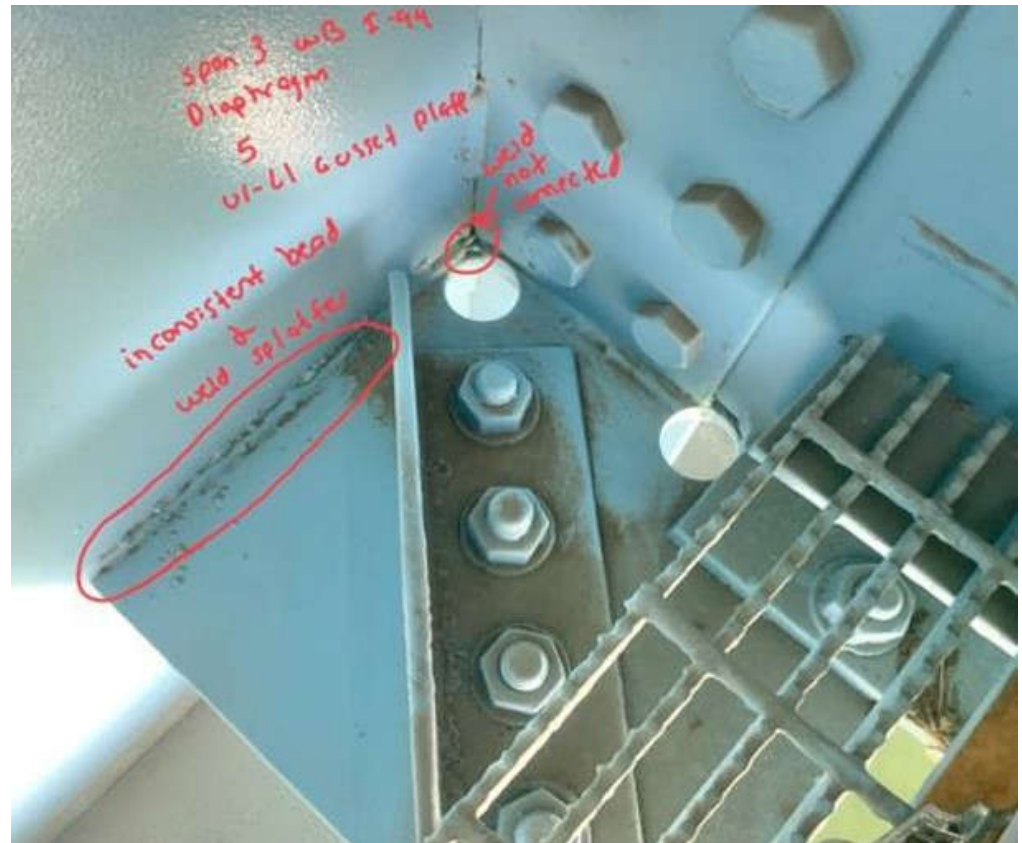
- Constraint-Induced Fracture (CIF details)
- Existing drilled holes in tension region

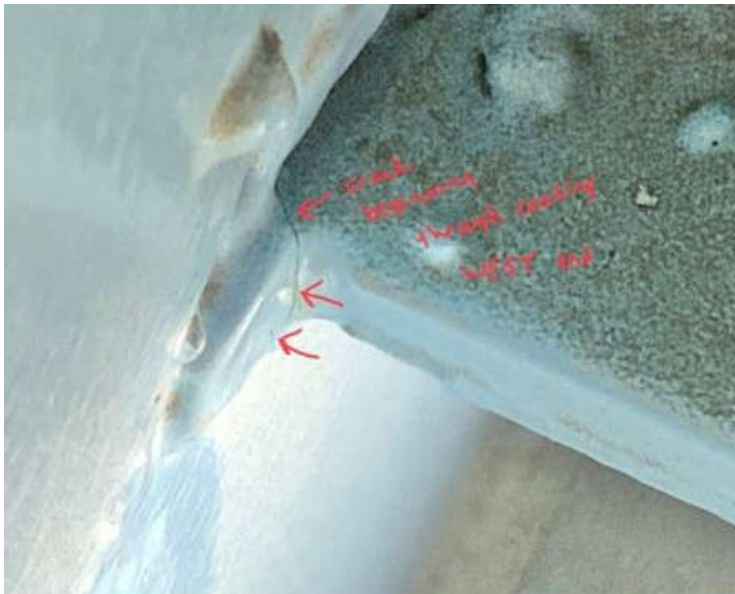
Potential distress observed at lateral gusset plate terminations

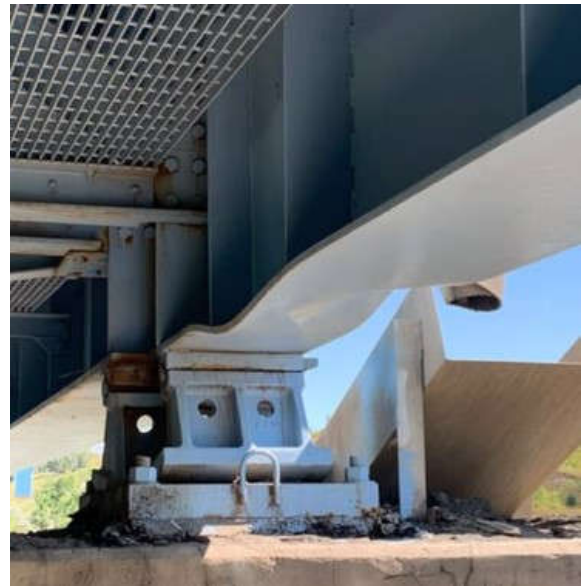
Rocker bearings misaligned

Deformation of main girder bottom flange

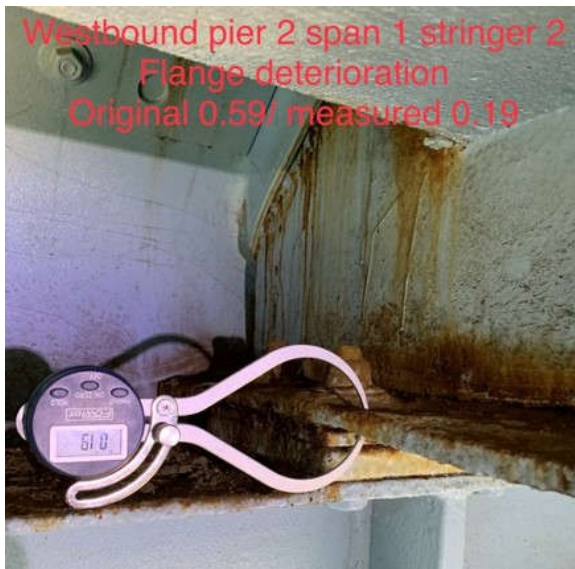
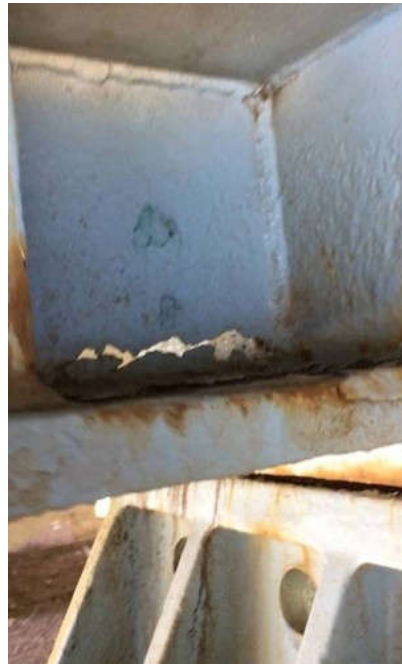
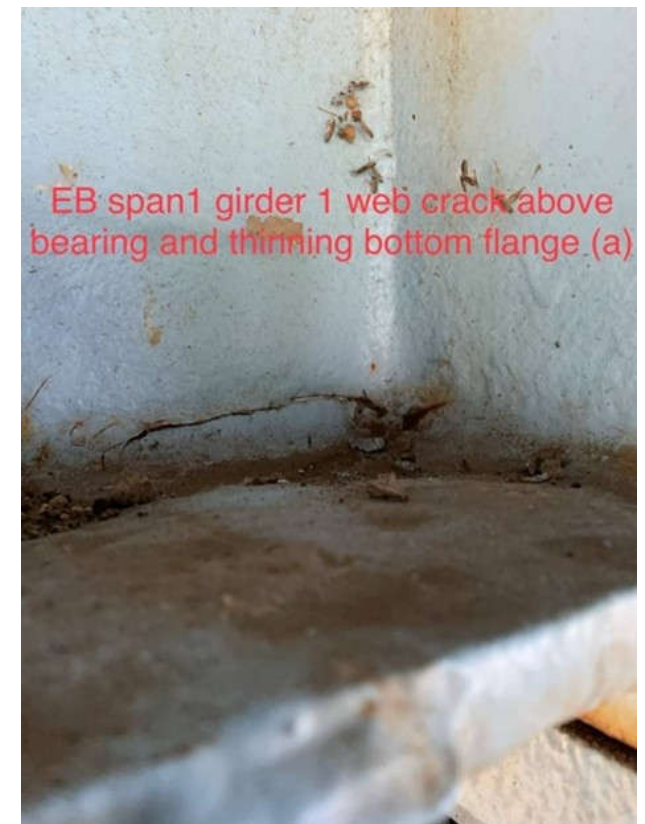
## ➤ Corrosion of NSTM members

Located at expansion joints primarily  
on girder webs and stringers

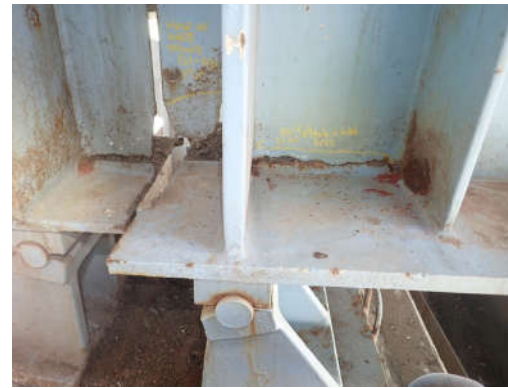
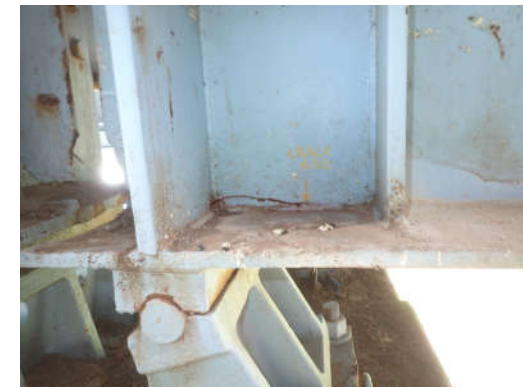
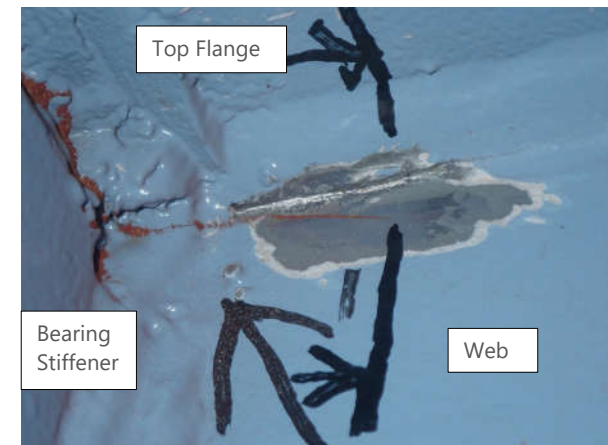
- Deterioration of girder ends near expansion joints
  - Corrosion holes
  - Misaligned rocker bearings
  - Inadequate gap for thermal expansion
  - Cracking along web-to-flange welds
  - Localized pitting and section loss
- Out-of-plane distortion girder web cracks
  - Confirmed with MT
  - Occurred at the intermediate pier of the two-span approach unit

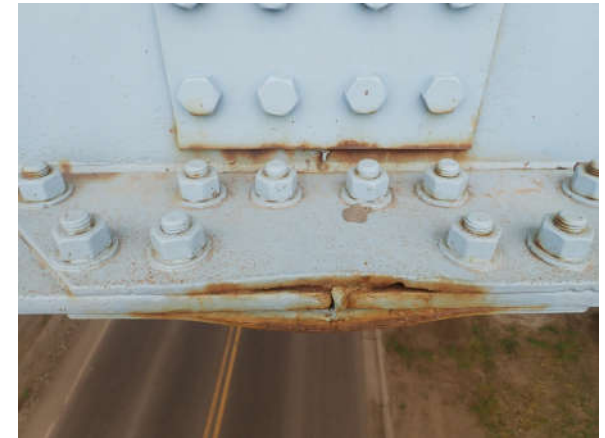
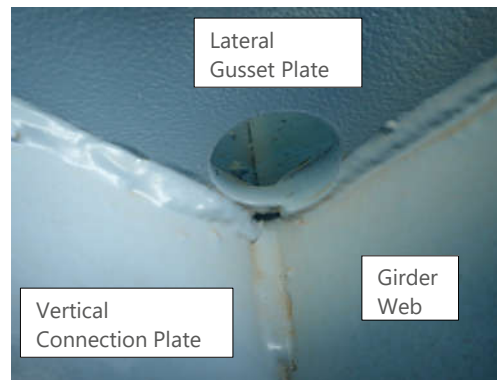
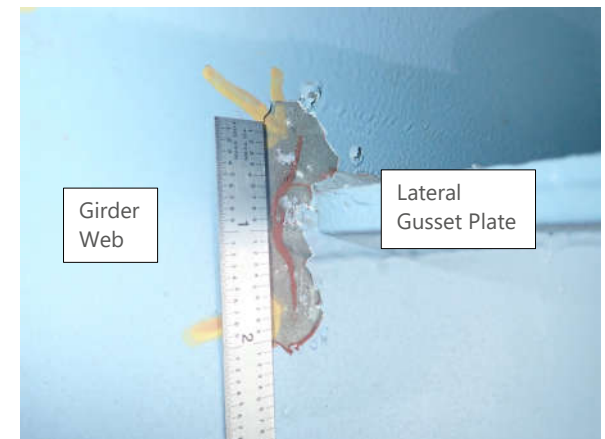
- Corrosion and pack rust at bolted field splices in Span 6
- Fatigue crack initiation at lateral gusset plate terminations
  - Paint cracking observed typically
  - Confirmed cracking at multiple locations with MT
- Inadequate CIF retrofits
  - Remnant lateral gusset plate and weld metal material was not removed when CIF retrofit holes were previously installed

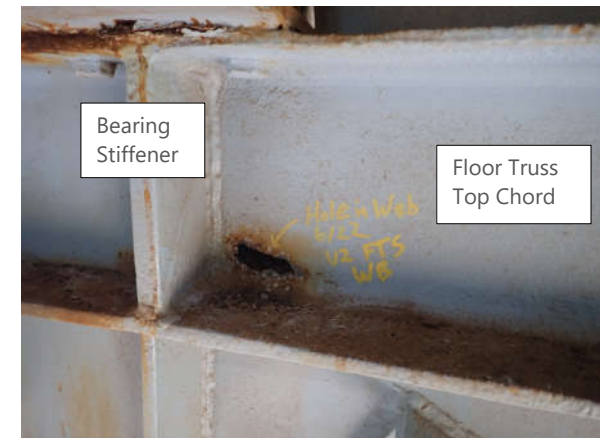
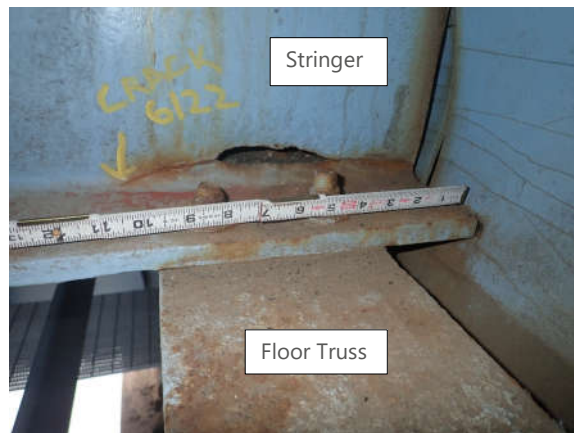
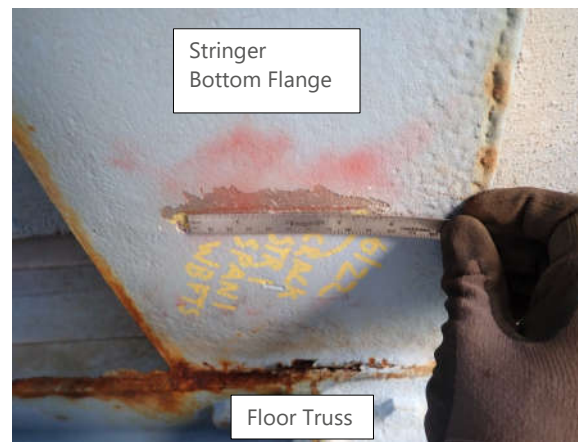
- Section loss in end floor truss members at expansion joints
  - Corrosion holes
  - Widespread debris and moisture accumulation
- Stringer cracking at web and bottom flange near expansion joints
  - Two locations had previously installed reinforcement plates which were only welded to web on three sides
