Tech Brief

May 2019

Drive-by Inspection of Barrier Systems

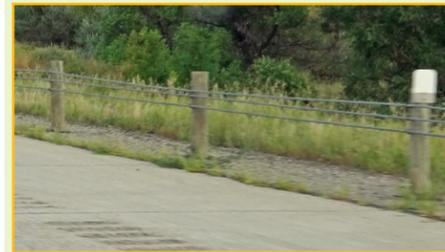
Noticeable sag in cables. Cables can lose tension because of construction stretch, anchor creep, fitting slippage, and/or previous impacts elsewhere in the same run of cable. (Photo I - Low Tension Cable).

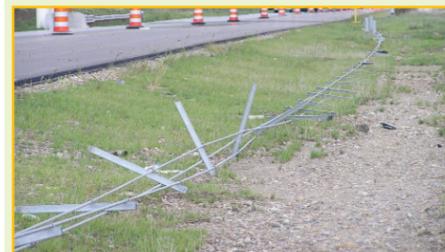
J

Low tension cable with damaged posts or missing hooks usually cause the cables to drop (Photo J), making repair more critical. High-tension cable guardrail remains effective with missing posts as long as cable heights are essentially maintained (Photo K).

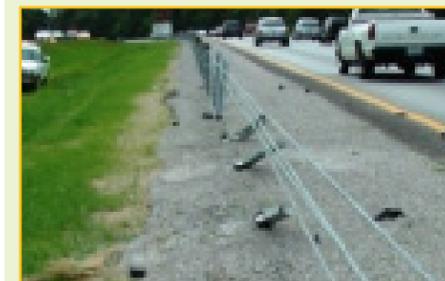
K

Damaged posts can also present a spearing concern should a secondary impact occur (Photo K); crews should remove damaged or bent-over posts to eliminate the spearing potential.

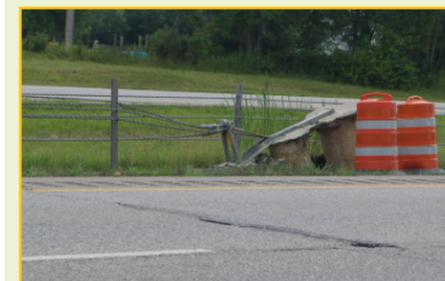
L

Most anchors for cable guardrail are designed that when impacted end-on the tension in the barrier run is released making it ineffective. Therefore, repair of the anchorage and resetting the cable should be a high priority. Maintenance personnel should also periodically inspect anchors for any damage or movement as seen in Photo L.

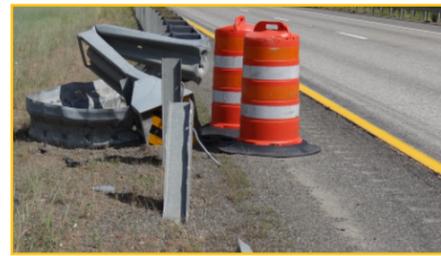
If a spearing condition is present and cannot be immediately repaired, the spear end should be lowered to the ground and retained by rebar pin(s) or a TMA may be appropriate. Photo A shows inadequate delineation and a potential of a spearing concern.

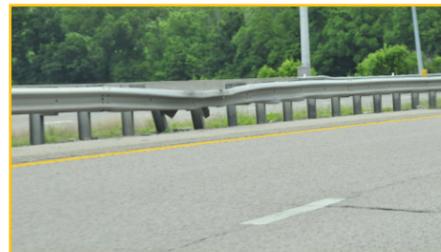
B

The purpose of guardrail is to contain the vehicle and not allow vaulting or underride. Therefore, any reduction in the system height to less than 26 ½" should be considered a high-priority repair (Photo B). However, the MGS system, originally installed at 31", should be evaluated if less than 28". Excessively high rail (>2 or 3") should also be evaluated.

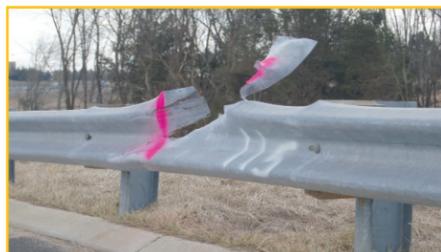
C

- Vertical tears in the w-beam (Photo C) that extend to the top or bottom of the rail greatly reduce the capacity of the rail and create areas of high stress concentrations.
- Non-manufactured holes (e.g., those caused by crash damage, lug nut damage, or corrosion) in the rail element that intersect the top or bottom edges of the rail.
- Non-manufactured holes or rail that has been cut with a torch. Rail element needs to be replaced (Photo D).
- Rail deflected more than 9 inches over a 25-foot length, (Photo E).
- Damaged or missing bolts at a splice.

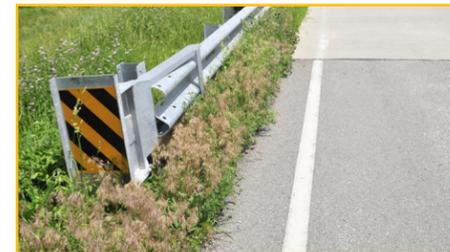
This is critical because the rail elements feed into the impact head on any head-on crash, absorbing the vehicle's energy. Photo F shows a poorly seated rail element. (Refer to installation manual for proper connection of head to post.)

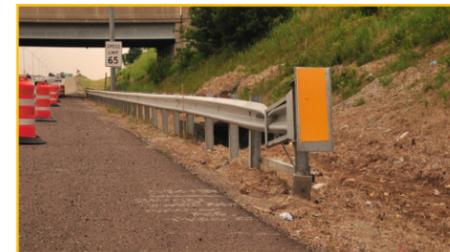
G

The axial strength of the rail must be maintained (i.e., no kinks or bends). (Photo G).

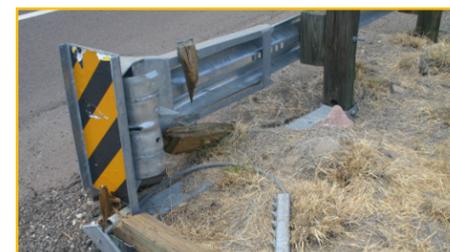
In Photo H the anchorage is lost and any motorist striking the rail downstream from the terminal end would likely penetrate the system rather than be redirected.
