NORTH DAKOTA DEPARTMENT OF TRANSPORTATION

PUBLIC INPUT MEETING - Drayton, ND

EXHIBIT 1
PROJECT LOCATION OVERVIEW
I-29 STRUCTURE REPLACEMENTS

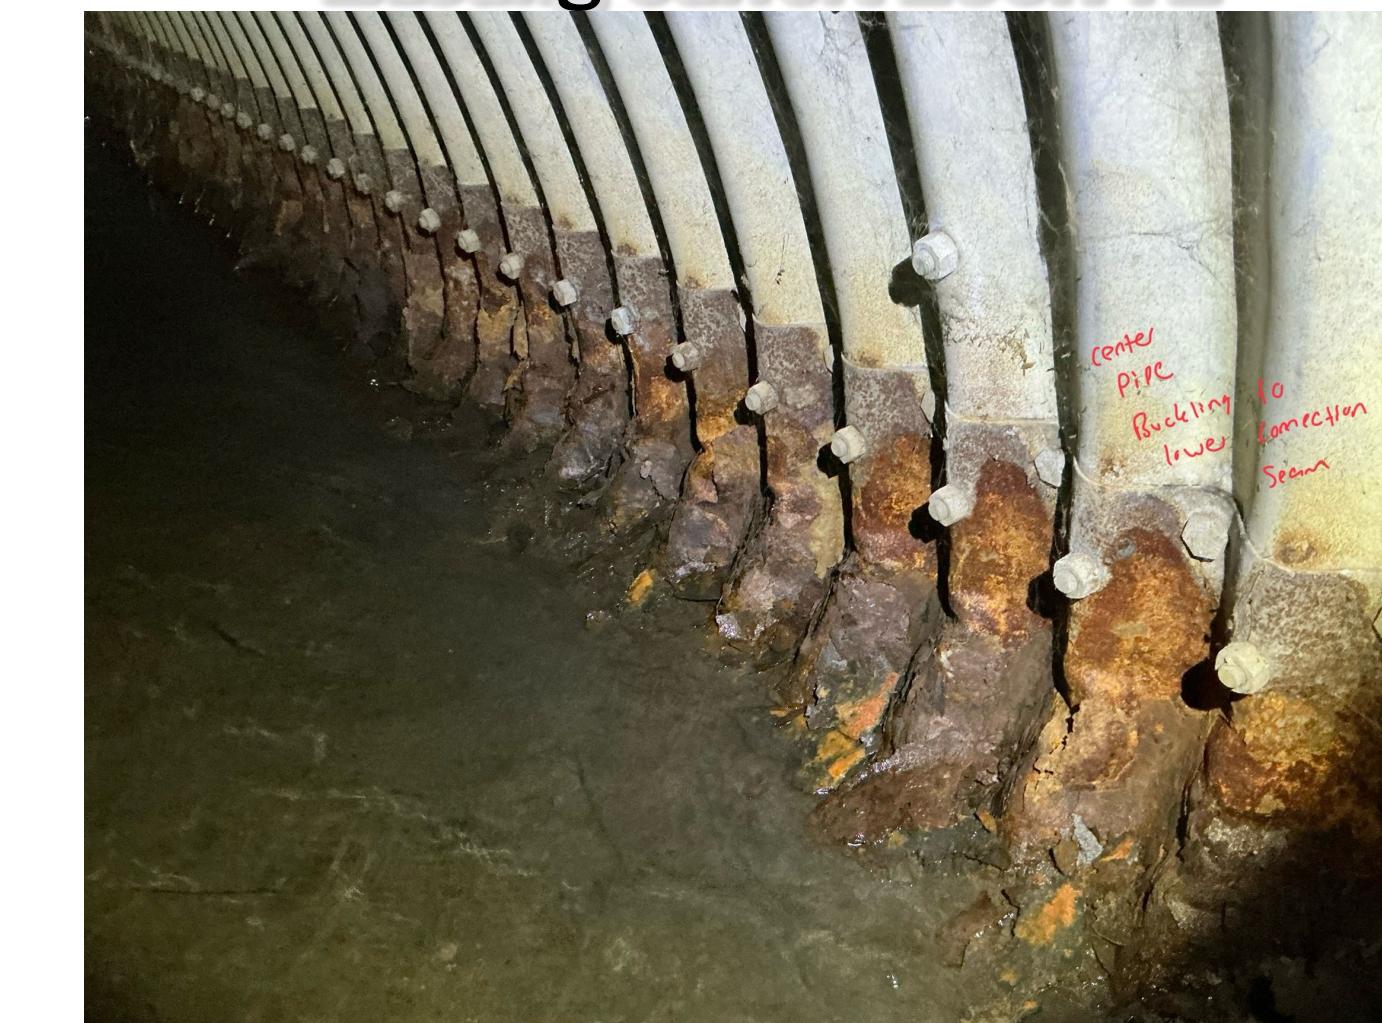
Existing Culvert 200.772

1. Rusting to flared end sections
2. Heaving and buckling
3. Erosion below the springline
4. Pitting and delamination in culverts

Proposed improvements are anticipated to take place during 2027 construction season pending funding; however, construction schedule is subject to change. NDDOT will know more once analysis is completed. The proposed replacements will consist of either concrete box culverts or concrete pipe culverts. The total approximate cost will be \$4 million.
