Phase I Environmental Site Assessment

Loaf N Jug Fueling Station
797 South Main Avenue
Dickinson, North Dakota

Project B2309746
November 28, 2023

Re: Revised- Phase I Environmental Site Assessment
Loaf N Jug Fueling Station
797 South Main Avenue
Dickinson, North Dakota

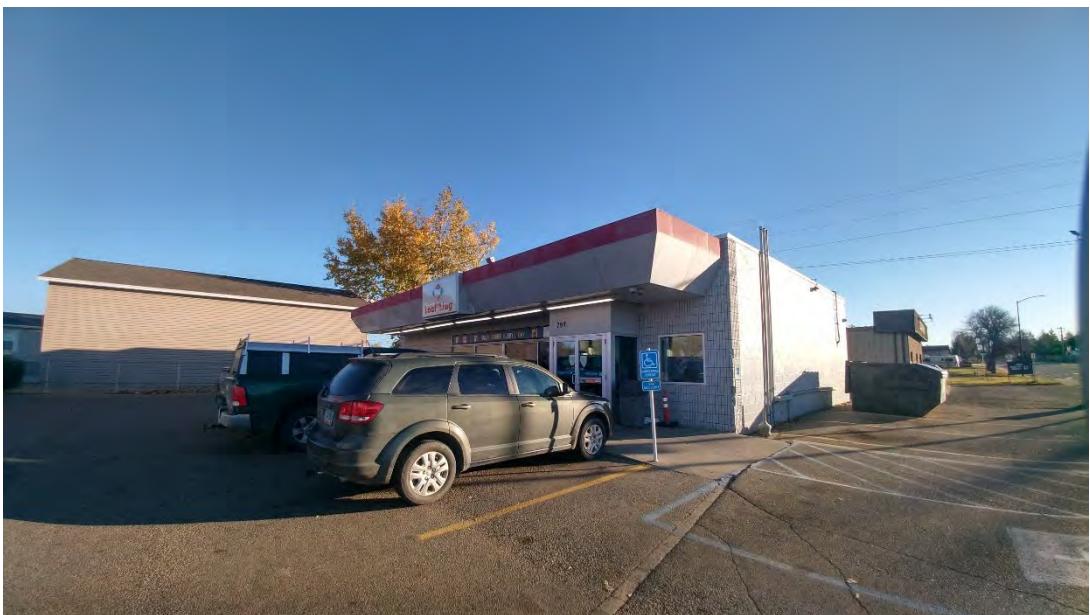
Photograph #1	Loaf N Jug Fueling Station	B2309746
Date:	October 20, 2023	
Direction:	Northeast	
Subject:	Site Overview

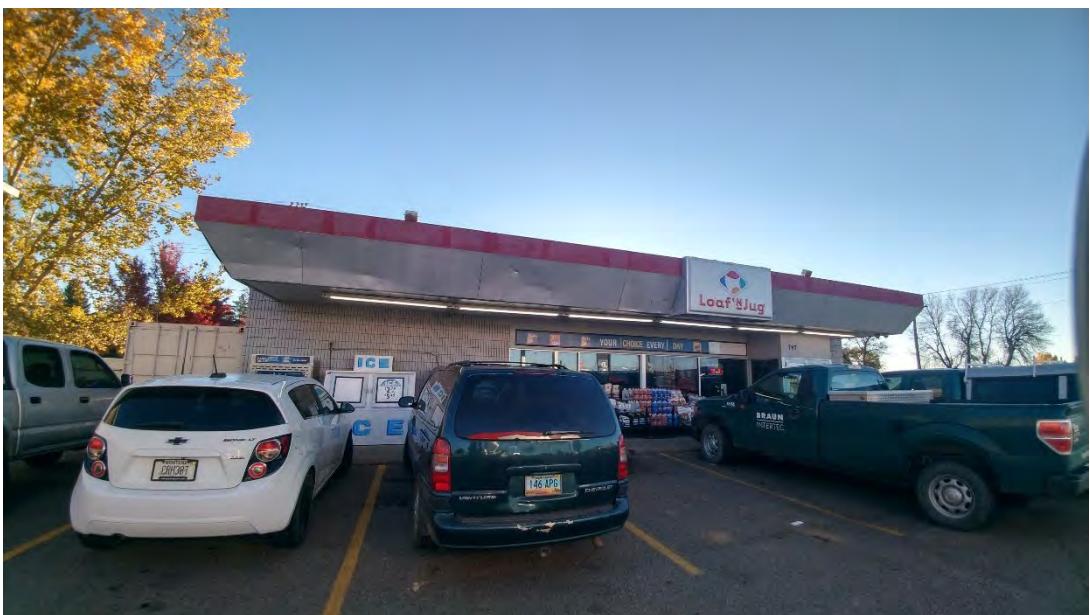
Photograph #2	Loaf N Jug Fueling Station	B2309746
Date:	October 20, 2023	
Direction:	East	
Subject:	Convenience Store overview

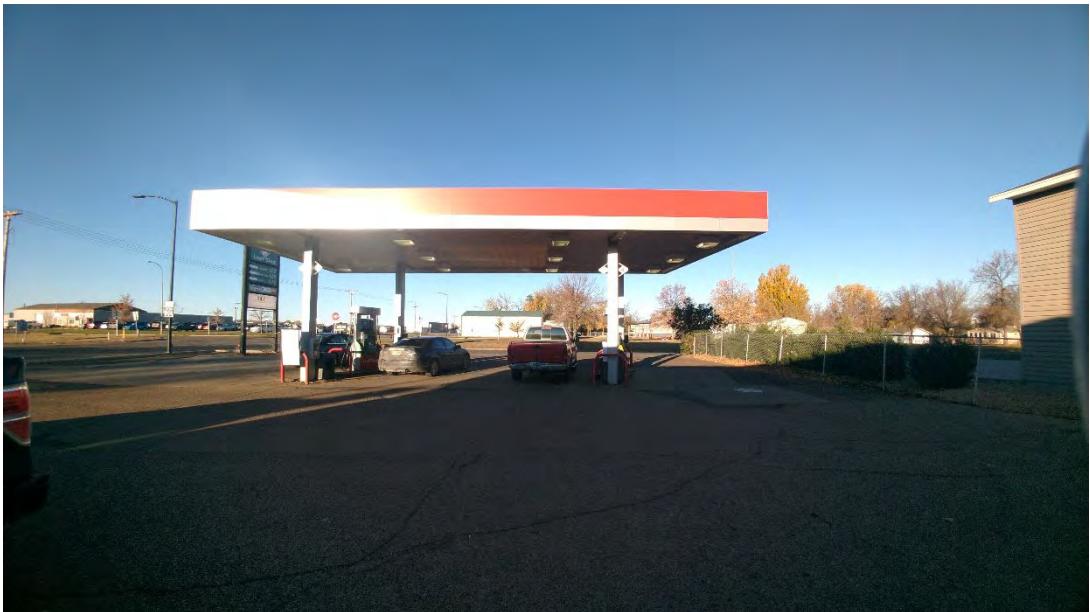
Photograph #3	Loaf N Jug Fueling Station	B2309746
Date:	October 20, 2023	
Direction:	West	
Subject:	Fueling Pumps	BRAUN INTERTEC

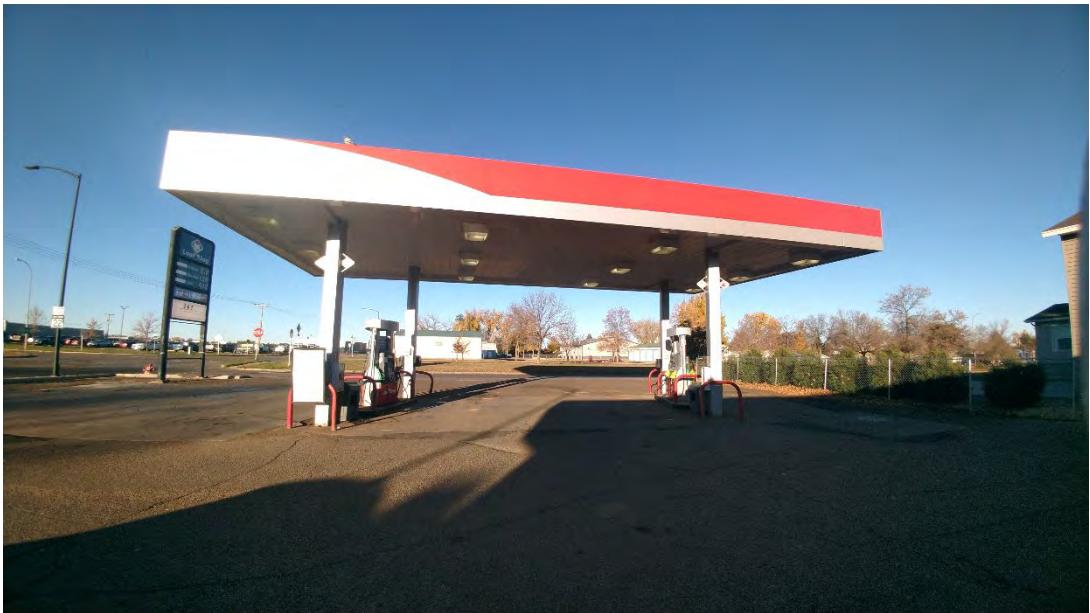
Photograph #4	Loaf N Jug Fueling Station	B2309746
Date:	October 20, 2023	
Direction:	West	
Subject:	Fueling Pumps	BRAUN INTERTEC

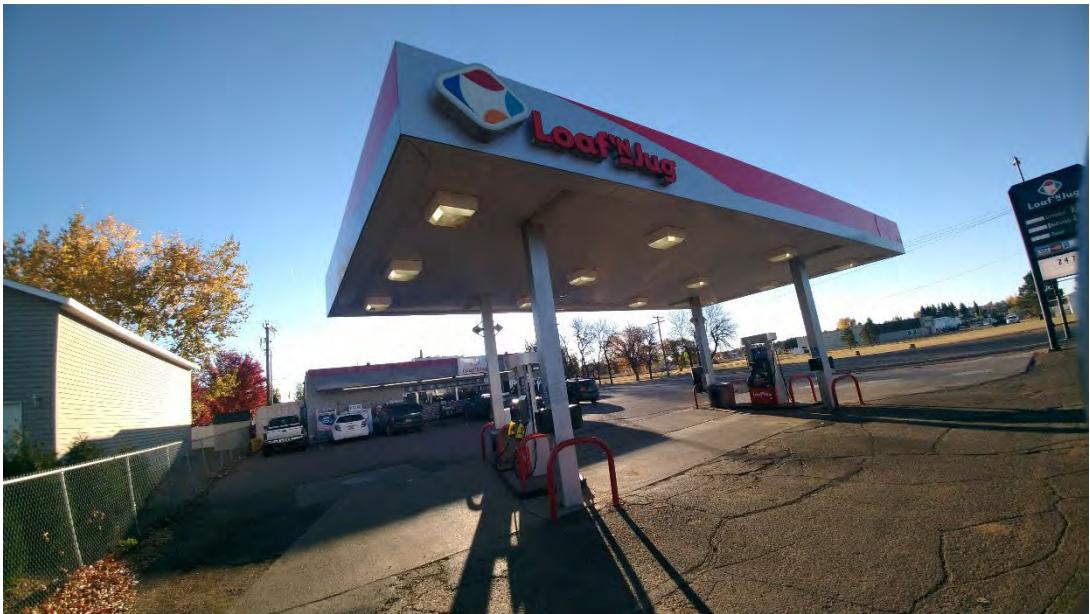
Various stained surfaces were noted around the fuel pumps and the parking lot. The petroleum-like stains were noted on the asphalt surface, which appeared to be in good condition at the time of the assessment.

Photograph #5	Loaf N Jug Fueling Station	B2309746
Date:	October 20, 2023	
Direction:	East	
Subject:	Fueling Pumps with stained surfaces	BRAUN INTERTEC

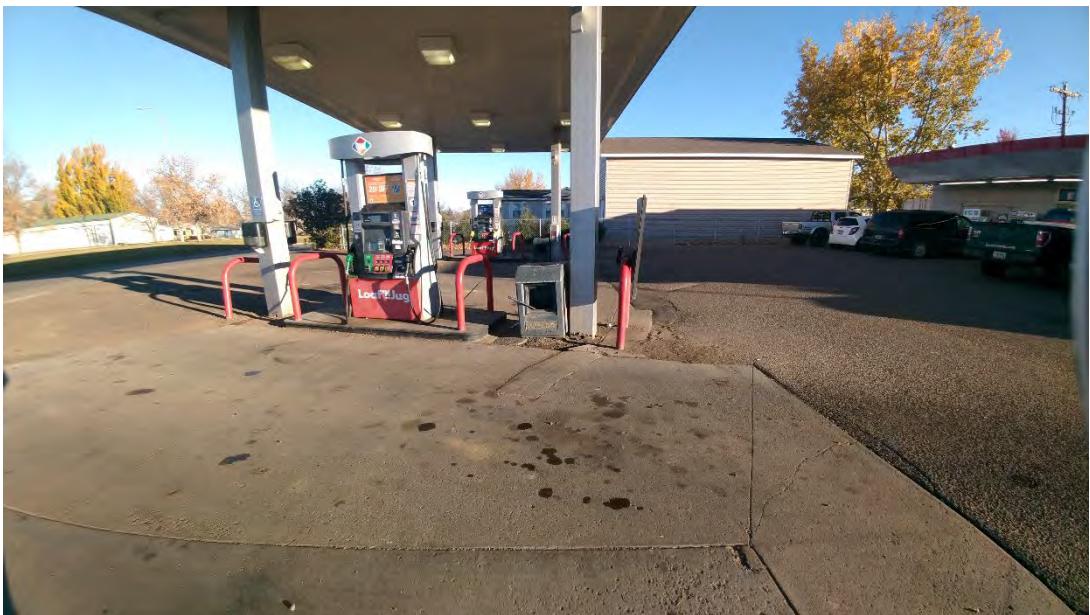
Photograph #6	Loaf N Jug Fueling Station	B2309746
Date:	October 20, 2023	
Direction:	North	
Subject:	Fueling Pumps with stained surfaces	BRAUN INTERTEC

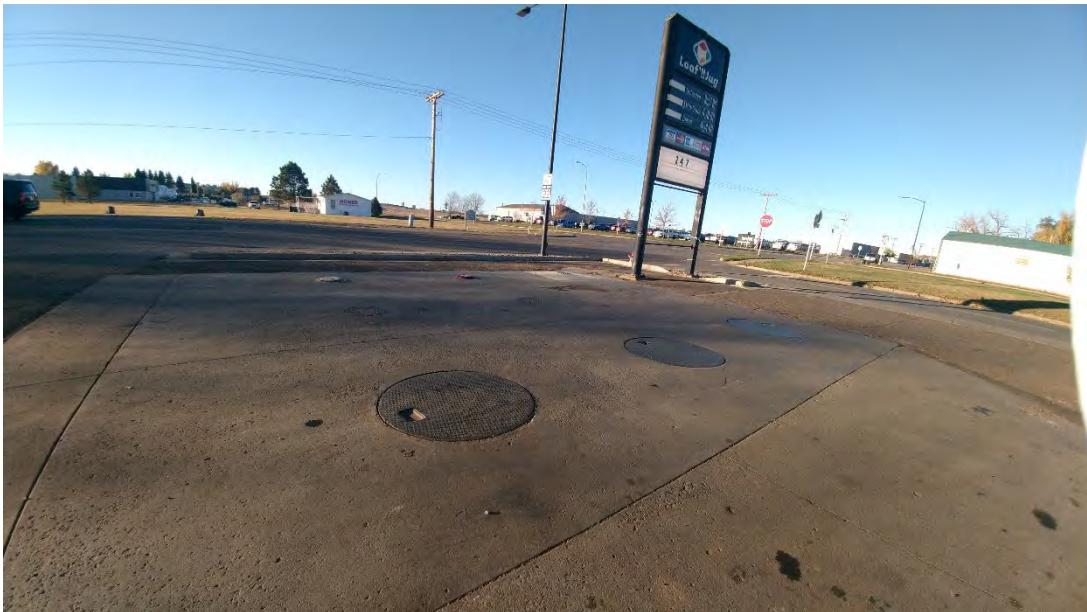
Three underground storage tanks were located on the southwestern portion of the Site (one 8,000-gallon diesel UST and two 8,000-gallon gasoline USTs). Based on the information provided by the store manager (Brianna), the tanks receive quarterly inspections and are filled weekly. The USTs were connected to the fueling pumps which had multiple petroleum-like stains noted on the asphalt surface.

Photograph #7	Loaf N Jug Fueling Station	B2309746
Date:	October 20, 2023	
Direction:	South	
Subject:	UST Tank Basin

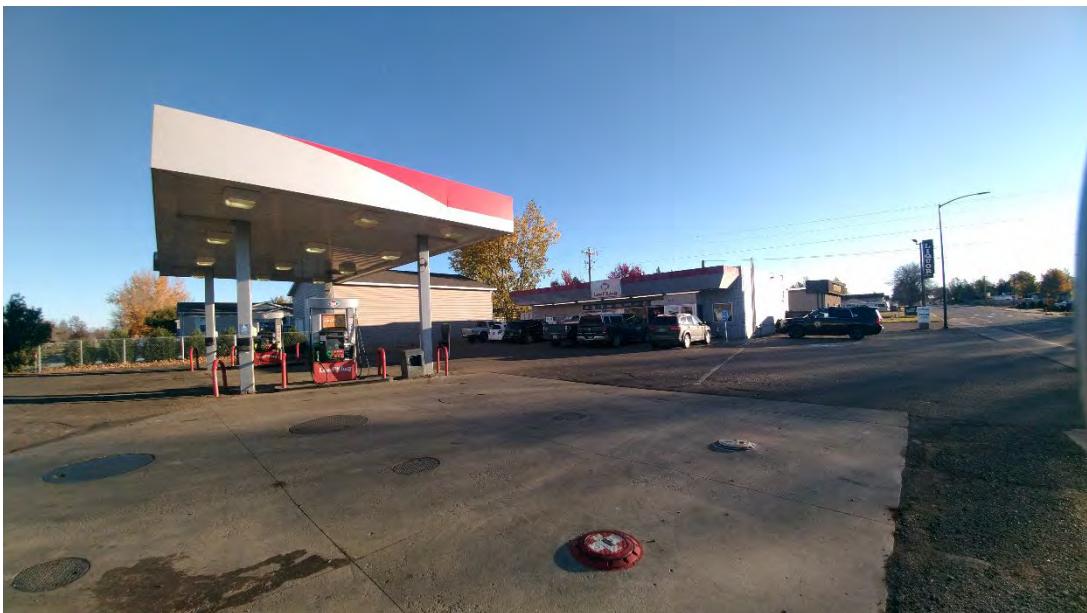
Photograph #8	Loaf N Jug Fueling Station	B2309746
Date:	October 20, 2023	
Direction:	East	
Subject:	UST Tank Basin

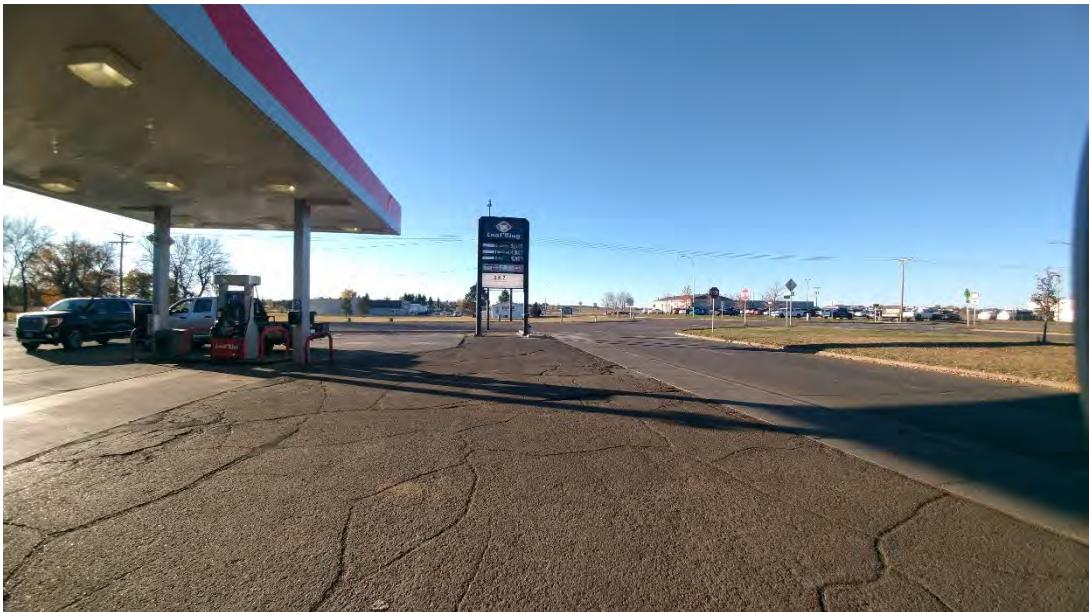
Photograph #9	Loaf N Jug Fueling Station	B2309746
Date:	October 20, 2023	
Direction:	South	
Subject:	Fueling Pumps and access to the Site	BRAUN INTERTEC

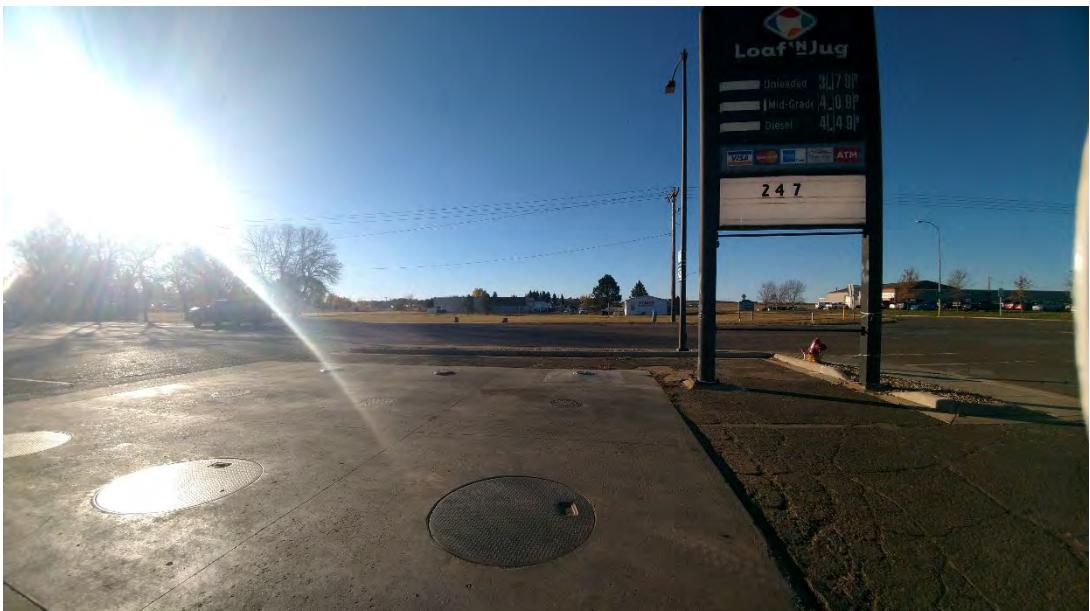
Photograph #10	Loaf N Jug Fueling Station	B2309746
Date:	October 20, 2023	
Direction:	South	
Subject:	UST Tank Basin	BRAUN INTERTEC

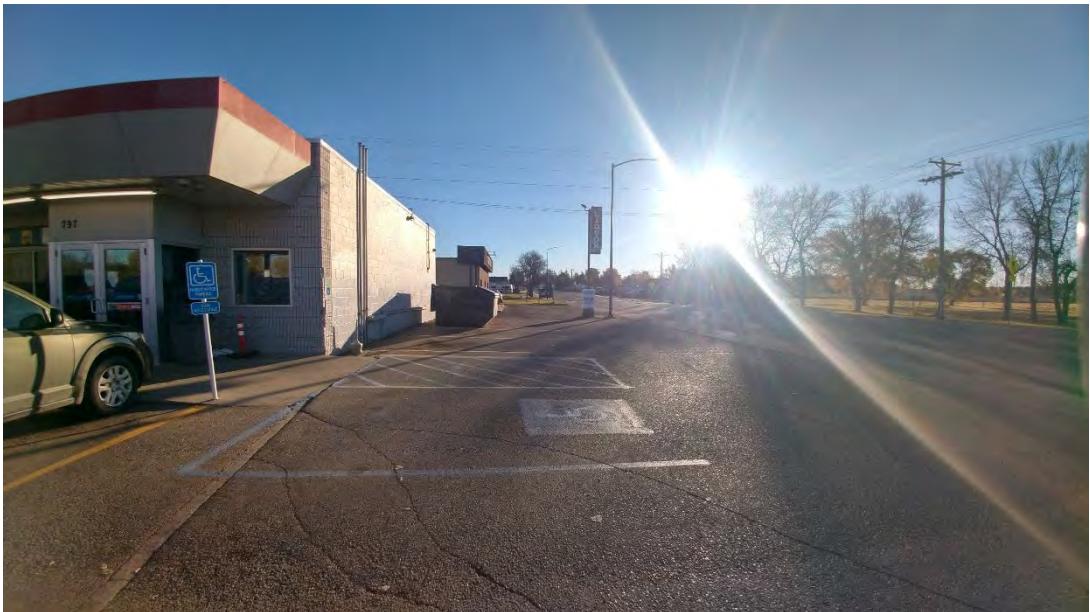
Photograph #11	Loaf N Jug Fueling Station	B2309746
Date:	October 20, 2023	
Direction:	East	
Subject:	Parking Lot	BRAUN INTERTEC

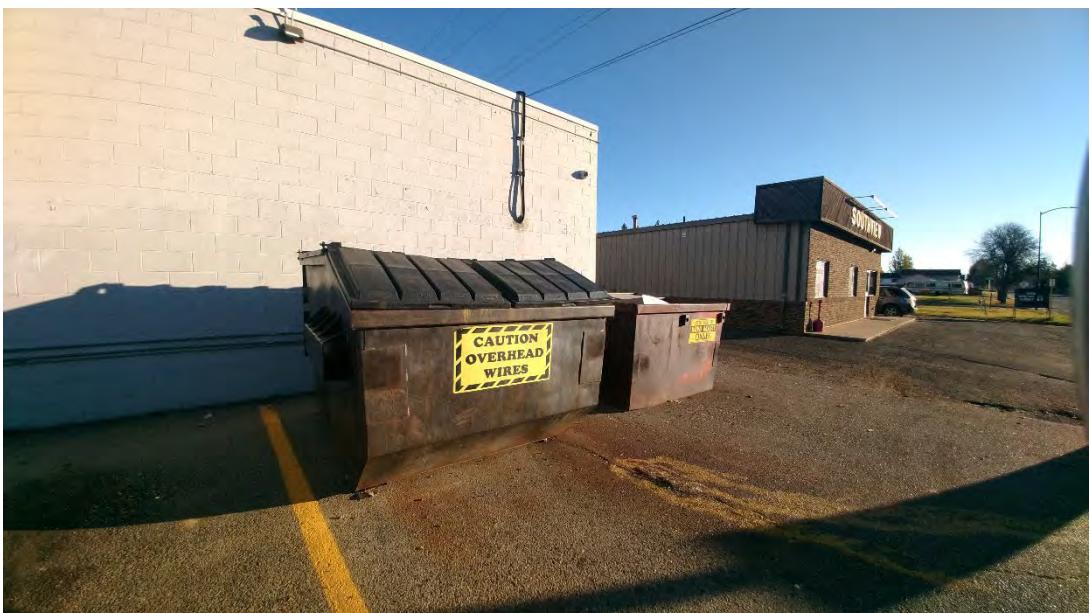
At the time of the reconnaissance, no indications of waste disposal areas, fill, mounds, depressions, burn pits or disturbed areas were observed that were suggestive of the presence of buried debris or other solid waste disposal with the exception of the solid waste dumpsters located on the south of the building and serviced by Waste Management.

Photograph #12	Loaf N Jug Fueling Station	B2309746
Date:	October 20, 2023	
Direction:	East	
Subject:	Solid waste dumpsters	BRAUN INTERTEC

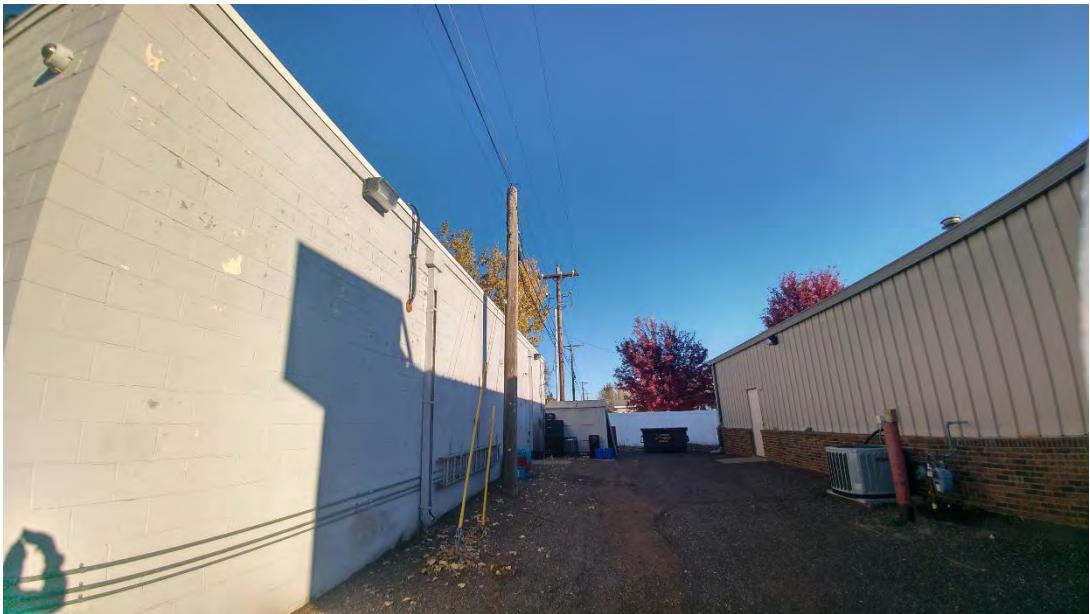
Photograph #13	Loaf N Jug Fueling Station	B2309746
Date:	October 20, 2023	
Direction:	North	
Subject:	Alley east of the building

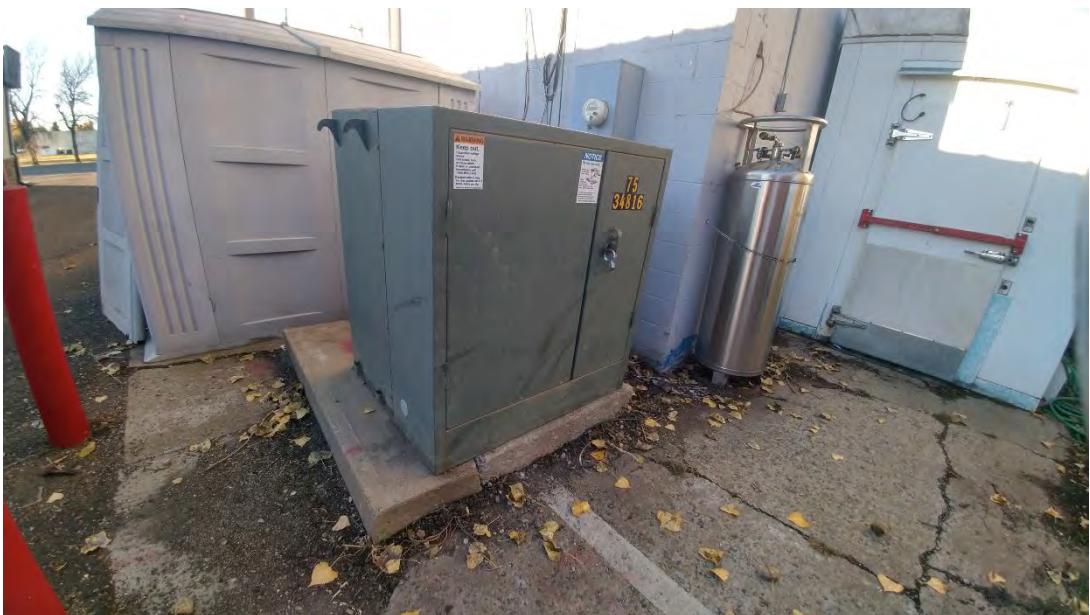
One slab-mounted electrical transformer was noted along the buildings northeastern corner. The transformers appeared to be in good condition with no indications of leaking or staining.

Photograph #14	Loaf N Jug Fueling Station	B2309746
Date:	October 20, 2023	
Direction:	North	
Subject:	Slab-mounted transformer

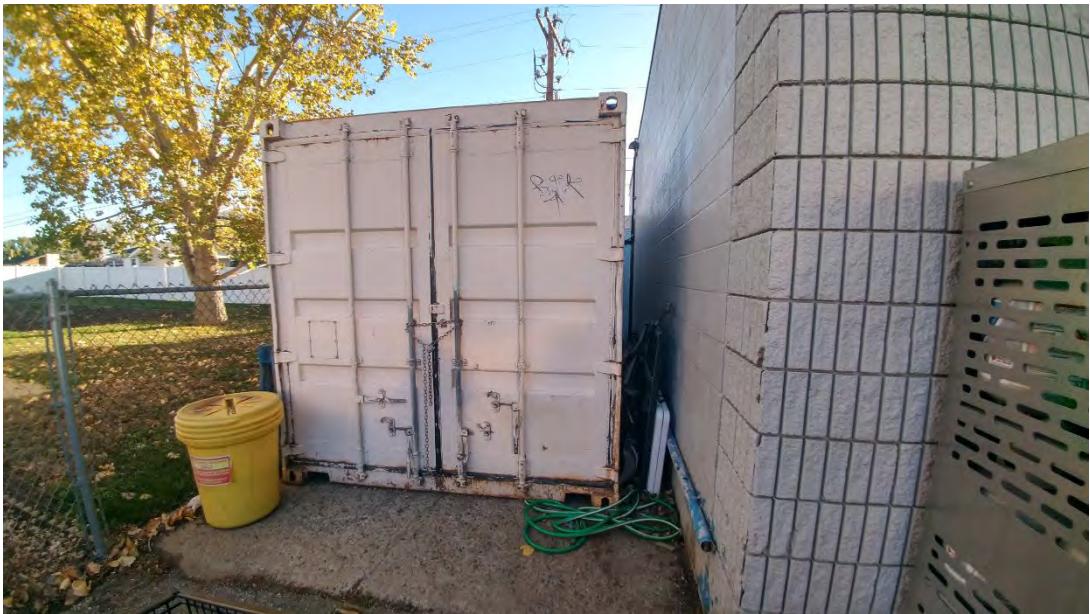
Photograph #15	Loaf N Jug Fueling Station	B2309746
Date:	October 20, 2023	
Direction:	East	
Subject:	C-Can for storage	BRAUN INTERTEC

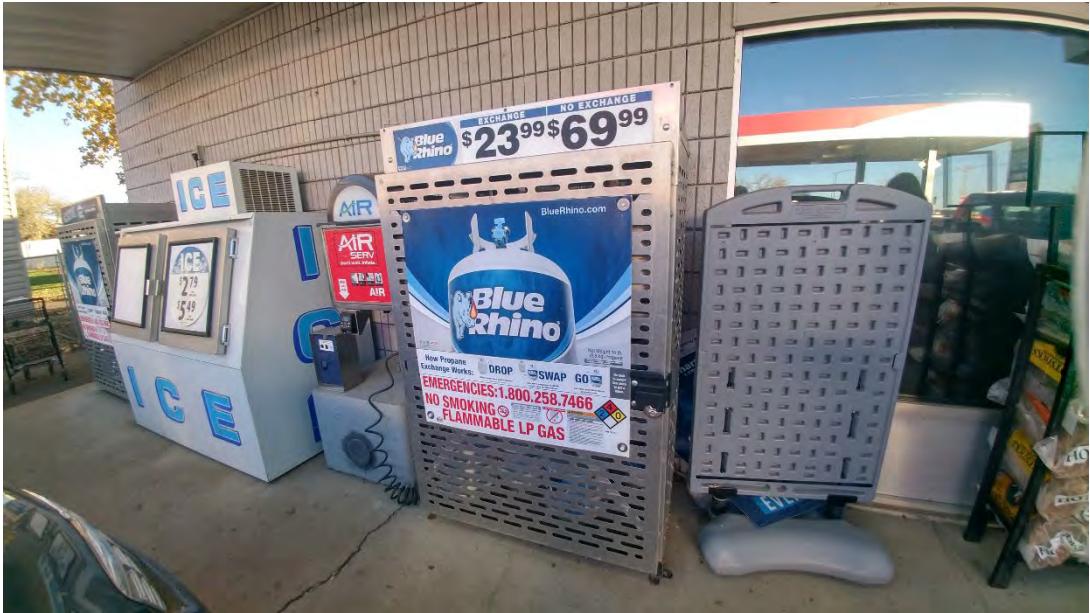
One air compressor was observed in the western portion of the building. The air compressor appeared to be in good condition with no indications of leaking or staining.

Photograph #16	Loaf N Jug Fueling Station	B2309746
Date:	October 20, 2023	
Direction:	East	
Subject:	Propane and air compressor	BRAUN INTERTEC

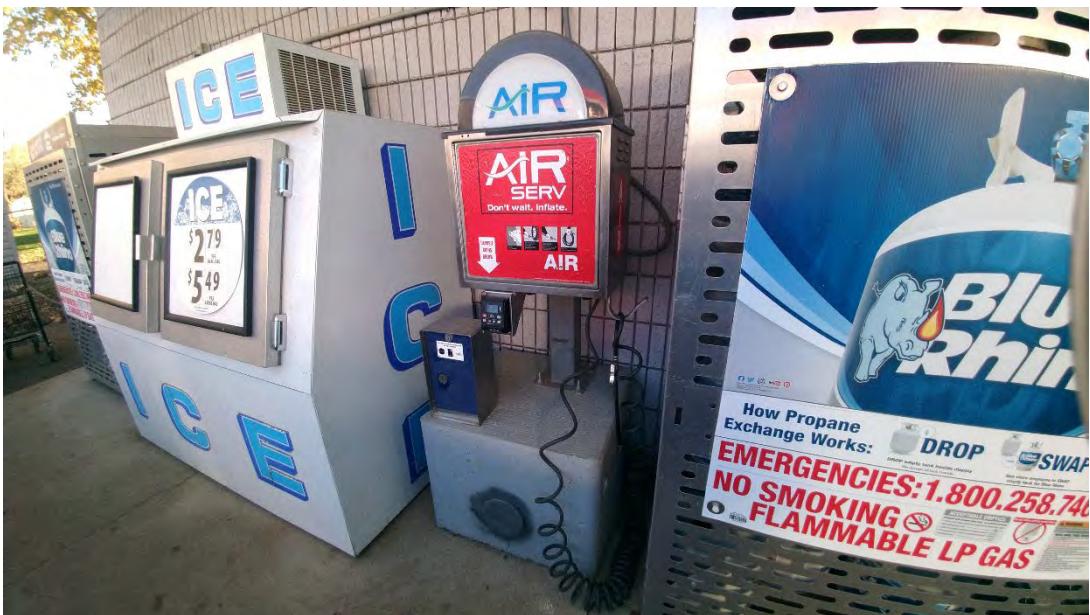
Photograph #17	Loaf N Jug Fueling Station	B2309746
Date:	October 20, 2023	BRAUN INTERTEC
Direction:	East	
Subject:	Air compressor in good conditions

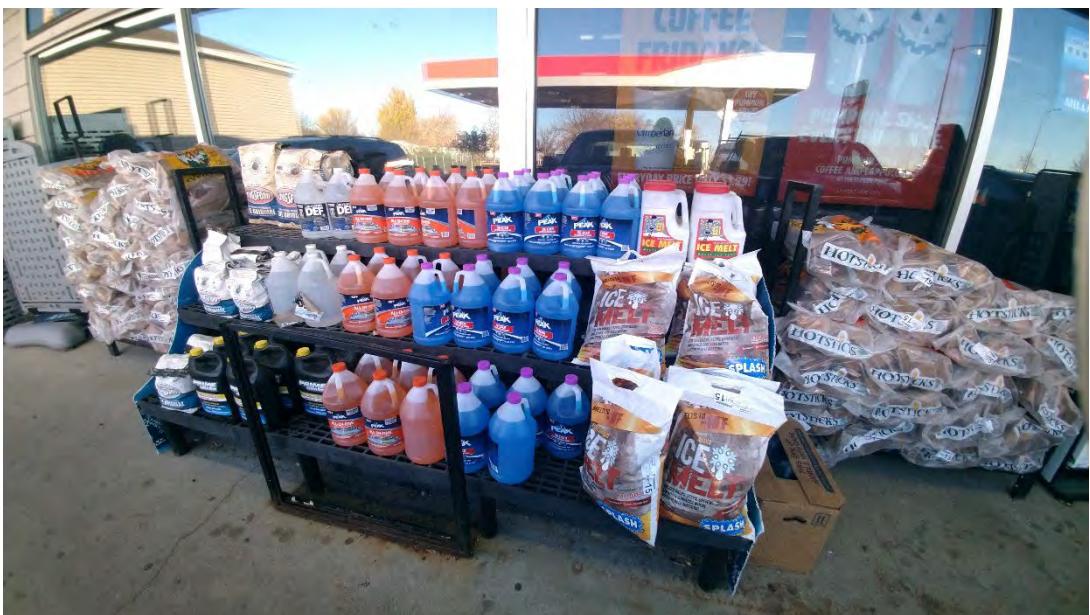
Photograph #18	Loaf N Jug Fueling Station	B2309746
Date:	October 20, 2023	BRAUN INTERTEC
Direction:	East	
Subject:	Hazardous substances for resale

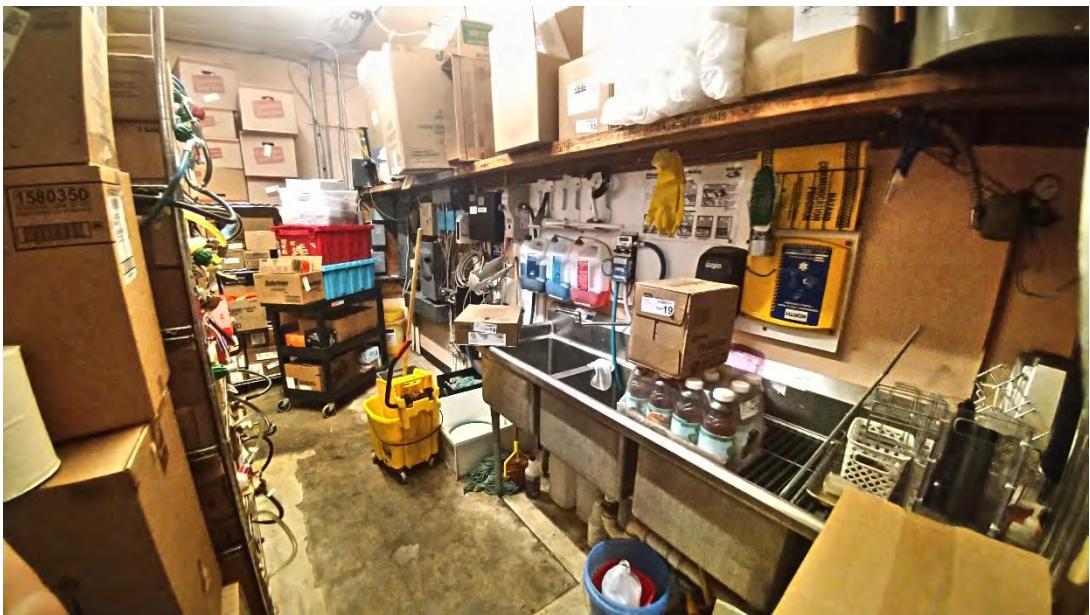
Various petroleum products ranging from 2 ounces to 2.5-gallons were noted throughout the maintenance room within the building. The containers were noted on the concrete floor and appeared to be in good condition with no indications of leaks or stains noted near or around them. Various petroleum products and hazardous substances were located within the convenience store and outside by the entrance for resale. These containers appeared to be in good condition with no indications of leaks or stains noted near or around them.

Photograph #20	Loaf N Jug Fueling Station	B2309746
Date:	October 20, 2023	
Direction:	North	
Subject:	Maintenance room with hazardous substances and good housekeeping noted	BRAUN INTERTEC

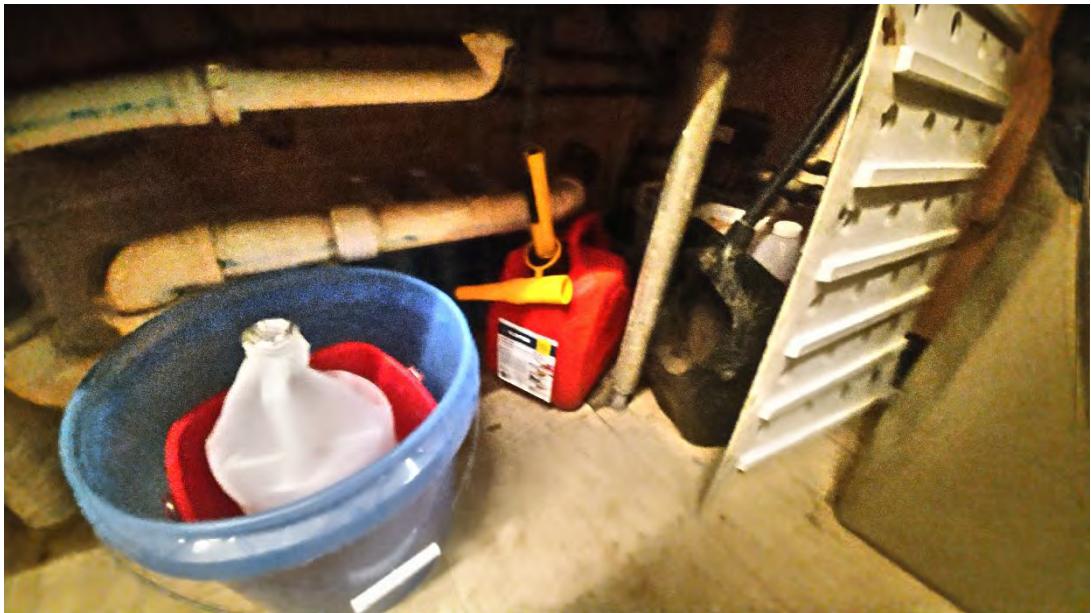
Photograph #21	Loaf N Jug Fueling Station	B2309746
Date:	October 20, 2023	
Direction:	East	
Subject:	Hazardous substances and good housekeeping noted	BRAUN INTERTEC

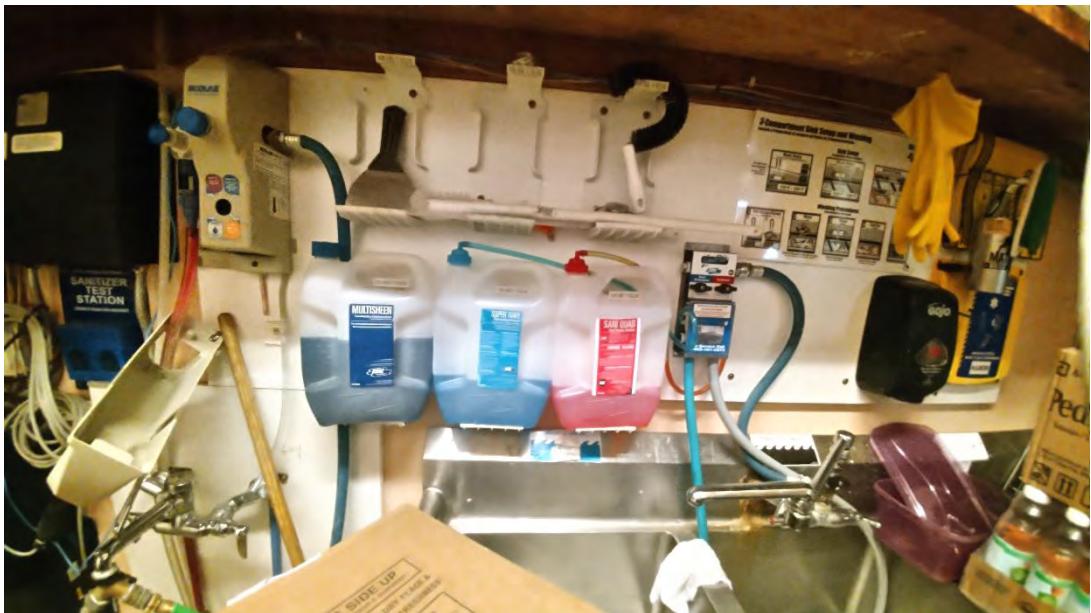
Photograph #22	Loaf N Jug Fueling Station	B2309746
Date:	October 20, 2023	
Direction:	East	
Subject:	Hazardous substances and good housekeeping noted	BRAUN INTERTEC

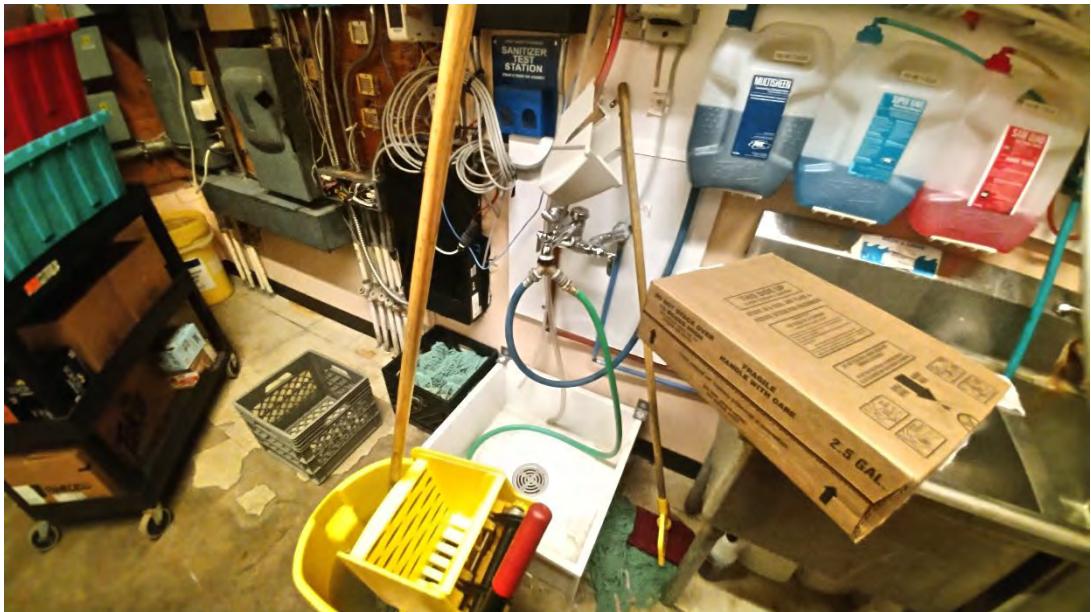
Photograph #23	Loaf N Jug Fueling Station	B2309746
Date:	October 20, 2023	
Direction:	East	
Subject:	Hazardous substances and good housekeeping noted	BRAUN INTERTEC

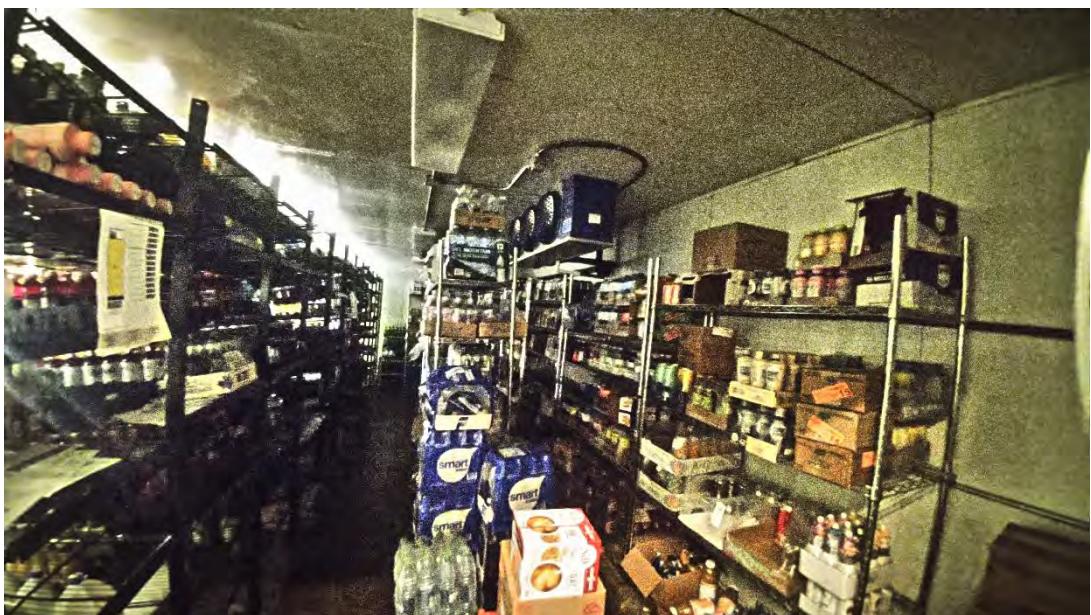
Photograph #24	Loaf N Jug Fueling Station	B2309746
Date:	October 20, 2023	
Direction:	North	
Subject:	Cooler	BRAUN INTERTEC

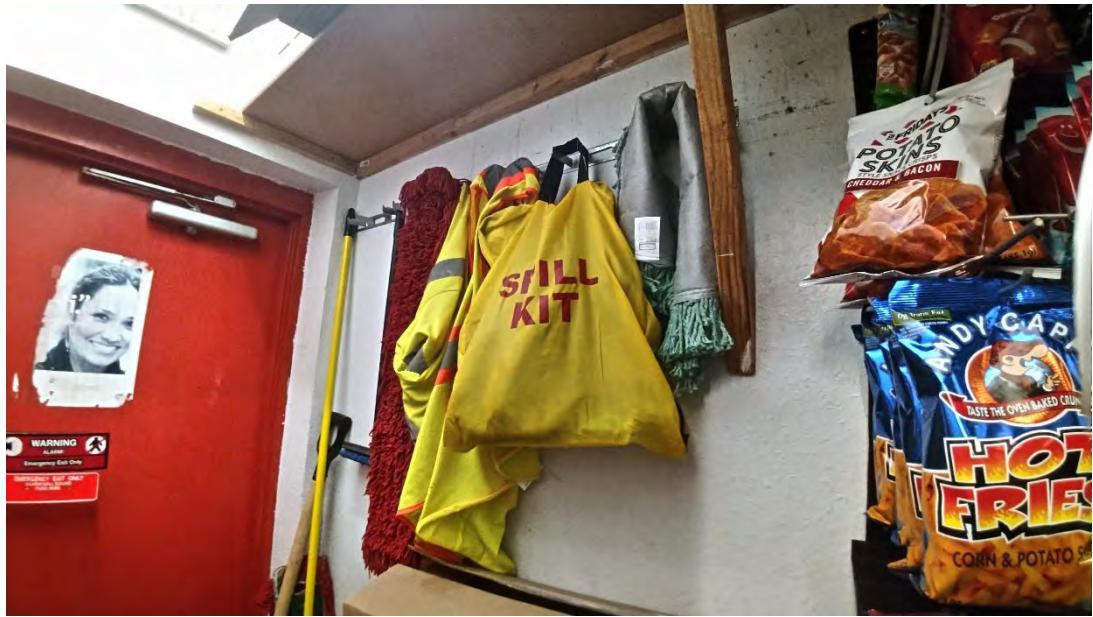
Photograph #25	Loaf N Jug Fueling Station	B2309746
Date:	October 20, 2023	
Direction:	North	
Subject:	Spill kit in hallway	BRAUN INTERTEC
