Experimental Study ND 92-03

**Road Condition - Weather Monitor
System to Determine Pavement Surface
And Atmospheric Conditions**

Final Report

Project IR-094-8(102)352

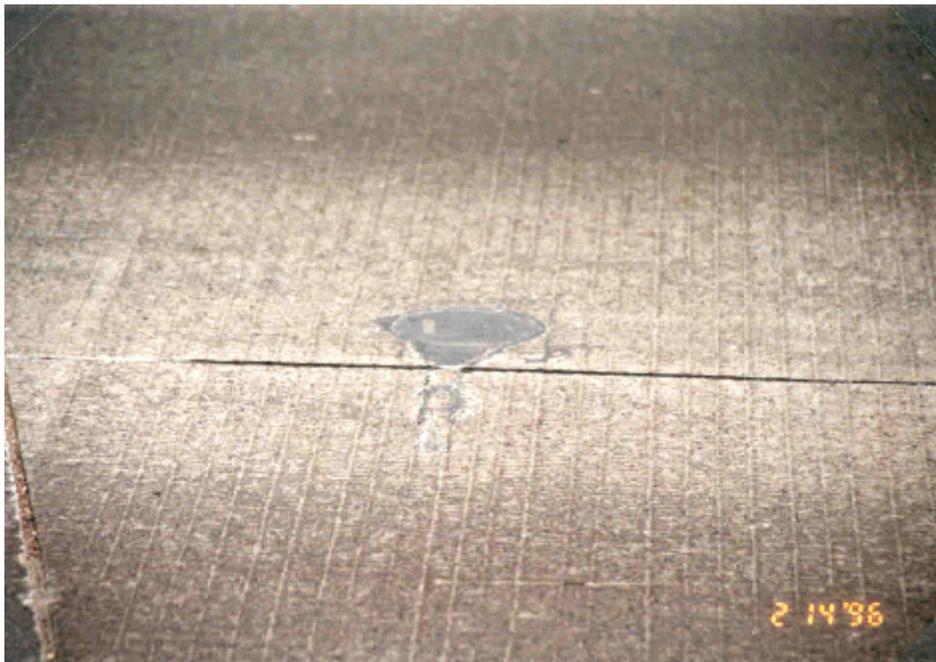
These percentages are estimates by the Fargo District and not based on recorded data. Photo 1 shows a surface sensor on the Red River Bridge.

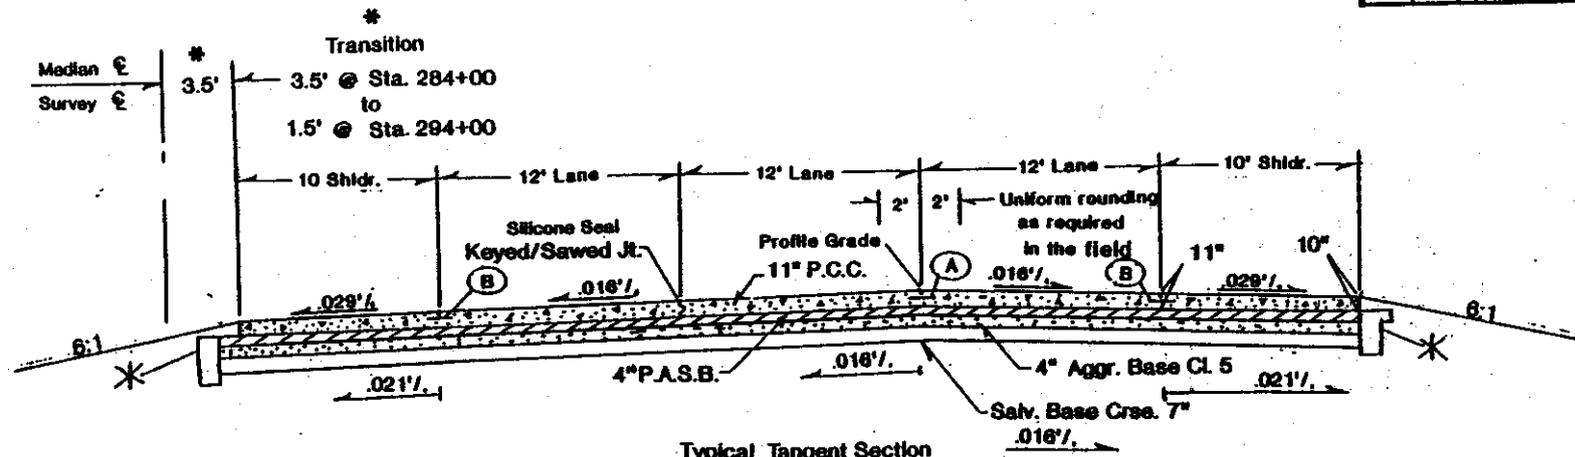
Typical Tangent Section
East Bound Roadway
Sta. 281+63 to 284+00

A - #4 Tie Bars spaced @ 2' - 6" C-C
B - #4 Tie Bars spaced @ 3' C-C

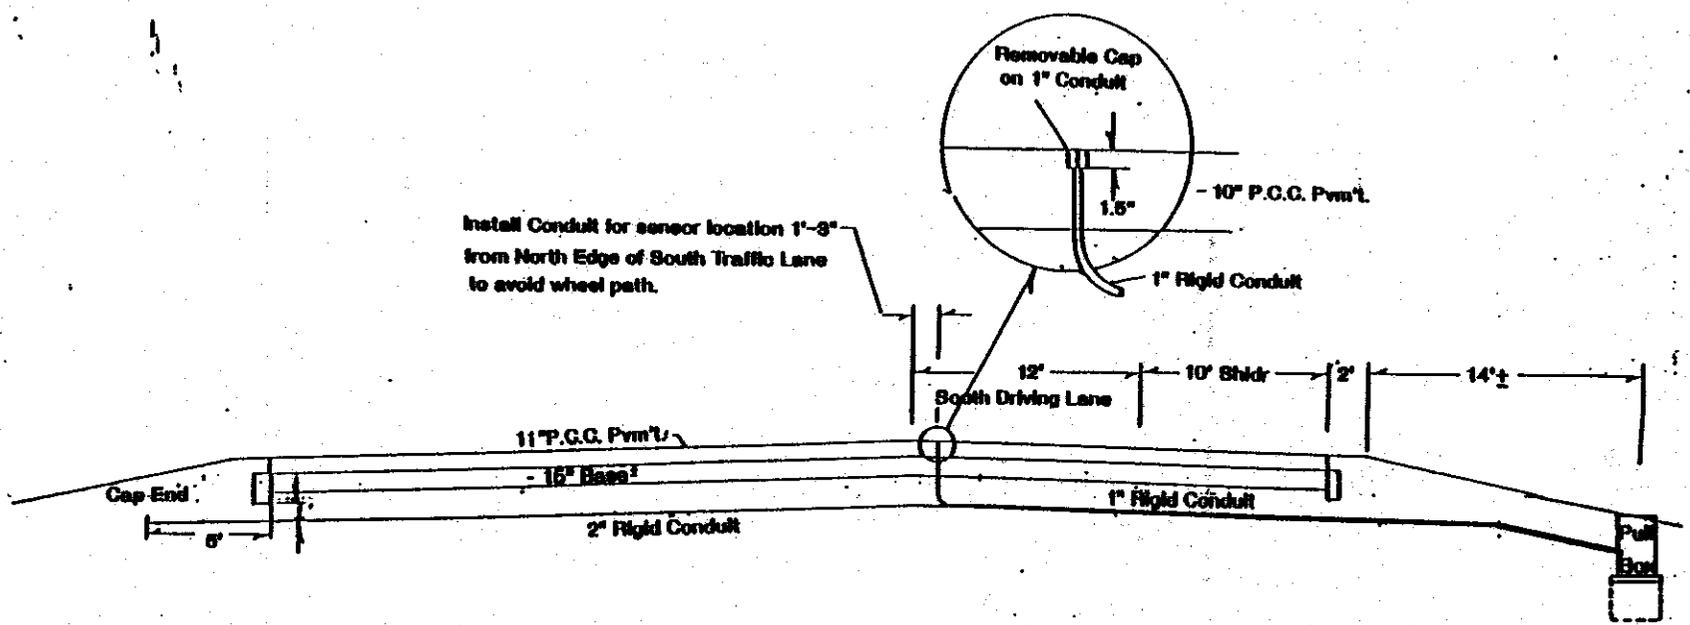
Conduit X-ing Detail
Sta. 293+00

Conduit Pipe to be Layed in same trench approximately 42" below Surface of Rdwy.

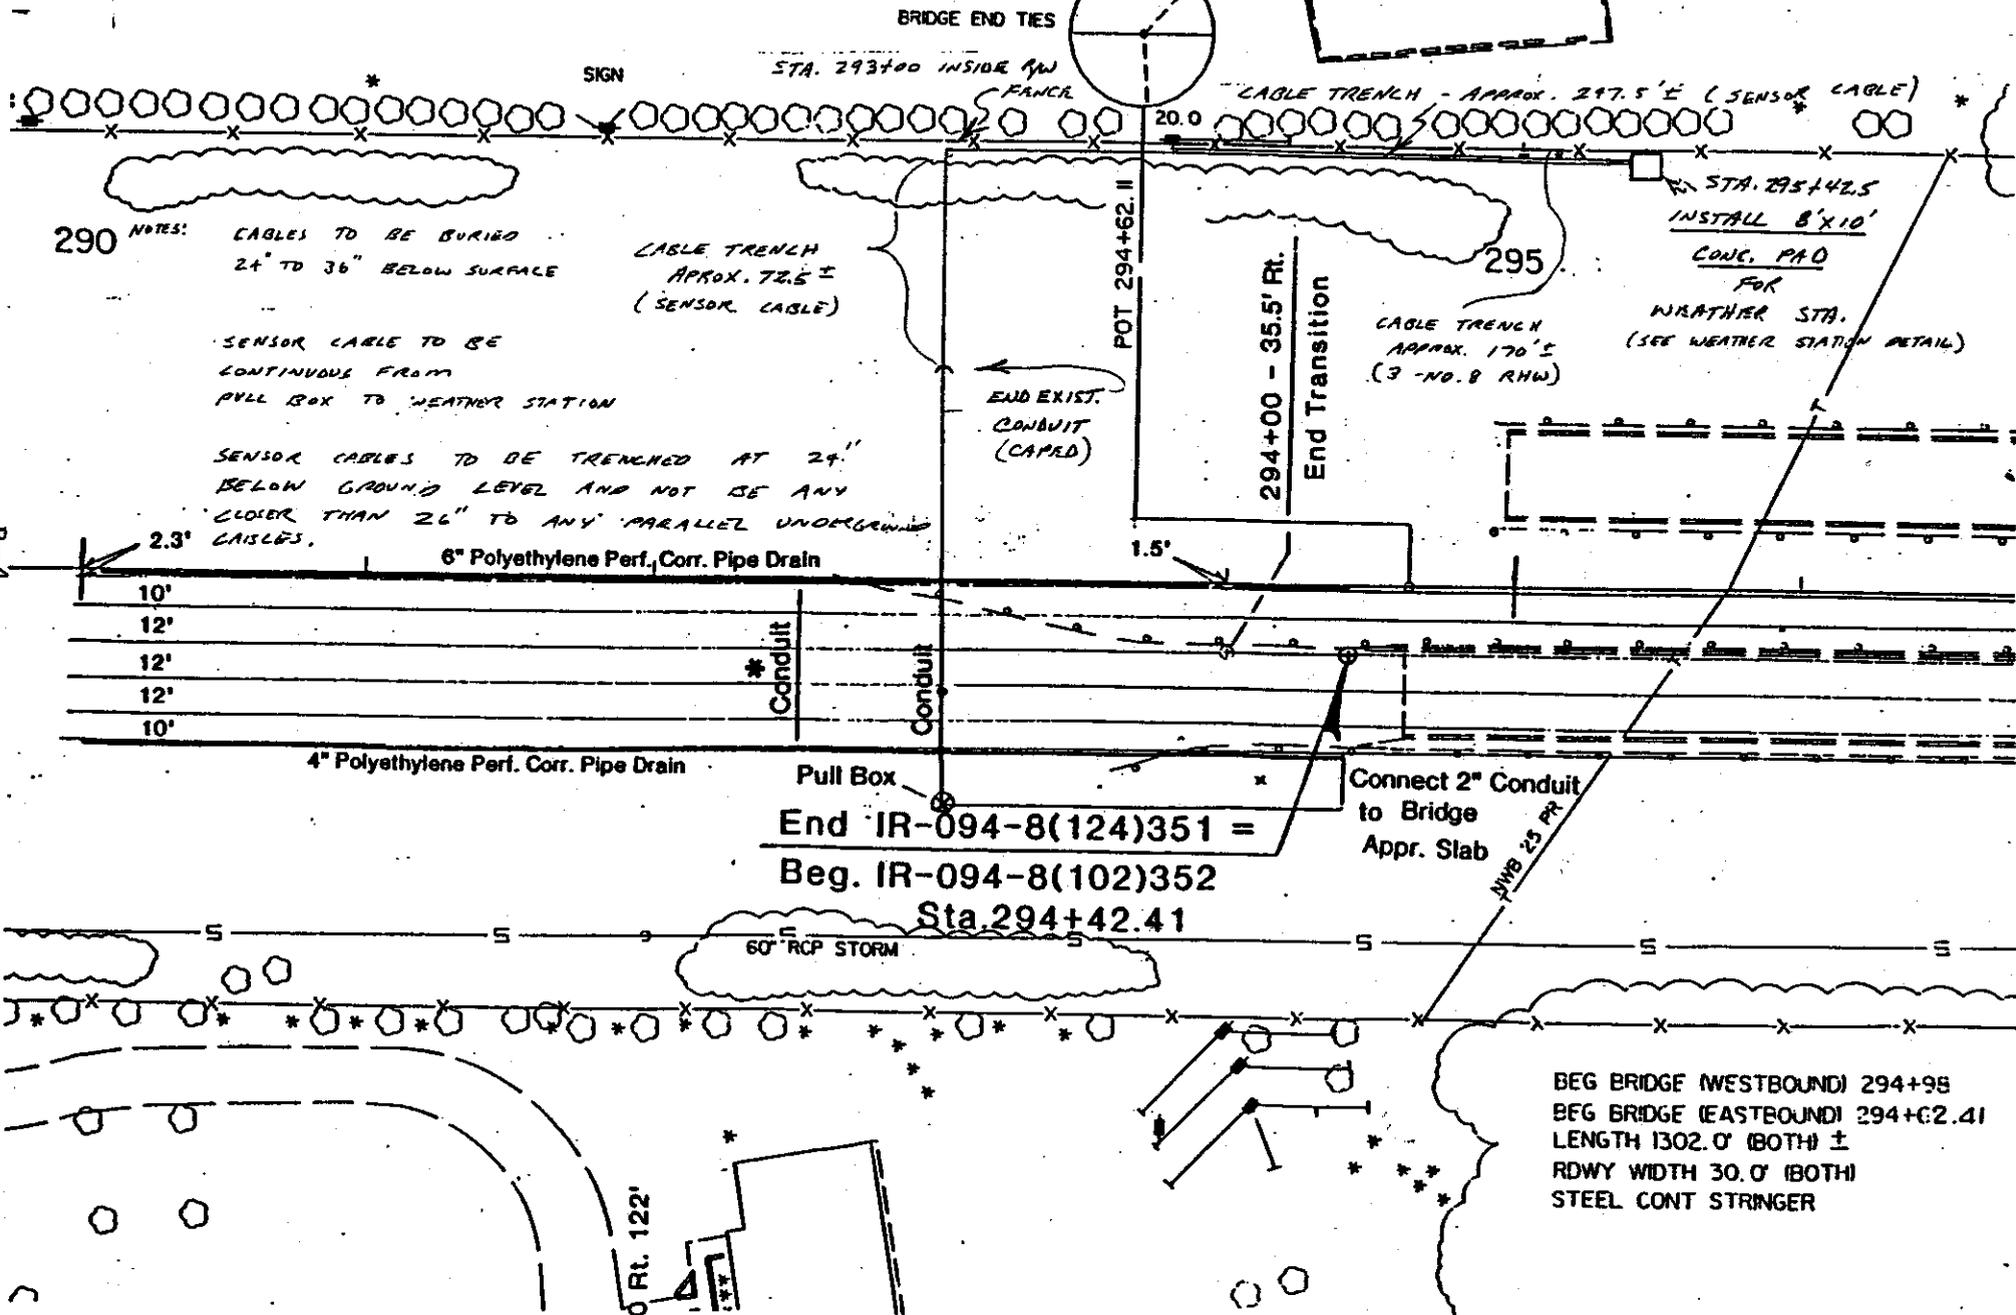
B-5

-INSTALL 3-NO. 8 RHW
STA 293+76.5 TO 295+42.5

-INSTALL 26' RIGID CONDUIT PLUS WEATHER HEAD @
POWER POLE STA. 293+76.5

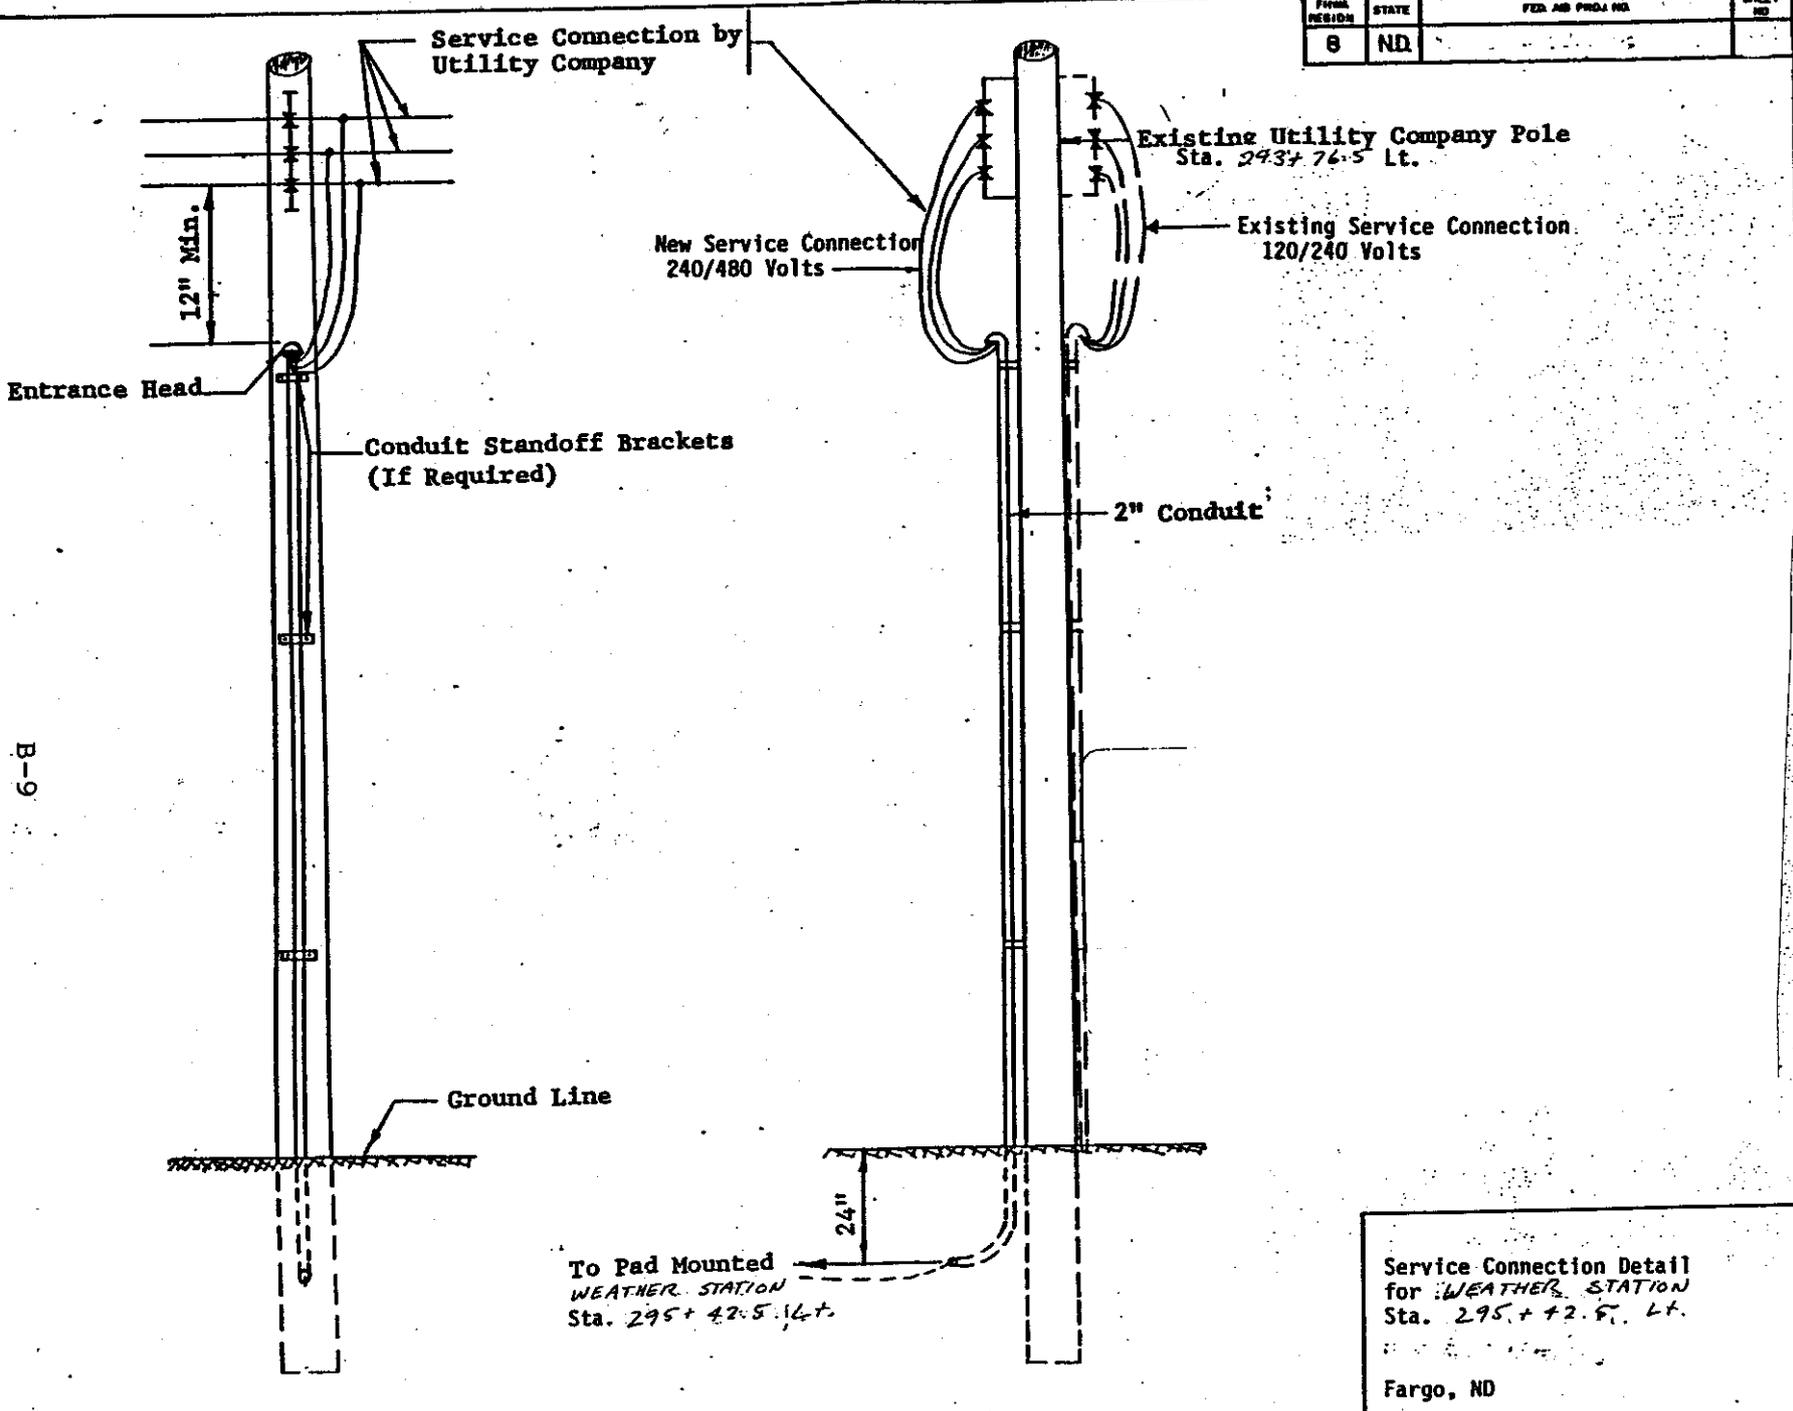
B-9

To Pad Mounted
WEATHER STATION
Sta. 295+42.5 Lt.

Service Connection Detail
for WEATHER STATION
Sta. 295+42.5 Lt.
 Fargo, ND

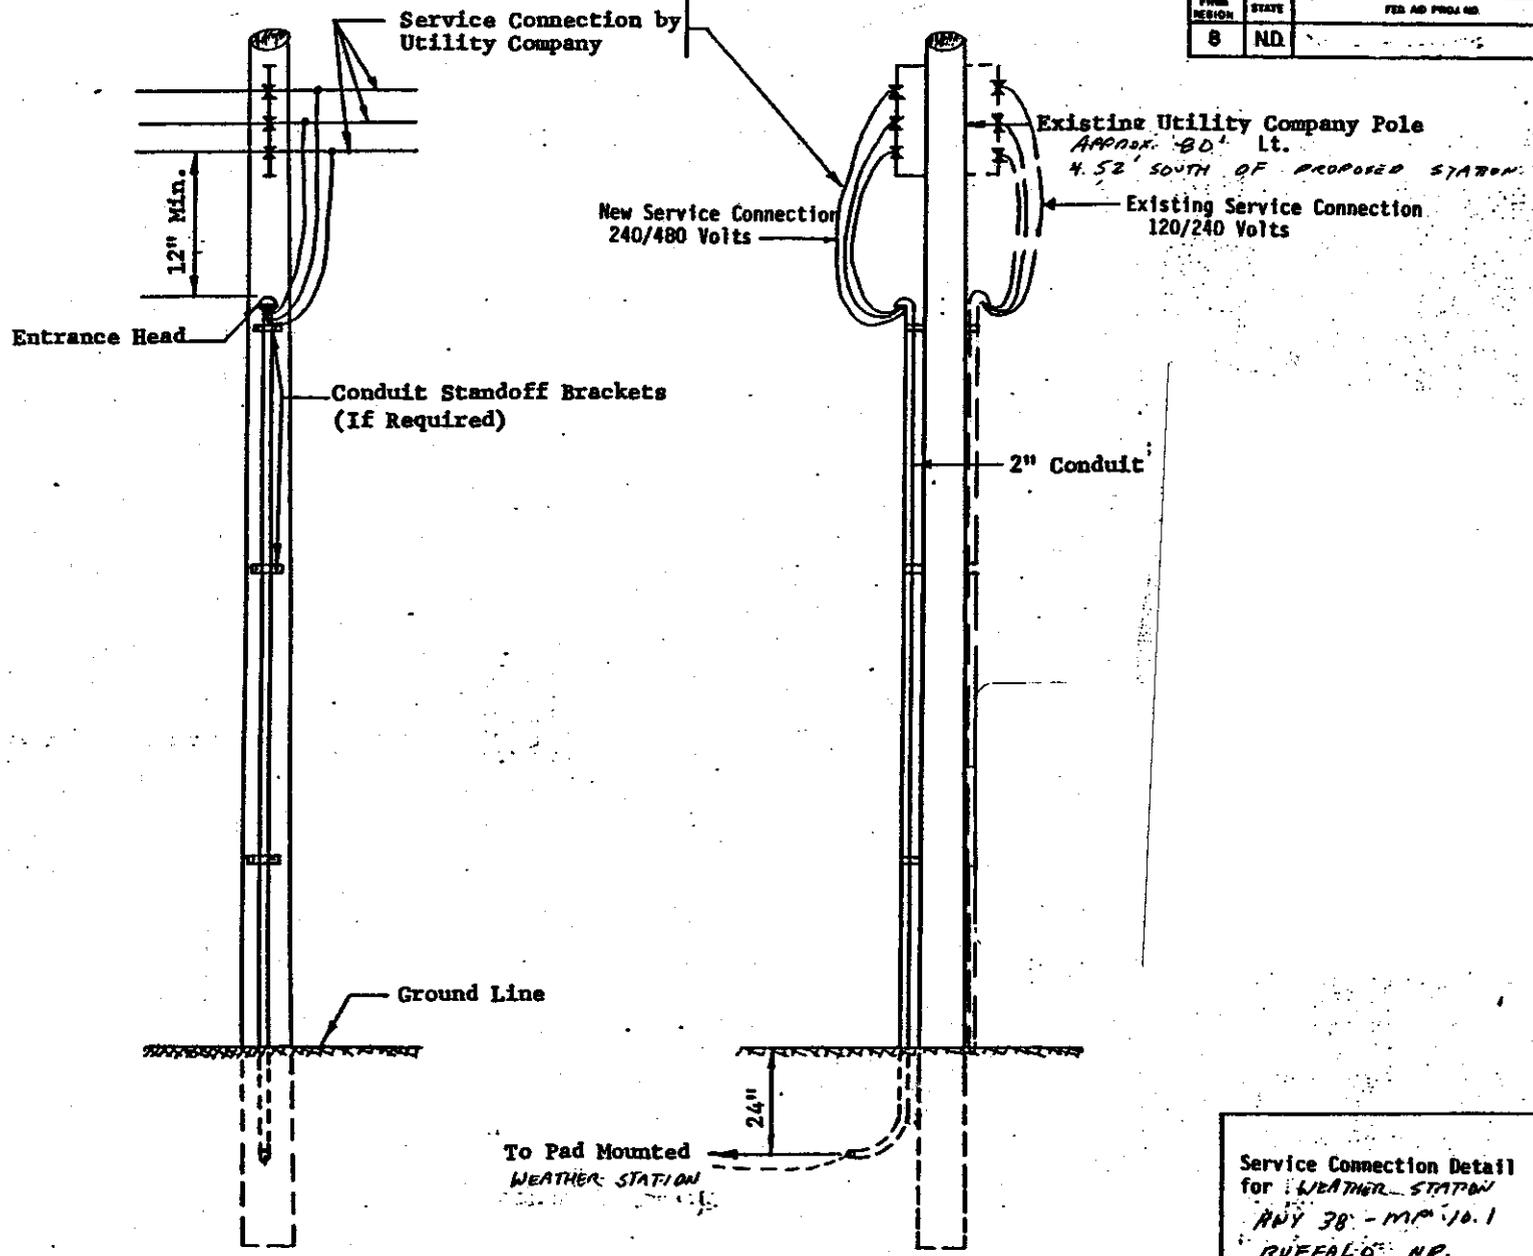
B-10

Service Connection Detail
 for WEATHER STATION
 RMY 38 - MP 10.1
 BUFFALO, ND.

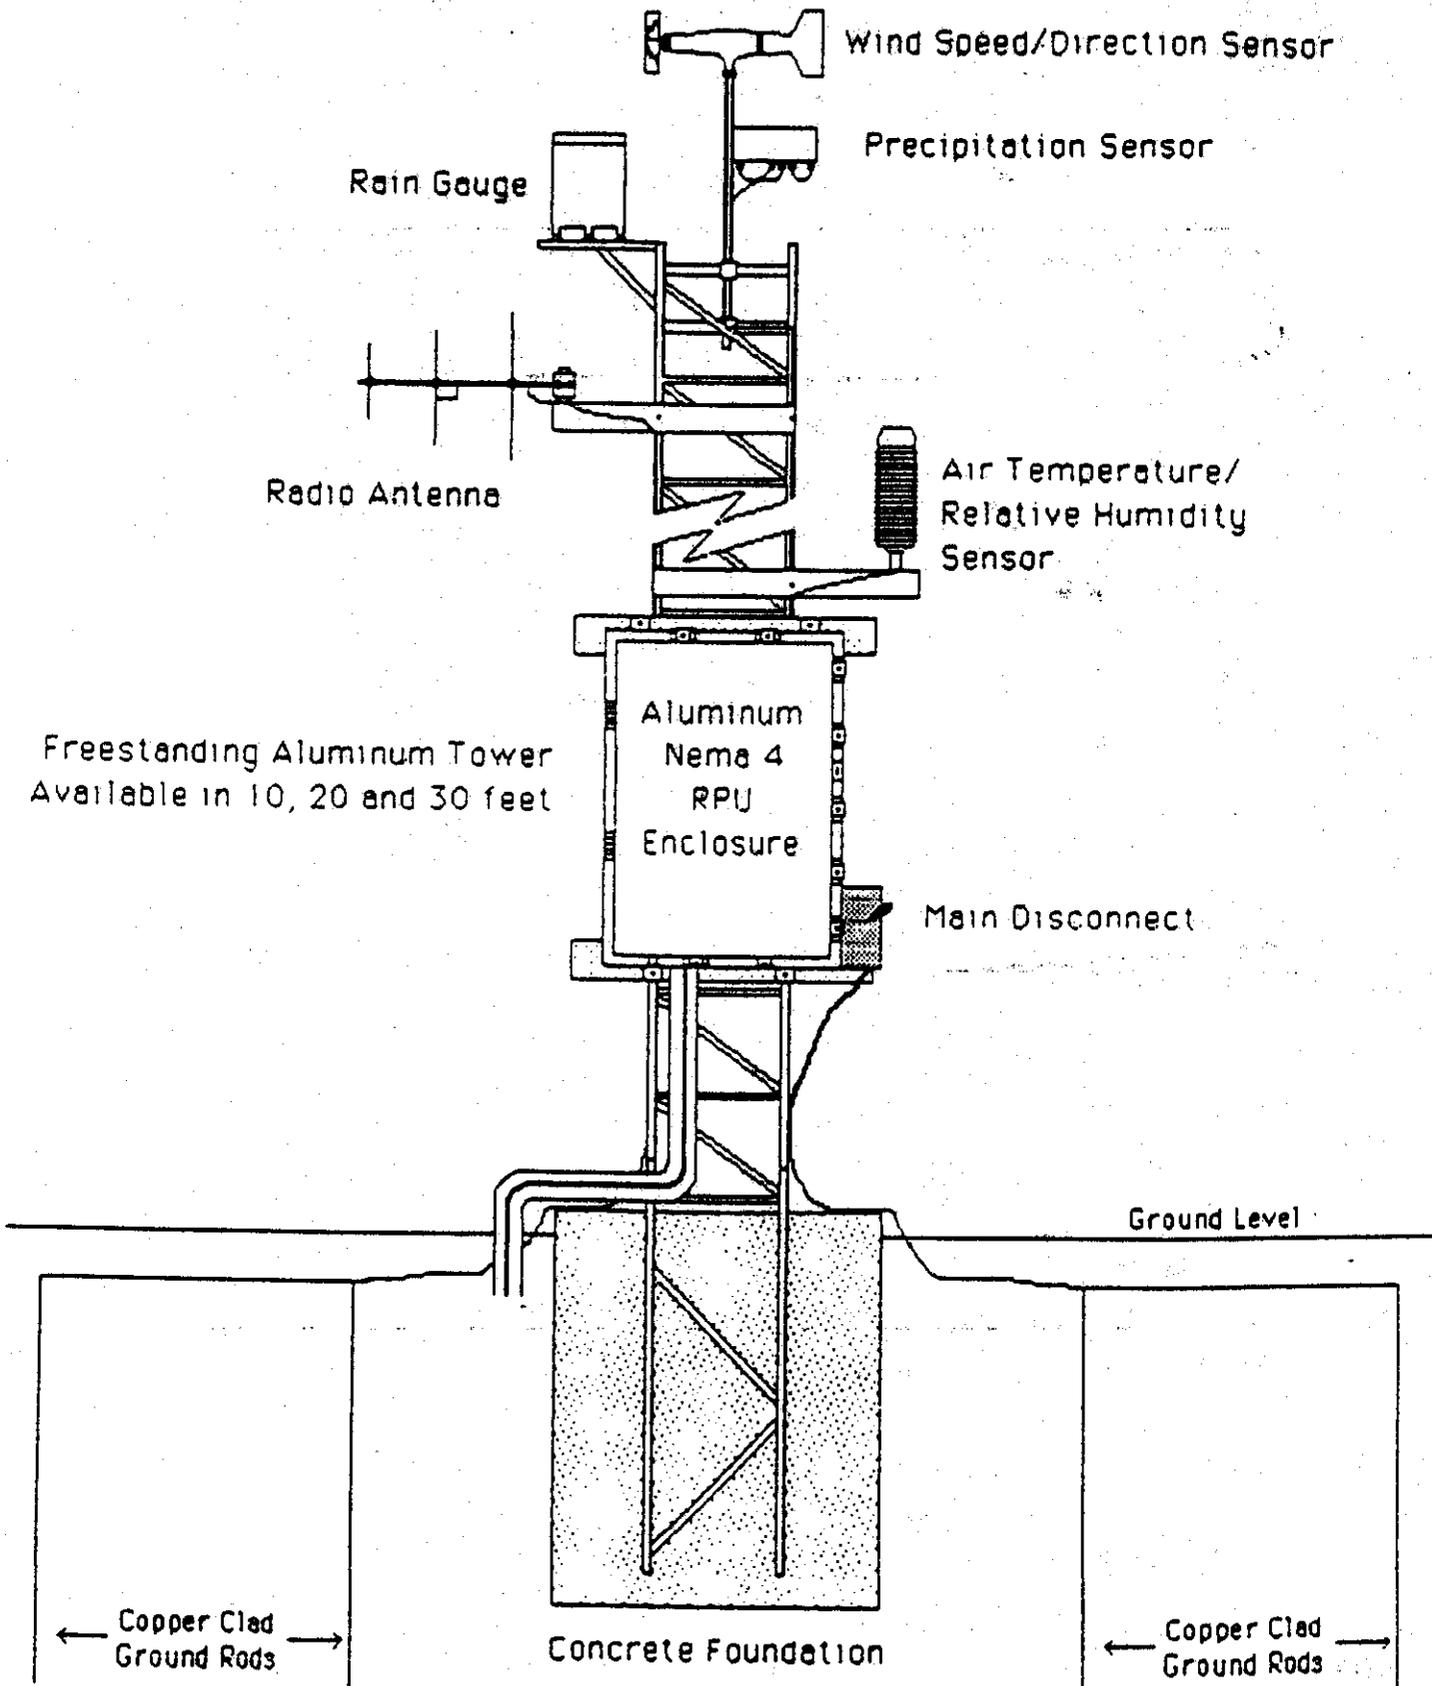
Typical Highway Remote Processing Unit (RPU) Showing Radio Communications

The RPUs receive data from the pavement sensors by way of cables inside conduit in the pavement. The RPUs send data to the CPUs by utilizing radio waves. Data collected from these stations include pavement and air temperature, wind speed, dew point, visibility, chemical concentration, and whether the pavement is wet or dry. Sensors in the roadway can detect the presence of ice, snow or frost.

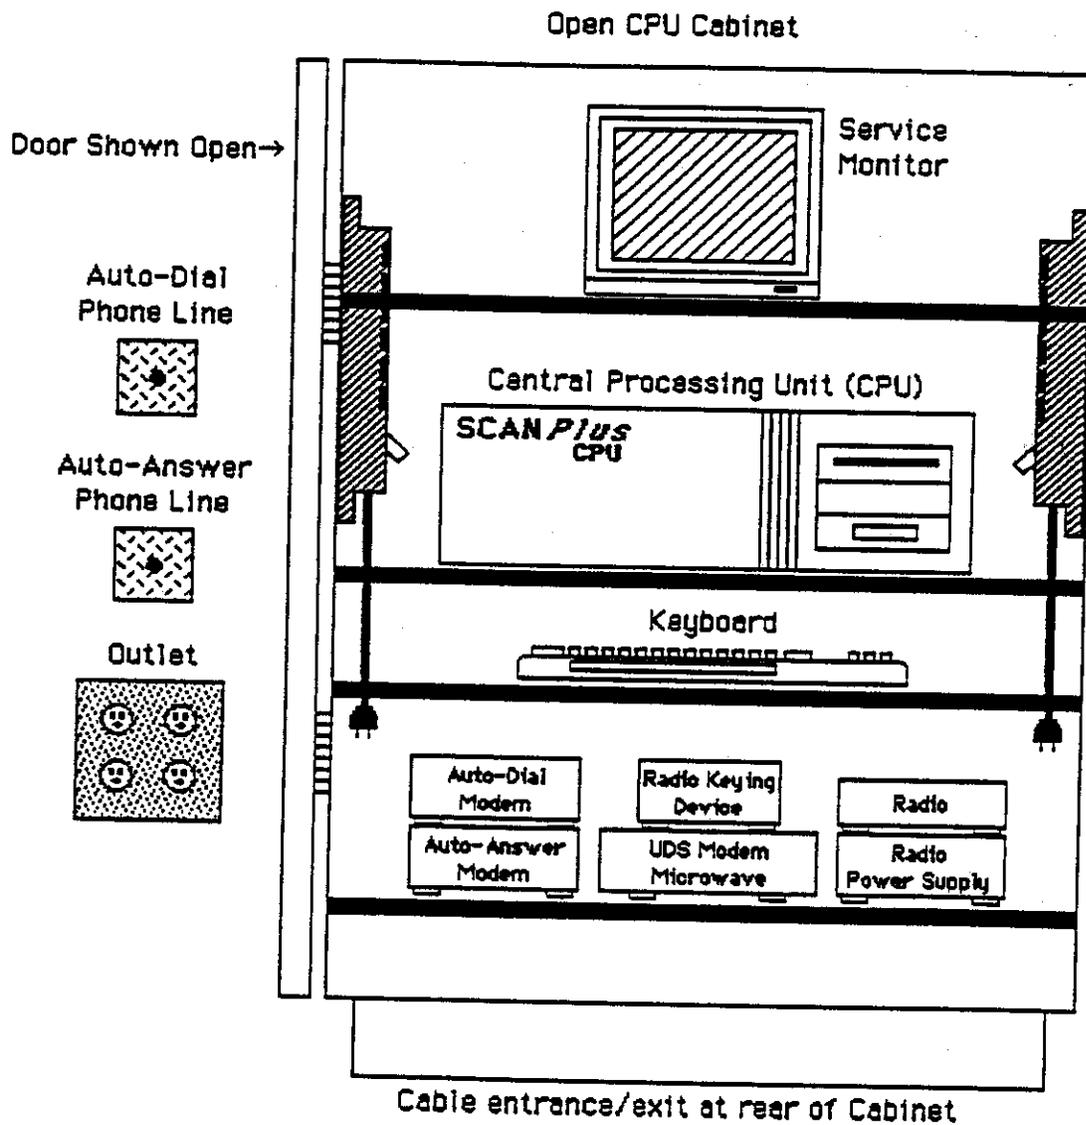
Data Handler with Central Processing Unit

The central monitoring equipment is located at the Fargo District and includes the Data Handler. The brain of the Data Handler is the SCAN Plus Central Processing Unit (CPU). It is microprocessor based and used for collection, storage and presentation of all sensor data. All wiring and hookups took place during the construction phase.

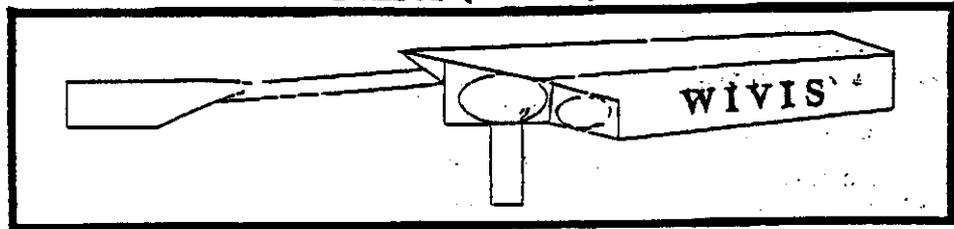
**Weather Identifier and VISibility
Sensor (WIVIS)**

- **Type of precipitation detection**
- **Intensity of precipitation (rain and snow)**
- **Measurement of precipitation**
- **Measurement of visibility**
