Experimental Study ND 94-02

**Experimental Feature "PavePrep"
Pavement Interlayer To Halt or
Retard Reflective Cracking**

Final Report

Projects SS-6-017(015)112 and NH-3-002(040)212R

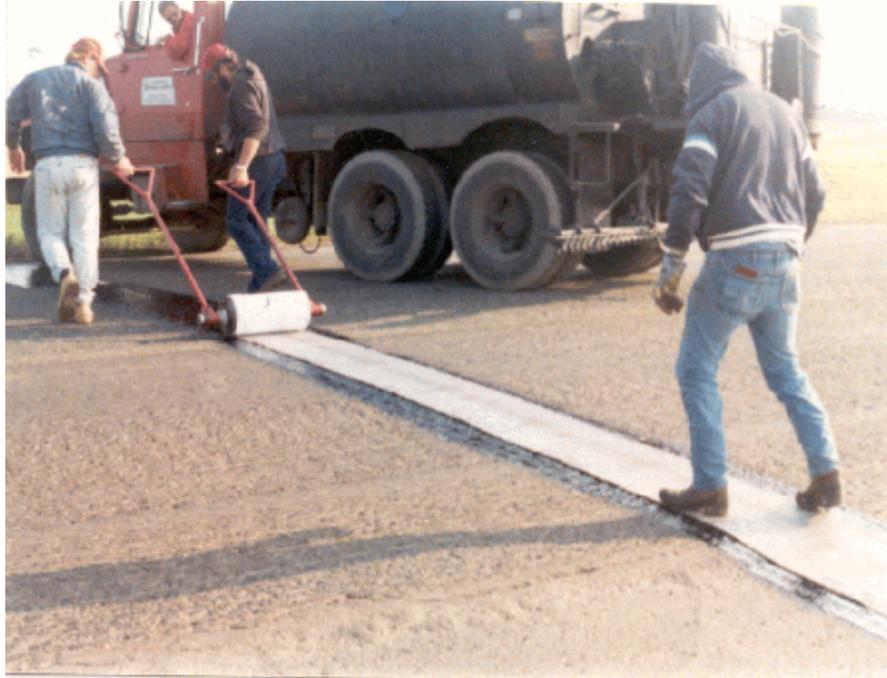
Photo 1--PavePrep installation

An AC 120-150 tack coat was applied at a rate of 0.25 gal/sy to each crack prior to installing the PavePrep. The installation method is shown in photo 1. The contractor placed the first asphalt overlay lift about an hour after the last PavePrep was laid. Problems developed soon after the paving began. The PavePrep material was being pulled up by the slow moving paver wheels. This is shown in photo 2. One reason this happened may be that the tack coat under the PavePrep did not cure enough to bond to the old roadway surface. Once the contractor got the feel of things the work progressed satisfactorily.

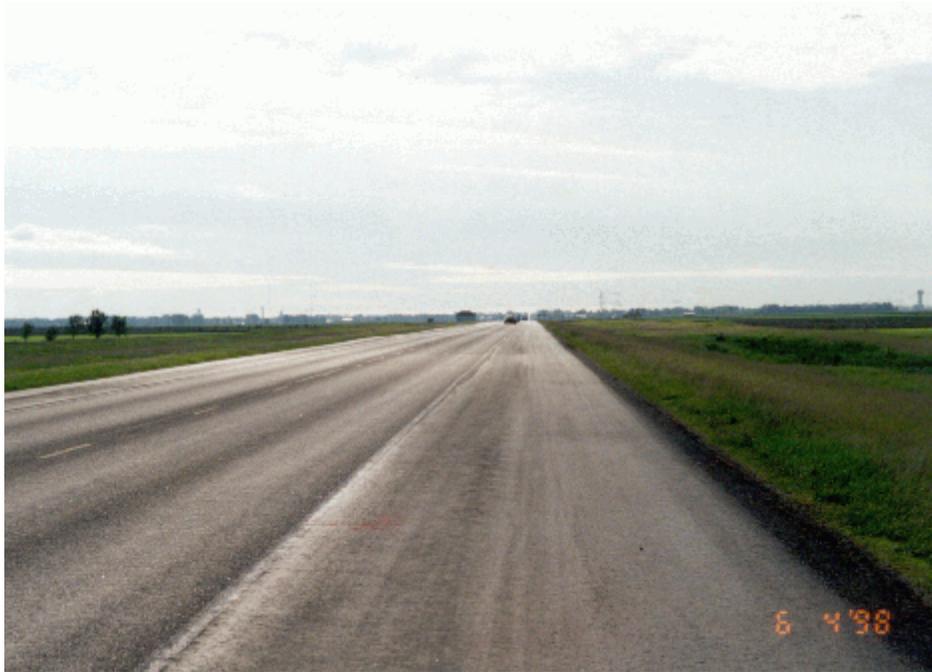
Photo 3--Control section--Highway 17

The experimental project was evaluated and cored on June 3, 1998. Photo 3 shows the beginning of the control section at station 592+00. The control section originally had about the same number of cracks as the PavePrep section.

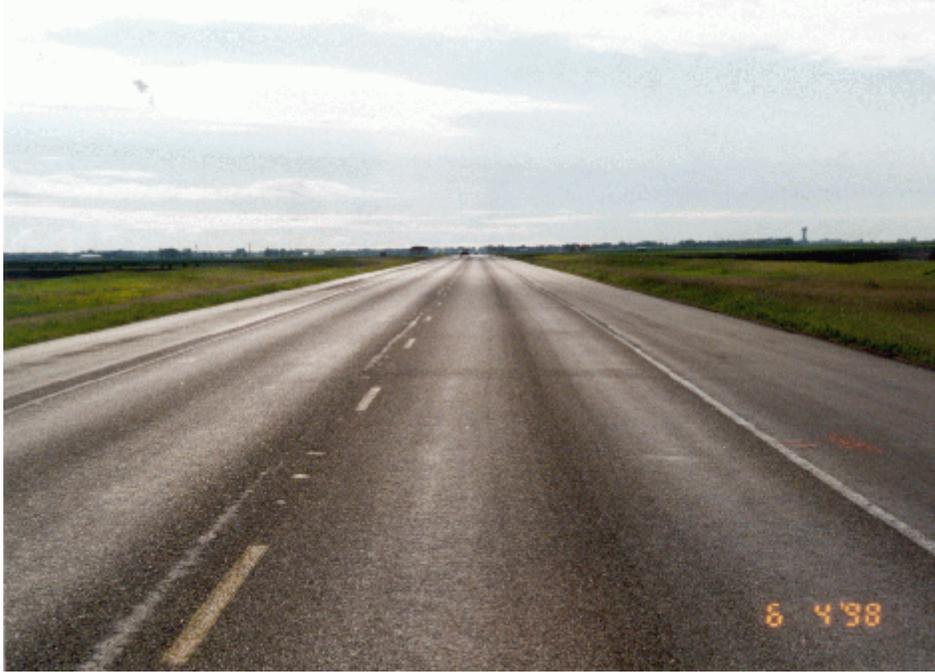
Photo 4--PavePrep section--Highway 17

Photo 4 shows the beginning of the PavePrep section. PavePrep had been placed on 2189.49 lineal feet of cracks. Of this, 417 feet was on longitudinal cracks. On June 3, 1998, the project looked good. It provided a good ride with no visible rutting. More cracks in the PavePrep section are reflecting through the shoulder and into the driving lane about three feet. This is also occurring in the control section. The project was contract chip sealed in June of 1996 shortly after the 1996 evaluation. This made the reflected cracks harder to see in 1997

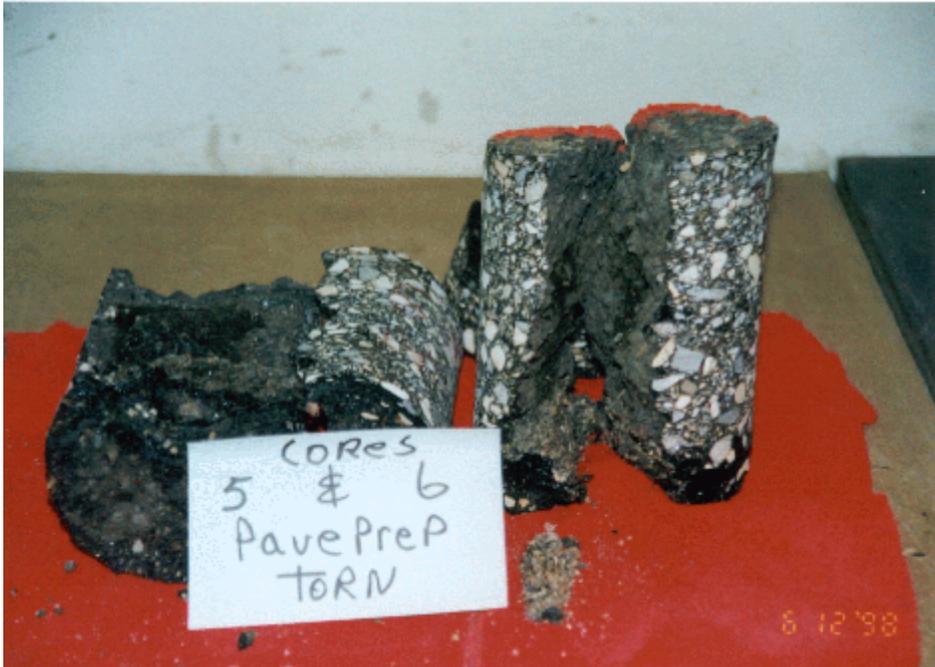
Photo 5--Cores 5&6 on Highway 17-----PavePrep torn

Nine cores were taken in the PavePrep section and five in the control section at Highway 17 for 1998. This was to determine if the reflected crack is directly over the underlying old crack. Cores would also provide information about whether the PavePrep is functioning as a moisture barrier or not. Comparing the present reflected crack to the original crack photos taken before the asphalt overlay, it was determined that most cracks have reflected almost vertically from the old crack. The core results for 1998 are shown below.

Core Observations 1998			
PavePrep Locations	PavePrep Broken	Remarks	Provides Water Barrier
604+58.0 E.B. W. B.	Yes No	Completely torn Reflected crack not over old crack	No Yes
606+68 E.B.	Yes	Completely torn	No
608+86.6 E.B. W.B. Shoulder	Yes Yes Yes	Completely torn Completely torn Completely torn	No No No
609+90.8 E.B. W.B. Shoulder	Yes Yes NO	Completely torn Completely torn	No No Yes

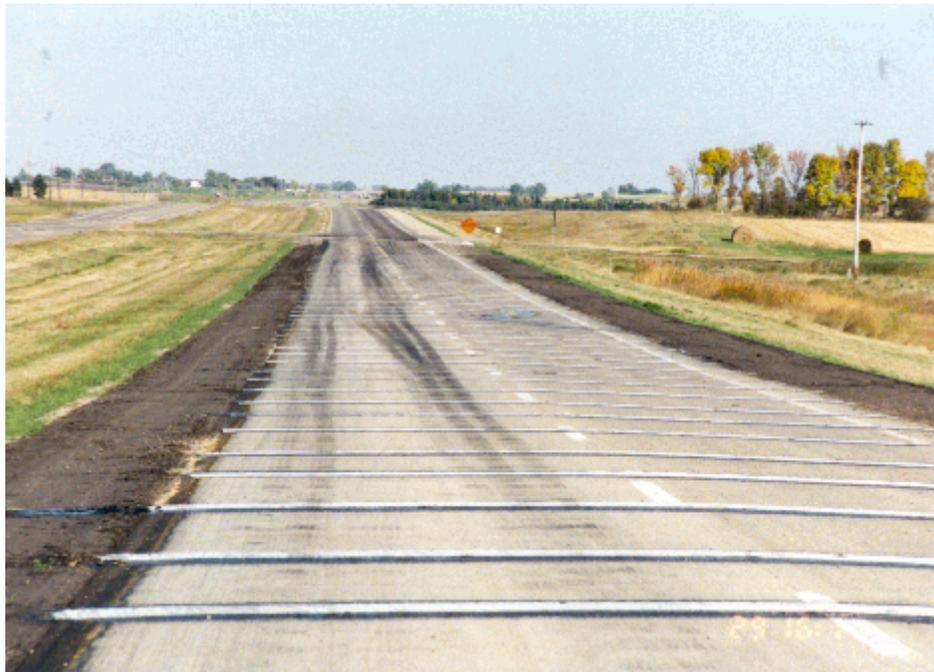
Photo 6 --East end overview of PavePrep section

The contractor, gaining experience from the Highway 17 project, was better prepared for this Highway 2 test section. Working on concrete with joints that are in a straight line also helps. The same basic procedure was used to install the PavePrep here as on Highway 17. The roadway was cleaned. A tack coat was applied over the joints at a rate of approximately 0.1 gal/sy. The PavePrep was placed over the joint and worked into the tack. Photo 6 shows a view of the PavePrep on the east end of the test section.

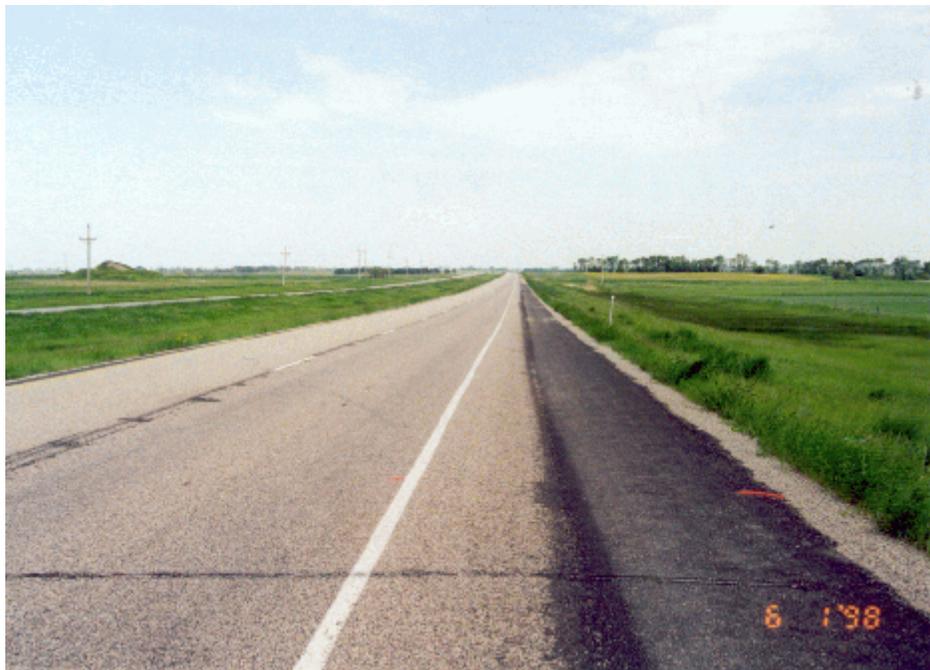
Photo 7 --PavePrep section overview--looking east

All of the joints in the PavePrep section were covered with the PavePrep material before the asphalt overlay. An overview of the PavePrep test section is shown in photo 7.

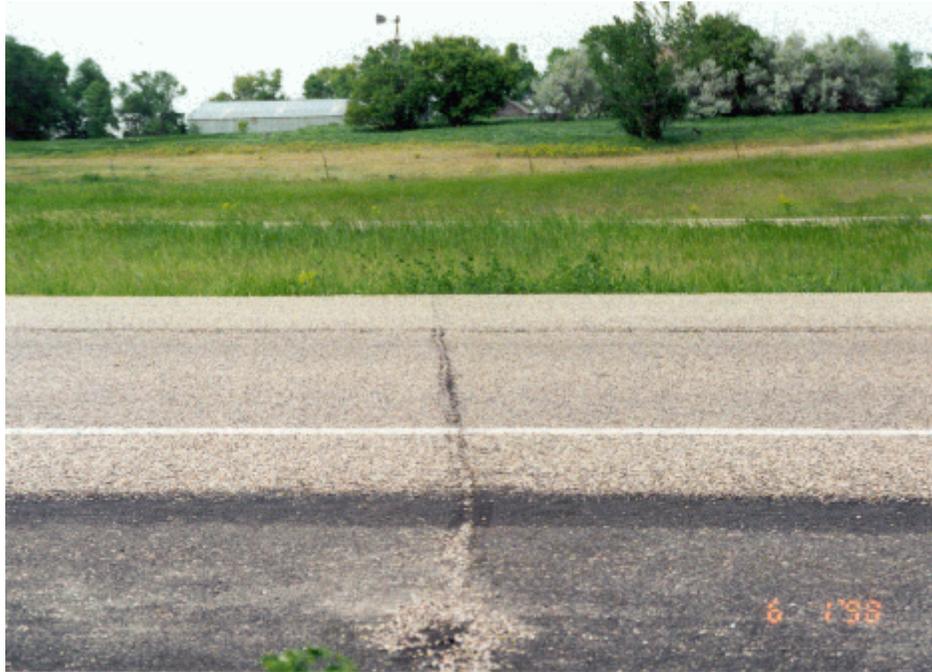
Photo 8 --Control section--reflected joint crack--sta.1213+23.9

The project was evaluated on June 1, 1998. The roadway appearance looked good. No rutting could be seen and the ride was smooth. The joints on this project are skewed and can be seen by the reflected crack in photo 8. Photo 8 is at station 1213+23.9 and shows that the crack reflects directly over the underlying joint. The crack is quite straight.

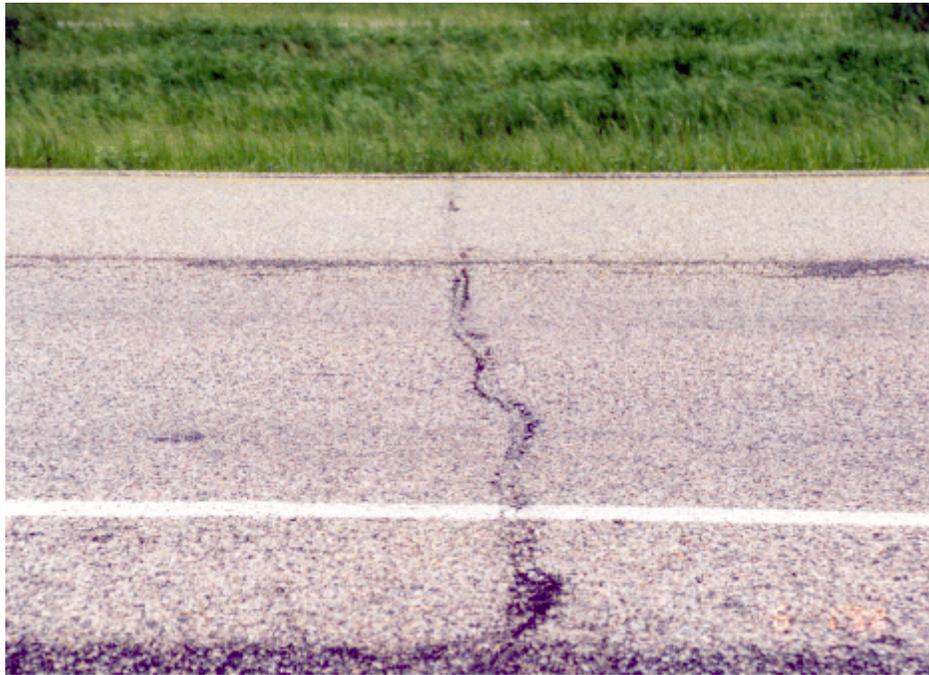
Photo 9 --PavePrep section--typical reflected joint crack--sta.1221+0.6

Photo 9 shows a reflected crack in the PavePrep section. The crack is fairly straight except for the shoulder.

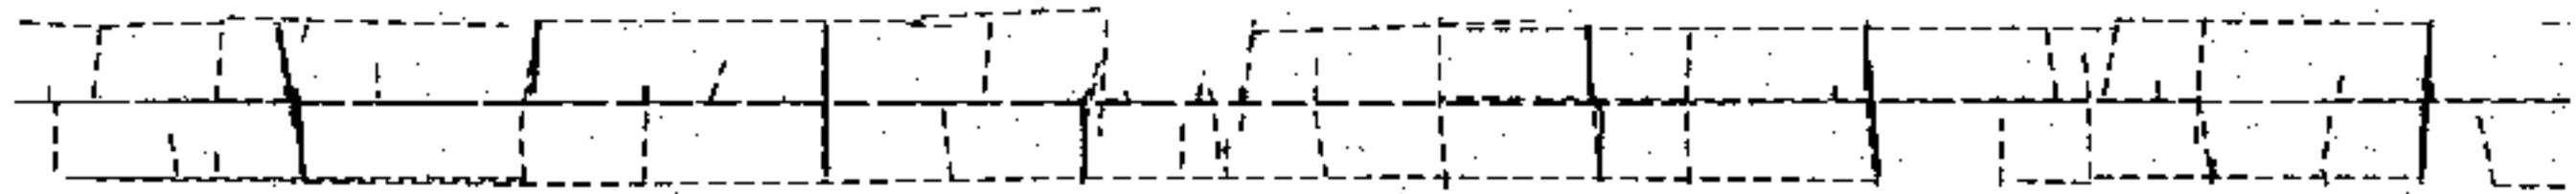
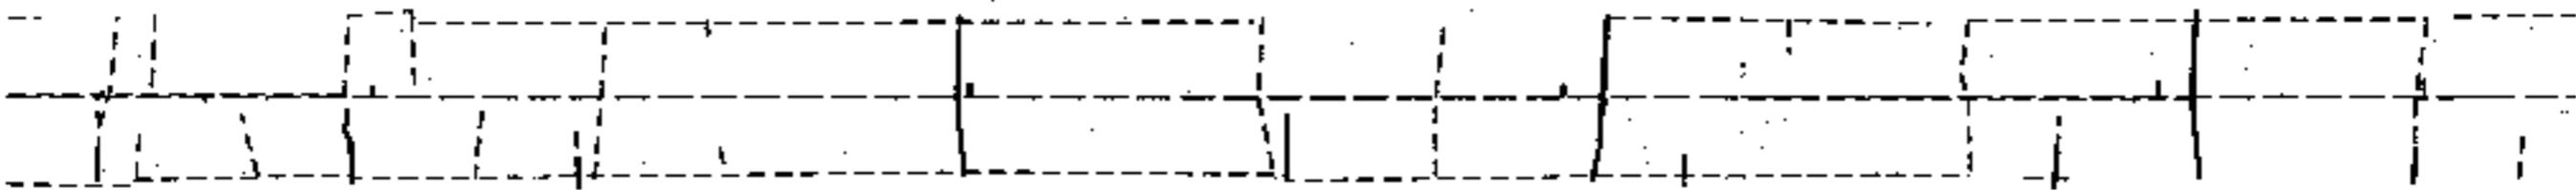
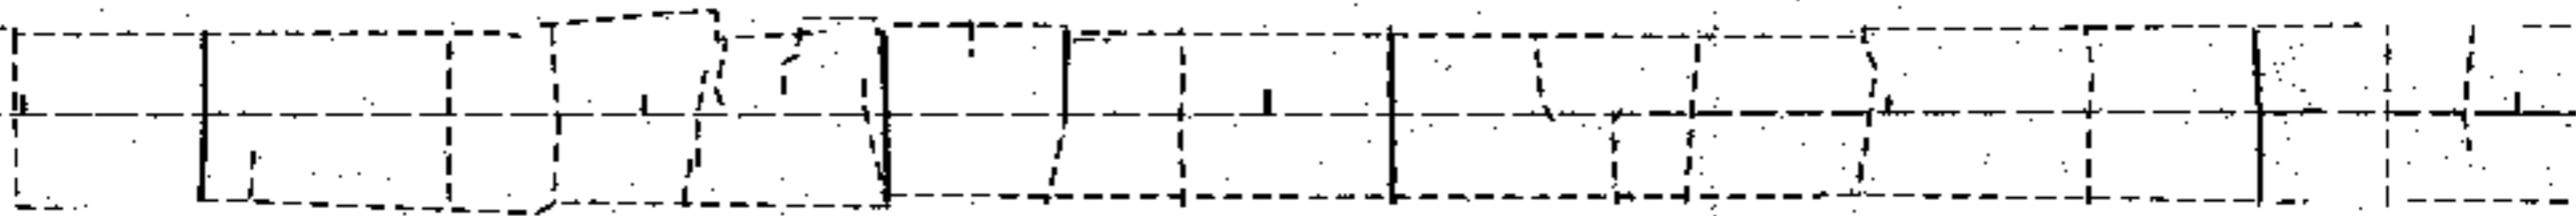
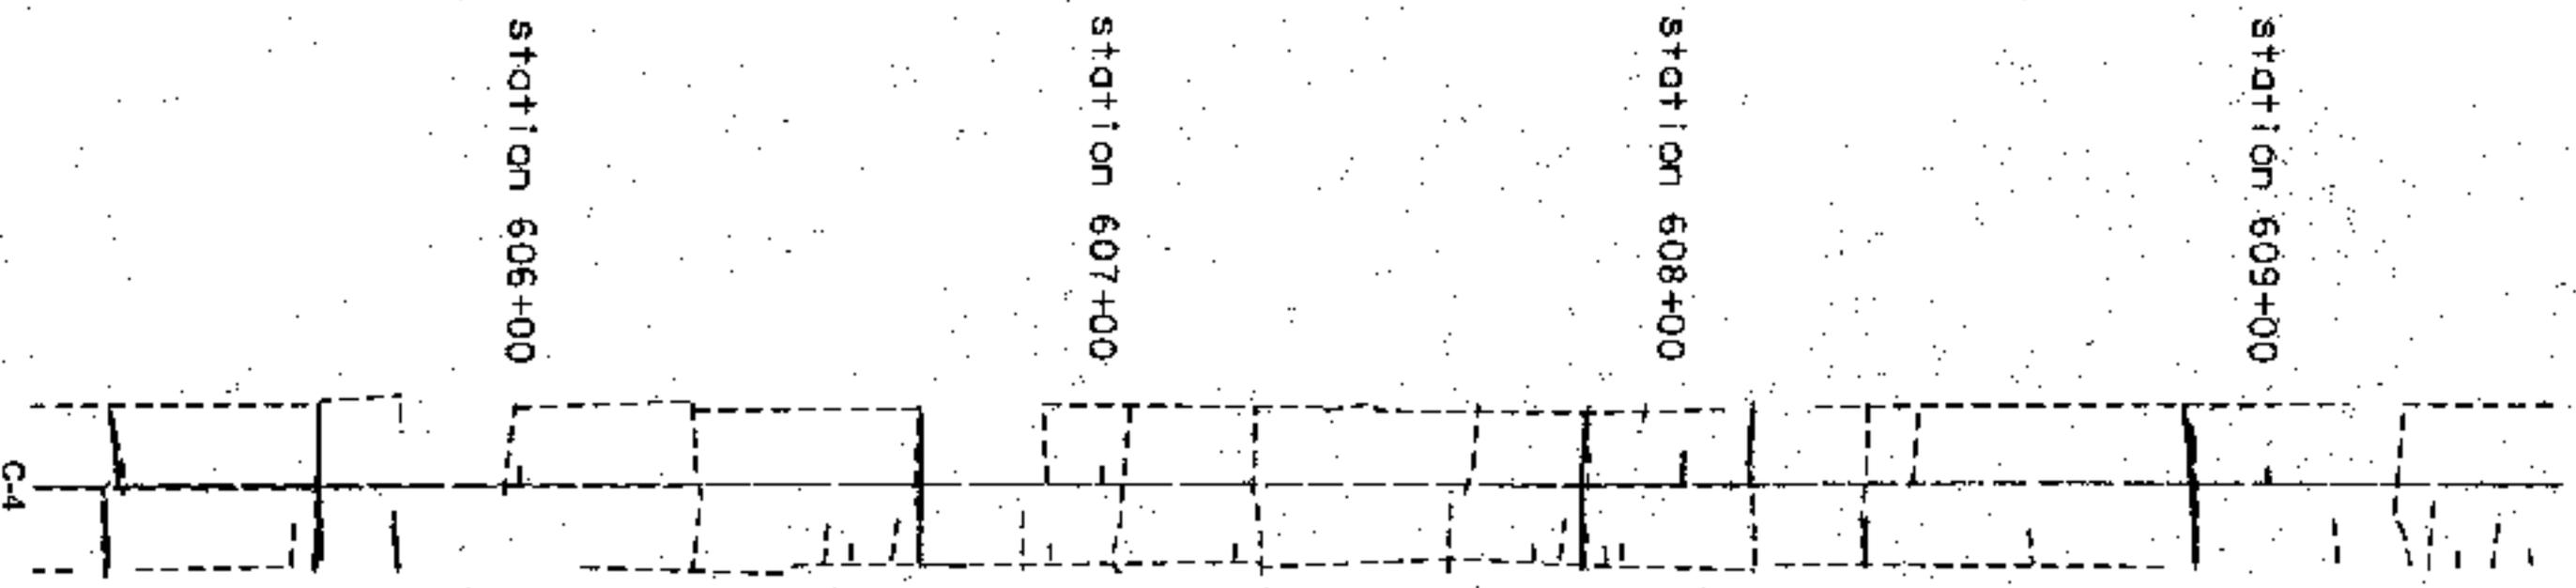
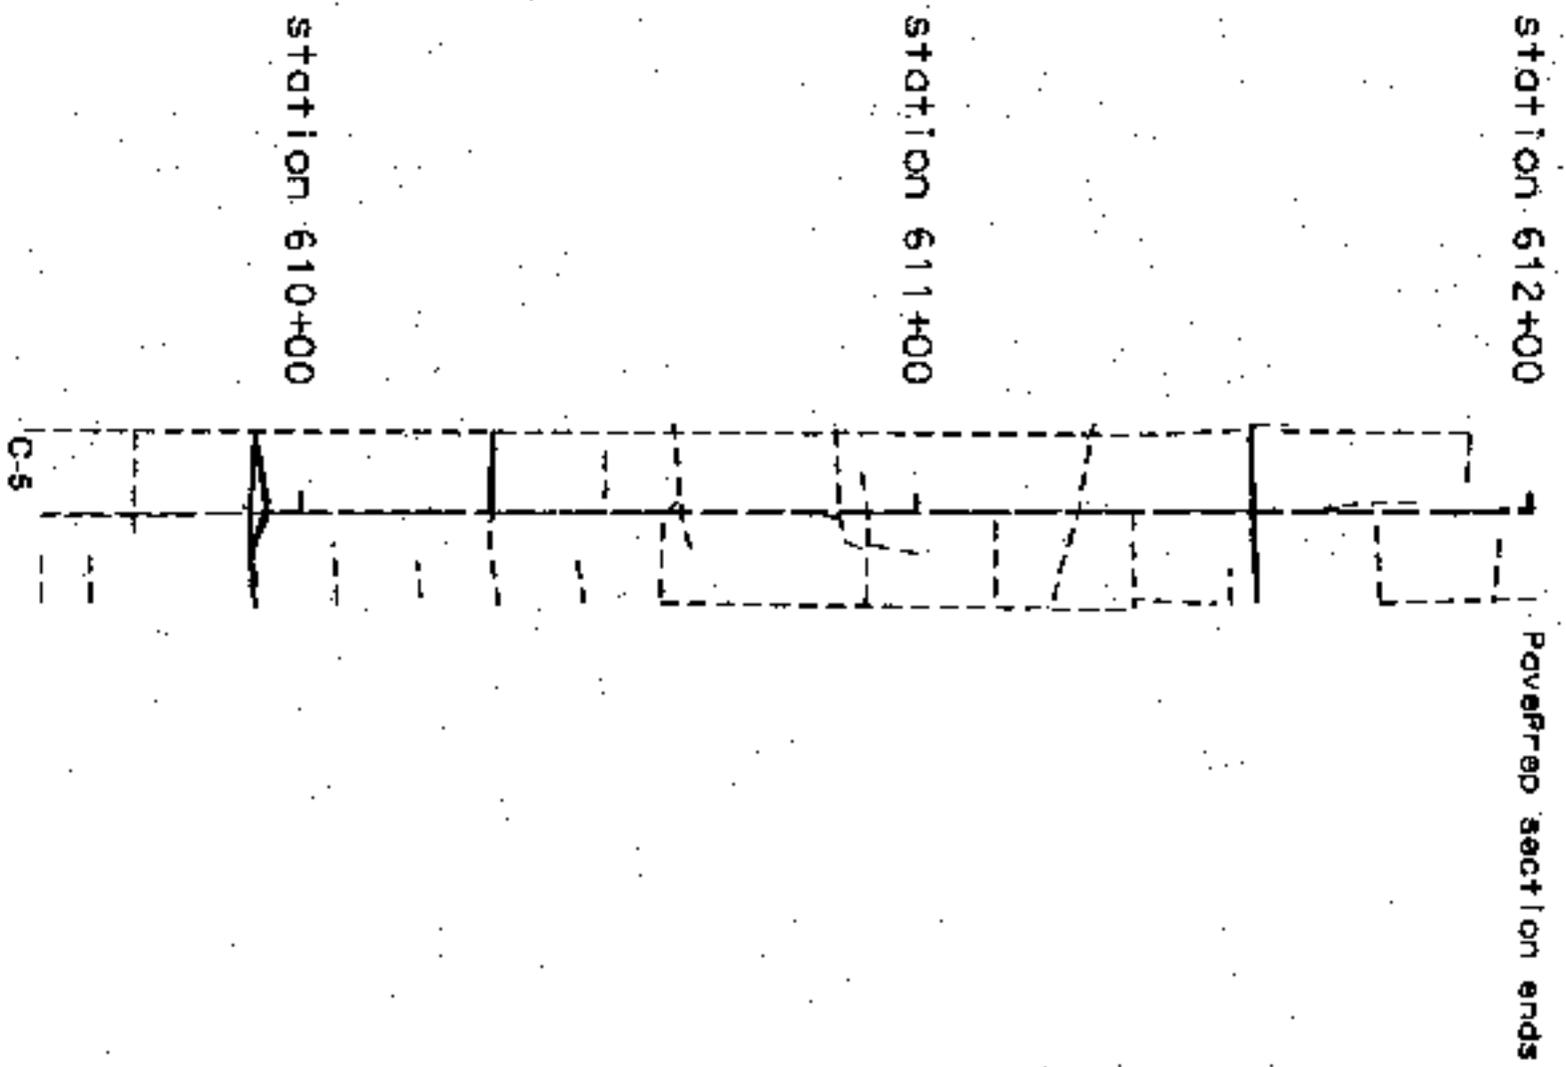
SS-6-017(015)112
 crack survey
 PavePrep

- REFLECTED CRACK 1998
- - - ORIGINAL CRACK 1994
- - - CENTERLINE

The annual crack survey was taken by the Grand Forks District in May of 1998. The crack data was plotted. It seems that the shoulders were not included in this year's annual survey. The lineal feet of the cracks by using a total station with a data collector is fairly close to the actual measurements taken in the field. The plots are located in Appendix C and show the original cracks (1994) and the location of the reflected cracks for 1998.

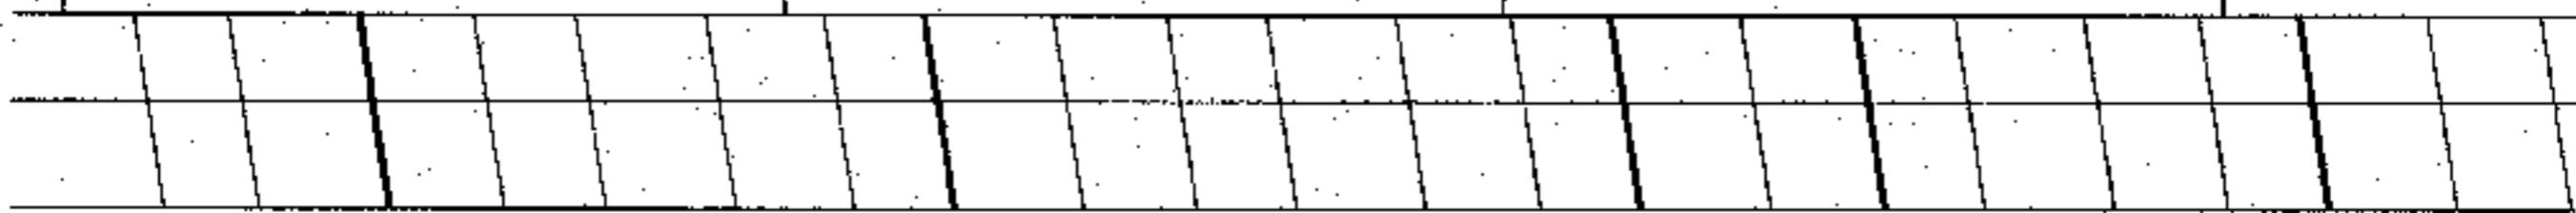
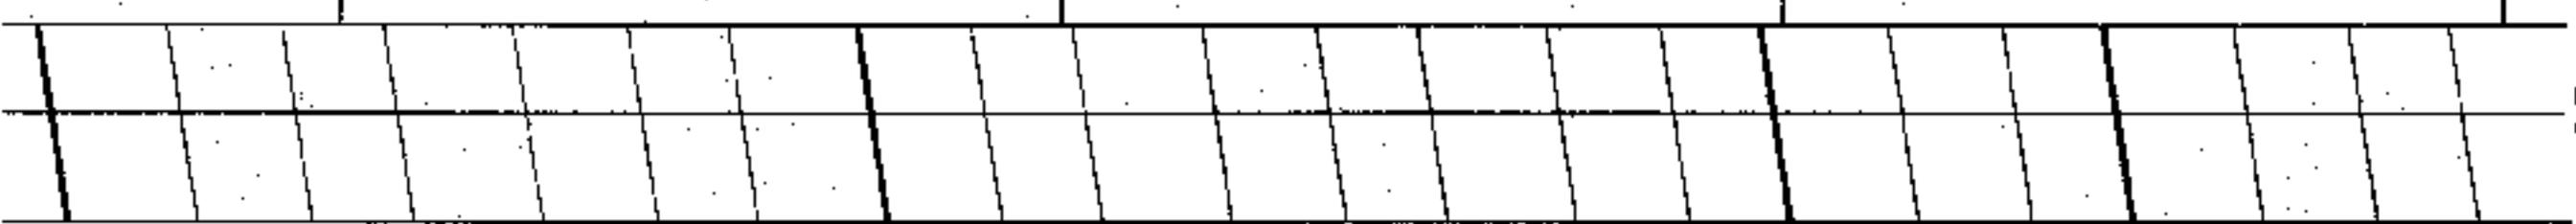
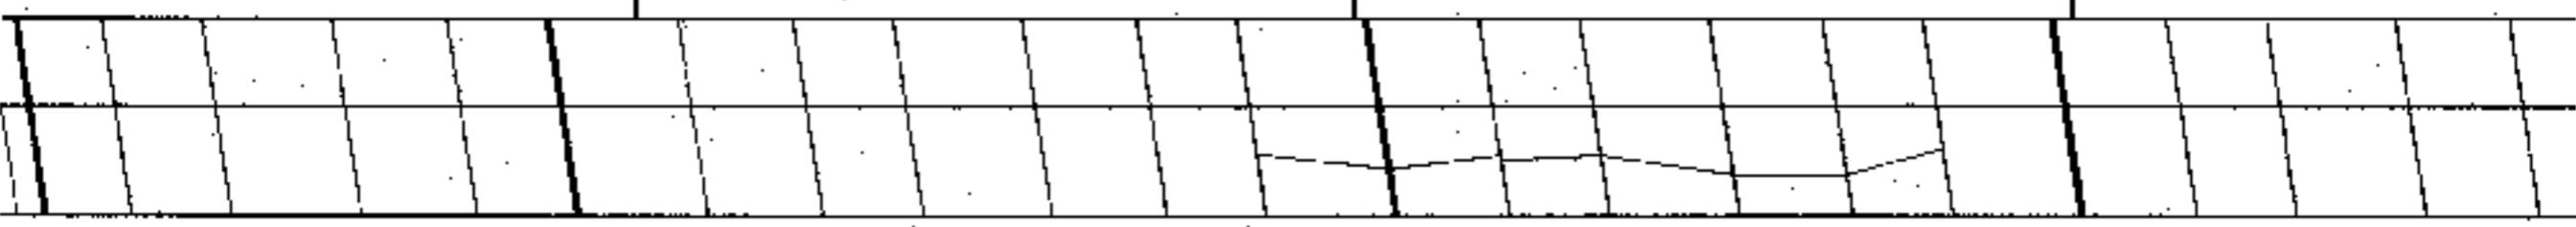
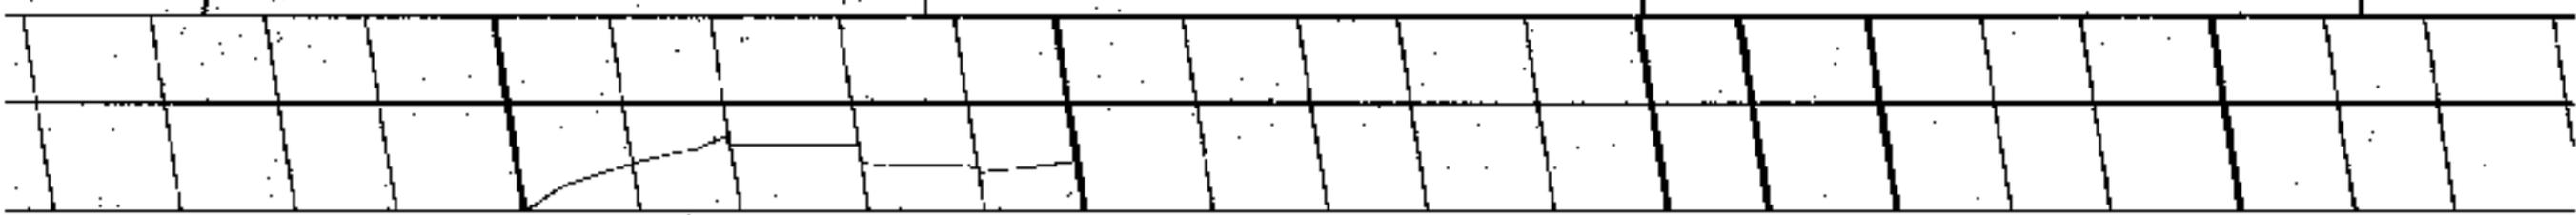
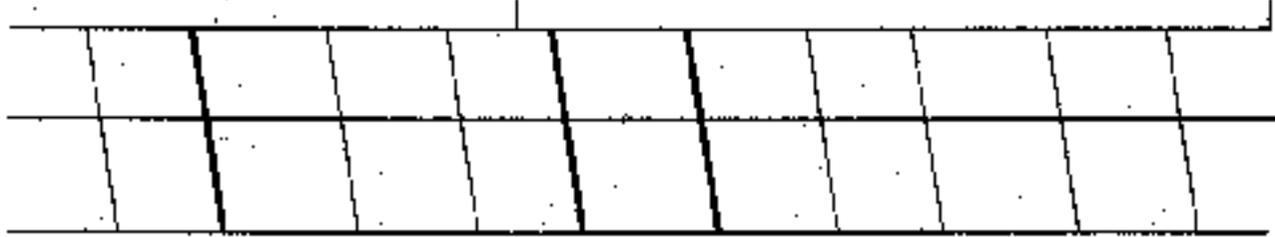
NH-3-002(040)212R - East Bound Lanes
Crack Survey for Paveprep Control

----- ORIGINAL JOINT CRACK

———— REFLECTED CRACK 1998

The original crack survey and 1998 reflected crack surveys were plotted and are found in Appendix C. In 1996, nine joint cracks had reflected in the control section and nine joints had reflected in the PavePrep section. In 1997, two more joints reflected in each section. The control and PavePrep sections each have 11 reflected cracks. The reflected crack count of 11 is the same for 1998. This is attributed to the very mild winter conditions. Most of the joints
