Experimental Study MR 96-03

**Evaluation of the "FiberDowel"
Corrosion Proof Dowel Bar System
as a Load Transfer Device**

Final Report

Project IM-8-029(007)022

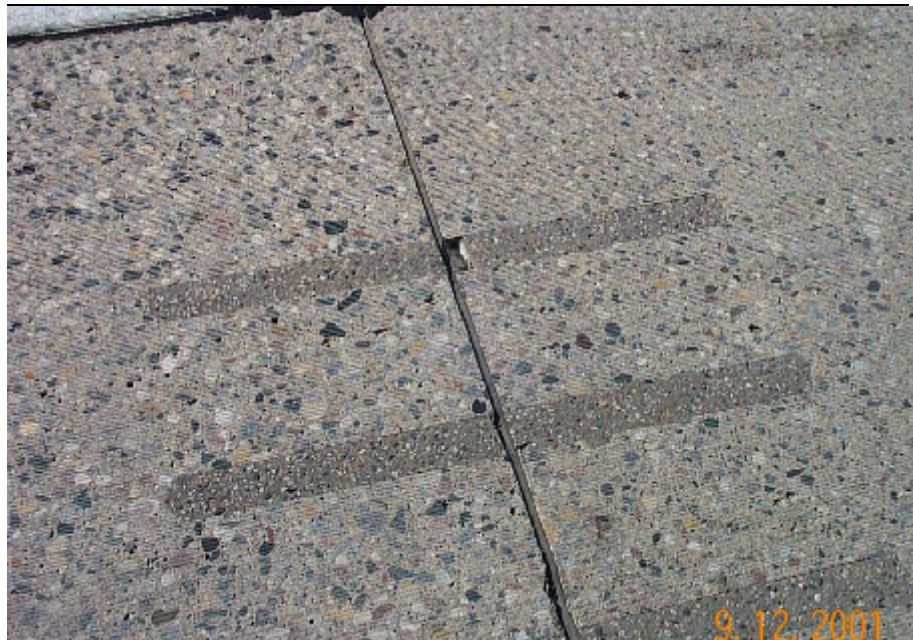
Materials and Research visited the test site on 9/12/01. Photo 1 depicts a view of a typical dowel bar slot where fiber dowels were installed. Notice also in photo 1 the distresses present near the joints. It is believed that the

Photo 1. A view of a typical test joint where "Fiberdowel" bars were installed.

distresses present were caused by a possible core board failure.
