Experimental Study ND 2002-01

**Base Reinforcement Using Geogrid**

**Fifth Evaluation Report**

NH-4-052(044)058

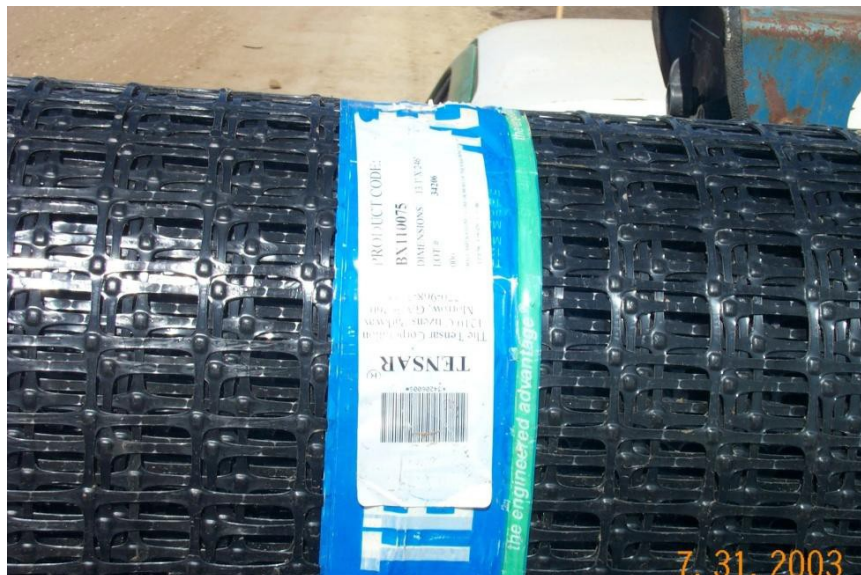
**Photo 3 – A roll of Tensar Geogrid BX 1100.**

The geogrid rolls were 13.1 feet wide. The stiffness of the geogrid helped to keep the material even and tight. The upper base material was placed on top of the geogrid with belly-dump trucks. The geogrid had a tendency to roll or cause a slight wave ahead of the tires if the truck was moving too fast. The geogrid would then become uneven in these areas. Base material was used in these areas to hold it down. This made it easier for the blade to spread the windrow. There were a few places where the uneven geogrid could not be smoothed out enough and was cut to lay flat and then covered with a geogrid patch. Another method was to fold the material under to take up the slack. The geogrid is supplied in rolls and has a tendency to roll back up. The contractor used large headed nails in some cases to hold down the geogrid. Photo 3 shows a roll of Tensar BX-1100 Geogrid.

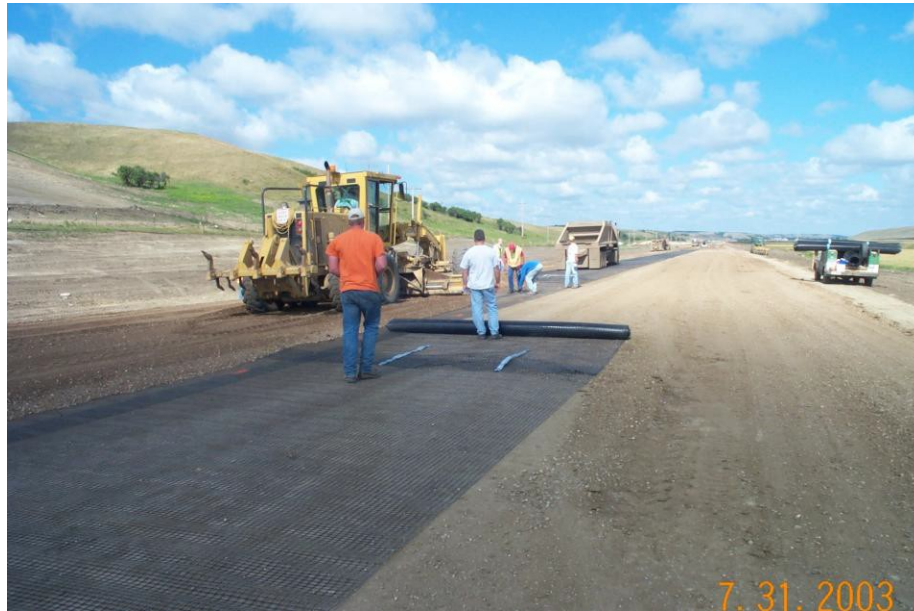
**Photo 4 – Starting new roll of geogrid.**

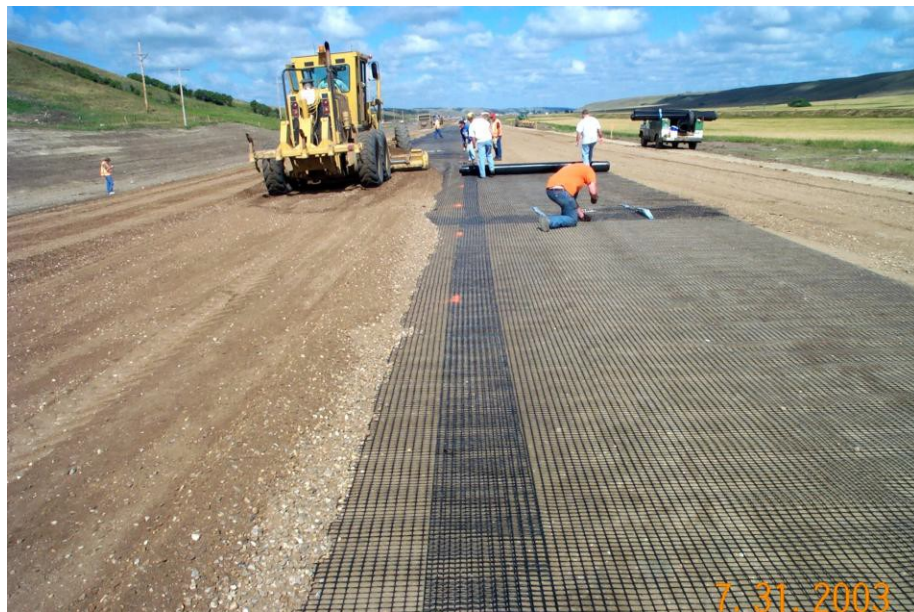
**Photo 5 – Nailing down overlap of new roll, rolling out geogrid, and spreading base material.**

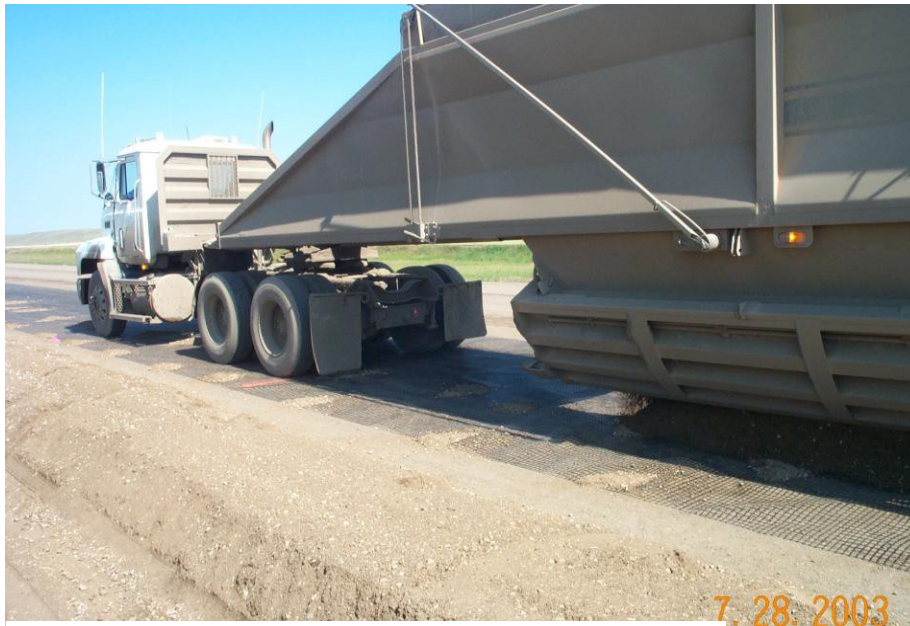
**Photo 8 – Placing the base material on the geogrid.**

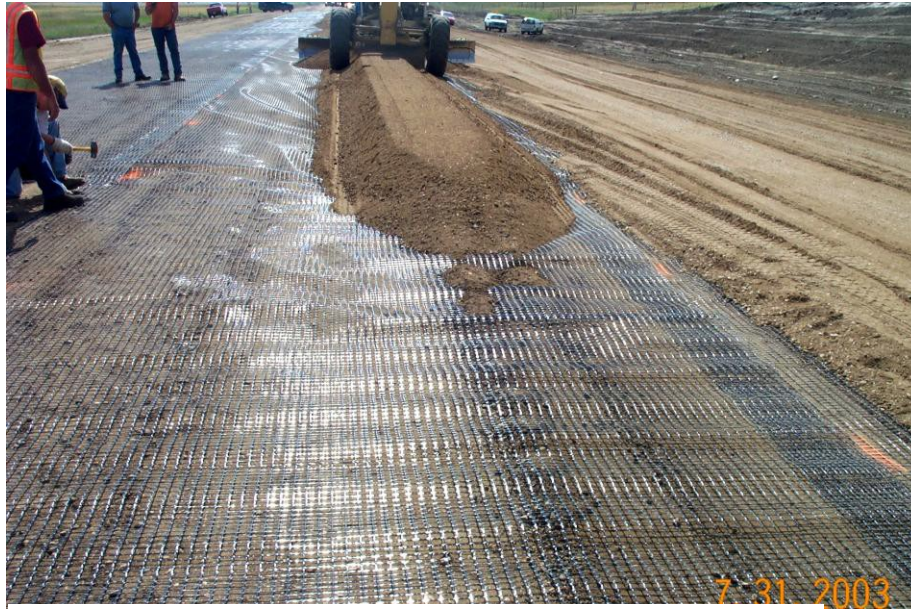
**Photo 10 – Some waves in the geogrid – nailing overlap area.**

The geogrid installation was completed with minimal problems. Patches had to be placed in a few areas due to geogrid tears. Waves in the geogrid occurred if aggregate dumping or spreading of the aggregate was placed too fast. Overall the geogrid installation went very well.

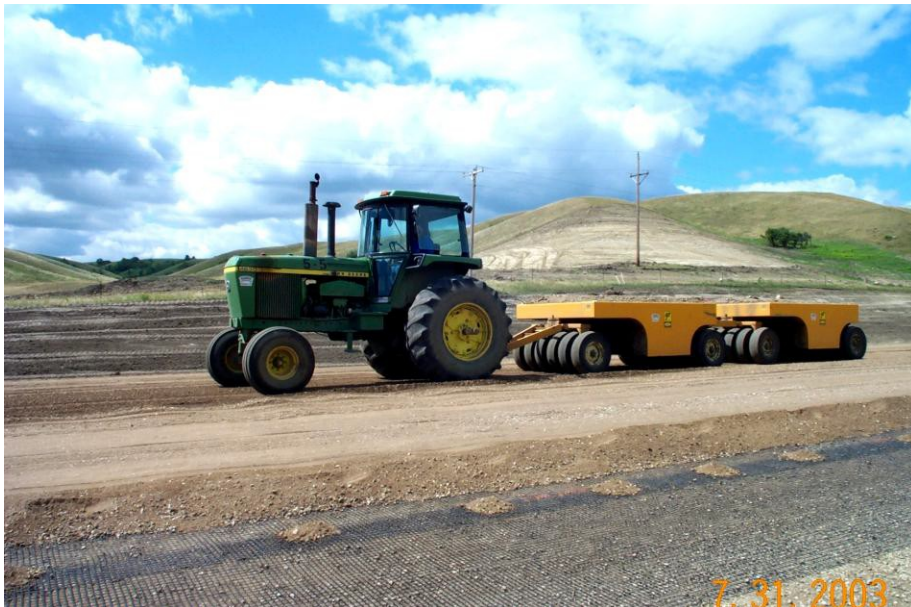
**Photo 11 - Compacting the base material on top of the geogrid.**

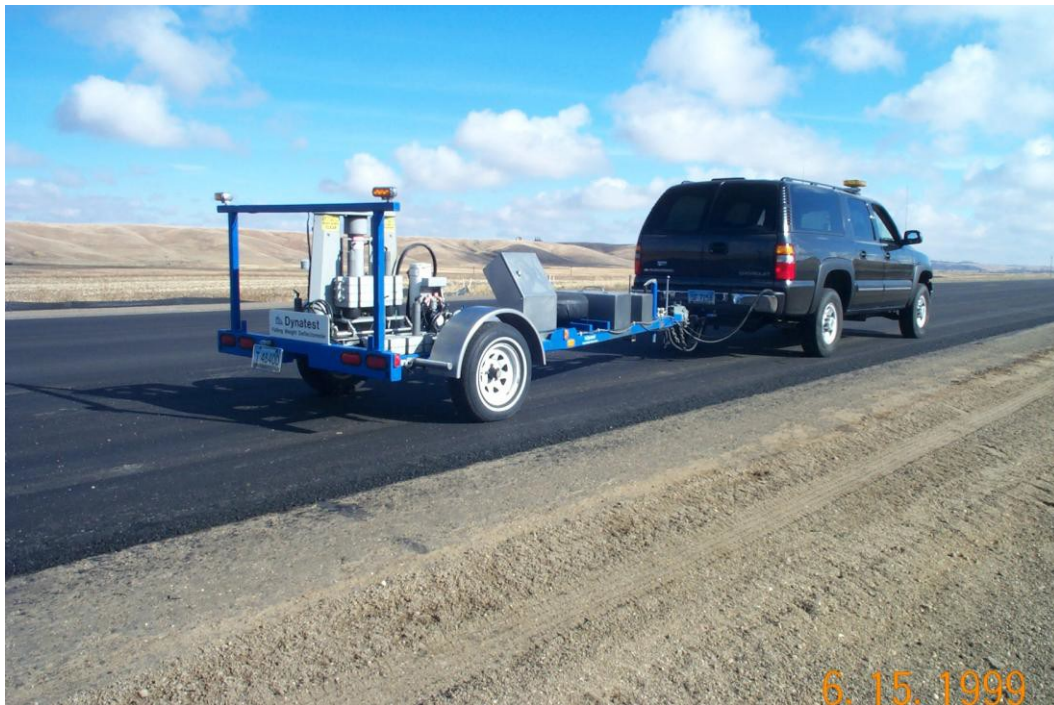
The Falling Weight Deflectometer (FWD) is a tool that is used to help evaluate the strength of roadway sections. It drops a pre-selected load onto the pavement surface. The resulting deflection of the roadway system is measured and stored. The modulus of each layer is calculated from the data using the Elmod 5 program. The FWD is shown in photo 12:

**Photo 12 – The FWD operation.**

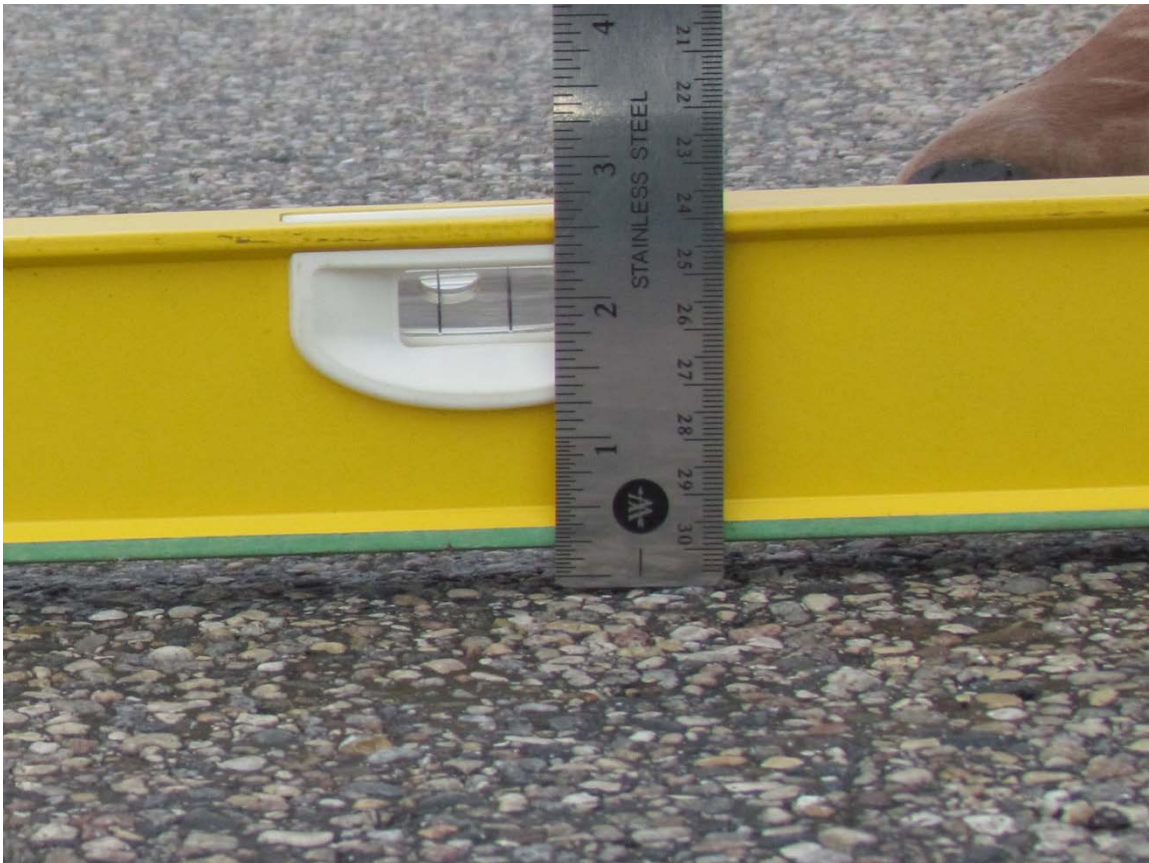
There were one 6' longitudinal crack in the outside wheel path, one transverse shoulder crack, and four transverse cracks approximately 2ft apart found in Section 3 which was a change from the fourth evaluation. Rutting was found from the visual inspection in Section 3. The rutting found was between 1/8" and 1/2", which was similar from the fourth evaluation. The rutting is shown in the photo below:

**Photo 6, Rutting in Section 3**
