Experimental Study ND 2003-02

**Concrete Bridge Deck Sealants**

**Construction and 1<sup>st</sup> Evaluation Report**

Project AC-IM-2-094(070)275

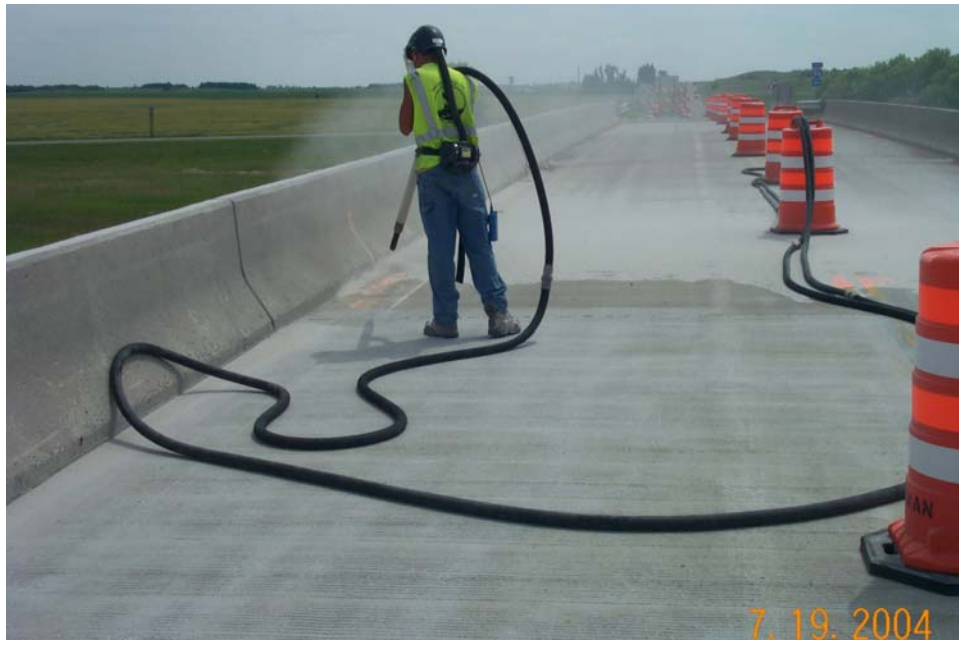
**Photo 1 - Sandblasting the bridge deck.**

Prior to application of the sealers, the bridge decks need to be prepped. The deck prep varies depending on the sealer used. Two bridge decks (1/2 of each deck) were prepped at a time. Radcon Formula #7 requires the deck to be free of dirt or aggregate; however, the contractor sandblasted the deck prior to applying this sealer. Tamms Dural 335 requires the deck to be sandblasted. Degusa Degadeck Crack Sealer requires the deck to be shot blasted. The photos below illustrate the deck prepping for these sealers.

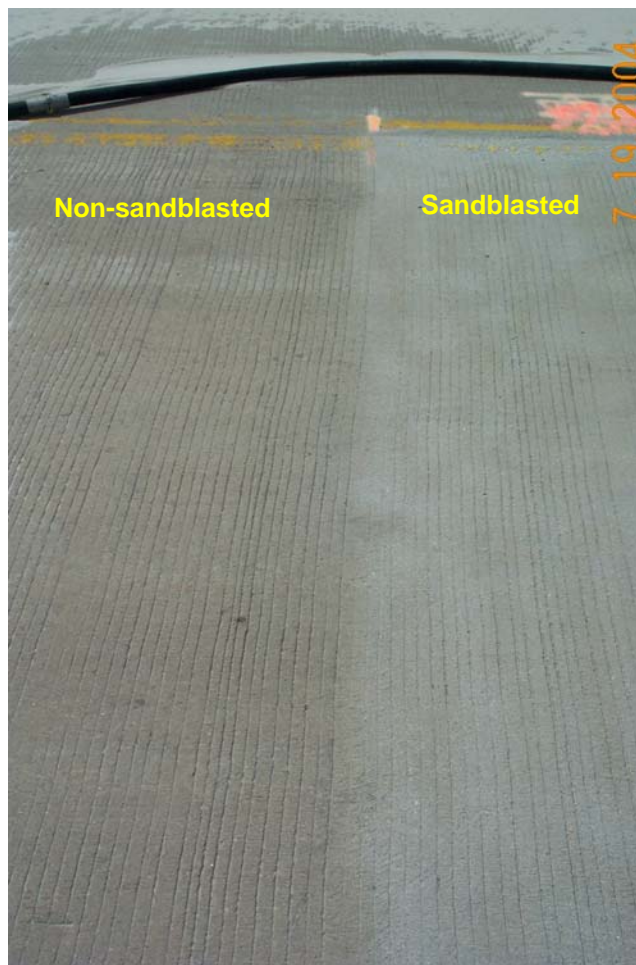
**Photo 2 - Difference between sandblasted and non-sandblasted portion of the deck.**

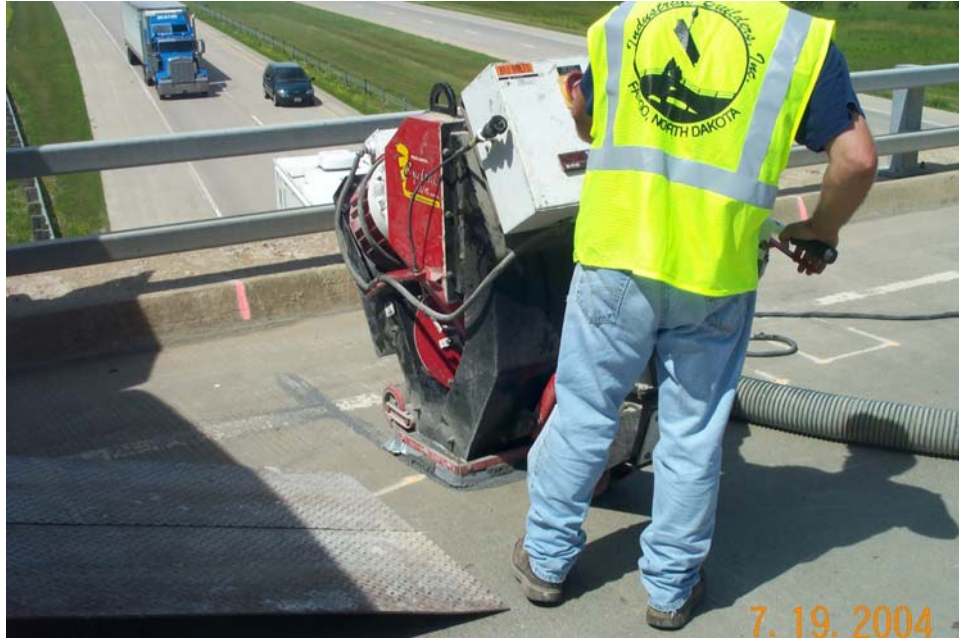
Photo 3 - Shotblasting the bridge deck.

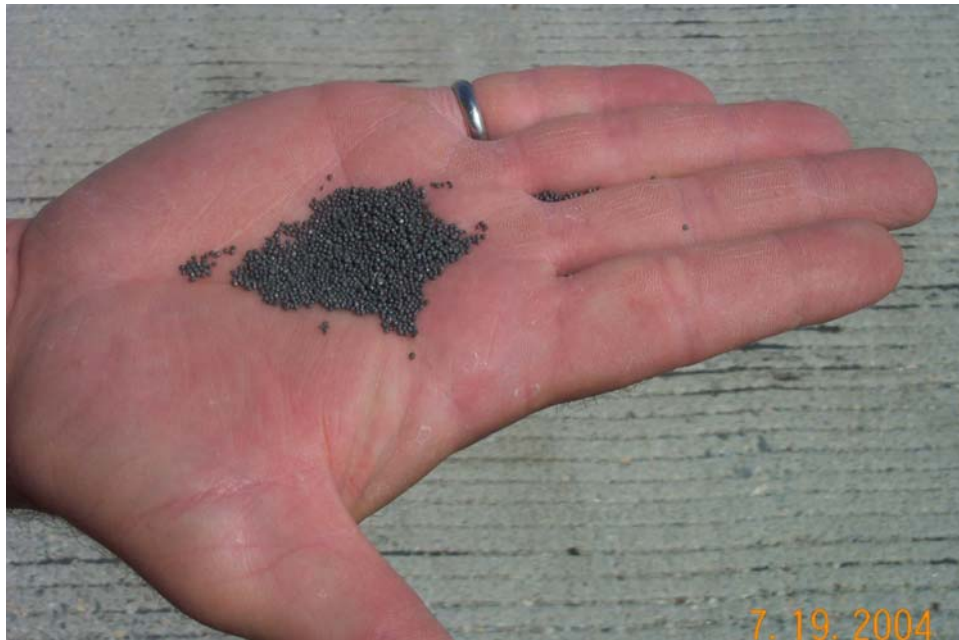
Photo 4 - Size of shot used in shotblasting.

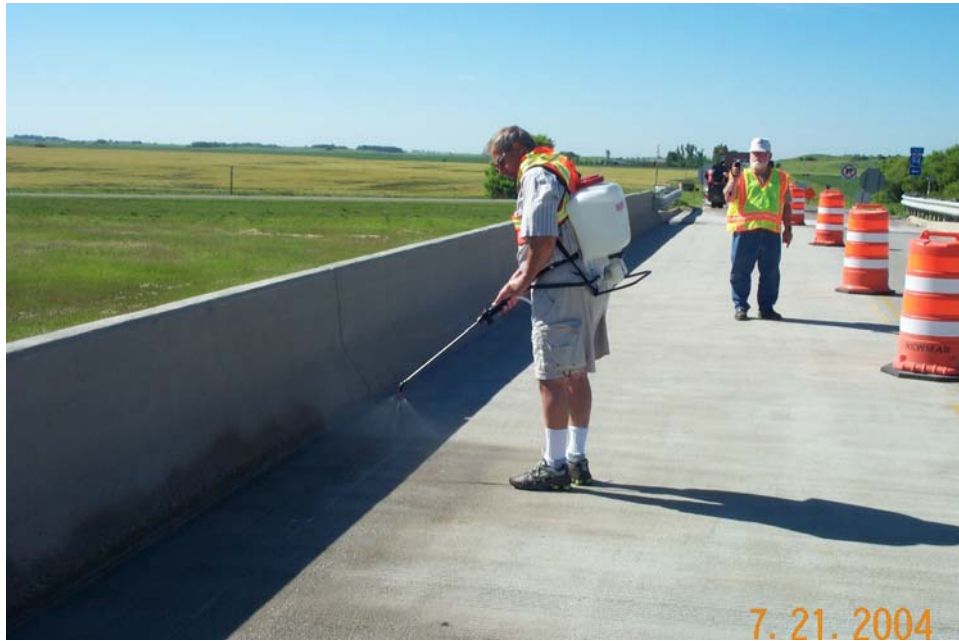
**Photo 6 - Backpack sprayer and application of Radcon Formula #7.**

Radcon Formula #7 came premixed and ready to use. This sealer was applied using a pressure backpack type sprayer. The application of this sealer was easy and no noticeable odor was observed. The sealer was applied until the surface was visibly wet for complete coverage. Cracks in the bridge deck were flooded with the sealer to ensure crack penetration. Radcon was applied at an average rate of 310 ft<sup>2</sup> per gallon. The manufacturer recommends an application rate of 150-170 ft<sup>2</sup> per gallon.

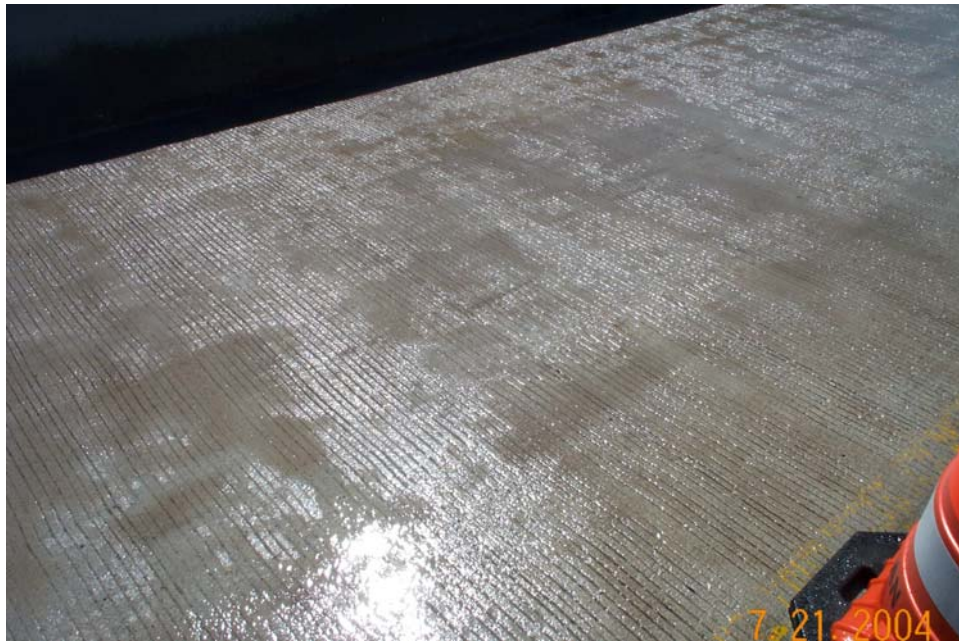
**Photo 7 - Radcon Formula #7 applied to the bridge deck.**

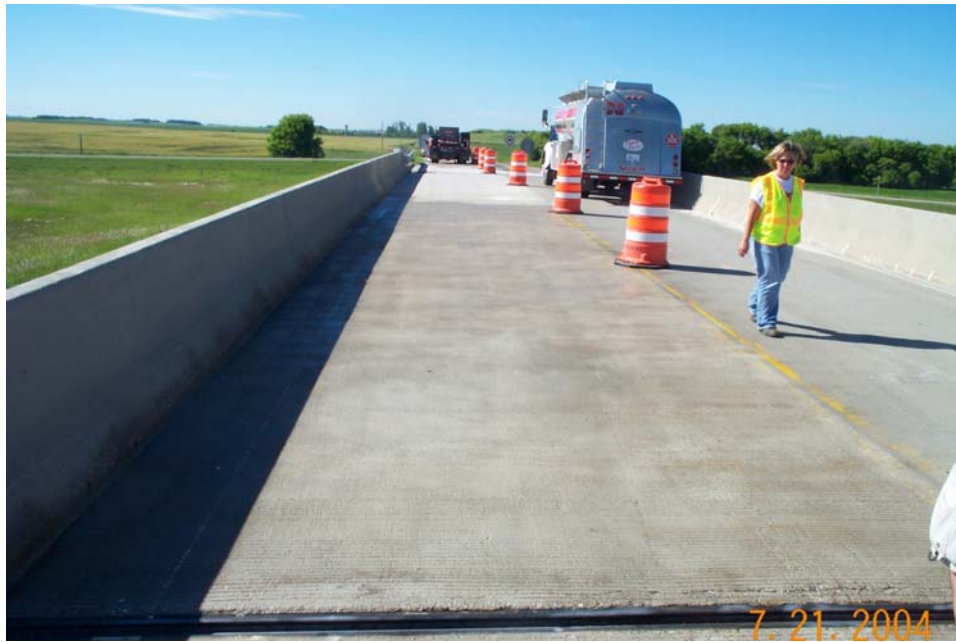
**Photo 8 - Overview of Radcon Formula #7 section of the deck after application.**

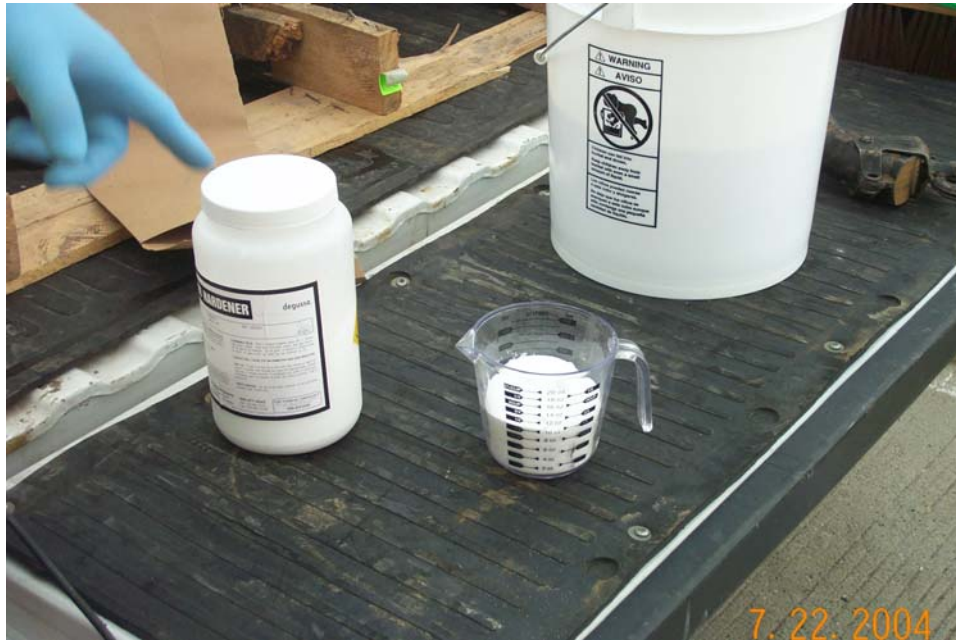
**Photo 9 - Hardener that is added to the resin of Degusa Degadeck Crack Sealer.**

Degusa Degadeck Crack Sealer is a two part methacrylate reactive resin that needs to be mixed on the jobsite. The resin needs to be mixed with a hardener at the jobsite. Once the hardener was added the resin and mixed, the sealer was then applied using brooms. Brooms were used so excess sealer could be removed from the tining in the concrete and not waste sealer. The application of this sealer was easy; however there was a very harsh odor that was observed. During the application of this sealer, one of the contractor's labor force noticed that the soles of their shoes (tennis) were dissolving. The sealer was applied until the surface was completely covered. Before the sealer started to harden, sand was applied to help maintain skid resistance. Cracks in the bridge deck were flooded with the sealer to ensure crack penetration.

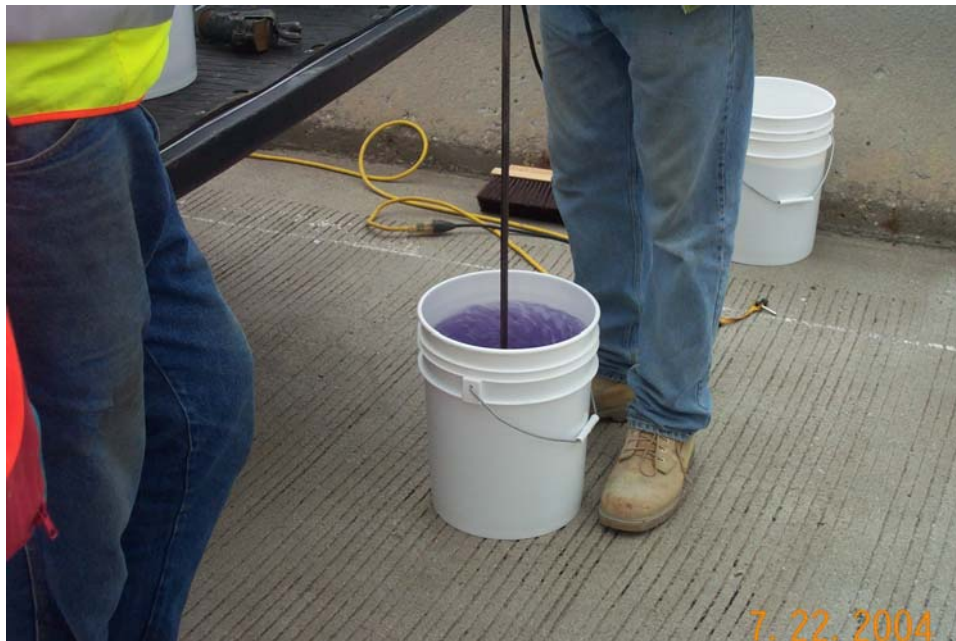
**Photo 10 - Mixing the resin and hardener of the Degusa Degadeck Crack Sealer.**

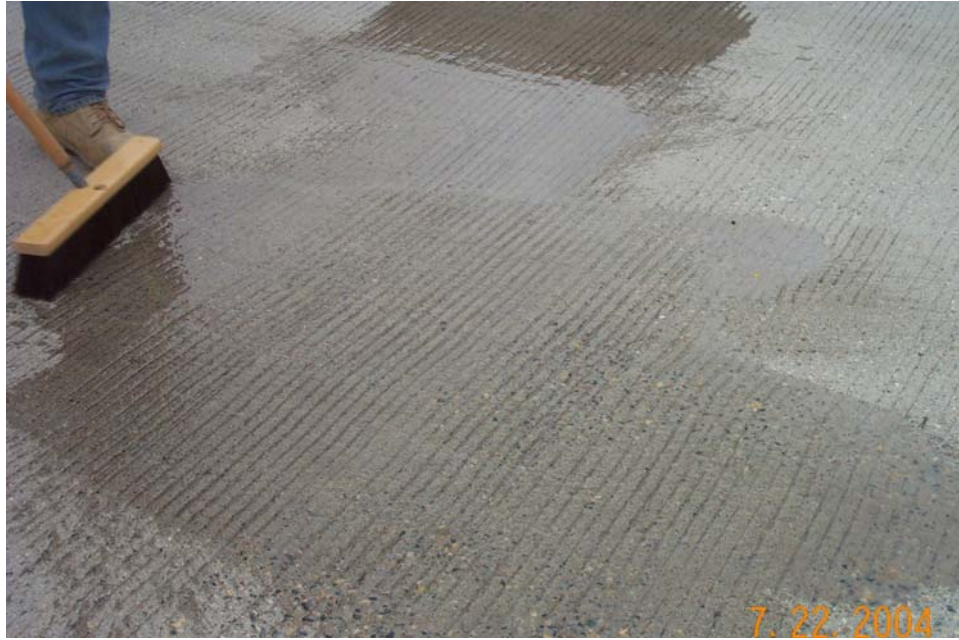
**Photo 11 - Applying Degusa Degadeck Crack Sealer with a broom.**

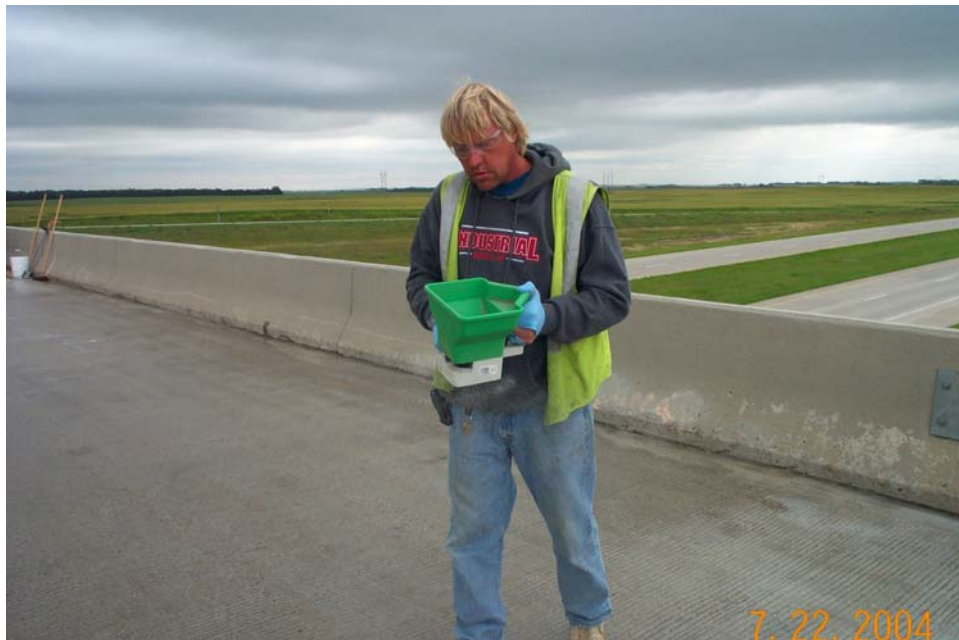
**Photo 12 - Broadcasting sand to help maintain skid resistance to the Degusa Degadeck Crack Sealer section.**

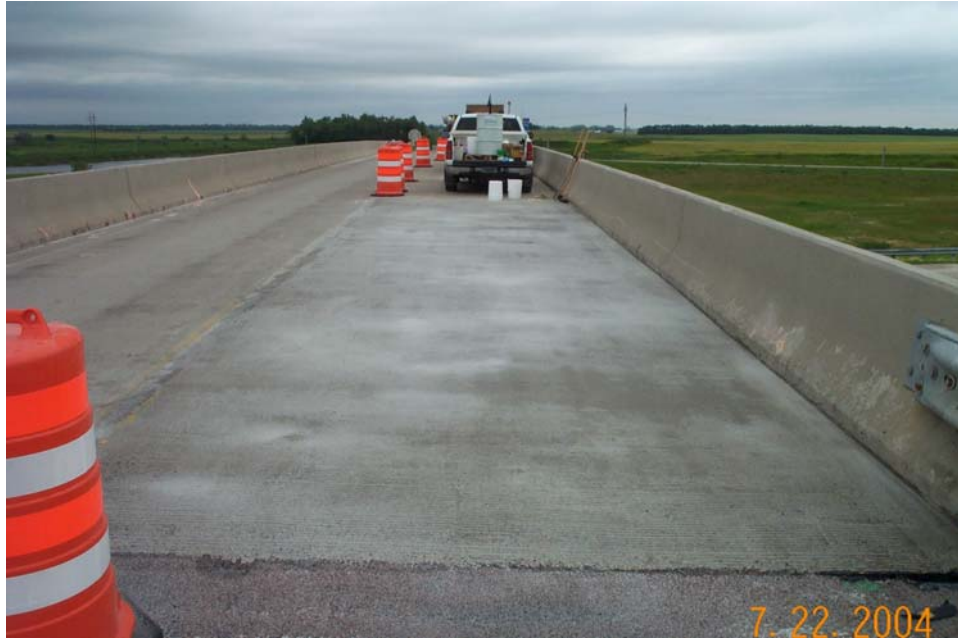
**Photo 13 - Overview of a Degusa Degadeck Crack Sealer section after sand was applied.**

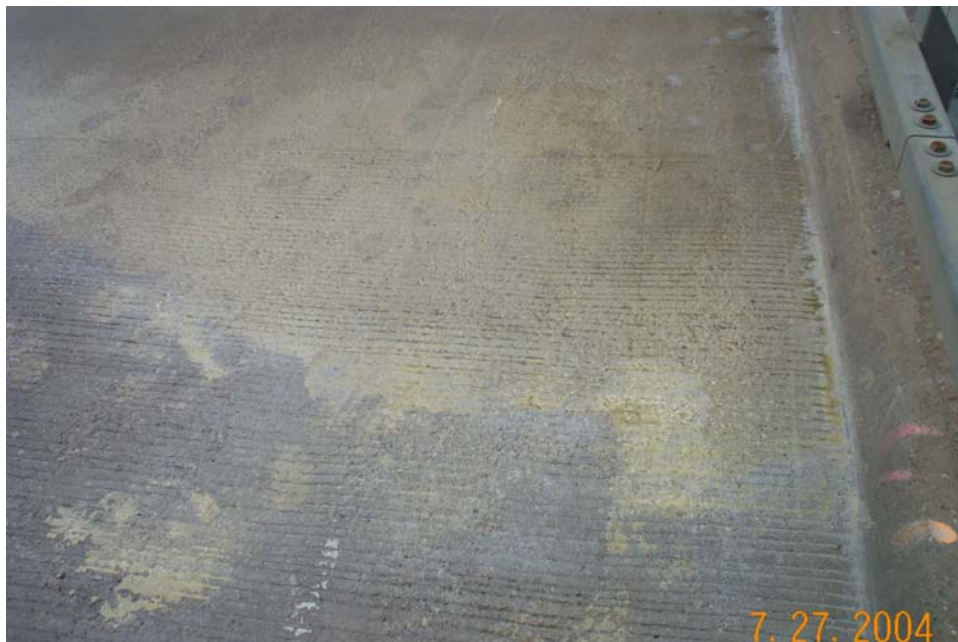
**Photo 14 - Chemical reaction between the Radcon Formula #7 and Degusa Degadeck Crack Sealer. Radcon was applied first and did not allow the Degusa Degadeck Crack Sealer to penetrate the concrete for adherence.**

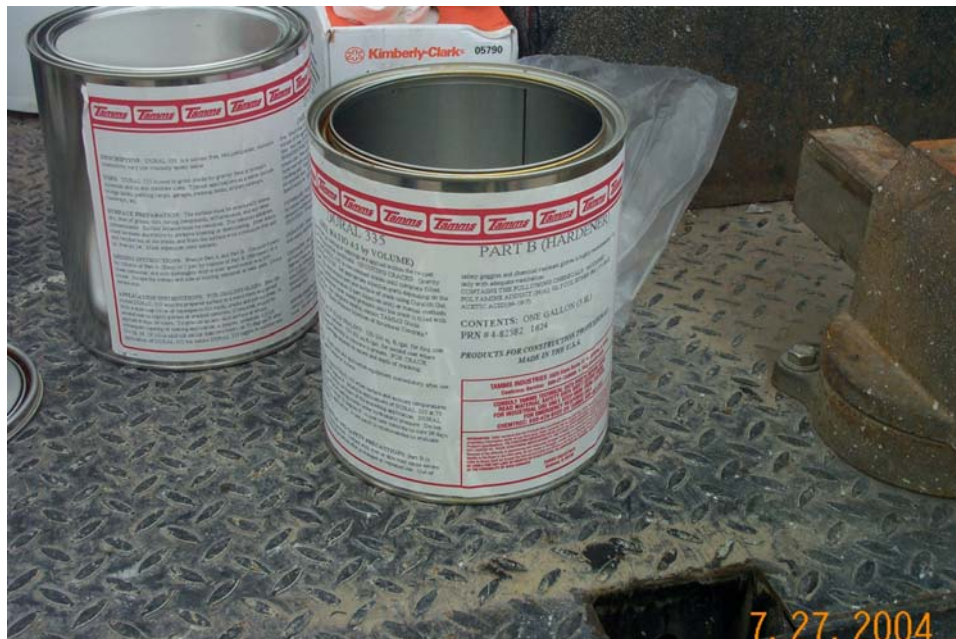
Photo 15 - Hardener that is added to the Tamms Dural 335 resin.

Tamms Dural 335 is a two part epoxy resin that needs to be mixed on the jobsite. Once the two components were mixed, the sealer was then applied using squeegees. Squeegees were used to allow the sealer to fill up the cracks. Some cracks in the bridge deck were flooded with the sealer to ensure crack penetration. The application of this sealer was easy with no odor observed. The sealer was applied until the surface was completely covered. Before the sealer started to harden, sand was applied to help maintain skid resistance.

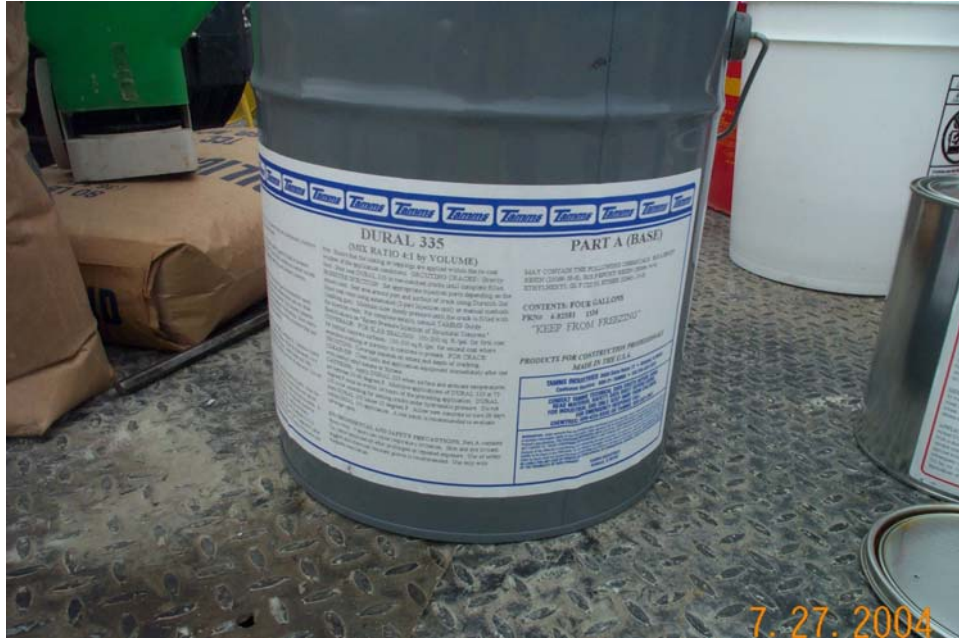
Photo 16 - Resin or base component of the Tamms Dural 335 sealer.

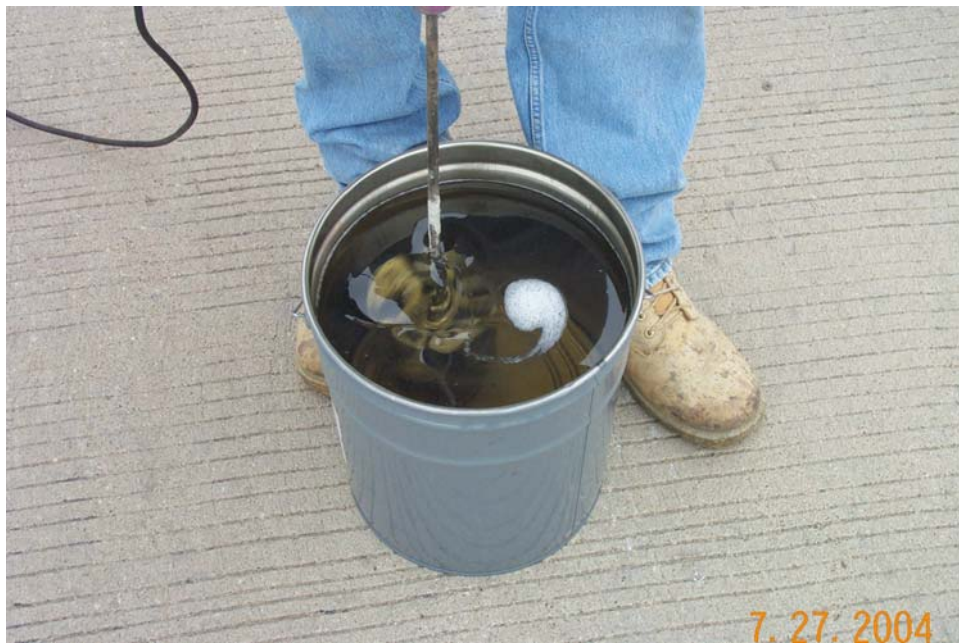
Photo 17 - Mixing the resin and hardener of the Tamms Durall 335 Sealer.

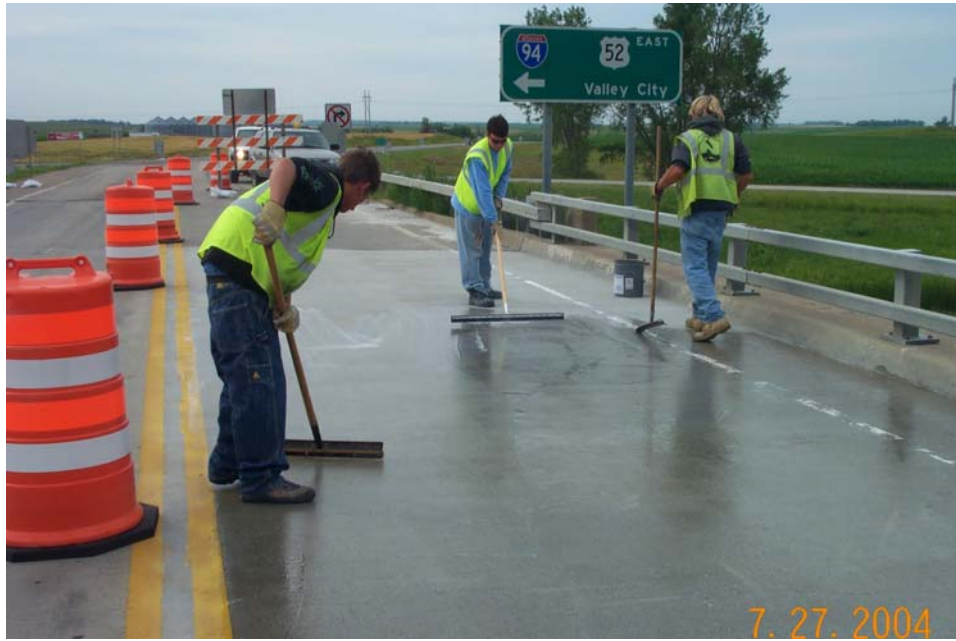
**Photo 18 - Applying Tamms Dural 335 Sealer with a squeegee.**

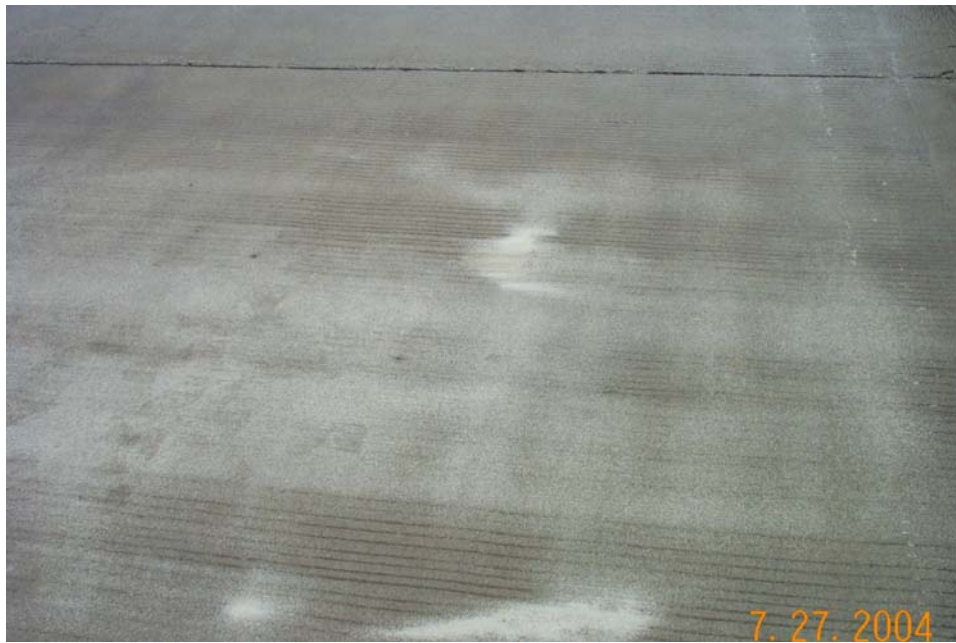
**Photo 19 - Applied sand to the Tamms Dural 335 sealer.**

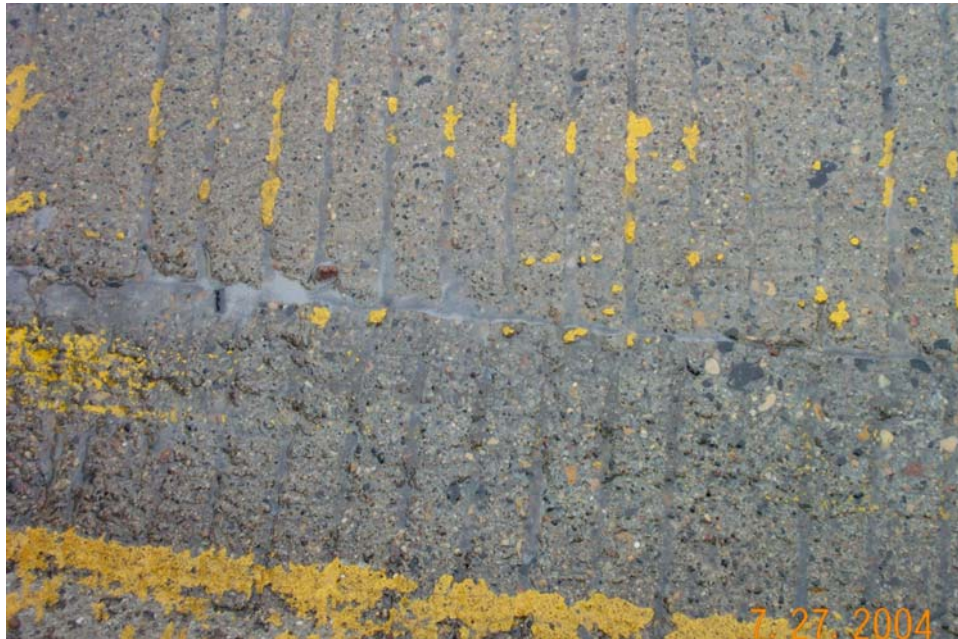
Photo 20 - Crack sealed with Tamms Dural 335.

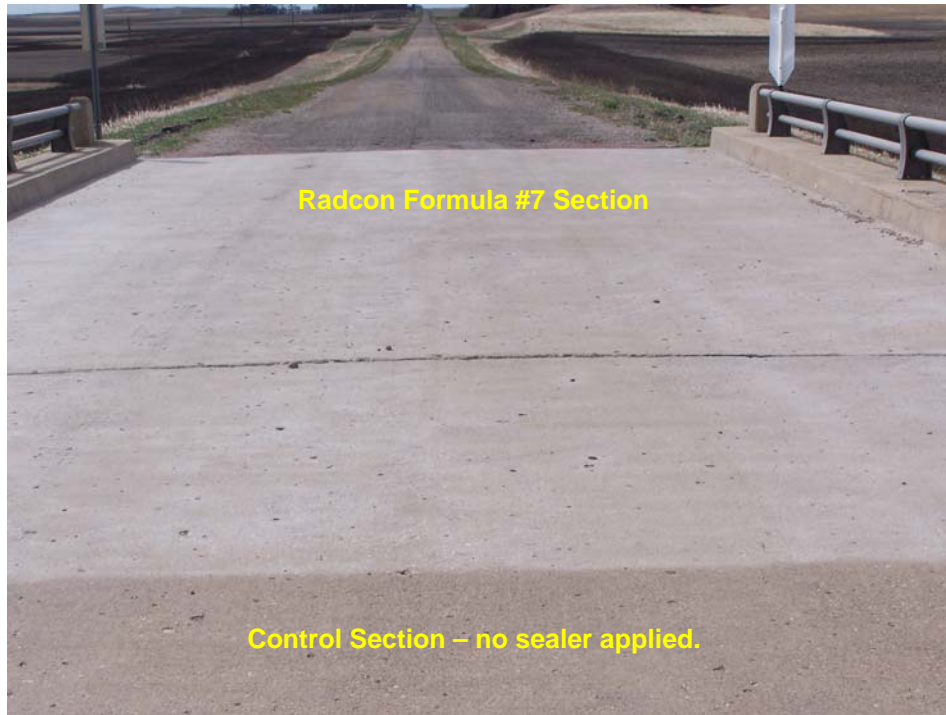
**Photo 21 - Overview of a Radcon Formula #7 section.**

Cracks that are located within the Radcon sections appear as they did prior to application of the sealer. This is not an indication that the cracks did not get sealed. Radcon is intended to penetrate the concrete and form a “gel” to seal up pores and cracks. Whether or not Radcon has sealed the cracks is unknown at this time but will be determined based on future chloride analysis of the concrete near the cracks. Photos 21 and 22 show conditions taken after one winter.

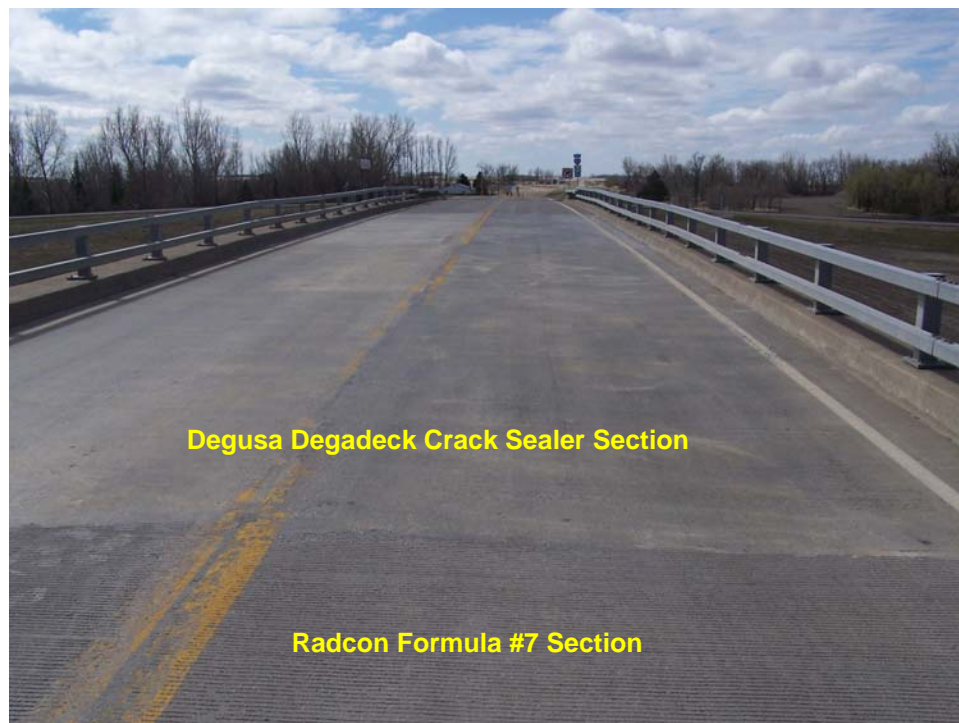
The bridge decks appearance in the location where Degusa Degadeck Crack Sealer was applied appears as a yellowish tint or film on the concrete. The thickness or the amount of material applied is very evident and the thicker the applied material, the more yellow the concrete.

**Photo 23 - Overview of a Degusa Degadeck Crack Sealer section.**

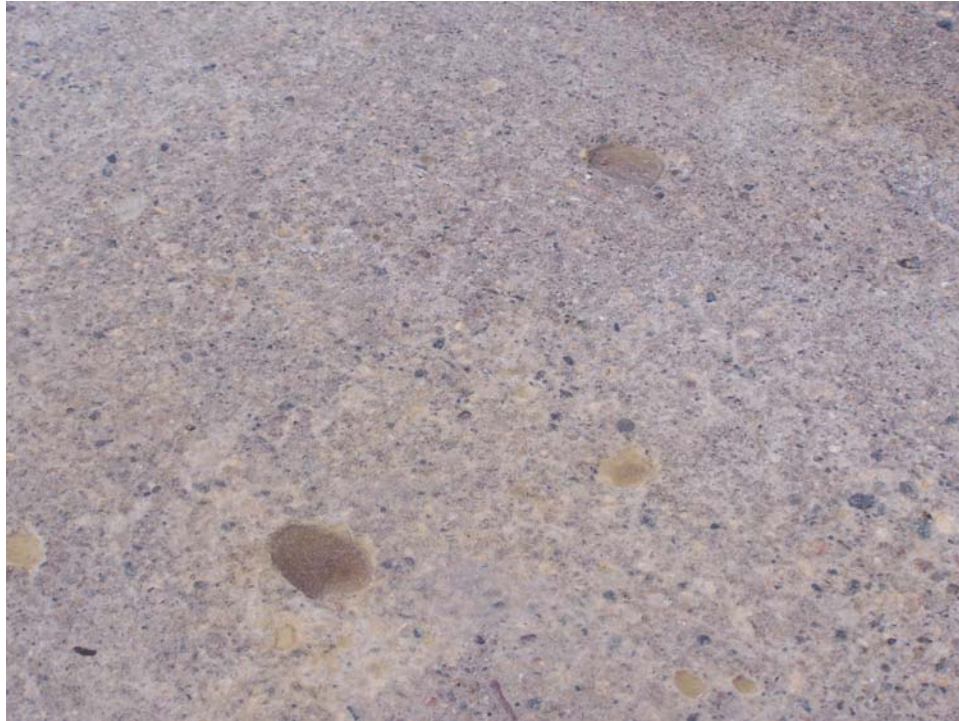
**Photo 24 - Popouts filled with Degusa sealer.**

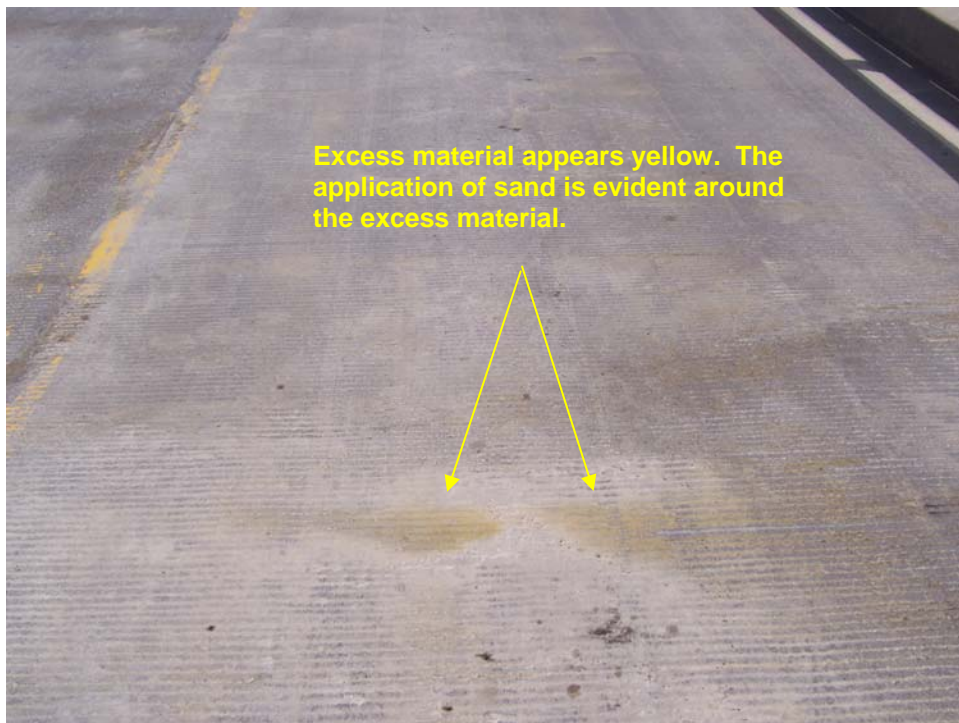
**Photo 25 - Excess material applied in a Degusa section. Applied sand is visibly noticeable as well.**

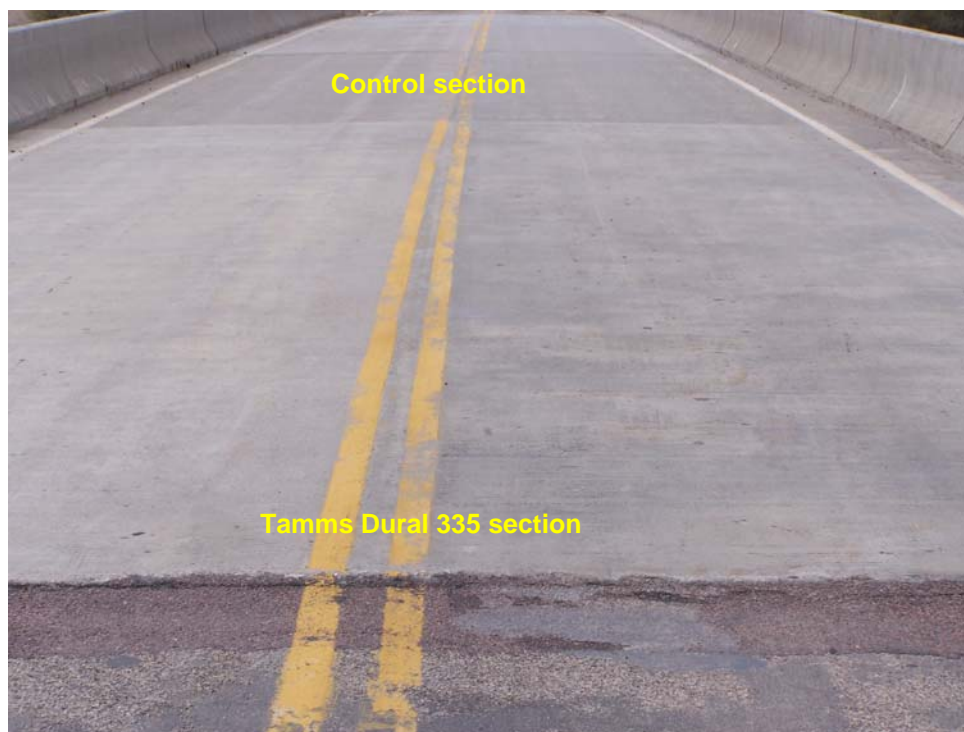
**Photo 26 - Overview of a Tamms Dural 335 section.**

The application of this product was conducted using a squeegee. Using a squeegee to apply this product on a tined surface leaves too much material in the tining. If this product is to be used in the future, a broom should be used to reduce the amount of material needed. A broom will still allow enough material to fill the larger cracks.

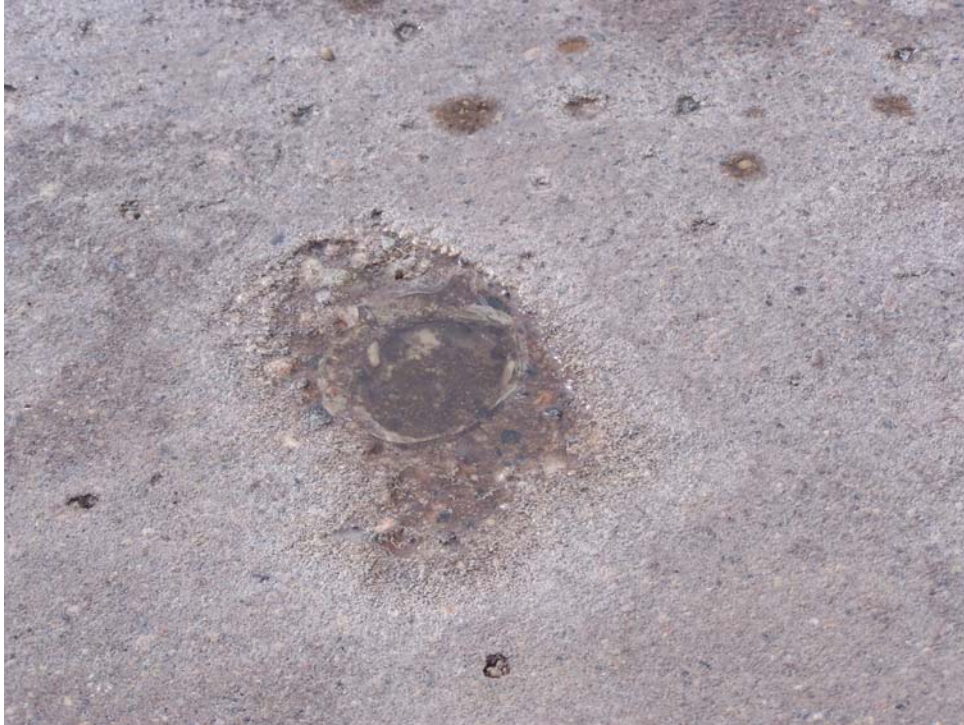
**Photo 27 - Material in popout. Note the Tamms material is clearer than the Degusa product.**

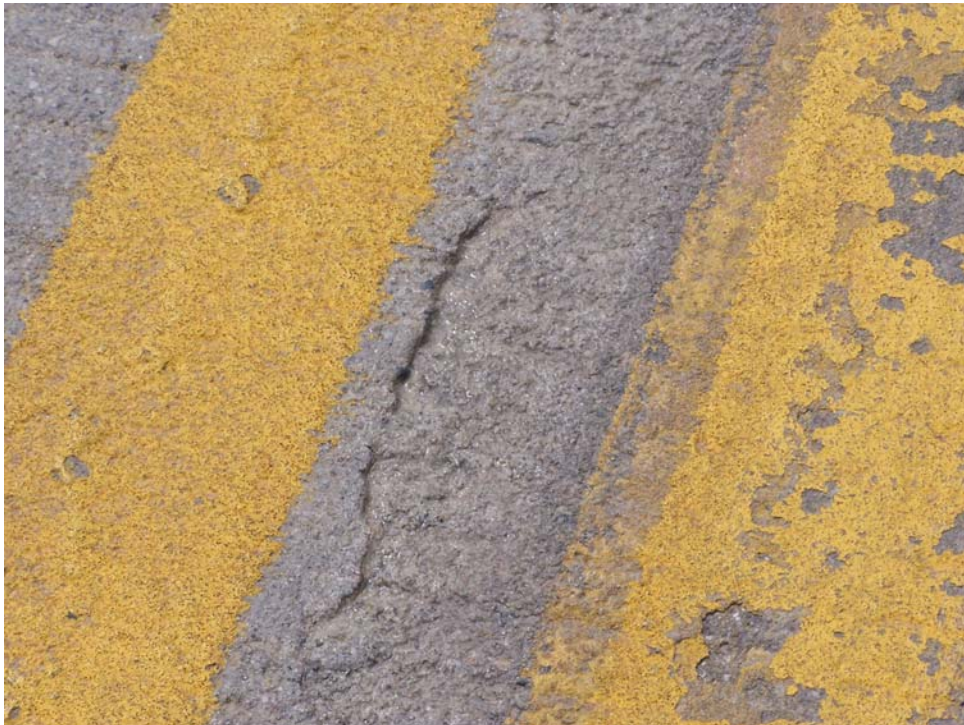
**Photo 28 - Crack filled with Tamms Dural 335.**

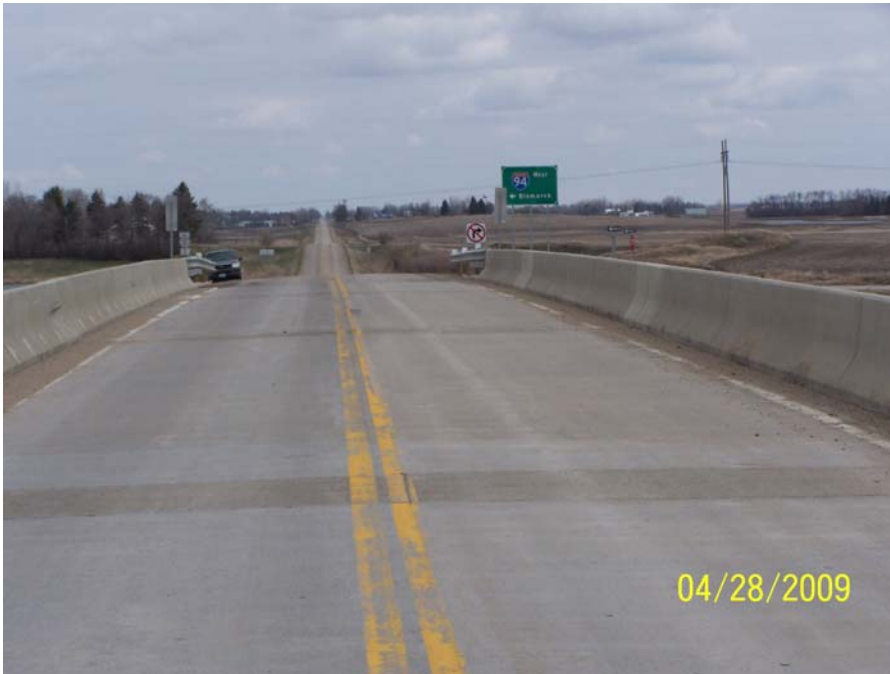
Photo 29: Eckelson Interchange

Moisture was visible near the cracks on the control section only. Most cracks on the sealed sections looked sealed.

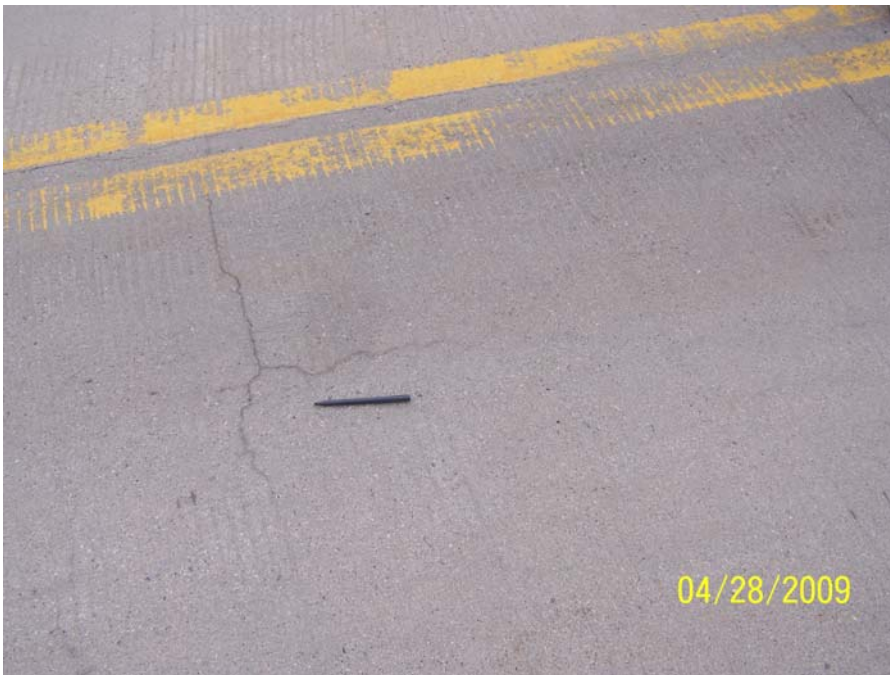
Photo 30: Eckelson Interchange moisture visible near cracks only in control section

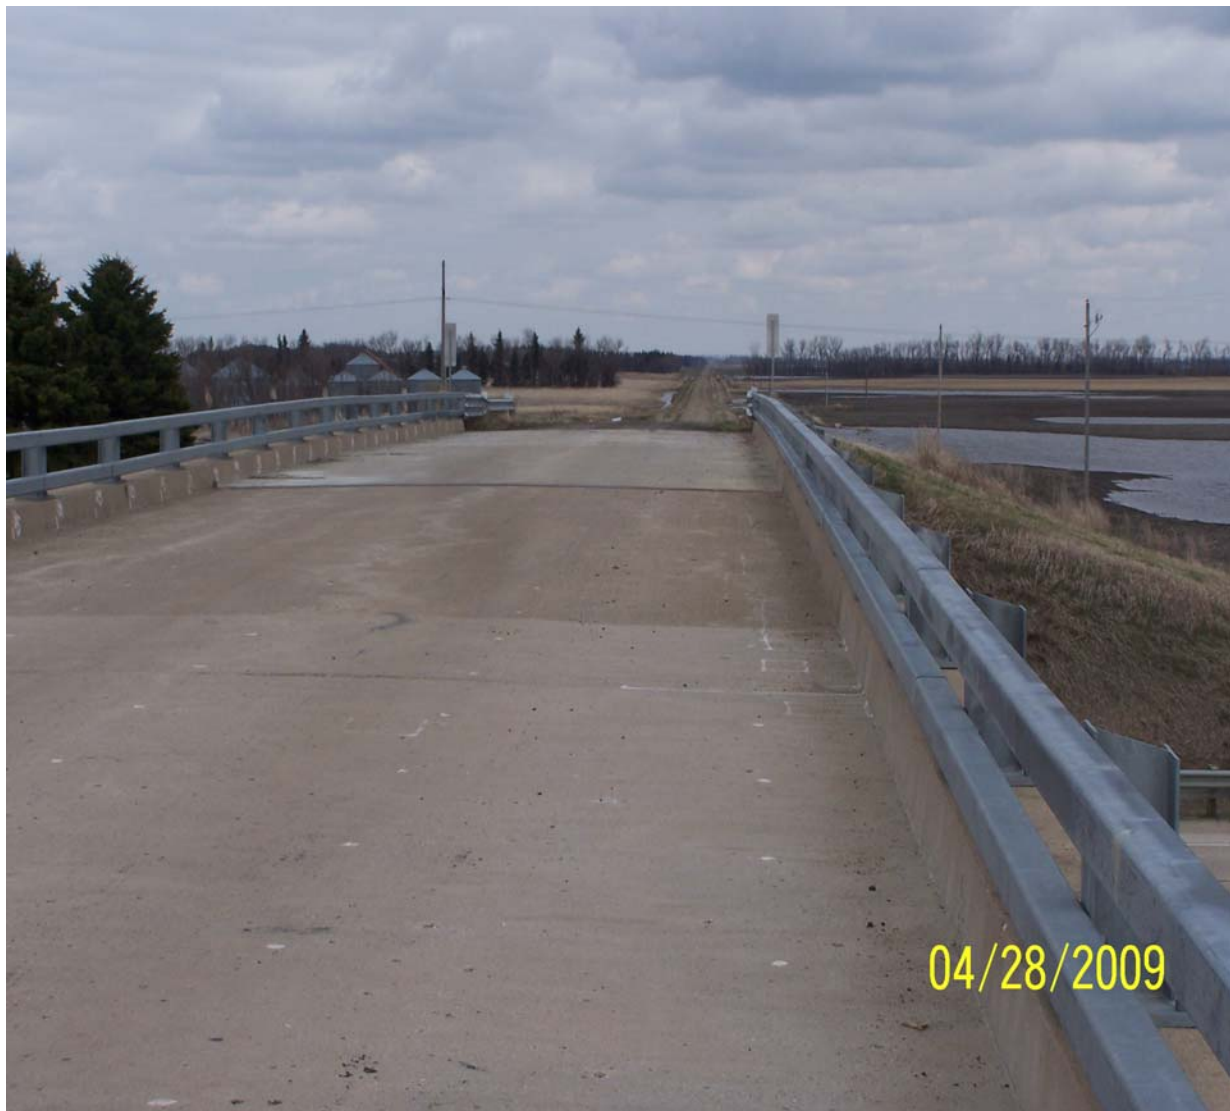
Photo 31: West Sanborn Separation Bridge

The West Sanborn Separation Bridge had some asphalt streaking on the Degadeck and Radcon sealers where asphalt patching took place on the ends of this bridge deck. This bridge deck also had popouts/spalls on the surface of the concrete which do not appear to be sealed. There was standing water on the TAMMS sealer portion.

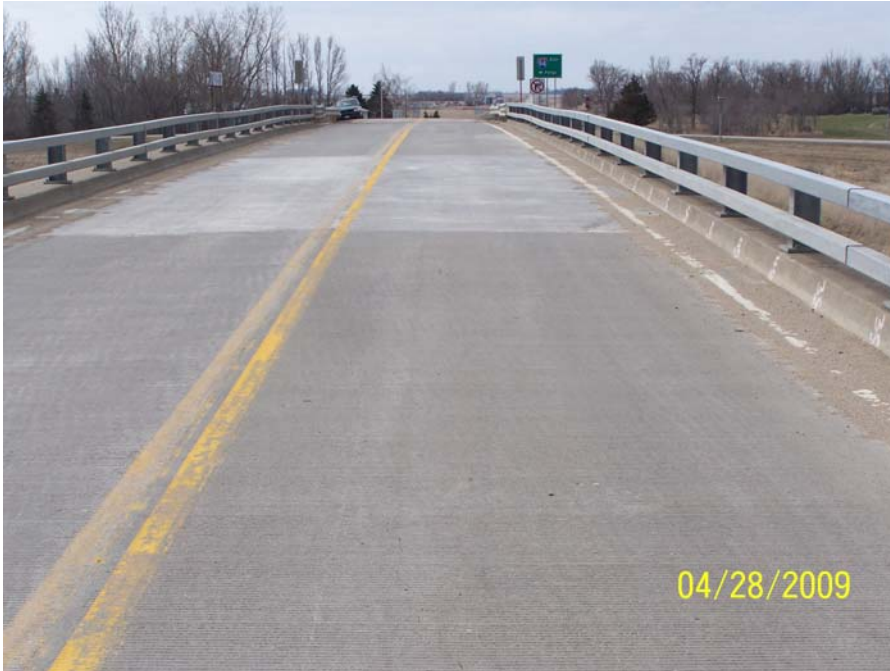
**Photo 32: Sanborn Interchange**

Moisture was visible around all cracks and did not appear to be sealed.

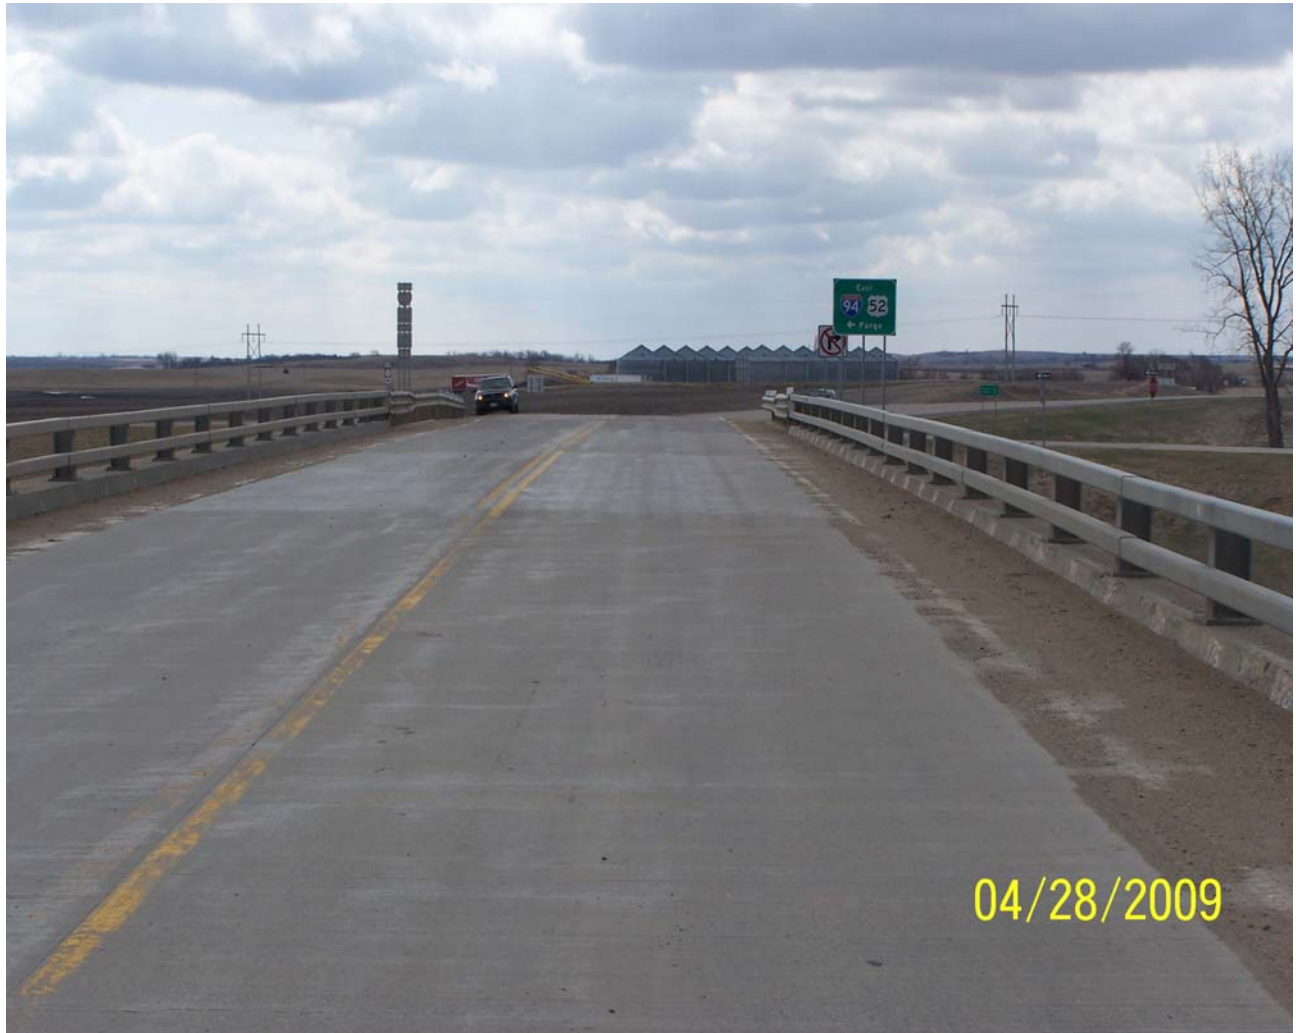
The bridge deck at the Oakes Interchange exhibited wear on the surface due to snowplows. Photo 33 shows the lighter areas in the concrete where the snowplow has taken the sealer off. Moisture was apparent near all large cracks.

**Photo 33: Photo of the Oakes interchange facing south**

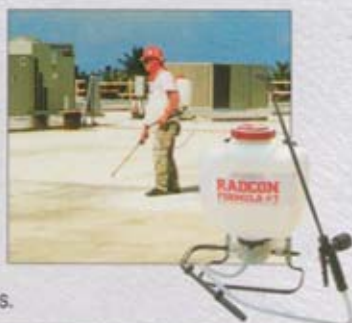
### BACK PACK SPRAY UNIT

Utilising a Solo® - 30psi pressurised knapsack spray, one can expect a coverage of 100 to 150 square metres per hour. This makes the unit ideal for small podium decks and balconies.
