Experimental Study ND 2003-02

**Concrete Bridge Deck Sealants**

**Construction and 1<sup>st</sup> Evaluation Report**

Project AC-IM-2-094(070)275

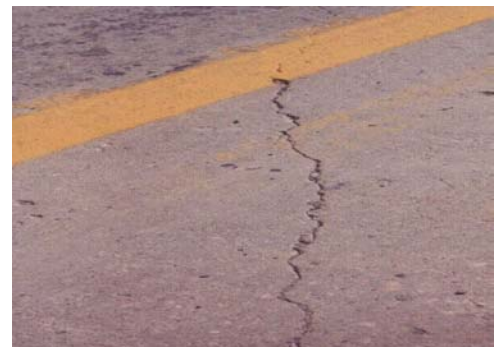
##### Step 1 – Evaluate

Inspect the concrete substrate before preparation. Note the location of surface cracks and the presence of dust, dirt, oil, laitance, curing compounds and other contaminants. Inspect the underside of the deck for signs of leakage due to full depth cracks. Check weather forecast to ensure dry conditions. Wet substrates must be allowed to dry prior to beginning work.

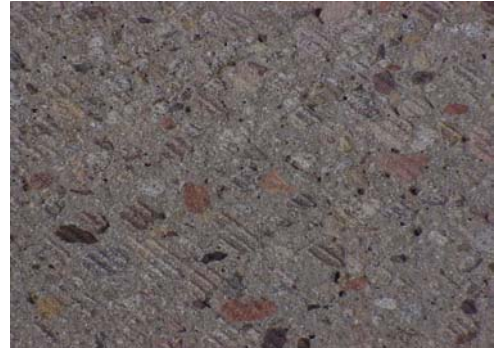
**Step 2 – Prepare the Substrate**

Using a dust-free, mobile shotblaster, brush-blast the substrate to expose surface cracking. Do not use wet preparation methods.

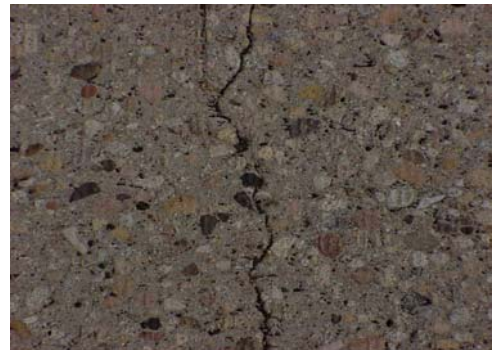
**Step 3 – Evaluate the Prepared Substrate**

Perform a second inspection, noting newly-found surface cracks. Mark these for pre-treatment. Clean out cracks and the deck surface with oil-free compressed air.

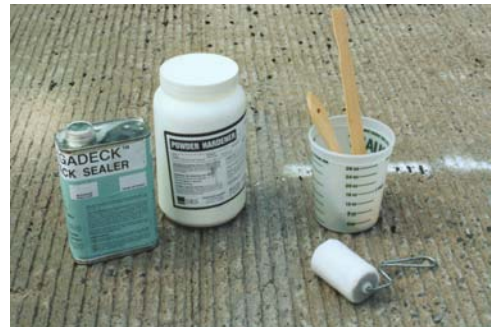
**Step 4 – Mix the Components**

Using clean, dry plastic buckets and scoops, add Powder Hardener to Crack Sealer and mix until dissolved (approximately 1 minute). A drill-mounted paddle mixer should be used for larger batches. Mixed DEGADECK Crack Sealer must be used immediately. Do not exceed 5-gallon (20 l) batch mixes.

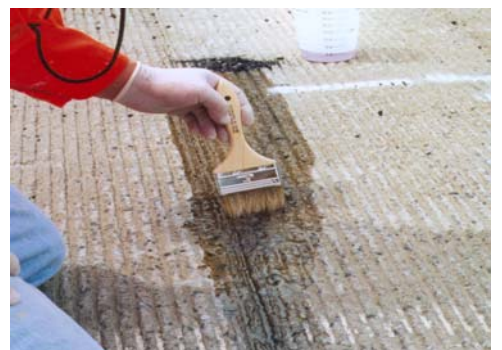
**Step 5 – Pre-treat Wide Cracks**

Cracks up to 1/8" (3 mm) should be treated individually prior to deck application. Full depth cracks may require alternative treatment to prevent runoff of resin. Fill wider cracks with dry, 30 mesh silica sand. Mix a small amount of Crack Sealer, pour into cracks and distribute with a paint brush. Squeeze bottles can also be used.

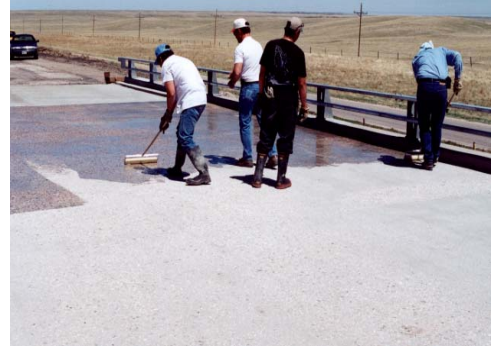
**Step 6 – Apply to Deck**

Immediately pour batches of mixed Crack Sealer onto the substrate. Do not allow the mixed batch to remain in the mixing vessel. Distribute with ½" to ¾" (13 - 20 mm) nap solvent grade paint rollers, working the material into cracks. Do not allow material to pond. Application rate is 100 ft<sup>2</sup>/gal (2.5 m<sup>2</sup>/l). Working time for DEGADECK Crack Sealer is between 10 to 15 minutes after Powder Hardener addition.

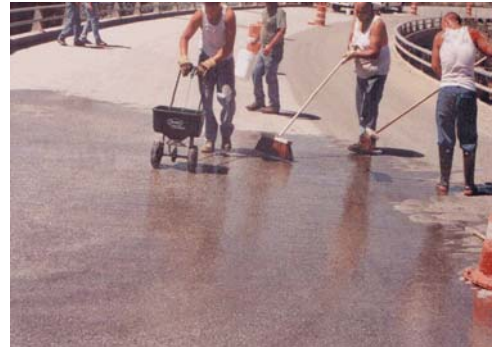
**Step 7 – Broadcast Sand**

Randomly broadcast a 30 mesh (600 µm), dry aggregate into the wet, uncured resin at the maximum rate of 4 lb/100 ft<sup>2</sup> (200 g/m<sup>2</sup>).

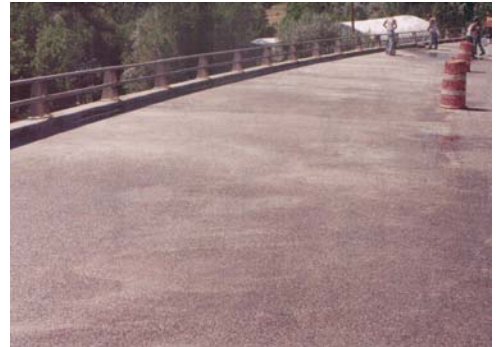
**Step 8 – Allow to Cure; Open to Traffic**

Allow one hour for Crack Sealer to gain full mechanical properties. Check for dry-to-touch condition. End result should be a darker-colored, matte finish with a minimal surface film and some loose broadcast aggregate. Open to traffic. Although the surface film is sacrificial, cracks will continue to be protected.
